Expertise

Protocol number: 46579034  
Order No. / Reference: 26630636  
Inspection date: 17 Jul 2026

Manufacturer: Volkswagen

Model: Tiguan 2.0 TDI SCR DSG R-Line

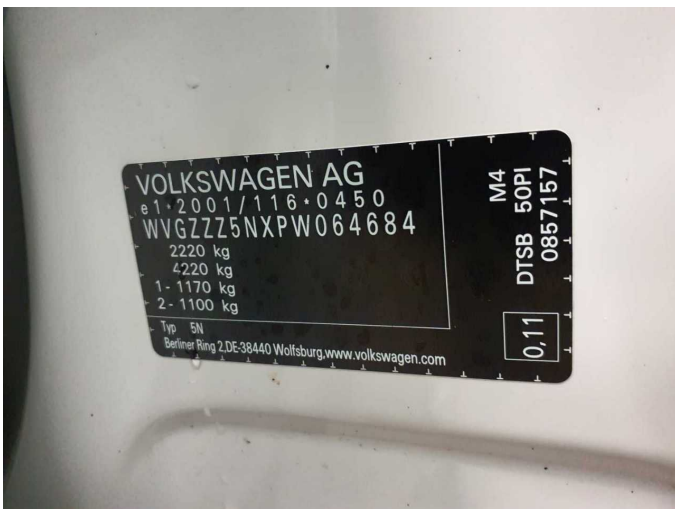
Figure 11: VIN

| VIN comparison | The vehicle identification number (VIN) was read from the vehicle and its conformity with the submitted documents was confirmed by the undersigned during the inspection. |

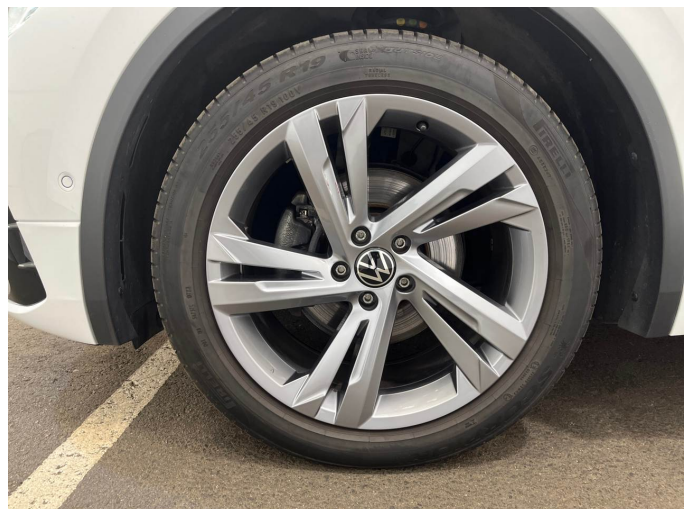
Figure 12: Mounted tyres

| Mounted tyres | | | | |
|---|---|---|---|---|
| 1) | 255/45 R19 100V | Summer tires (with run-flat tires) on Light alloy | Pirelli | 5mm / 5mm |
| 2) | 255/45 R19 100V | Summer tires (with run-flat tires) on Light alloy | Pirelli | 6mm / 6mm |

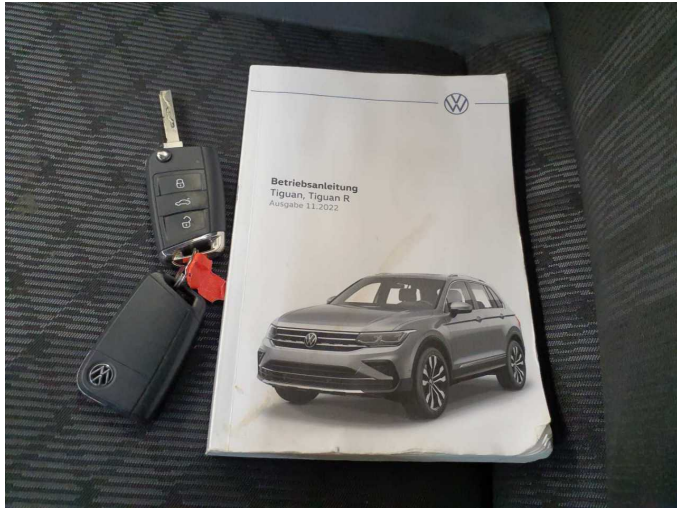
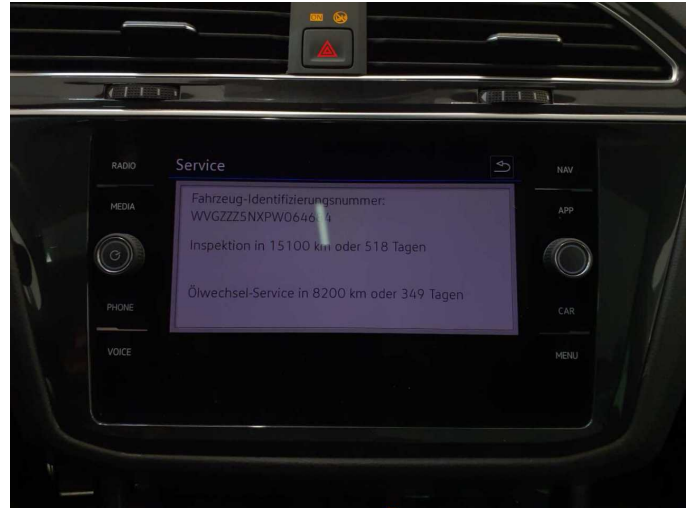
| Documents submitted | At the time of the inspection, the vehicle registration certificate Part 2 (title) was available, but the vehicle registration certificate Part 1 (document) was not. (Copy) |

Figure 13: Documents

Figure 14: Documents

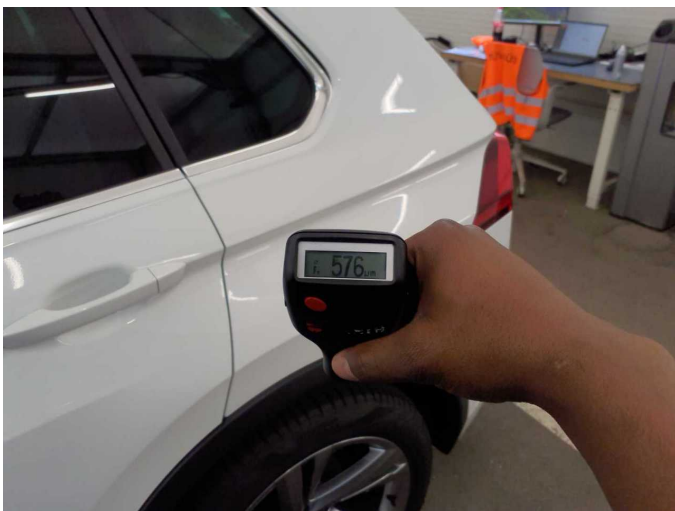
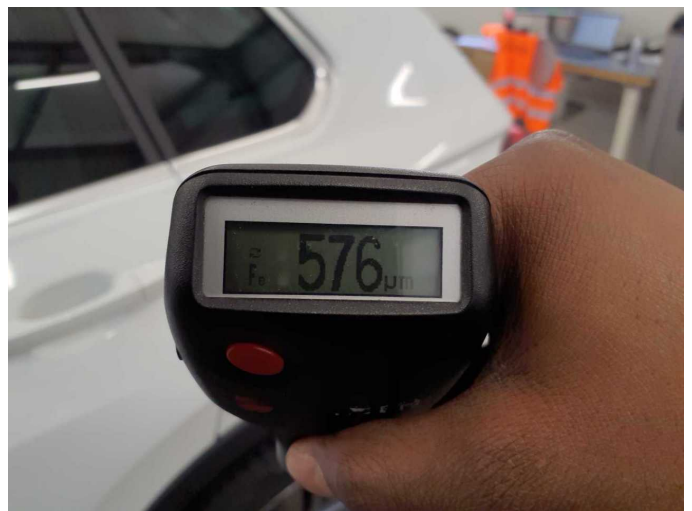
1 Side panel - rear left side, Professionally carried out, Invoice of repair done Non-existent

Side panel - rear left side 576  $\mu\text{m}$  |

Repainting 1: Side panel - rear left side
