Expertise

Protocol number: 46378441  
Order No. / Reference: 26657182  
Inspection date: 6 Jul 2026

Manufacturer: Peugeot

Model: 5008 BlueHDi 130 EAT8 GT

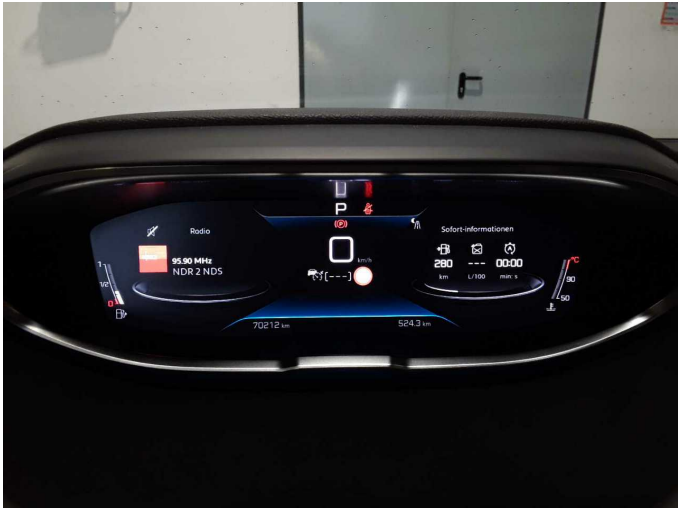
| Vehicle details | |
|---|---|
| Mileage (Read) | 70,212 km |

Figure 7: Instrument cluster

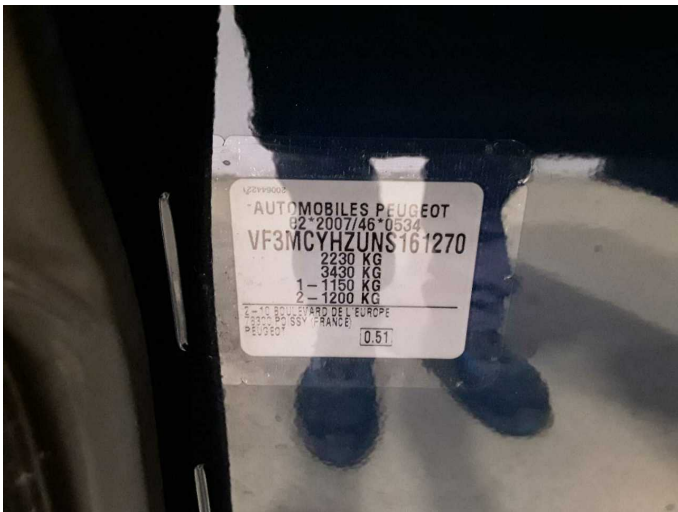
| VIN comparison | The vehicle identification number (VIN) was read from the vehicle and its conformity with the submitted documents was confirmed by the undersigned during the inspection. |

Figure 11: VIN

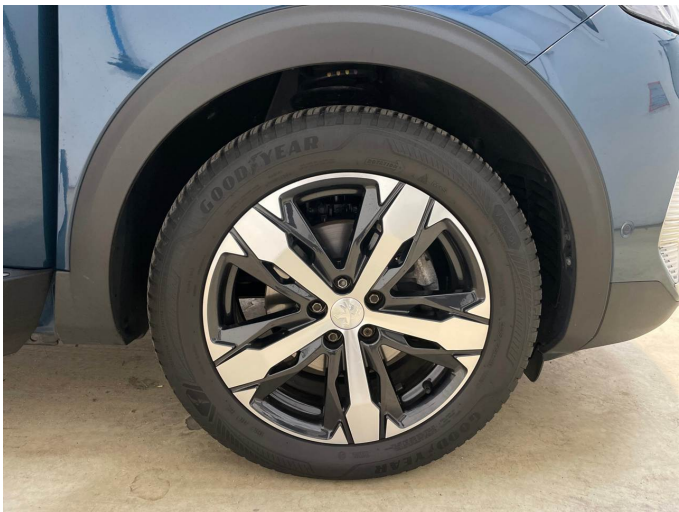
| Tyres | | | | |
|---|---|---|---|---|
| 1) | 225/55 R18 102V | All-season tyres on Light alloy | Goodyear | 6mm / 6mm |
| 2) | 225/55 R18 102V | All-season tyres on Light alloy | Goodyear | 6mm / 6mm |

Figure 12: Mounted tyres

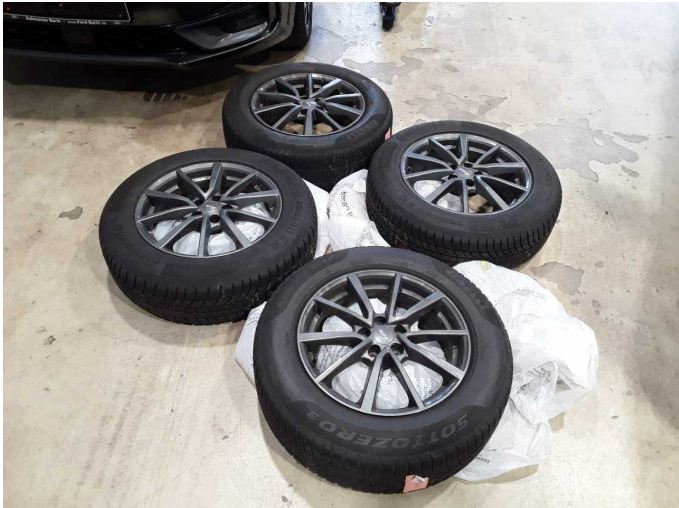
| Tyres | | | | |
|---|---|---|---|---|
| 1) | 215/65 R17 99H | Winter tyres on Light alloy | Pirelli | 4mm / 4mm |
| 2) | 215/65 R17 103H | Winter tyres on Light alloy | Continental | 8mm / 8mm |

Figure 16: Additional tyres

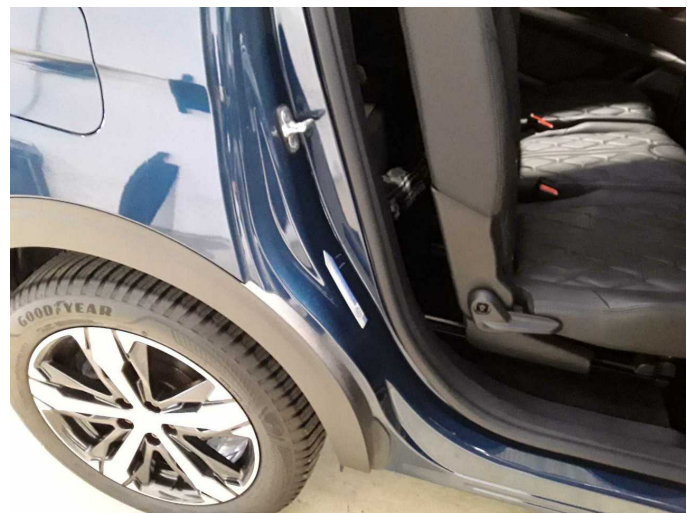
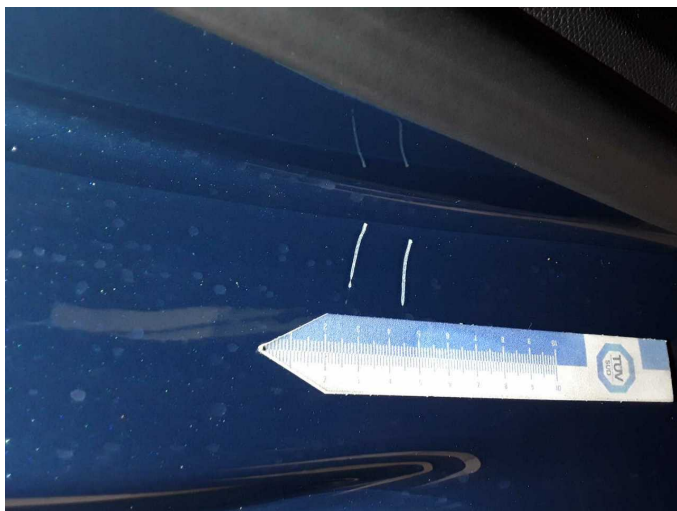
Damage 1: Side panel - rear right side: Sill - Scratch(es) - Smart repair

| No. | Component group | Description |
|---|---|---|
| 1 | Side panel - rear right side | Sill - Scratch(es) - Smart repair |

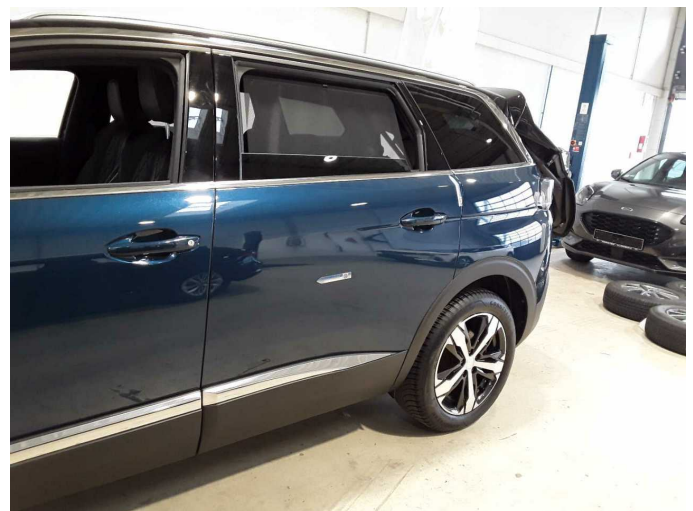
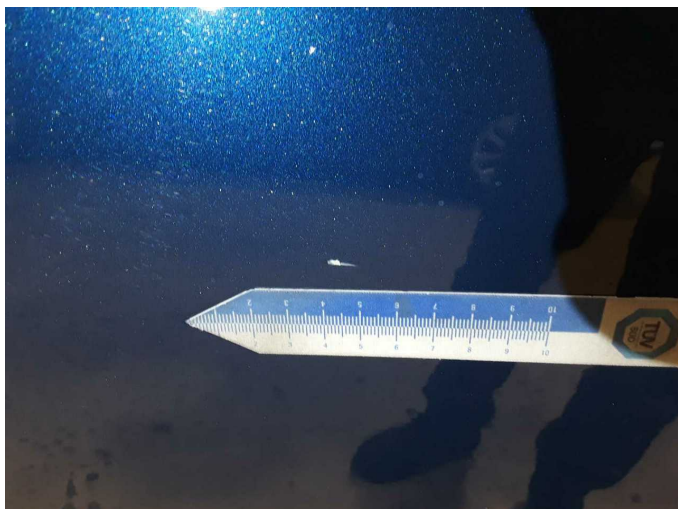
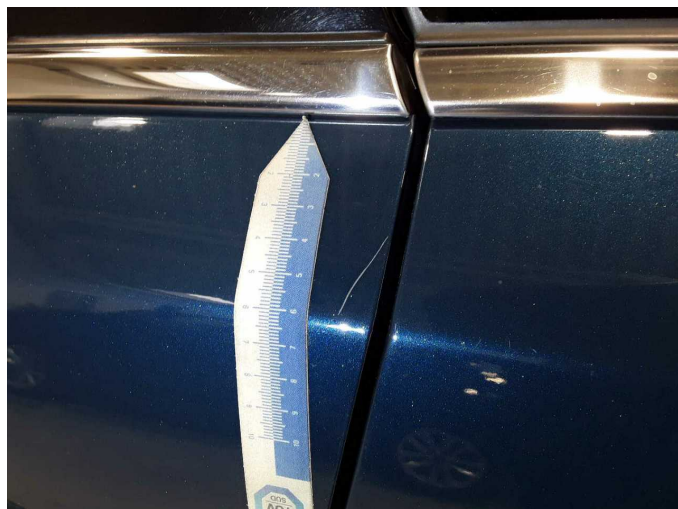
Damage 2: Door - rear left side: Door - Scratch(es) - Paint

**Damage 2:** Door - rear left side: Door - Scratch(es) - Paint

| No. | Component group | Description |
|---|---|---|
| 2 | Door - rear left side | Door - Scratch(es) - Paint |

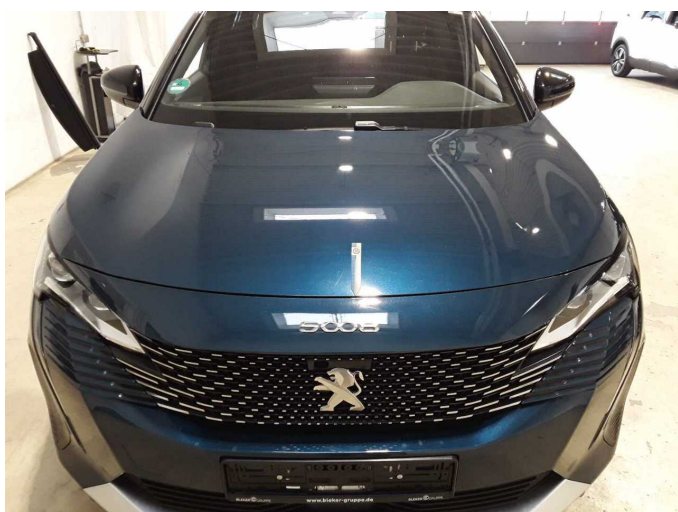
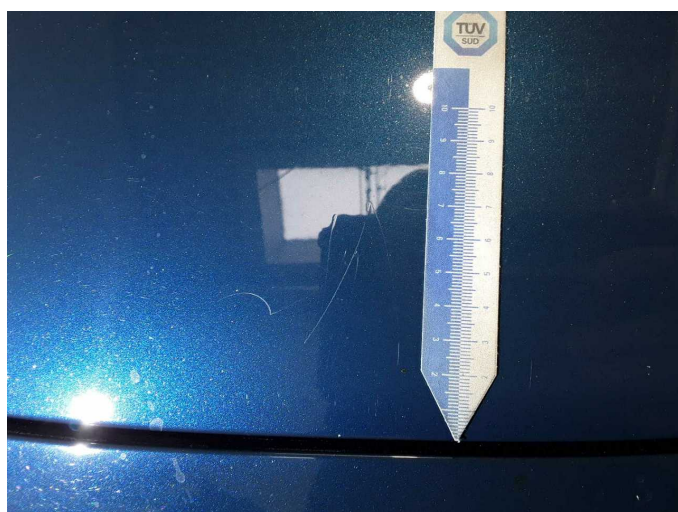
**Damage 3:** Bonnet: Bonnet - Scratch(es) - Paint

| No. | Component group | Description |
|---|---|---|
| 3 | Bonnet | Bonnet - Scratch(es) - Paint |

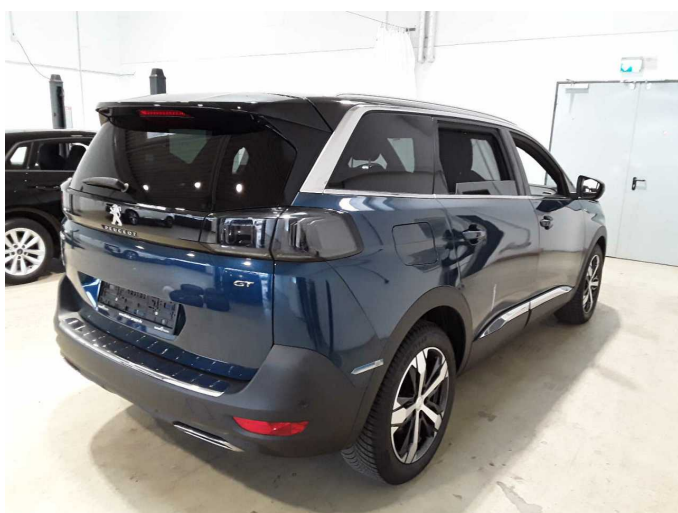
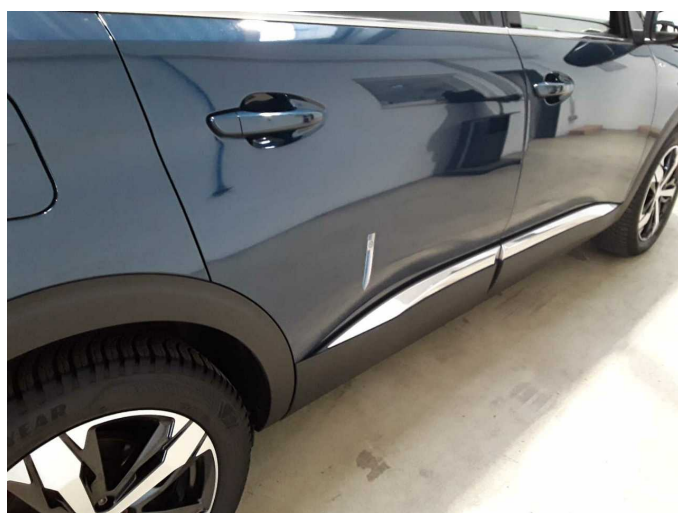
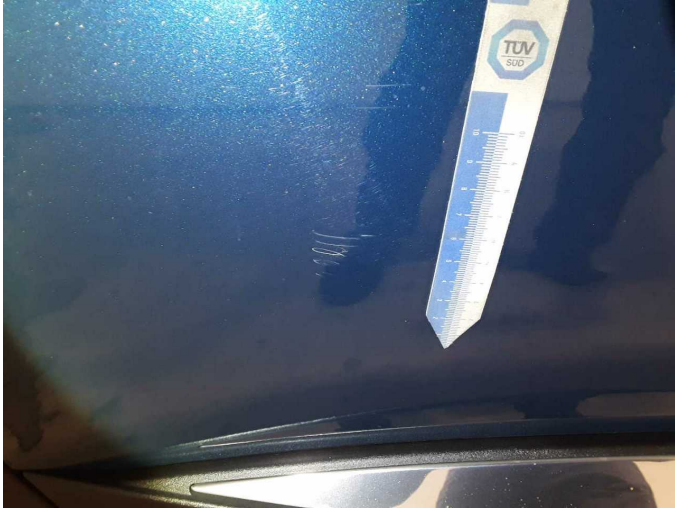
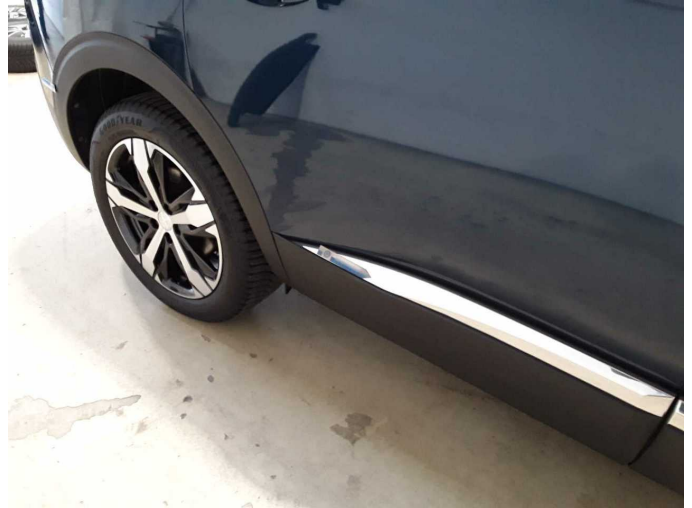
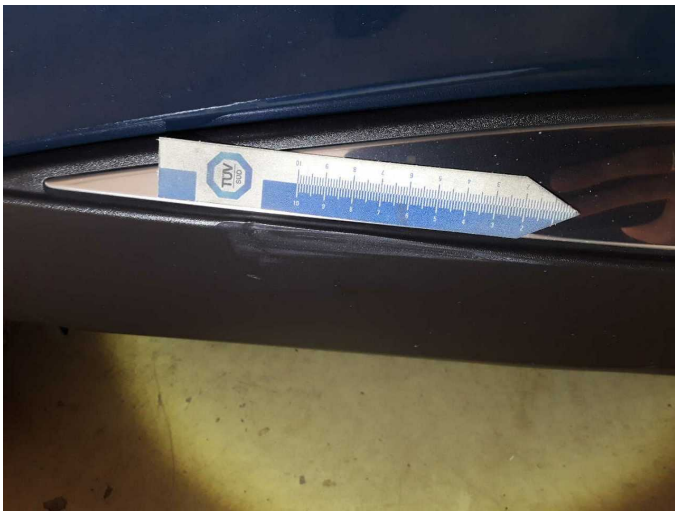
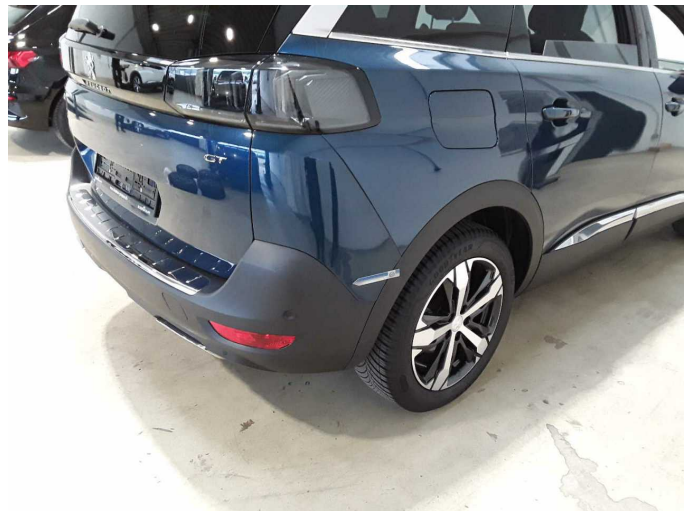
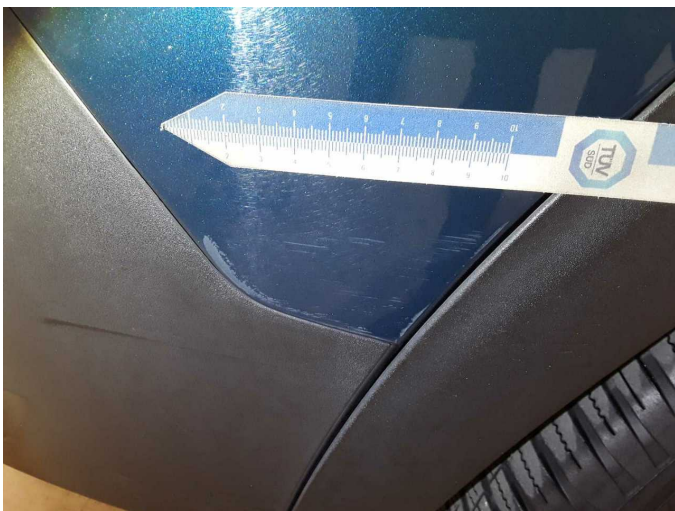
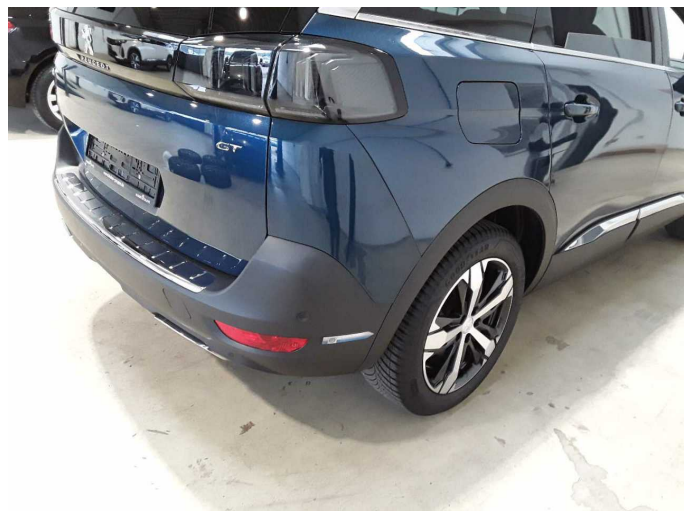
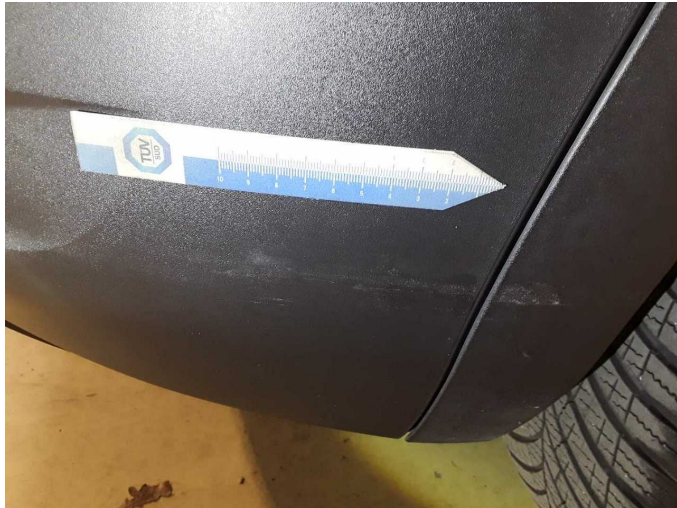
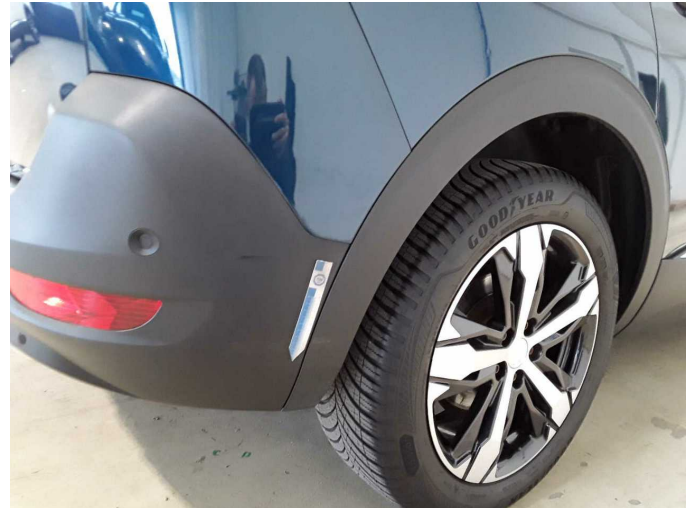
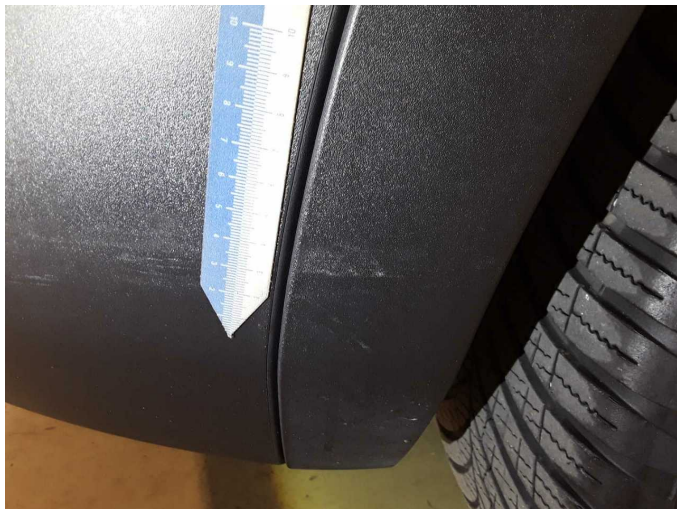
1 Side right

**Accident 1:** Side right

**Accident 1: Side right**

Non-repaired previous damages were found at the vehicle. The necessary repair costs are listed in the expert report or if necessary, are listed in detail in a separately enclosed repair cost calculation.

- Die beigefügte Reparaturkostenkalkulation wurde nach bestem Wissen und Gewissen unter eingeschränkten Besichtigungsbedingung im demontagefreien Zustand erstellt. Es können aufgrund verdeckter Beschädigung erhebliche Mehrkosten und somit Abweichung der für den Unfall ausgewiesenen Reparaturkosten nicht ausgeschlossen werden
