Expertise

Protocol number: 45462013
Order No. / Reference: 26243298
Inspection date: 13 May 2026

Model: Kodiaq 2.0 TDI DSG Ambition

VIN: TMBJJ9NS3P8520995

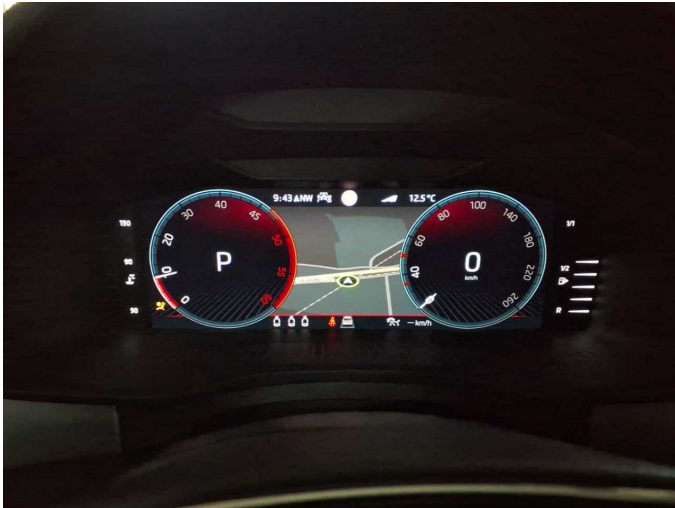
Figure 7: Instrument cluster

Mileage (Read) 127,030 km

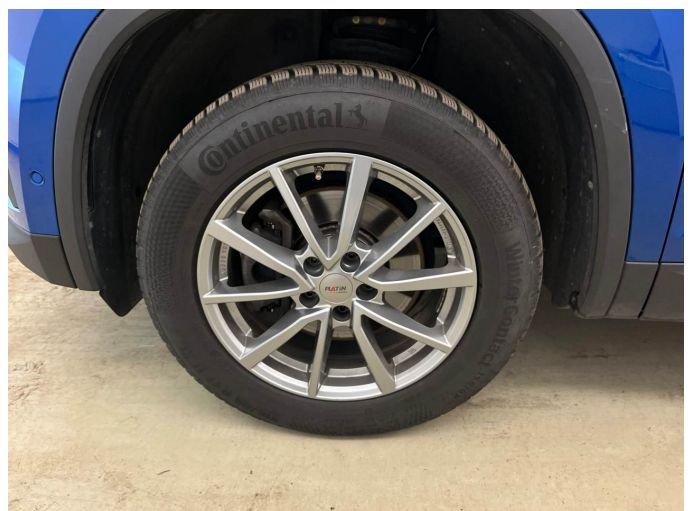
Figure 12: Mounted tyres

#	Tyre size	Type of tyre	Manufacturer	Tread depth
1)	215/65 R17 103H	Winter tyres on Light alloy	Bridgestone	4mm / 4mm
2)	215/65 R17 103H	Winter tyres on Light alloy	Bridgestone	4mm / 4mm

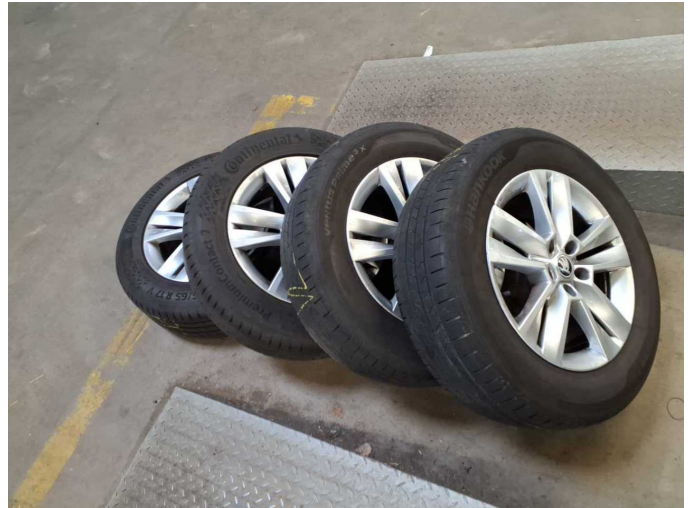
Figure 14: Additional tyres

#	Tyre size	Type of tyre	Manufacturer	Tread depth
1)	215/65 R17 99V	Summer tyres on Light alloy	Hankook	4mm / 4mm
2)	215/65 R17 99V	Summer tyres on Light alloy	Hankook	5mm / 5mm

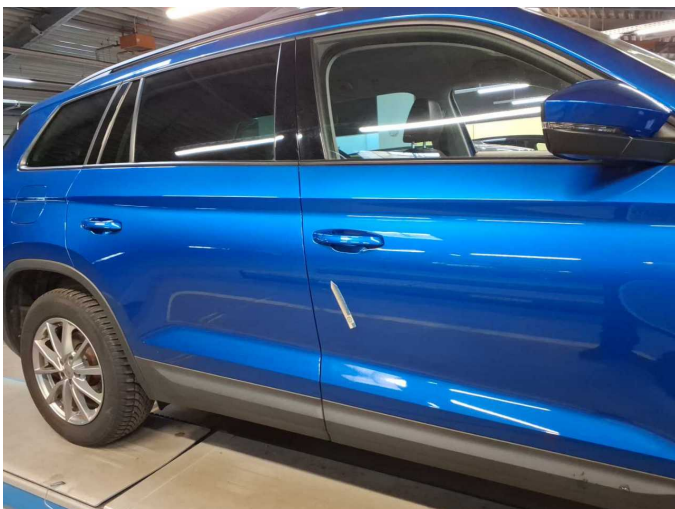
Damage 2: Door - front right side: Door - dent(s) - Smooth repair work

No.	Component group	Description
1	Equipment	Vehicle key (Batterie) - Empty - Replace
2	Door - front right side	Door - dent(s) - Smooth repair work
3	Bonnet	Bonnet - dent(s) - Smooth repair work
4	Airbag systems	Airbag system - Functional / admissibility - Perform diagnosis
5	Door - rear right side	Door - Dent / paintcoat damage - Repair and paint

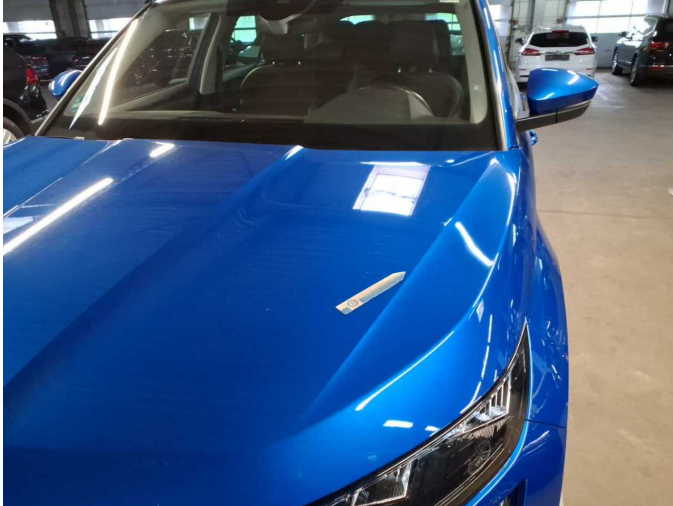
Damage 3: Bonnet: Bonnet - dent(s) - Smooth repair work

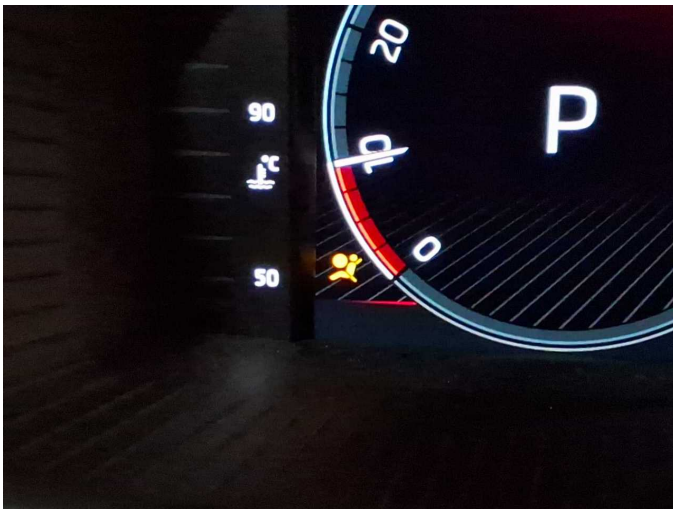
Damage 4: Airbag systems: Airbag system - Functional / admissibility - Perform diagnosis

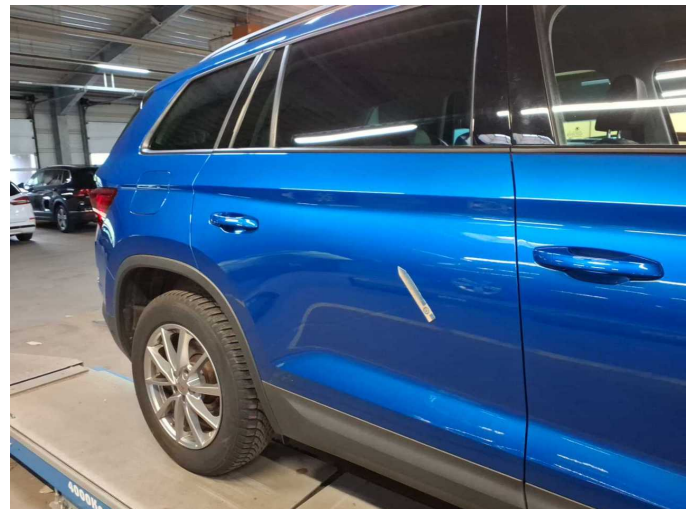
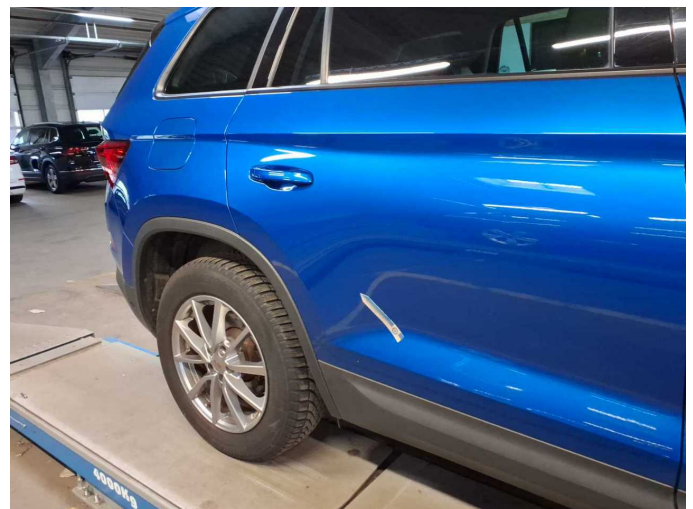
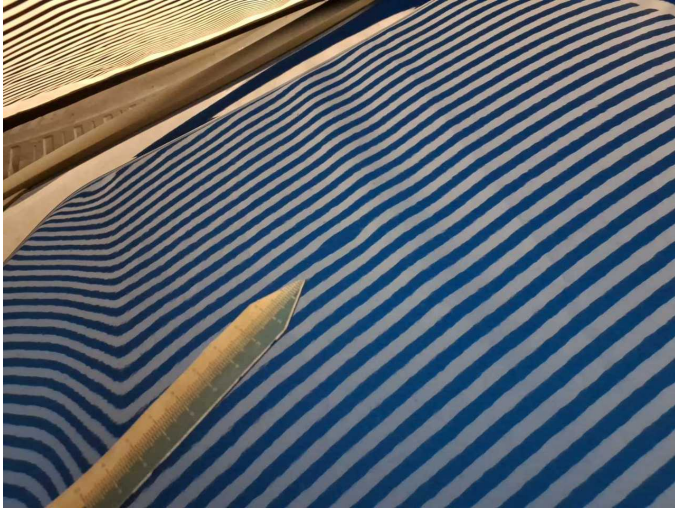
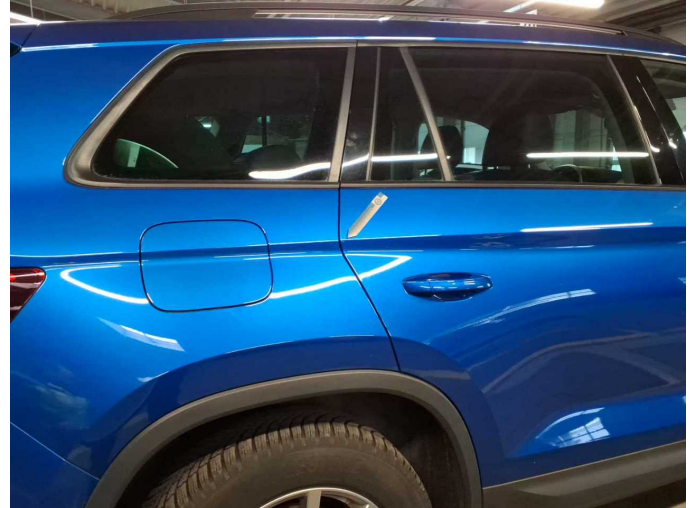
Damage 5: Door - rear right side: Door - Dent / paintcoat damage - Repair and paint
