Expertise

Protocol number: 46541216  
Order No. / Reference: 26630066  
Inspection date: 10 Jul 2026

Manufacturer: Volvo

Model: XC60 B4 D Ultimate Dark

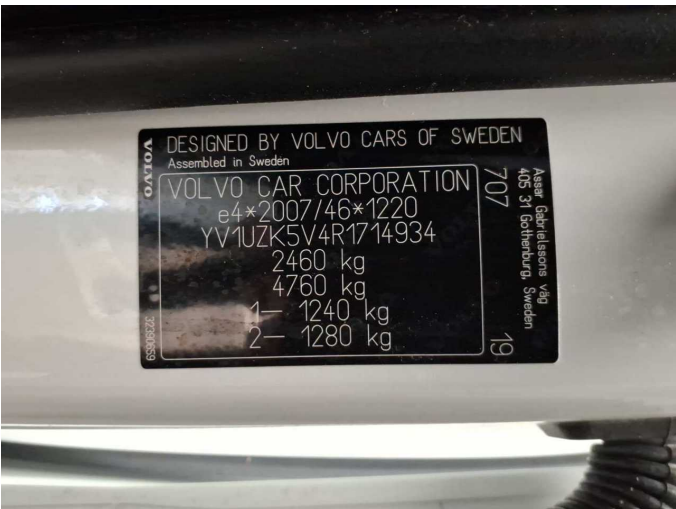
Figure 11: VIN

| VIN comparison | The vehicle identification number (VIN) was read from the vehicle and its conformity with the submitted documents was confirmed by the undersigned during the inspection. |

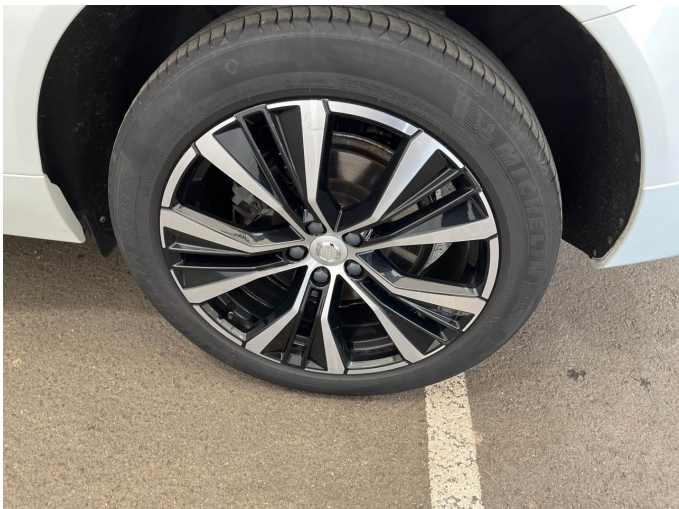
Figure 12: Mounted tyres

| # | Tyre size | Type of tyre | Manufacturer | Tread depth |
|---|---|---|---|---|
| 1) | 255/45 R20 105Y | Summer tyres on Light alloy | Falken | 6mm / 6mm |
| 2) | 255/45 R20 105Y | Summer tyres on Light alloy | Michelin | 6mm / 6mm |

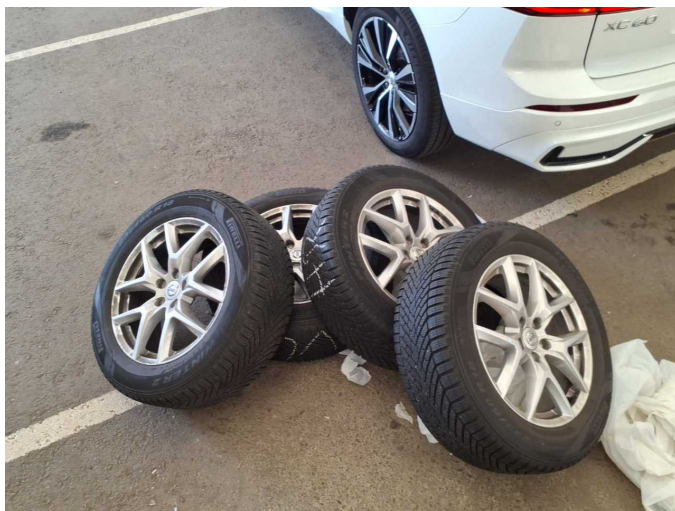
Figure 15: Additional tyres

| # | Tyre size | Type of tyre | Manufacturer | Tread depth |
|---|---|---|---|---|
| 1) | 235/60 R18 107V | Winter tyres on Light alloy | Pirelli | 5mm / 5mm |
| 2) | 235/60 R18 107V | Winter tyres on Light alloy | Pirelli | 6mm / 6mm |

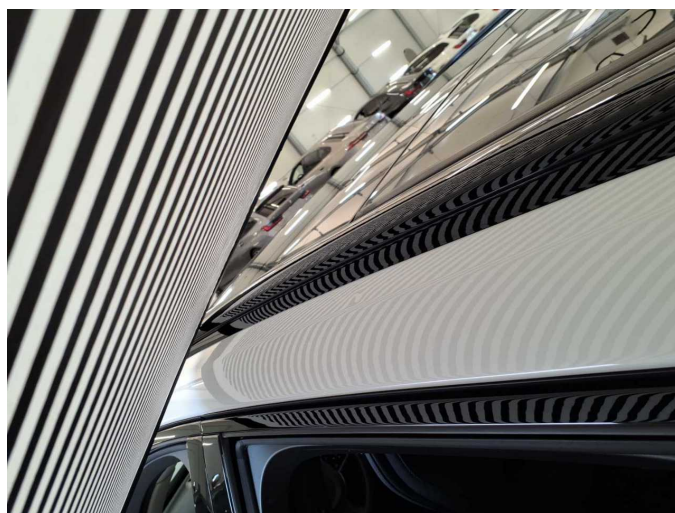
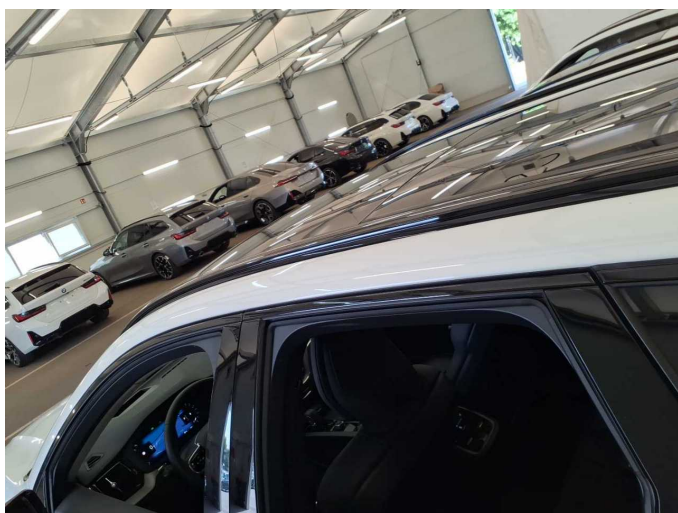
| No. | Component group | Description |
|---|---|---|
| 1 | Roof | Roof rail - left side - dent(s) - Smooth repair work |

**Damage 1:** Roof: Roof rail - left side - dent(s) - Smooth repair work

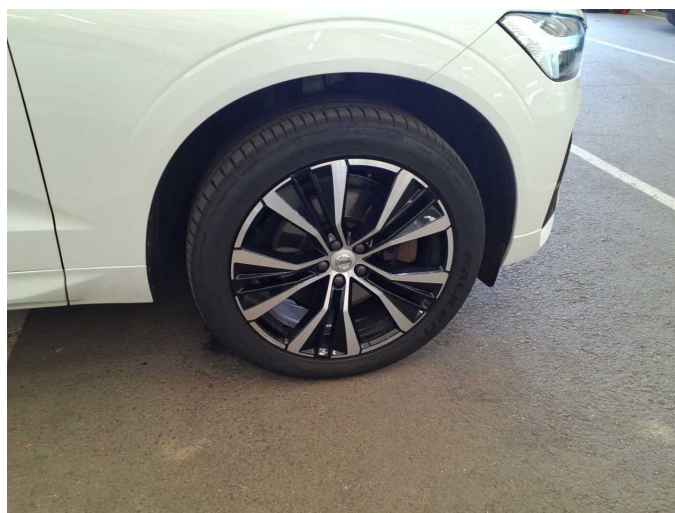
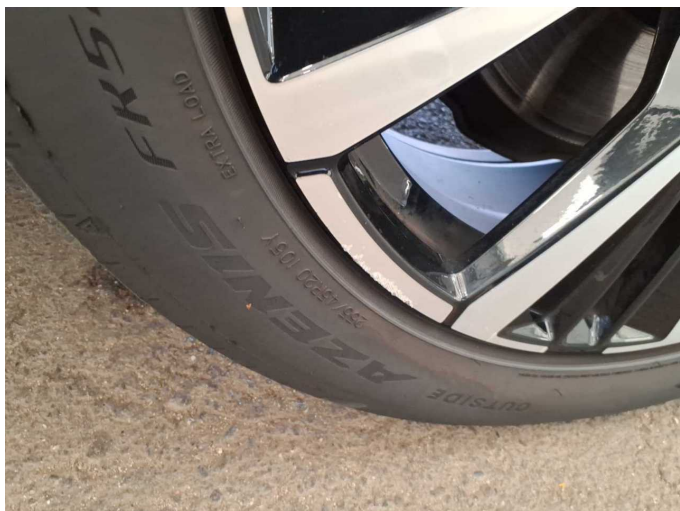
| No. | Component group | Description |
|---|---|---|
| 2 | Wheel / tyres | Alloy rim - front right side - Scratch(es) - Loss in value |

**Damage 2:** Wheel / tyres: Alloy rim - front right side - Scratch(es) - Loss in value

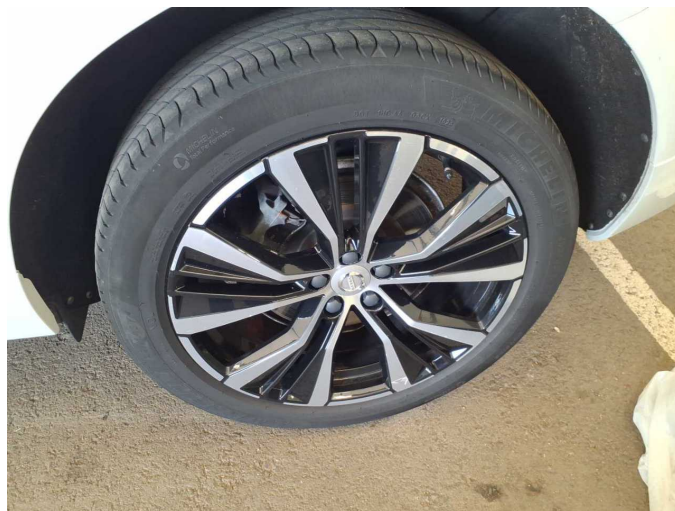
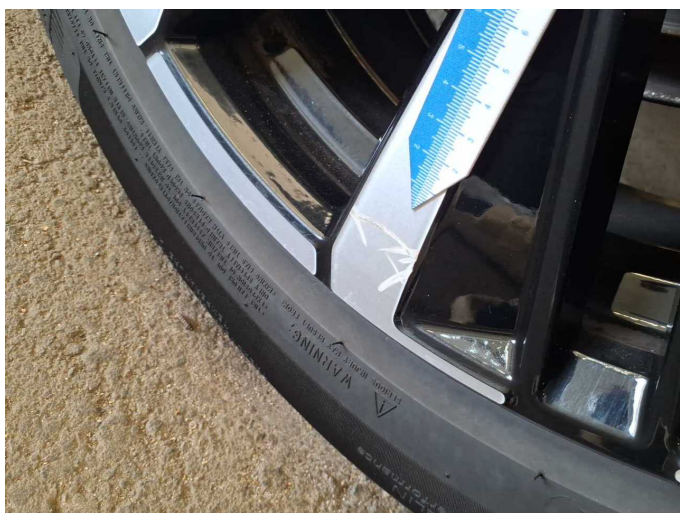
| No. | Component group | Description |
|---|---|---|
| 3 | Wheel / tyres | Alloy rim - rear left side - Scratch(es) - Loss in value |

**Damage 3:** Wheel / tyres: Alloy rim - rear left side - Scratch(es) - Loss in value

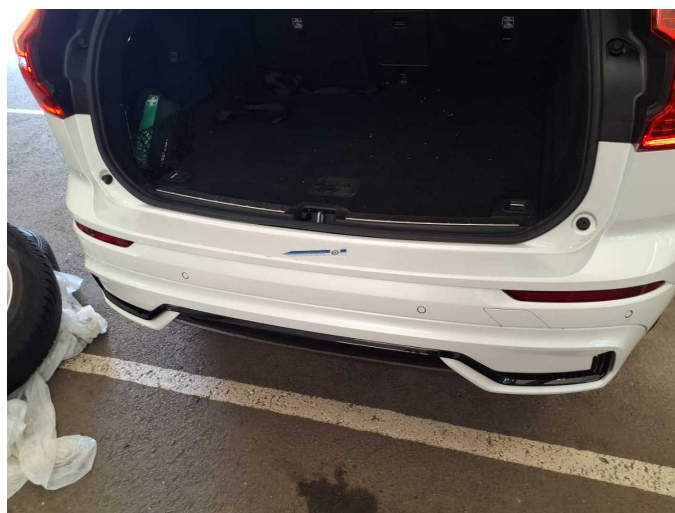
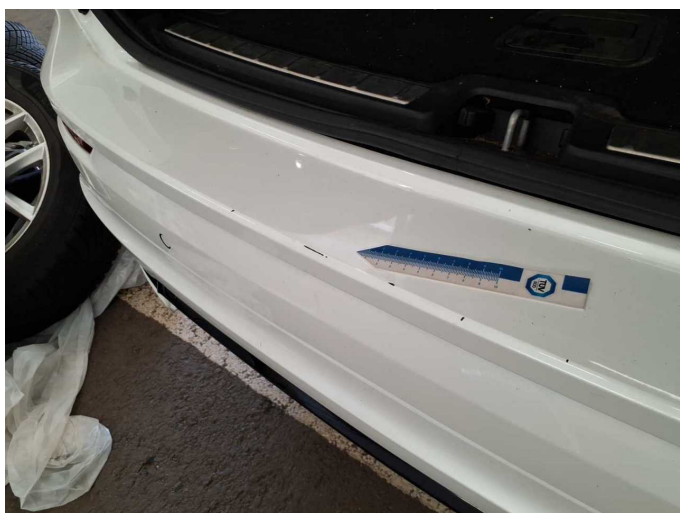
| No. | Component group | Description |
|---|---|---|
| 4 | Rear bumper | Rear bumper (Ladekante) - Scratched - Paint |

**Damage 4:** Rear bumper: Rear bumper (Ladekante) - Scratched - Paint
