Expertise

Protocol number: 46891409  
Order No. / Reference: 26748641  
Inspection date: 5 Aug 2026

Manufacturer: Volkswagen

Model: Passat Variant 2.0 TDI SCR DSG Business

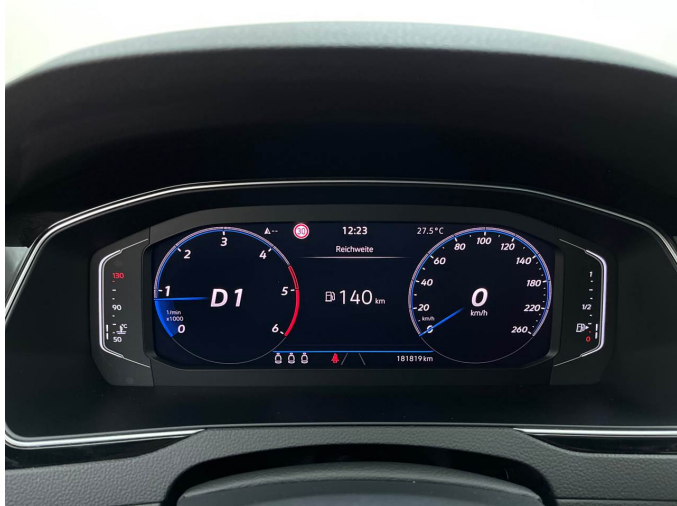
Figure 7: Instrument cluster

| Vehicle details | |
|---|---|
| Mileage (Read) | 181,819 km |

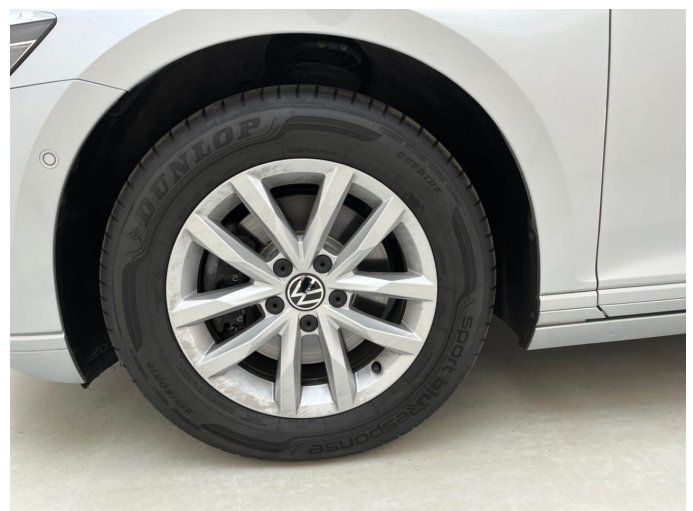
Figure 12: Mounted tyres

| # | Tyre size | Type of tyre | Manufacturer | Tread depth |
|---|---|---|---|---|
| 1) | 215/60 R16 95V | Summer tyres on Light alloy | Dunlop | 5mm / 5mm |
| 2) | 215/60 R16 95V | Summer tyres on Light alloy | Dunlop | 5mm / 5mm |

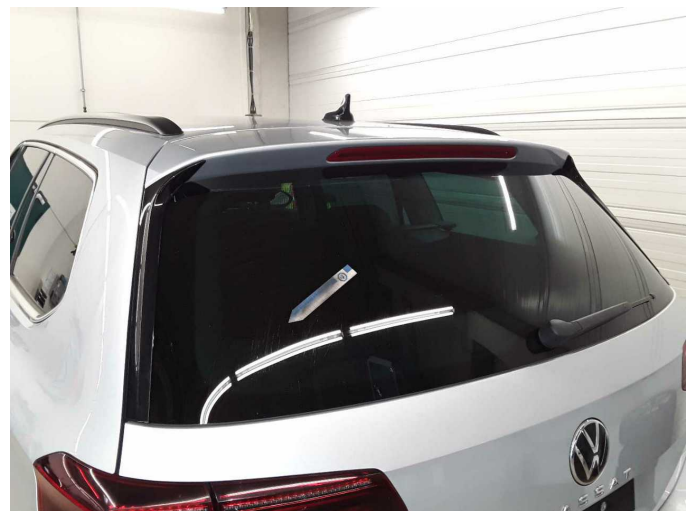
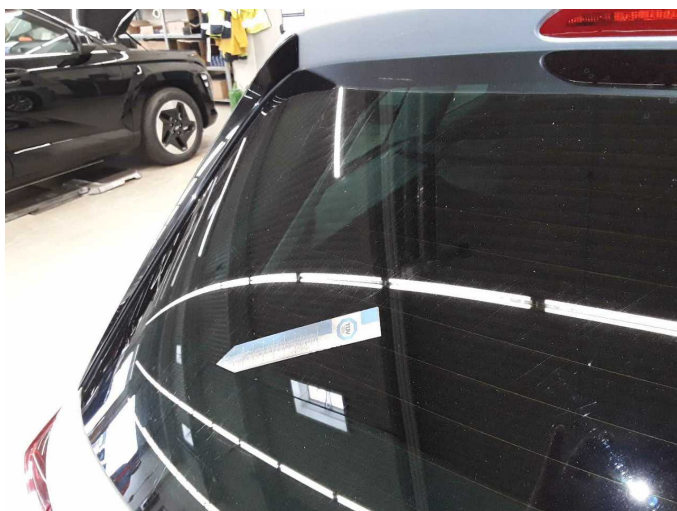
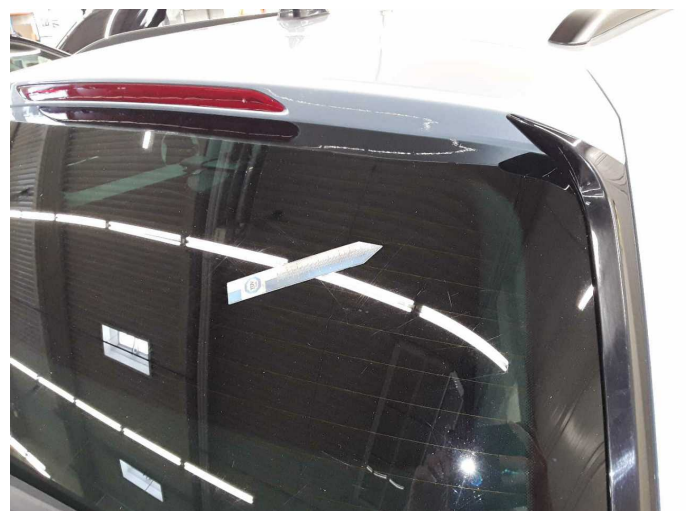
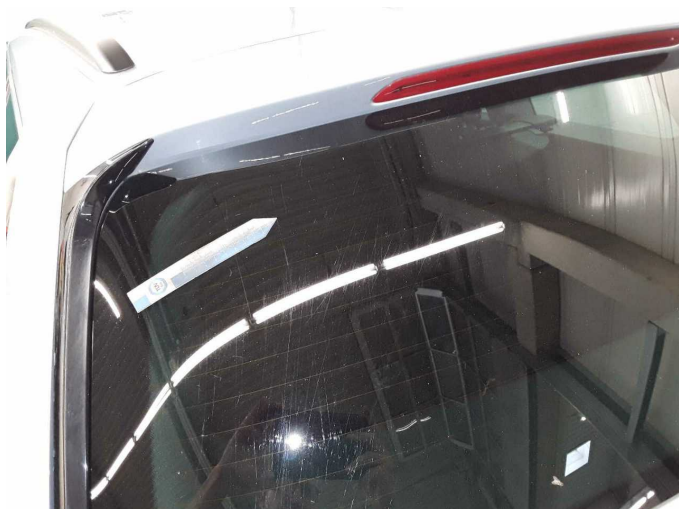
Damage 2: Vehicle glazing: Rear window - Scratch(es) - Loss in value

**Damage 2:** Vehicle glazing: Rear window - Scratch(es) - Loss in value

| No. | Component group | Description |
|---|---|---|
| 2 | Vehicle glazing | Rear window - Scratch(es) - Loss in value |

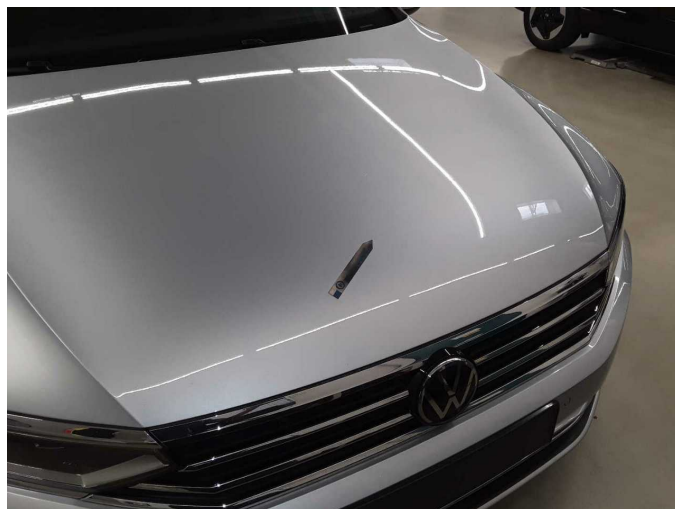
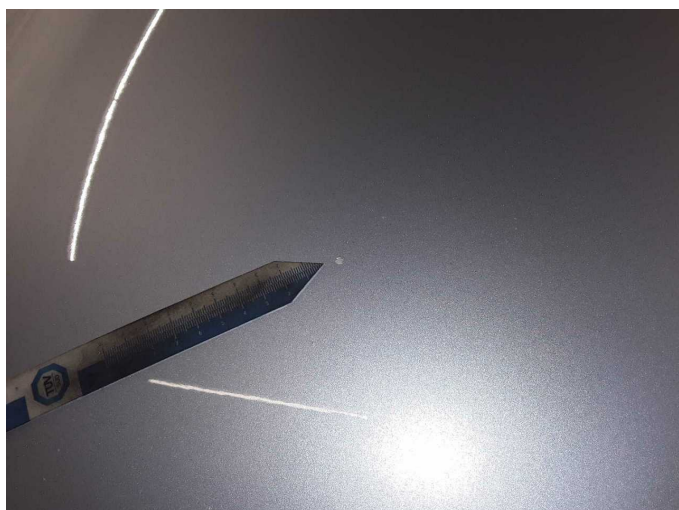
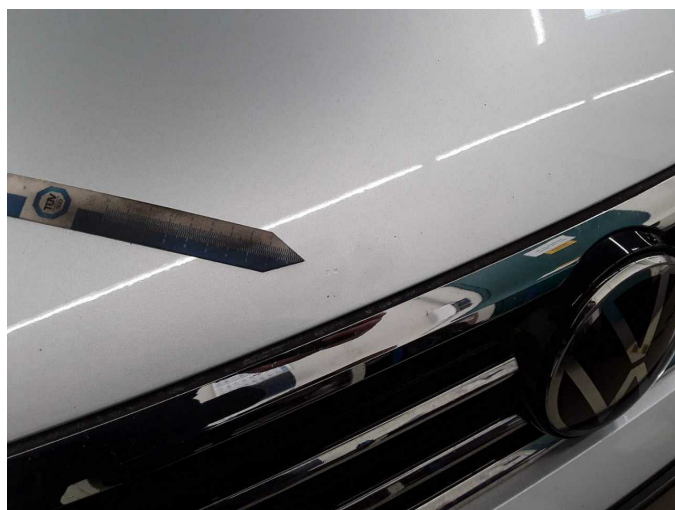
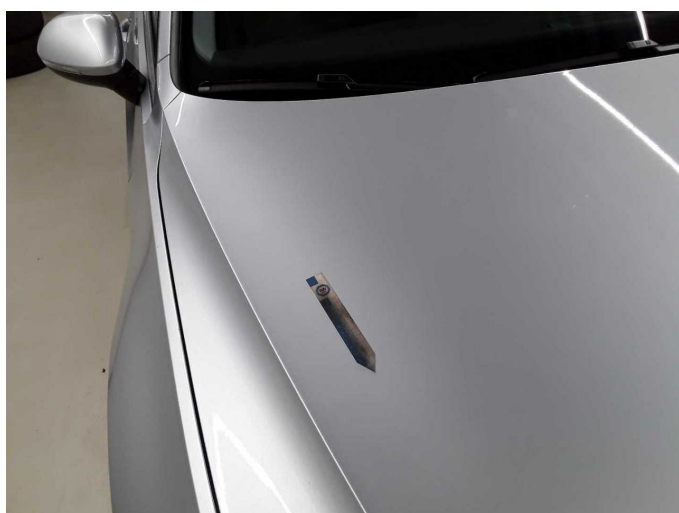
**Damage 3:** Bonnet: Bonnet - Stone chips - Smart repair

| No. | Component group | Description |
|---|---|---|
| 3 | Bonnet | Bonnet - Stone chips - Smart repair |

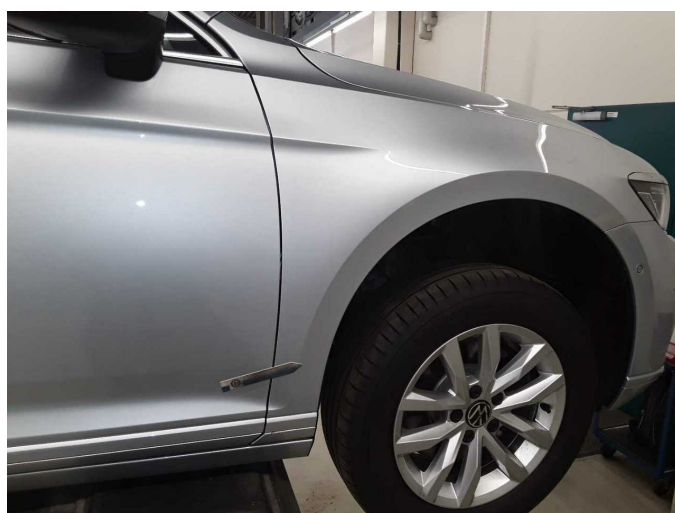
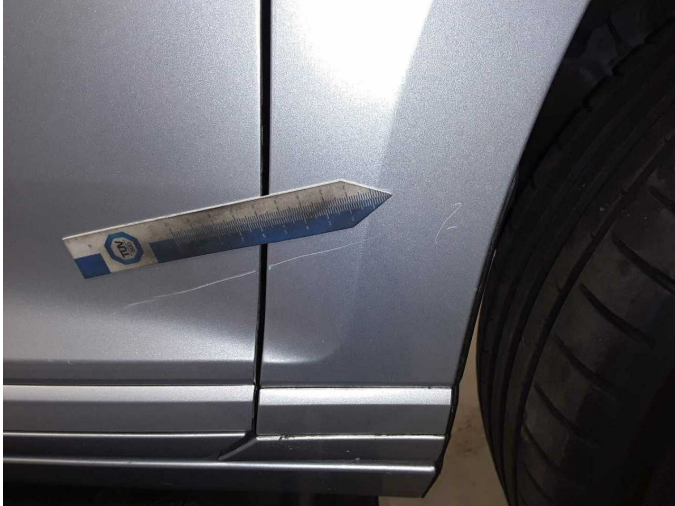
**Damage 4:** Mudguard - right side: Mudguard - right side - Scratch(es) - Smart repair

| No. | Component group | Description |
|---|---|---|
| 4 | Mudguard - right side | Mudguard - right side - Scratch(es) - Smart repair |

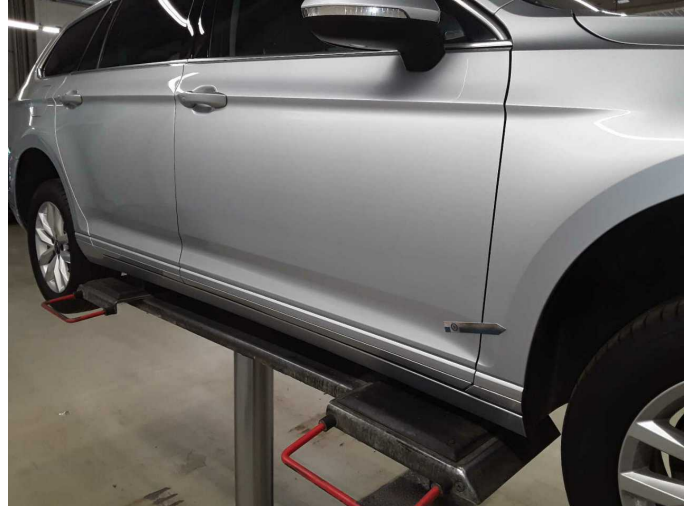
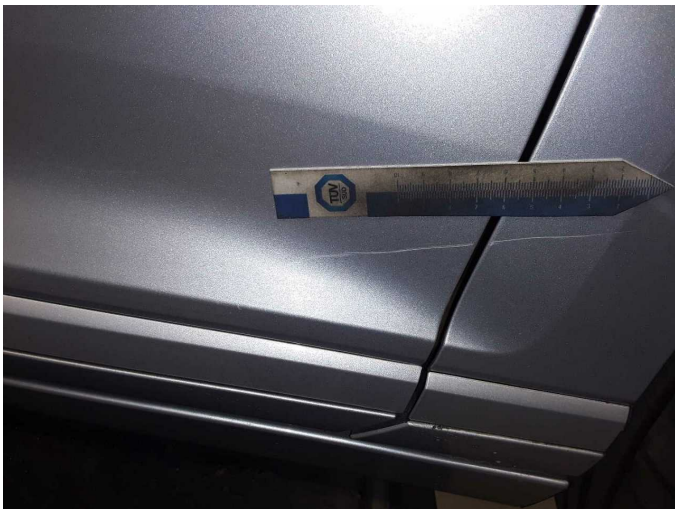
**Damage 5:** Door - front right side: Door (Unten) - Scratch(es) - Smart repair

| No. | Component group | Description |
|---|---|---|
| 5 | Door - front right side | Door (Unten) - Scratch(es) - Smart repair |

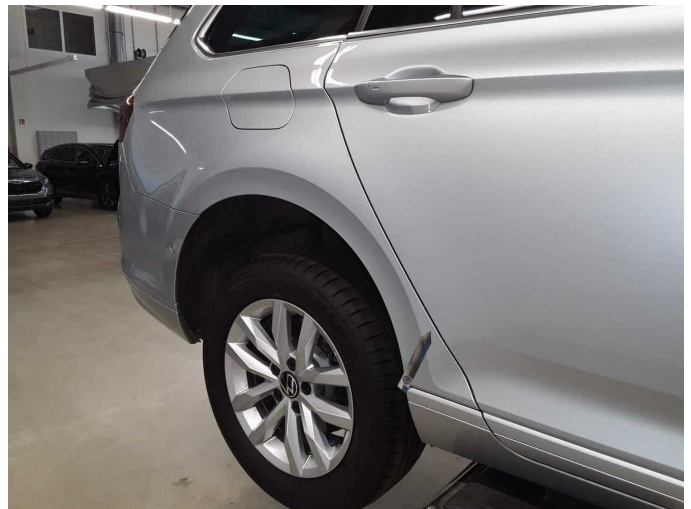
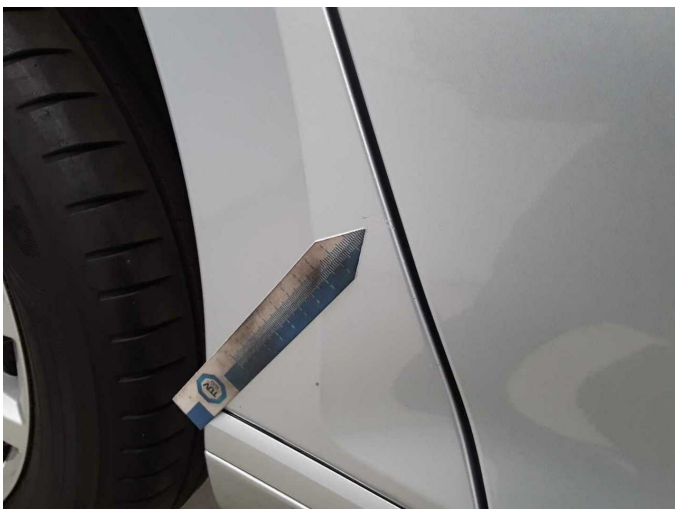
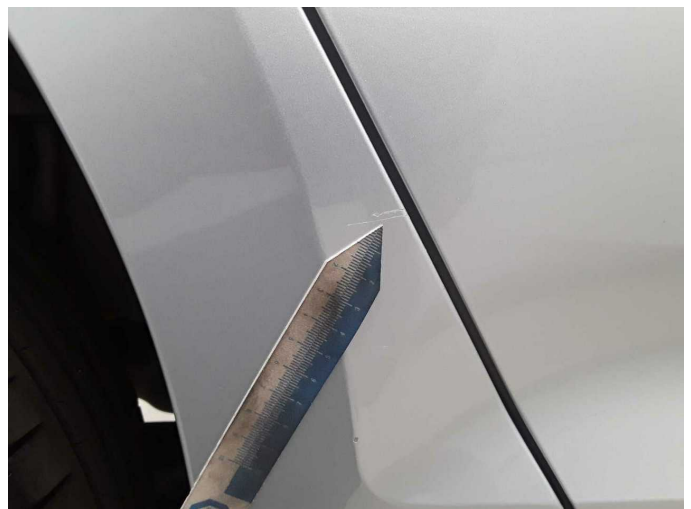
**Damage 6:** Side panel - rear right side: Side panel - Scratch(es) - Smart repair

| No. | Component group | Description |
|---|---|---|
| 6 | Side panel - rear right side | Side panel - Scratch(es) - Smart repair |

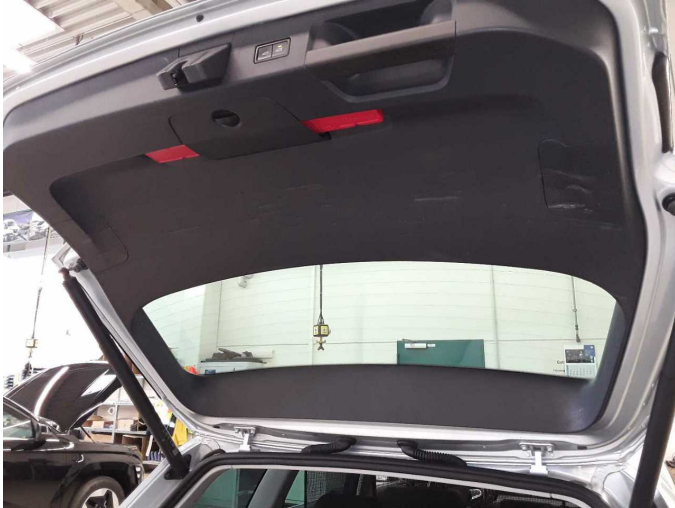
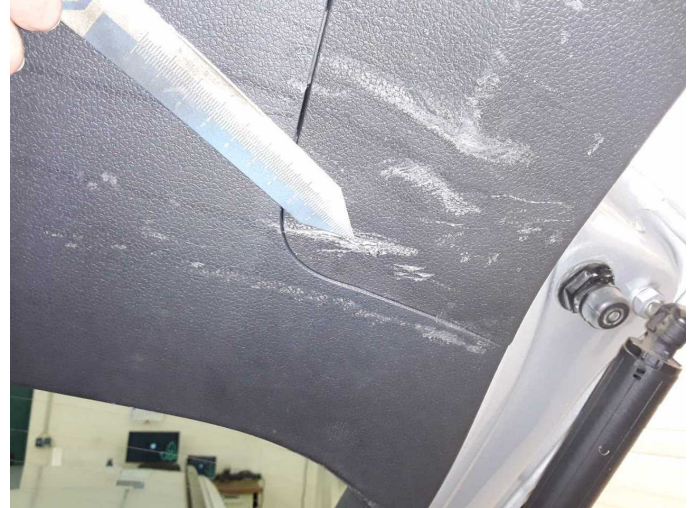
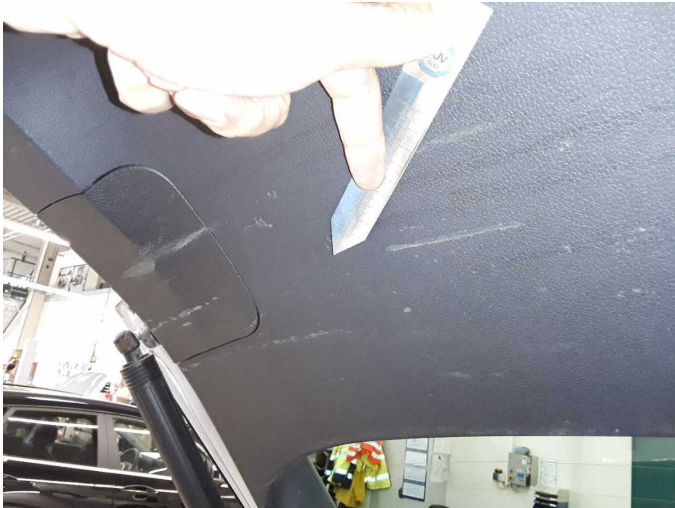
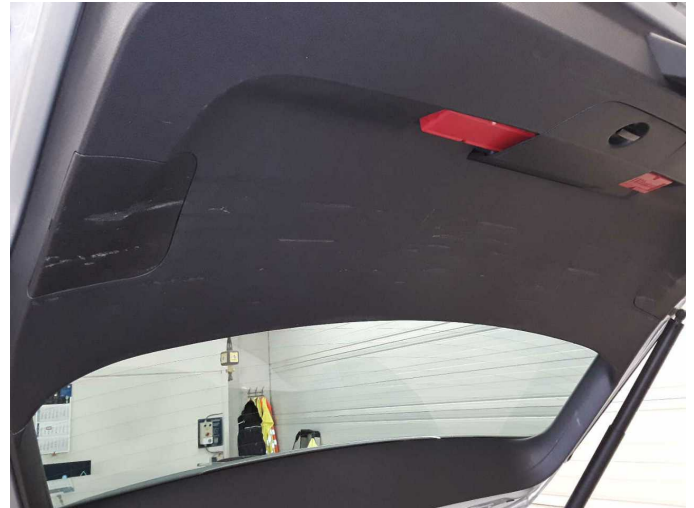
**Damage 7:** Boot lid / rear door: Trim - standard - lower - Scratch(es) - Replace

| No. | Component group | Description |
|---|---|---|
| 7 | Boot lid / rear door | Trim - standard - lower - Scratch(es) - Replace |

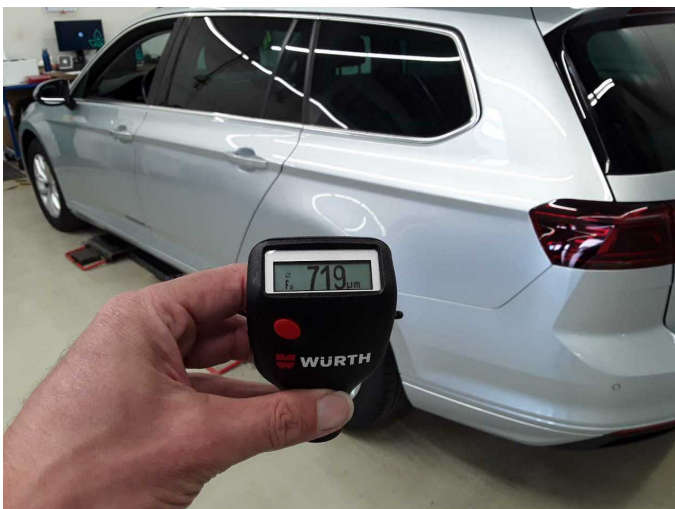
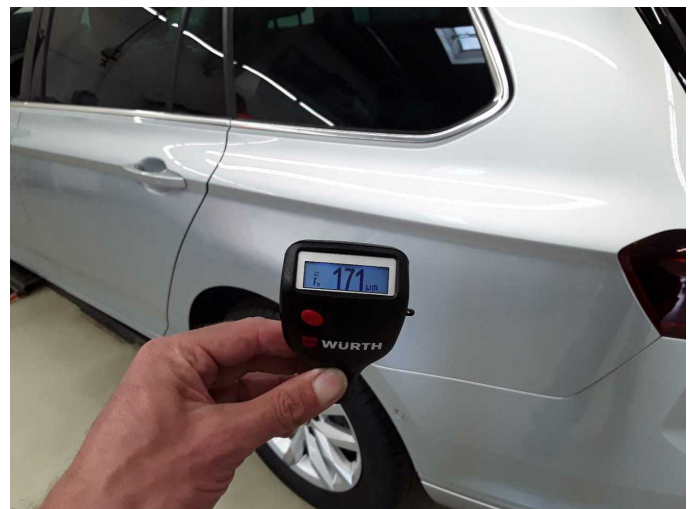
| 1 | Side panel - rear left side, Professionally carried out |

| Side panel - rear left side | 719 µm |

Side panel - rear left side: 719 µm
