## Expertise

Protocol number: 45968815  
Order No. / Reference: 26479556  
Inspection date: 12 Jun 2026

Model: Octavia Combi 2.0 TDI DSG Style

VIN: TMBJJ8NX2PY062226

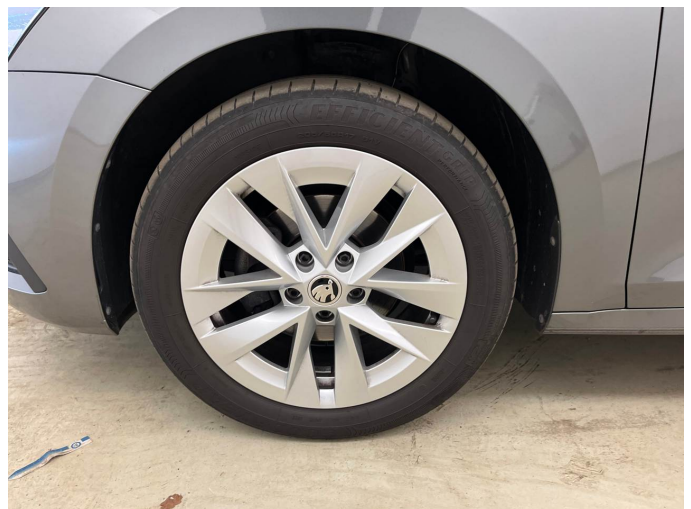
Figure 12: Mounted tyres

Mounted tyres				
#	Tyre size	Type of tyre	Manufacturer	Tread depth
1)	205/55 R17 91V	Summer tyres on Light alloy	Goodyear	4mm / 4mm
2)	205/55 R17 91V	Summer tyres on Light alloy	Goodyear	4mm / 4mm
Additional tyres				
#	Tyre size	Type of tyre	Manufacturer	Tread depth
1)	205/60 R16 96H	Winter tyres on Light alloy	Continental	5mm / 5mm
2)	205/60 R16 96H	Winter tyres on Light alloy	Continental	5mm / 5mm
Replacement				
Typ	Tyre size	Type of tyre	Manufacturer	Tread depth
	Tirefit	Expiration date 09/2026

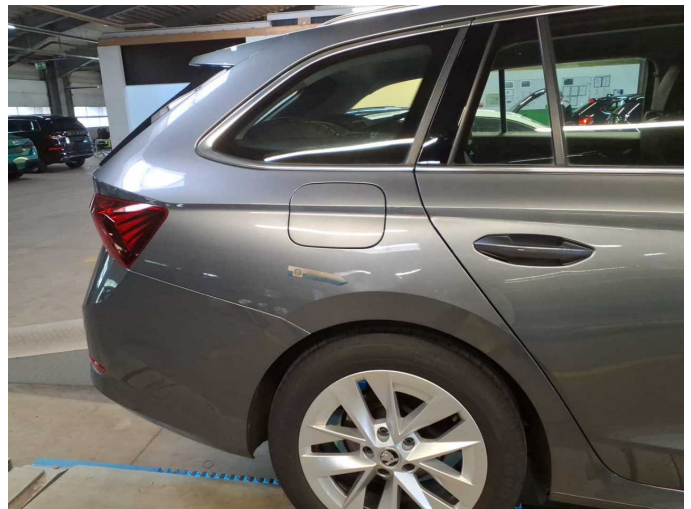
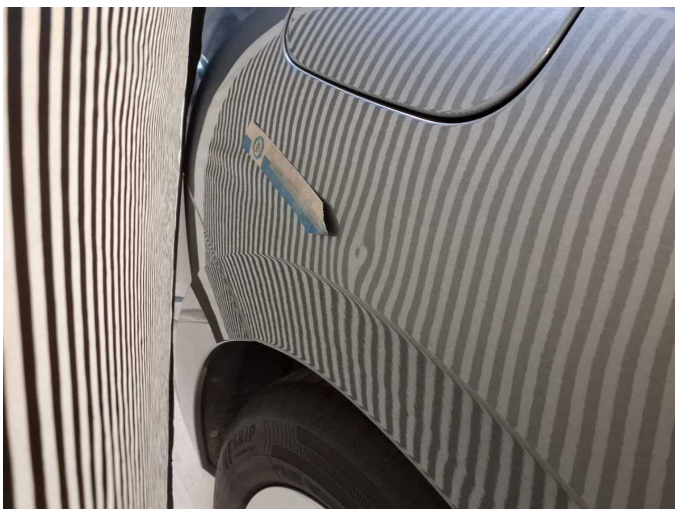
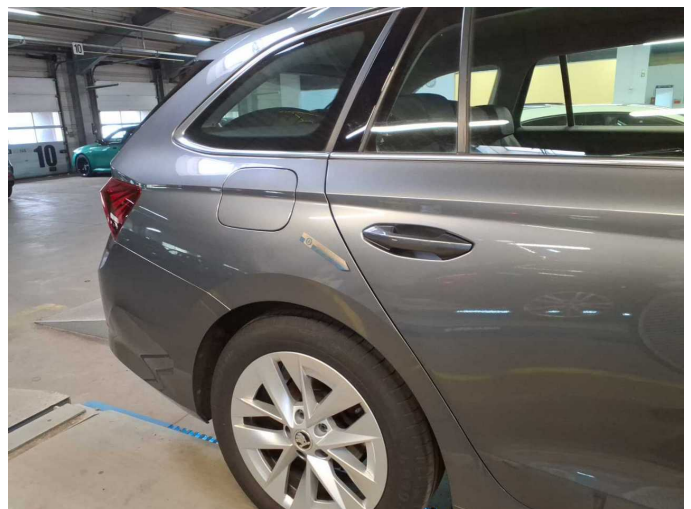
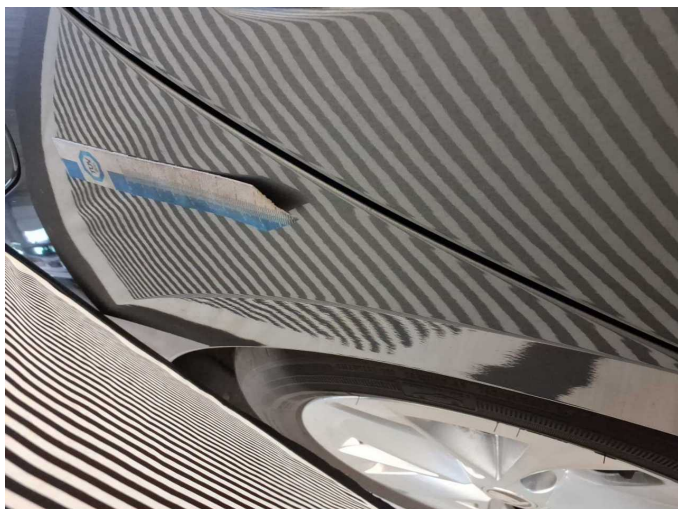
Damage 2: Side panel - rear right side: Side panel - dent(s) - Smart repair

**Damage 2:** Side panel - rear right side: Side panel - dent(s) - Smart repair

No.	Component group	Description
1	Equipment	Vehicle key (Batterie) - Empty - Replace
2	Side panel - rear right side	Side panel - dent(s) - Smart repair
3	Vehicle glazing	Windscreen (Rissbildung) - Stone chips - Replace

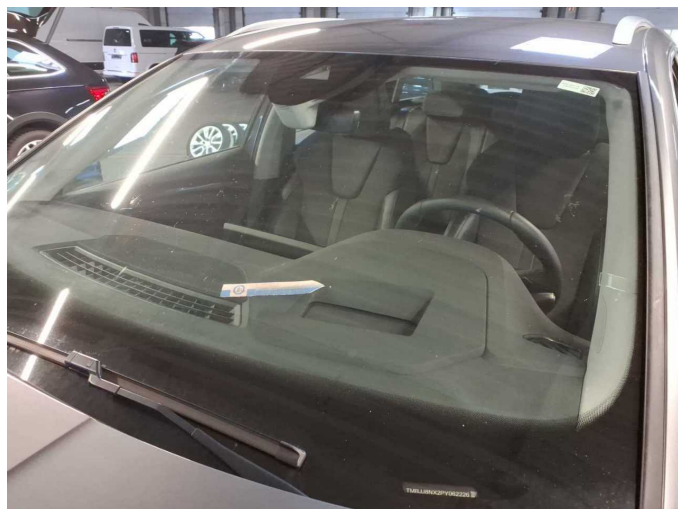
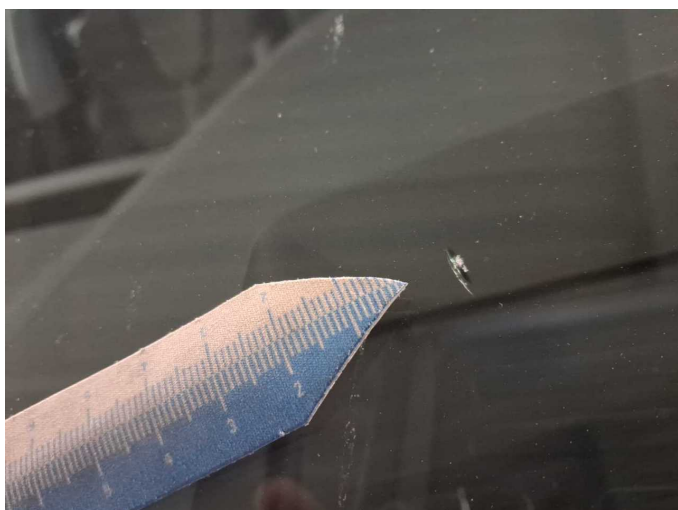
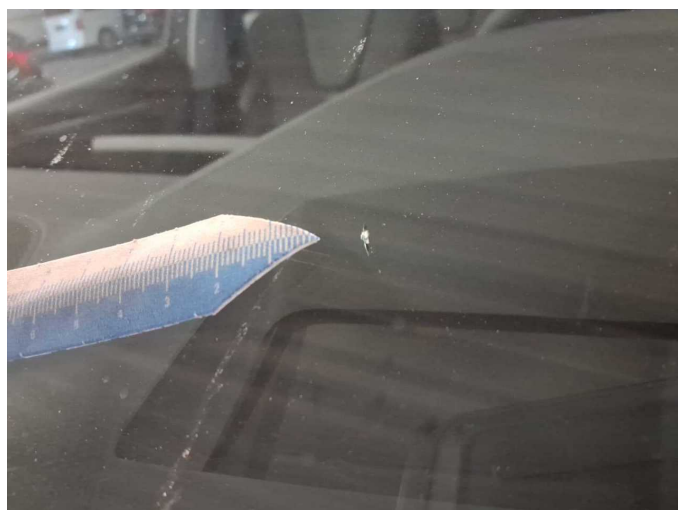
**Damage 3:** Vehicle glazing: Windscreen (Rissbildung) - Stone chips - Replace
