Expertise

Protocol number: 46584398  
Order No. / Reference: 26725536  
Inspection date: 16 Jul 2026

Manufacturer: Skoda  
VIN: TMBLR9NP6P7034734

Model: Superb Combi 2.0 TDI 4x4 DSG Premium Edition

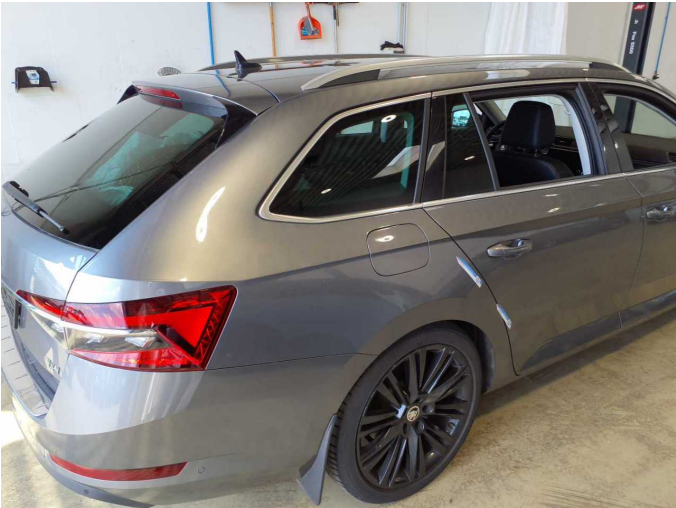
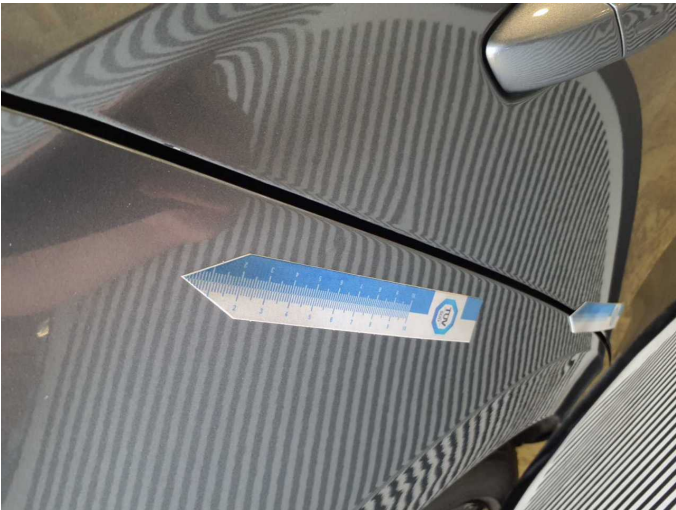
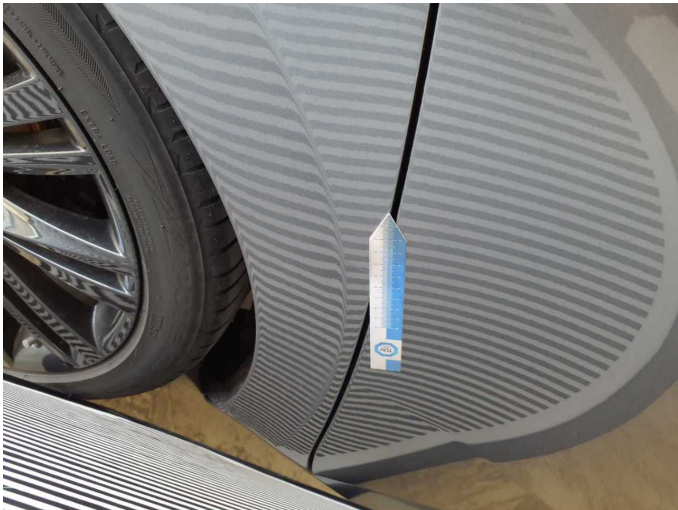
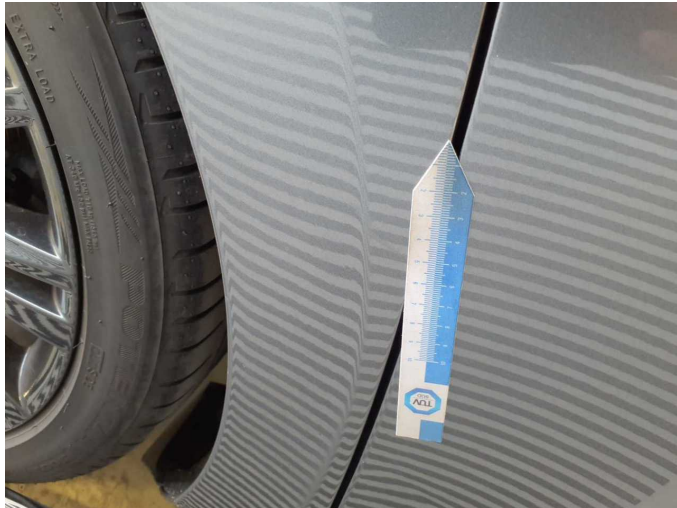
| No. | Component group | Description |
|---|---|---|
| 2 | Side panel - rear right side | Side panel - dent(s) - Smooth repair work |

Damage 2: Side panel - rear right side: Side panel - dent(s) - Smooth repair work

**Damage 2:** Side panel - rear right side: Side panel - dent(s) - Smooth repair work

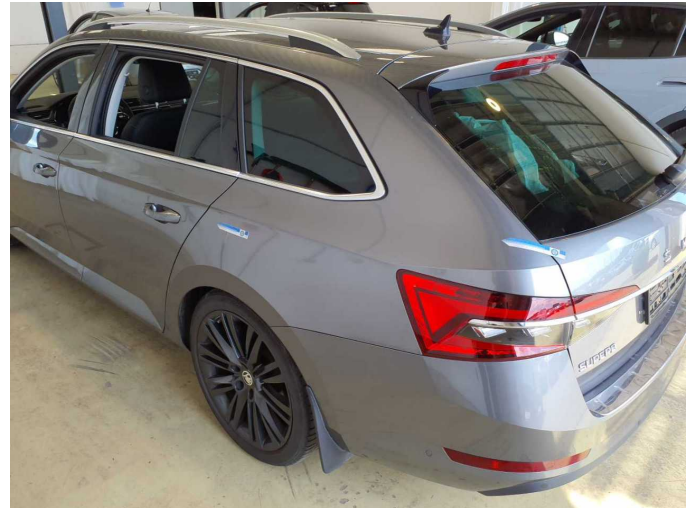
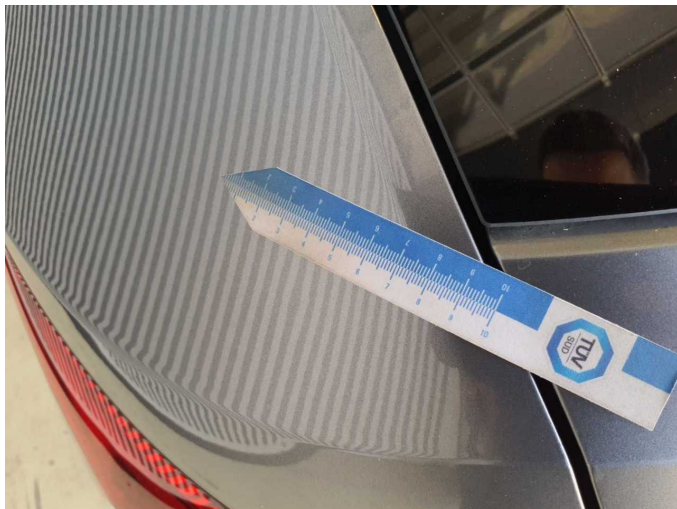
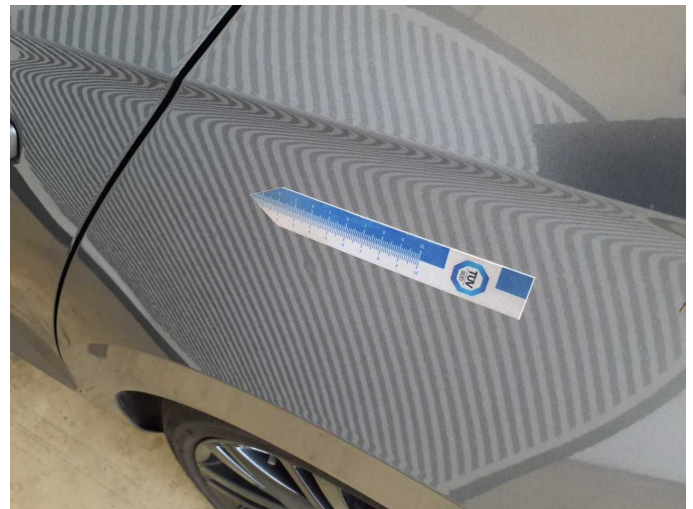
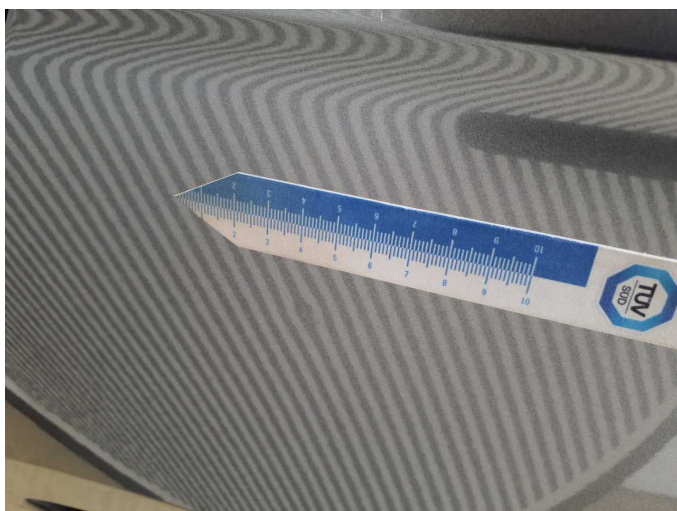
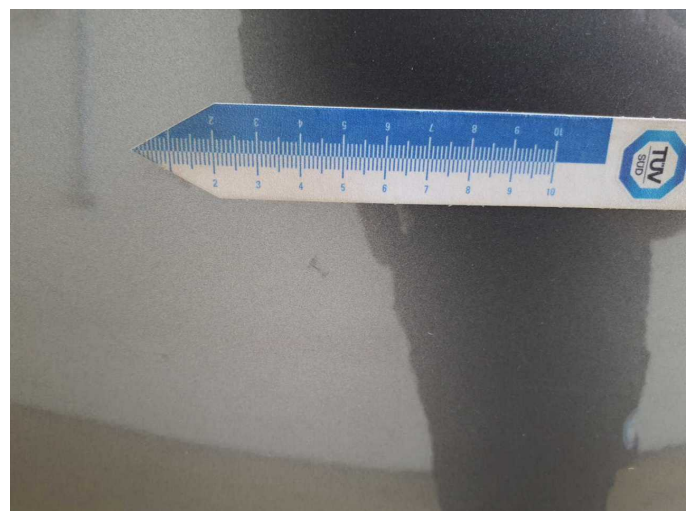
| No. | Component group | Description |
|---|---|---|
| 3 | Side panel - rear left side | Side panel - Dent / paintcoat damage - Smart repair |

**Damage 3:** Side panel - rear left side: Side panel - Dent / paintcoat damage - Smart repair

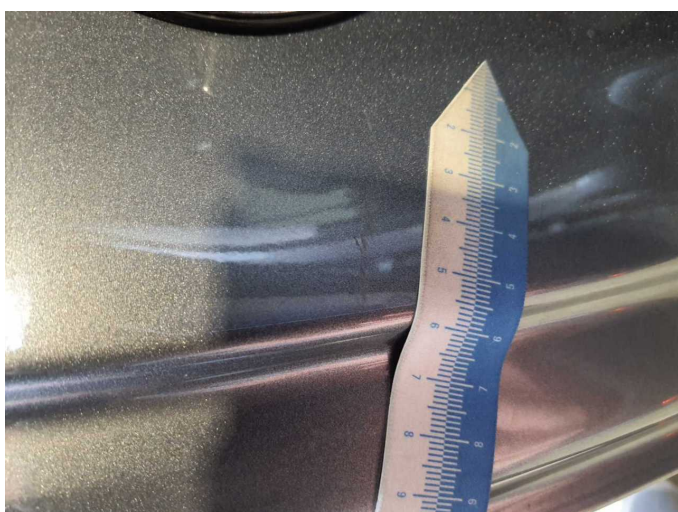
| No. | Component group | Description |
|---|---|---|
| 4 | Side panel - rear right side | Sill - Scratch(es) - Smart repair |

**Damage 4:** Side panel - rear right side: Sill - Scratch(es) - Smart repair

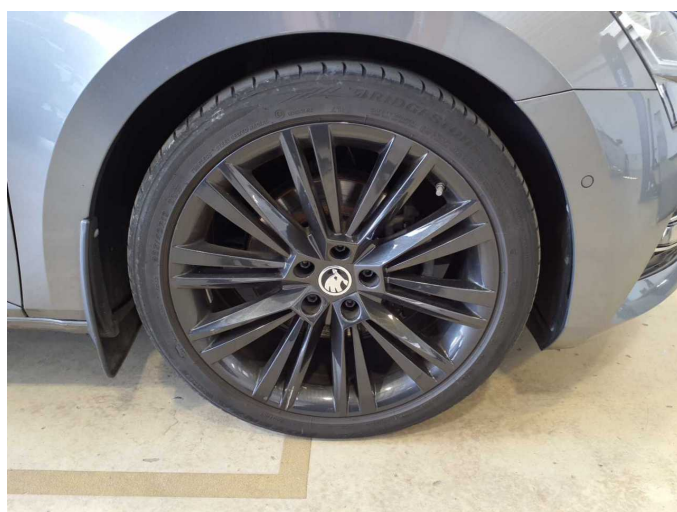
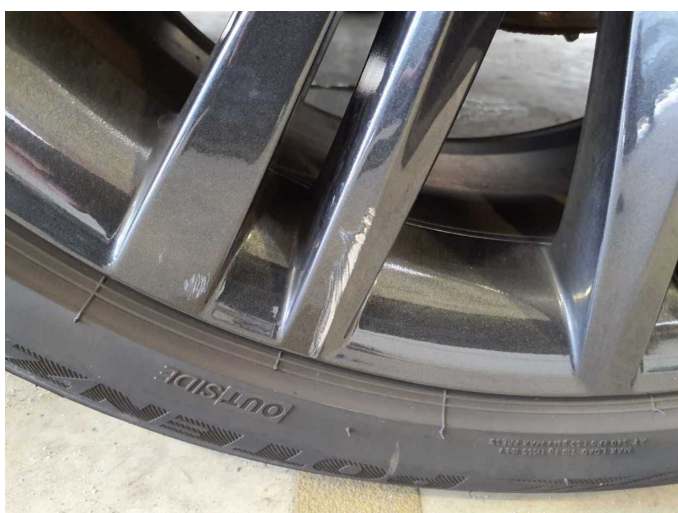
| No. | Component group | Description |
|---|---|---|
| 5 | Wheel / tyres | Alloy rim - front right side - Scratch(es) - Loss in value |

**Damage 5:** Wheel / tyres: Alloy rim - front right side - Scratch(es) - Loss in value

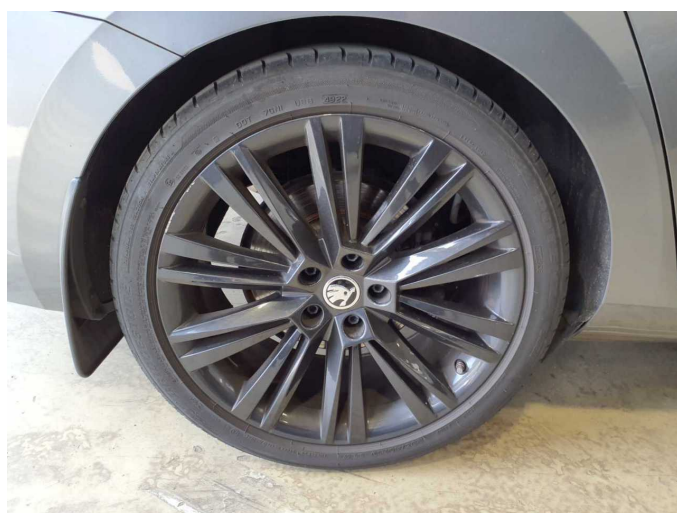
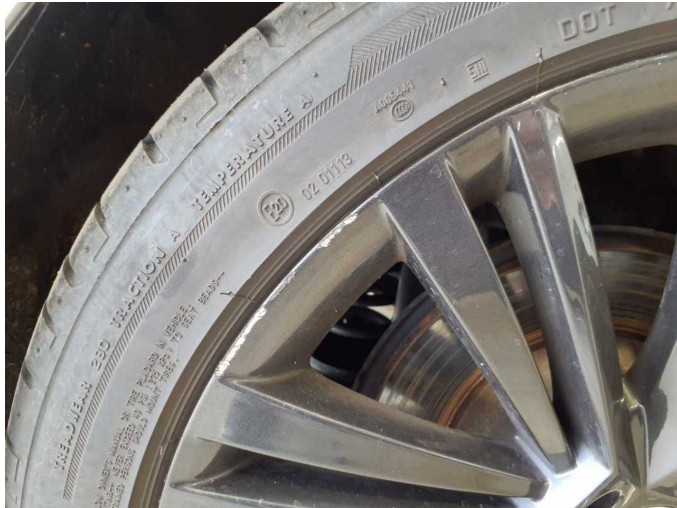
| No. | Component group | Description |
|---|---|---|
| 6 | Wheel / tyres | Alloy rim - rear right side - Scratch(es) - Loss in value |

**Damage 6:** Wheel / tyres: Alloy rim - rear right side - Scratch(es) - Loss in value

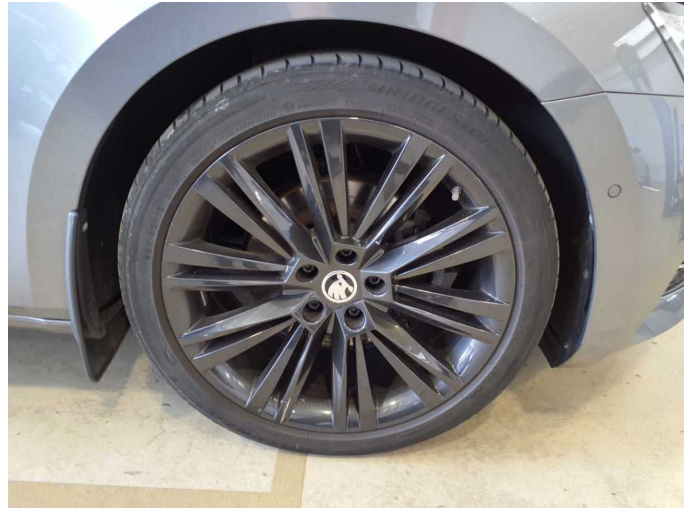
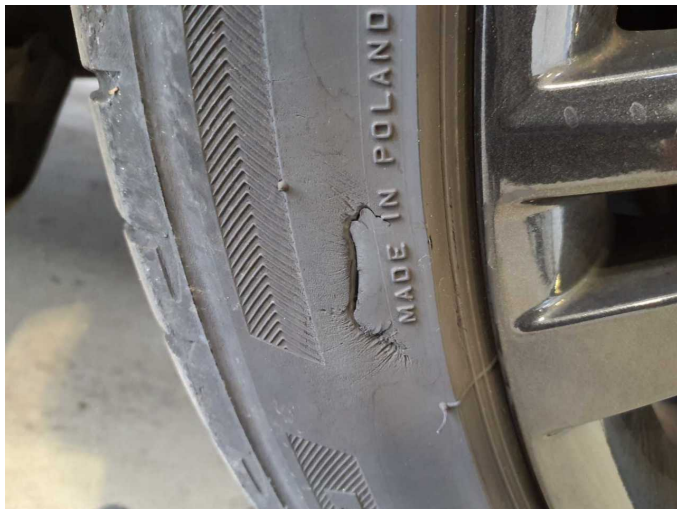
| No. | Component group | Description |
|---|---|---|
| 7 | Wheel / tyres | Tyre - front right side (nicht fahrbereit) - Broken / torn - Replace |

**Damage 7:** Wheel / tyres: Tyre - front right side (nicht fahrbereit) - Broken / torn - Replace

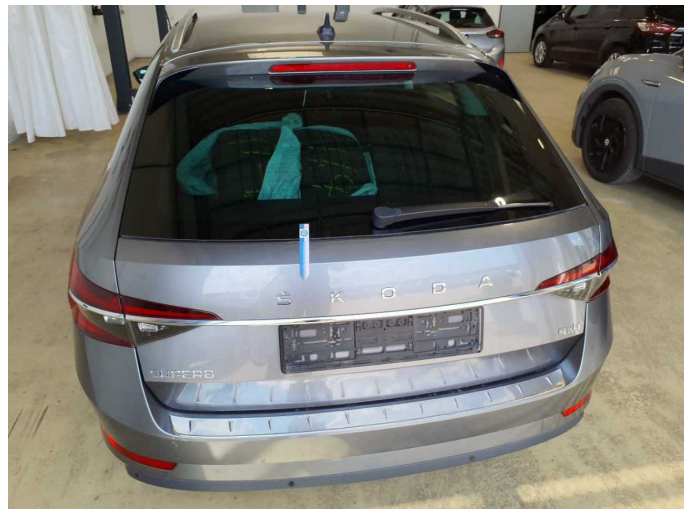
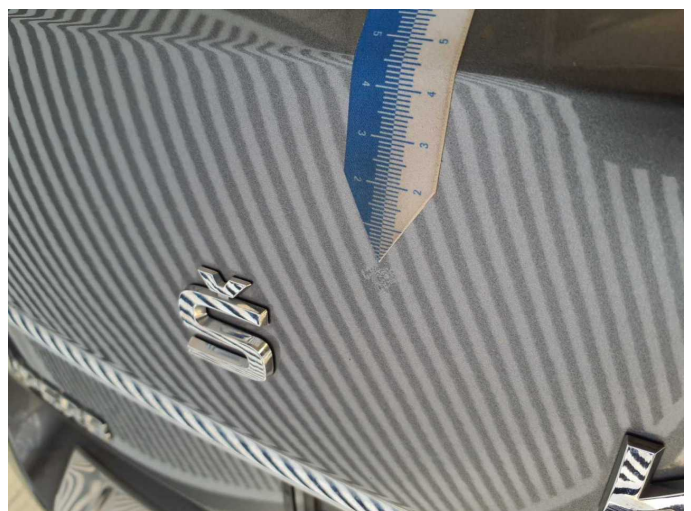
| No. | Component group | Description |
|---|---|---|
| 8 | Boot lid / rear door | Boot lid - Corrosion - Repair and paint |

**Damage 8:** Boot lid / rear door: Boot lid - Corrosion - Repair and paint

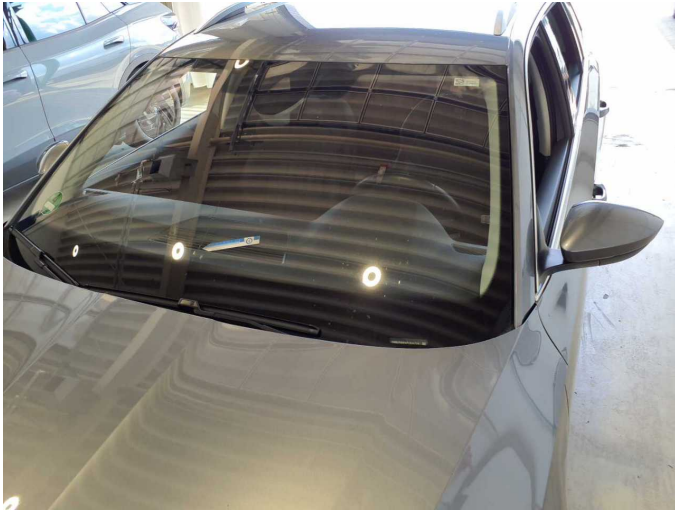
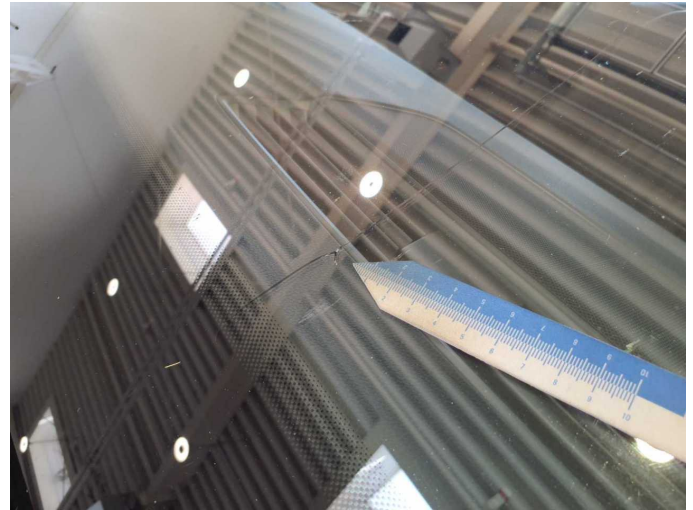
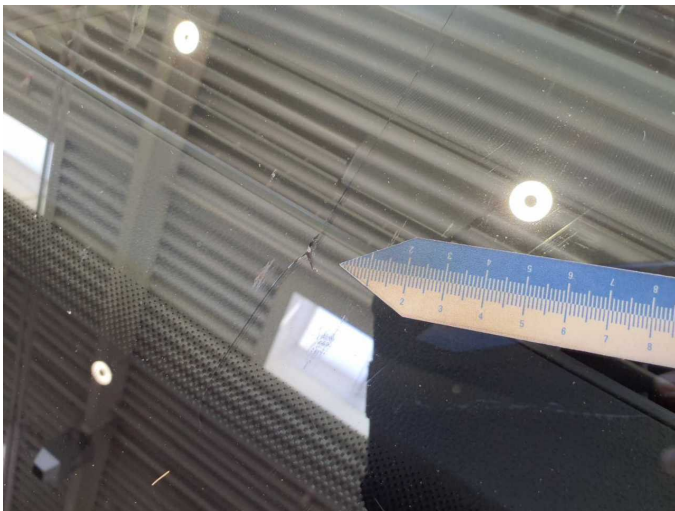
| No. | Component group | Description |
|---|---|---|
| 9 | Vehicle glazing | Windscreen - Broken / torn - repair according to calculation |

**Damage 9:** Vehicle glazing: Windscreen - Broken / torn - repair according to calculation
