Expertise

Protocol number: 46415879  
Order No. / Reference: 26600731  
Inspection date: 8 Jul 2026

Manufacturer: Volkswagen

Model: Passat Variant 2.0 TDI SCR DSG Business

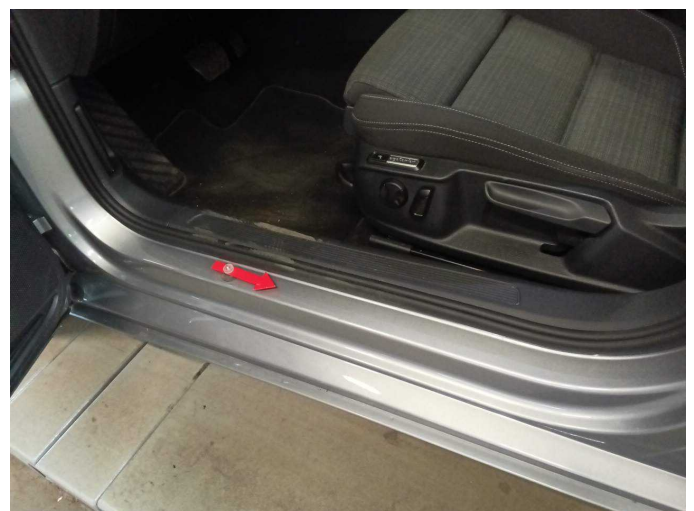
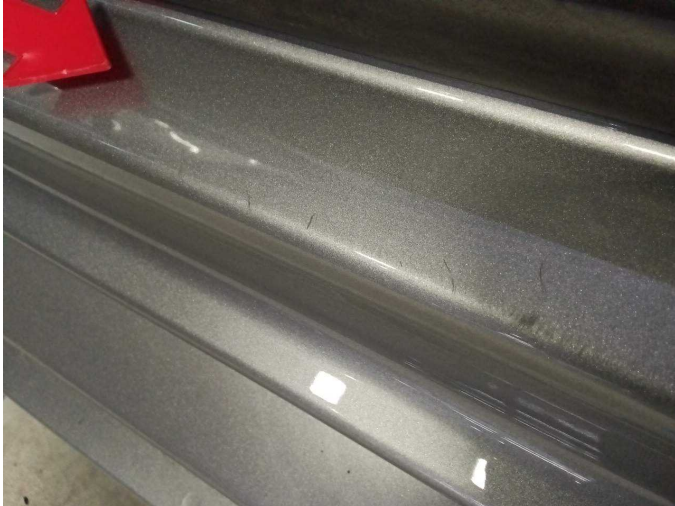
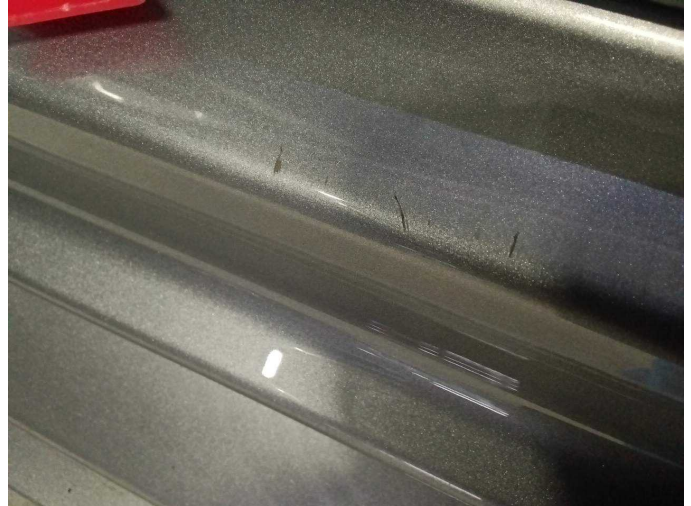
| No. | Component group | Description |
|---|---|---|
| 1 | Sill - left side | Sill - Scratch(es) - Smart repair |

Damage 1: Sill - left side: Sill - Scratch(es) - Smart repair

**Damage 1:** Sill - left side: Sill - Scratch(es) - Smart repair

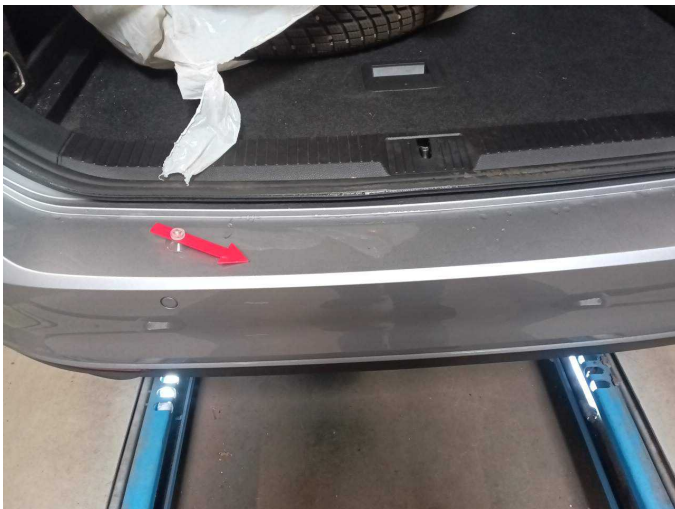
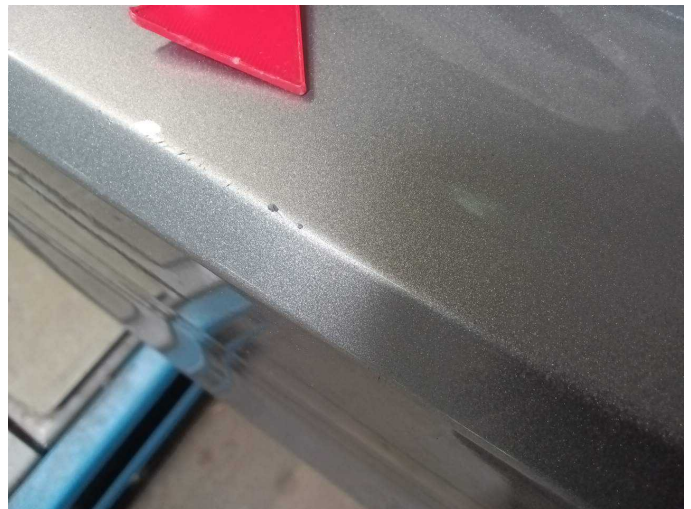
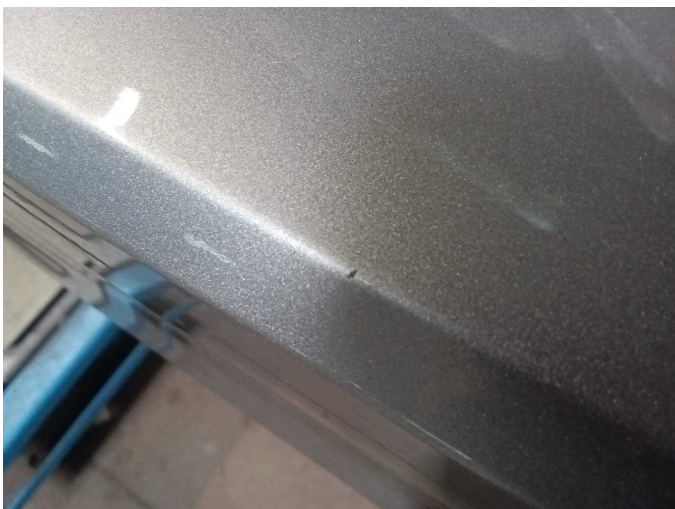
| No. | Component group | Description |
|---|---|---|
| 2 | Rear bumper | Rear bumper - Scratch(es) - Smart repair |

**Damage 2:** Rear bumper: Rear bumper - Scratch(es) - Smart repair

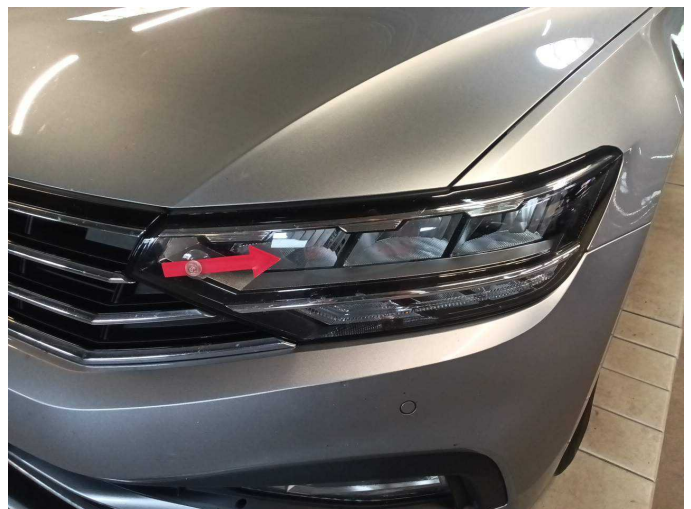
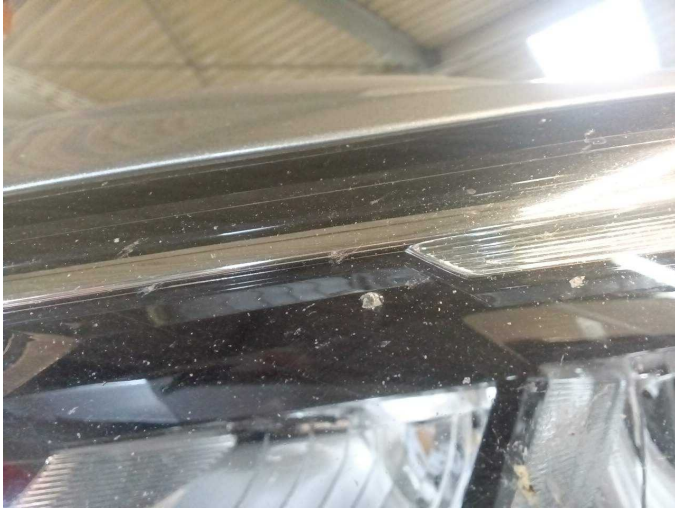
| No. | Component group | Description |
|---|---|---|
| 3 | Headlight | Headlight - left side - Stone chips - Loss in value |

**Damage 3:** Headlight: Headlight - left side - Stone chips - Loss in value

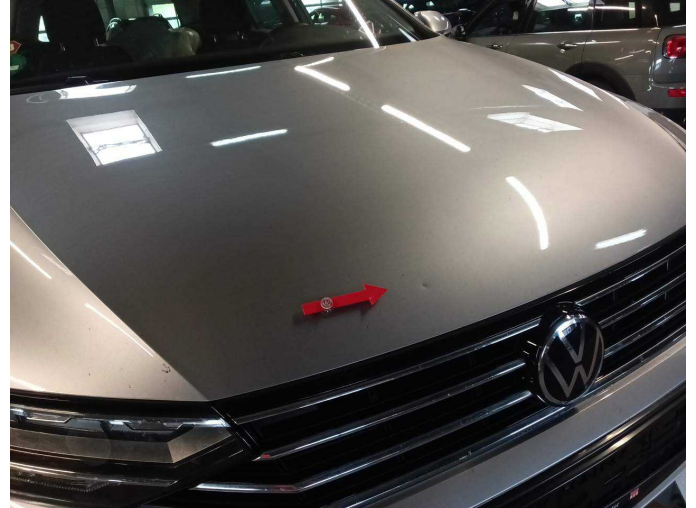
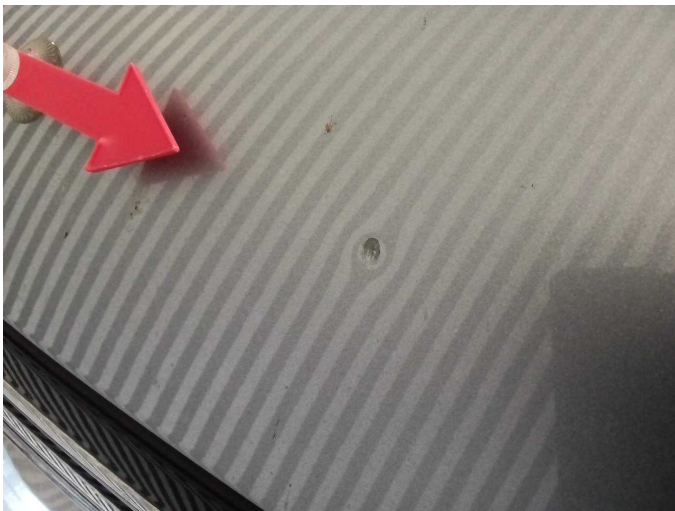
| No. | Component group | Description |
|---|---|---|
| 4 | Bonnet | Bonnet - Dent / paintcoat damage - Repair and paint |

**Damage 4:** Bonnet: Bonnet - Dent / paintcoat damage - Repair and paint

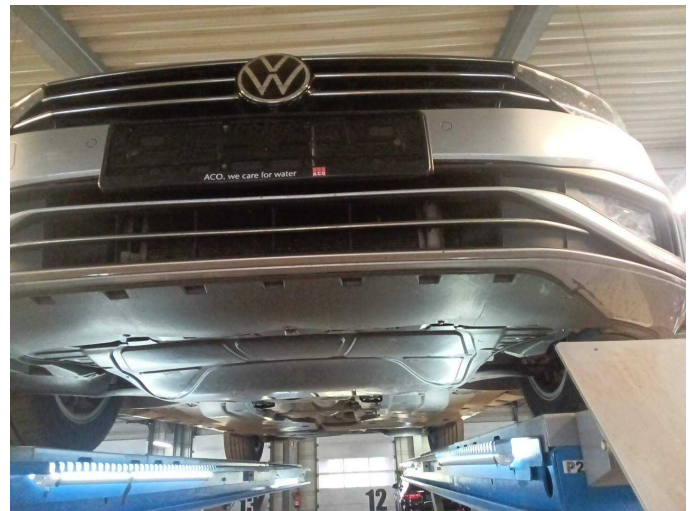
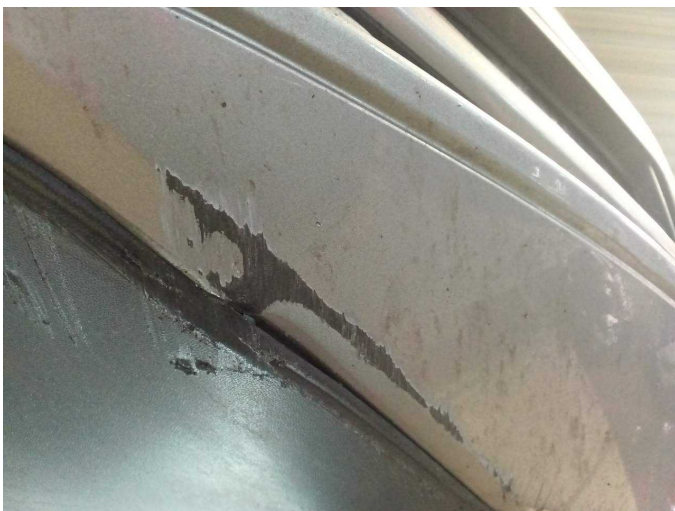
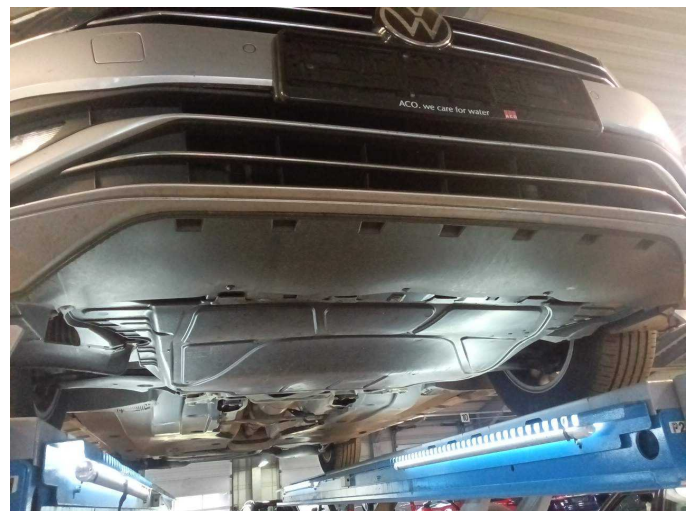
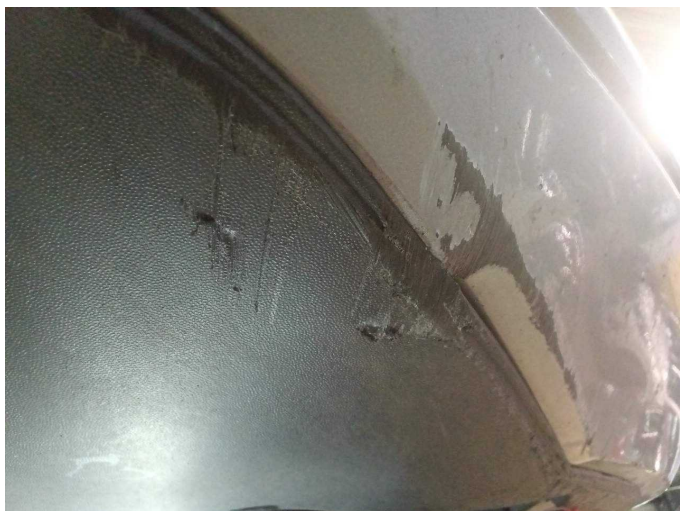
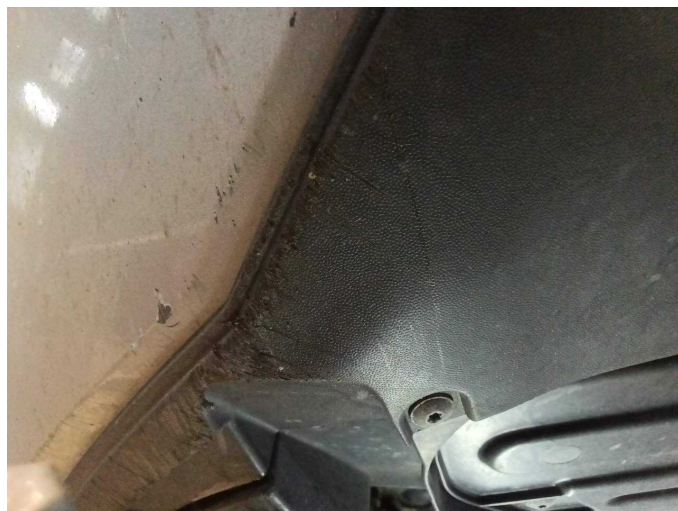
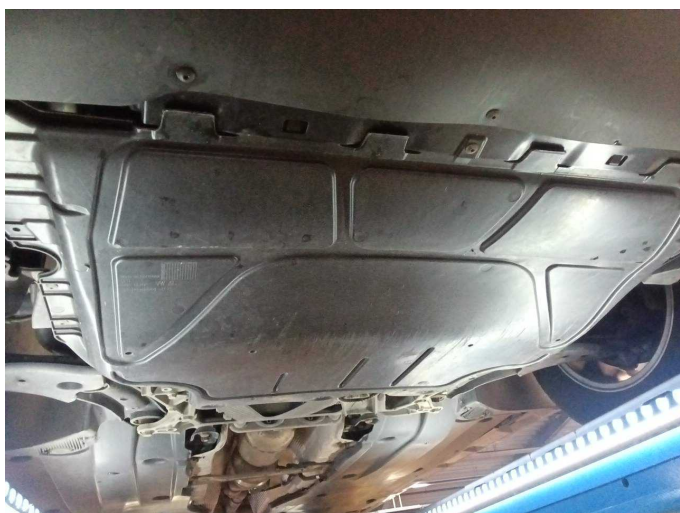
| No. | Accident |
|---|---|
| 1 | Front |

Non-repaired previous damages were found at the vehicle. The necessary repair costs are listed in the expert report or if necessary, are listed in detail in a separately enclosed repair cost calculation.

**Accident 1:** Front

**Accident 1: Front**

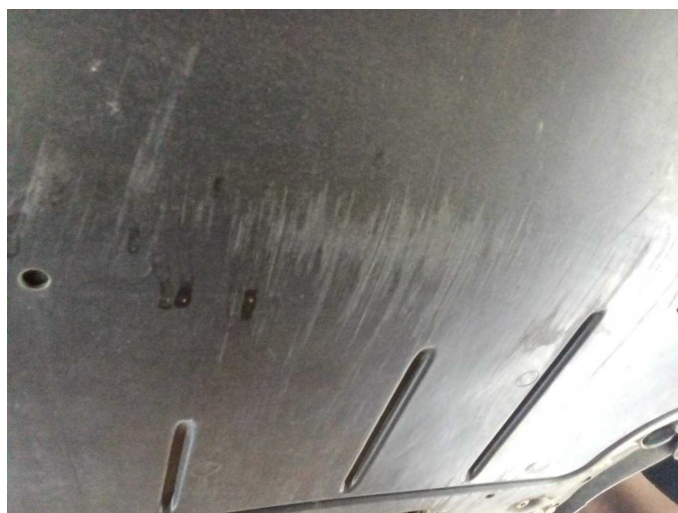
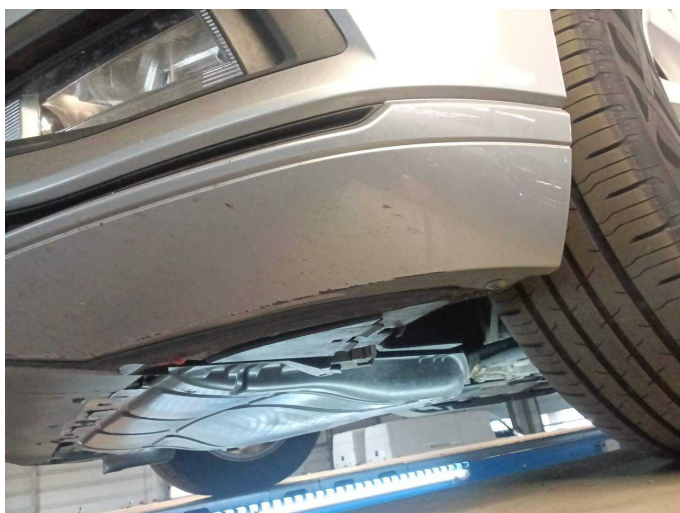
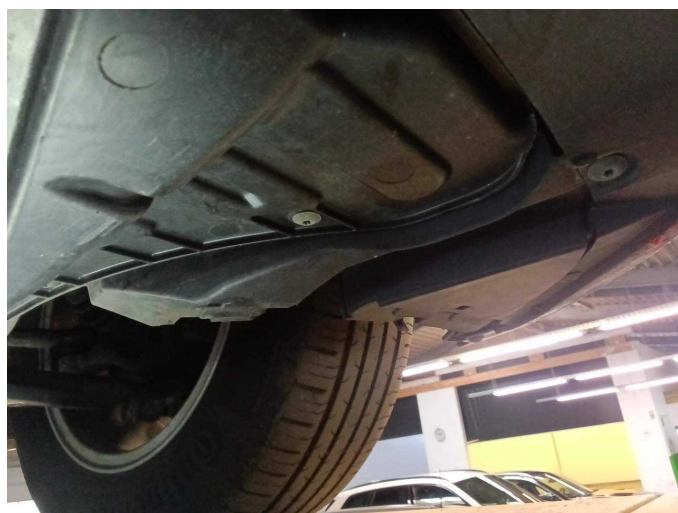
**Accident 1: Front**
