Expertise

Protocol number: 46383592  
Order No. / Reference: 26453982  
Inspection date: 7 Jul 2026

Manufacturer: Mercedes-Benz

Model: GLC 220 d 4Matic 9G-TRONIC

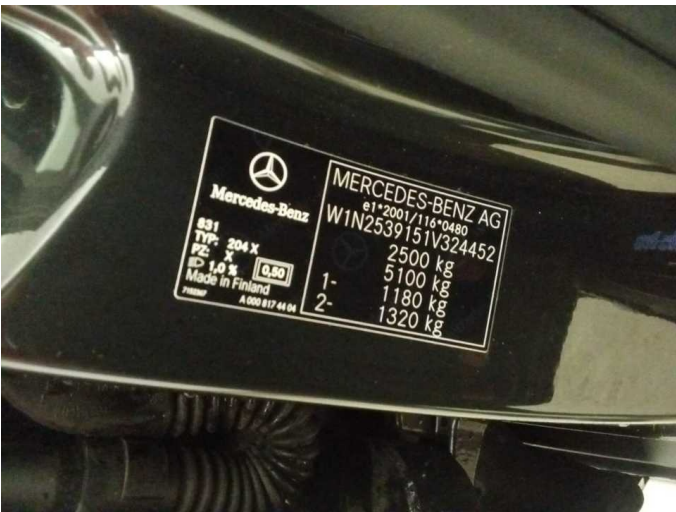
Figure 11: VIN

| VIN comparison | The vehicle identification number (VIN) was read from the vehicle and its conformity with the submitted documents was confirmed by the undersigned during the inspection. |

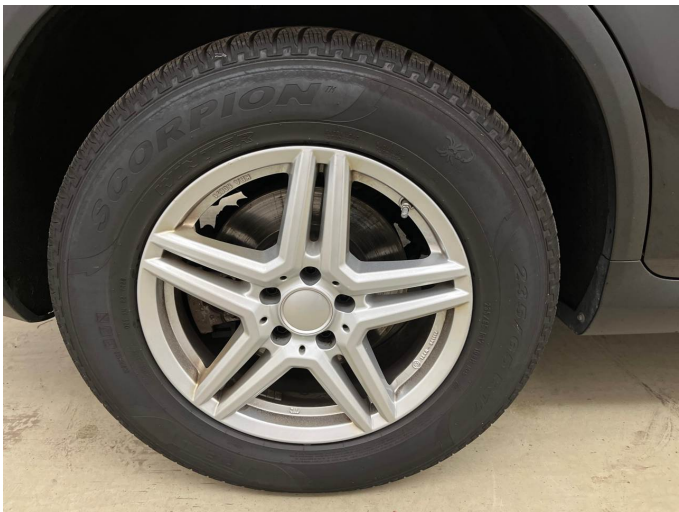
Figure 12: Mounted tyres

| Tyres | | | | |
|---|---|---|---|---|
| 1) | 235/65 R17 108H | Winter tyres on Light alloy | Pirelli | 5mm / 5mm |
| 2) | 235/65 R17 108H | Winter tyres on Light alloy | Pirelli | 4mm / 4mm |

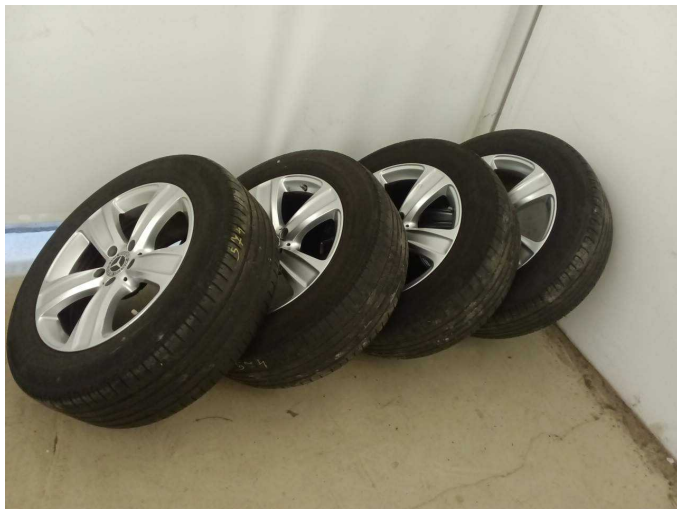
Figure 15: Additional tyres

| Tyres | | | | |
|---|---|---|---|---|
| 1) | 235/65 R18 103V | Summer tyres on Light alloy | Bridgestone | 4mm / 4mm |
| 2) | 235/65 R18 103V | Summer tyres on Light alloy | Bridgestone | 3mm / 3mm |

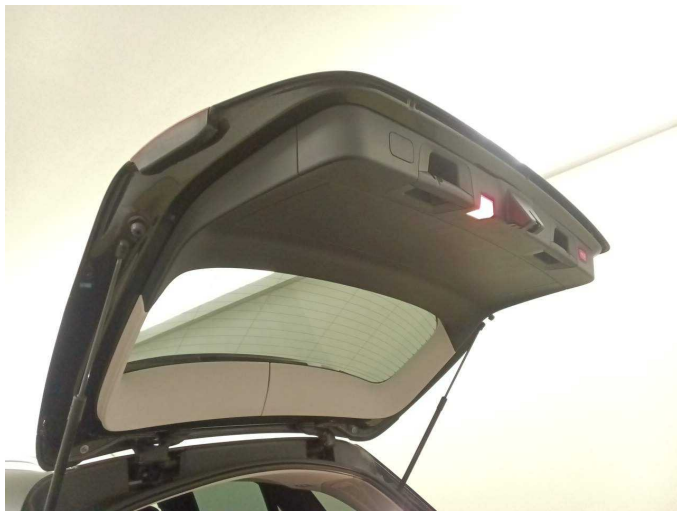
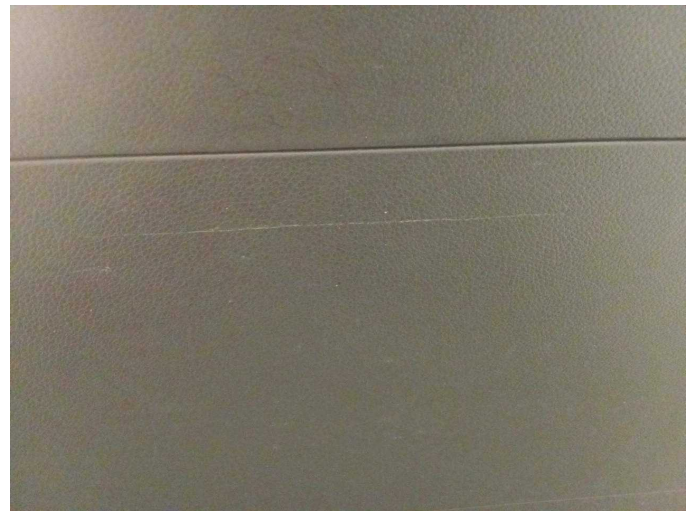
| No. | Component group | Description |
|---|---|---|
| 1 | Trim / covers | Boot lid - interior trim - Scratched - Replace |

Damage 1: Trim / covers: Boot lid - interior trim - Scratched - Replace

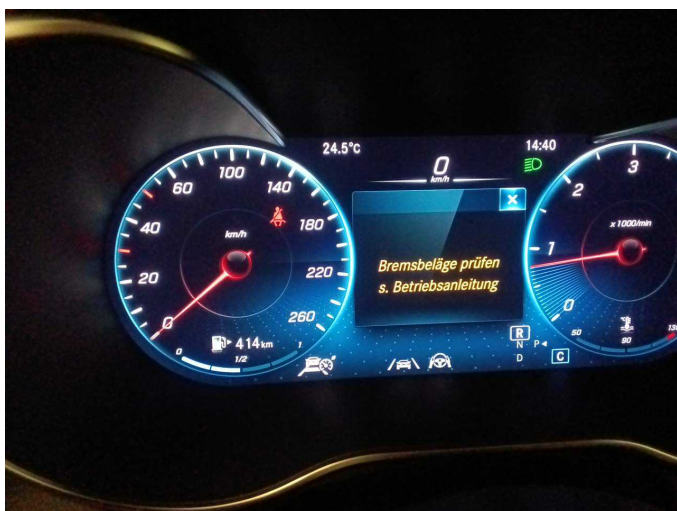
| No. | Component group | Description |
|---|---|---|
| 2 | Braking system | Brake pads - rear - on - Perform |

Damage 2: Braking system: Brake pads - rear - on - Perform

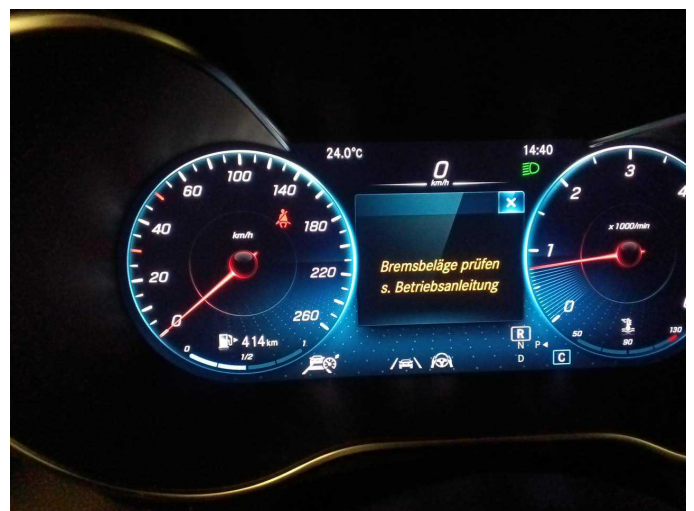
| No. | Component group | Description |
|---|---|---|
| 3 | Braking system | Brake pads - front - on - Perform |

Damage 3: Braking system: Brake pads - front - on - Perform

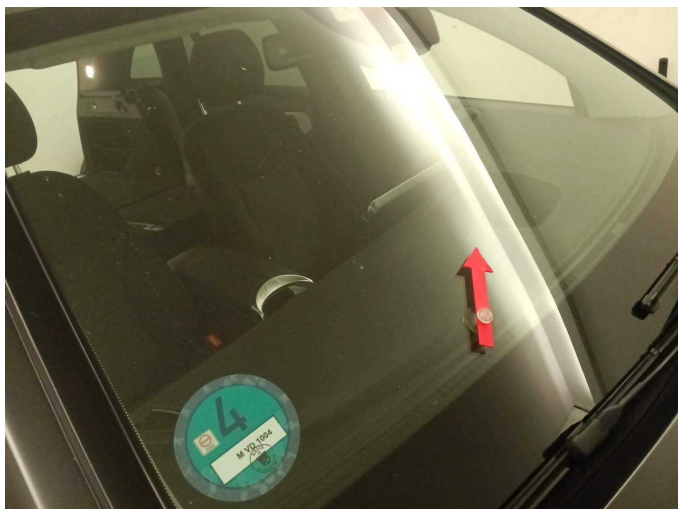
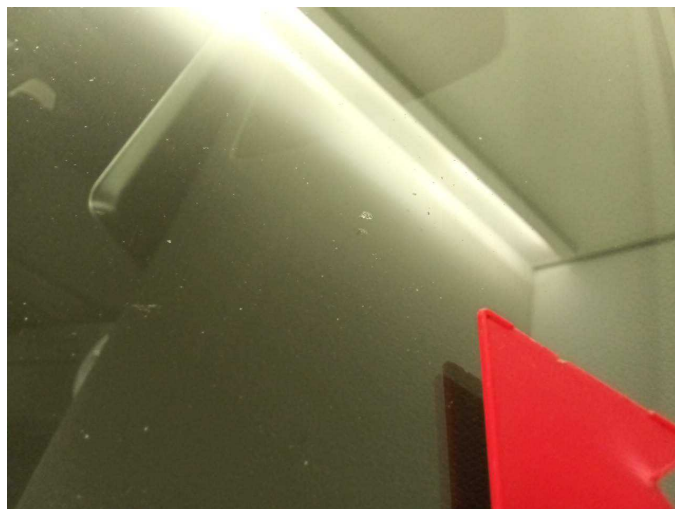
| No. | Component group | Description |
|---|---|---|
| 1 | Vehicle glazing | Windscreen - Stone chips - No deduction |

**Wear and tear 1:** Vehicle glazing: Windscreen - Stone chips - No deduction

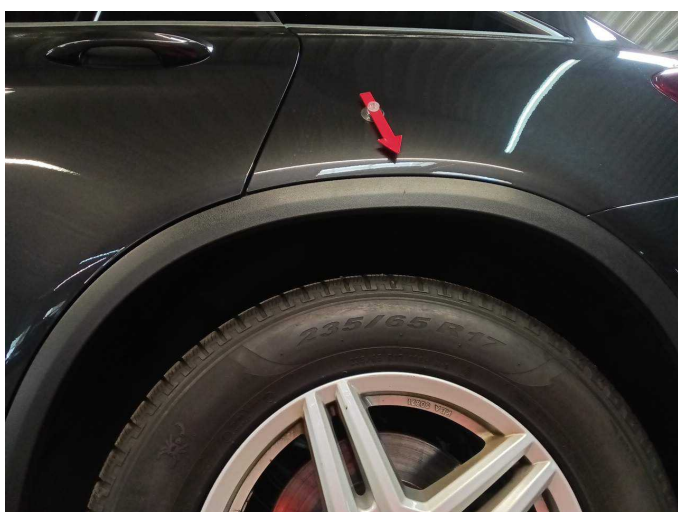
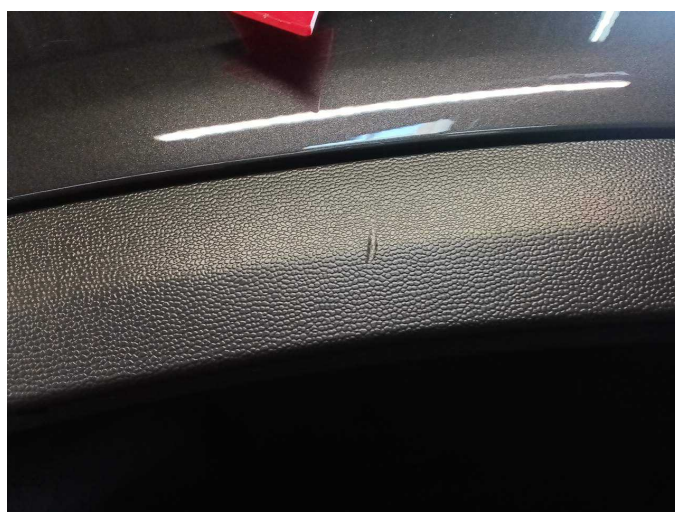
| No. | Component group | Description |
|---|---|---|
| 2 | Side panel - rear left side | Wheel well extension - Scratch(es) - No deduction |

**Wear and tear 2:** Side panel - rear left side: Wheel well extension - Scratch(es) - No deduction

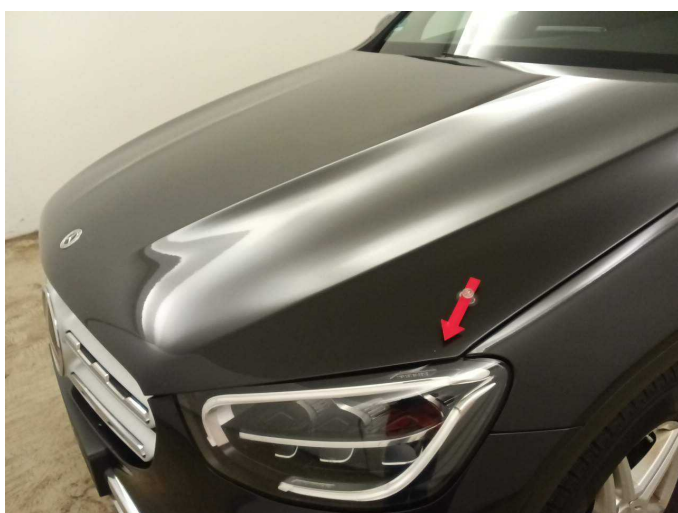
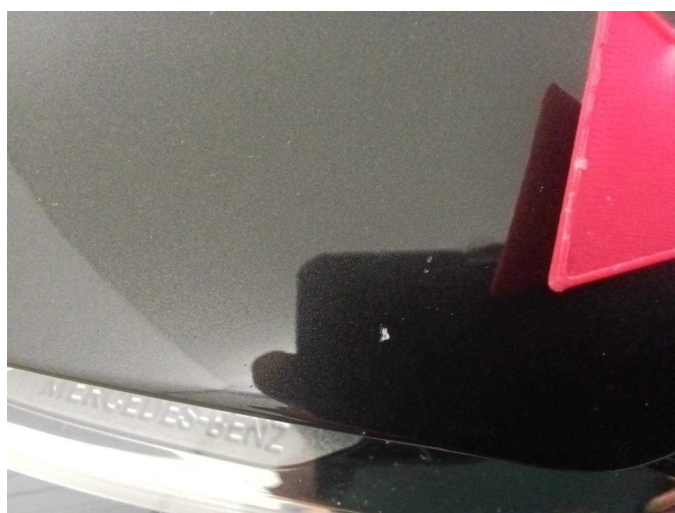
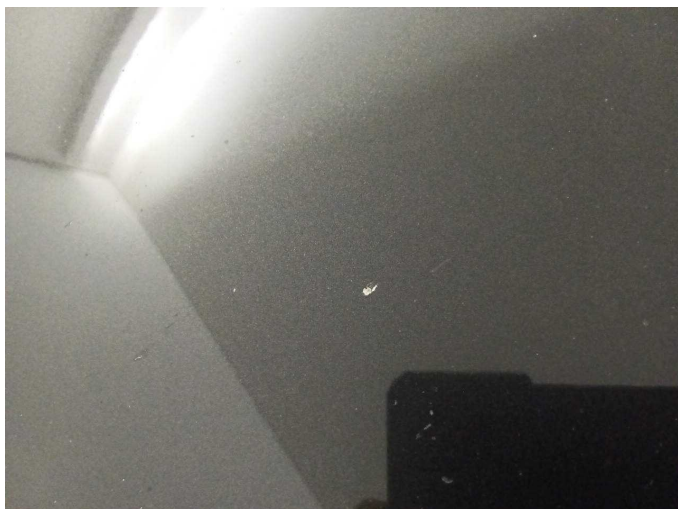
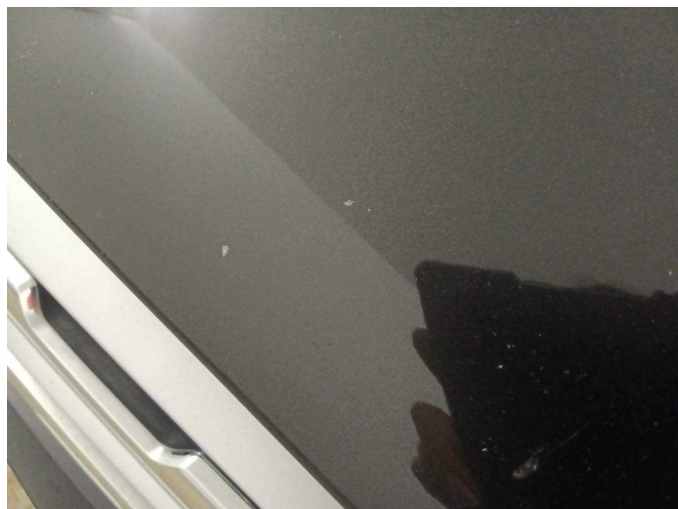
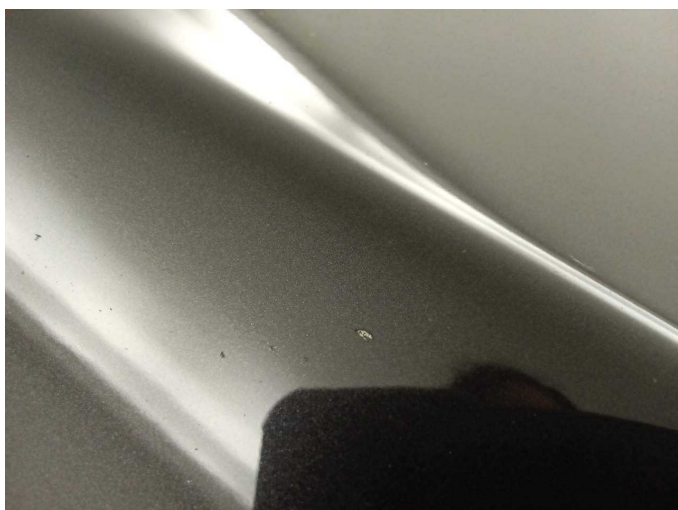
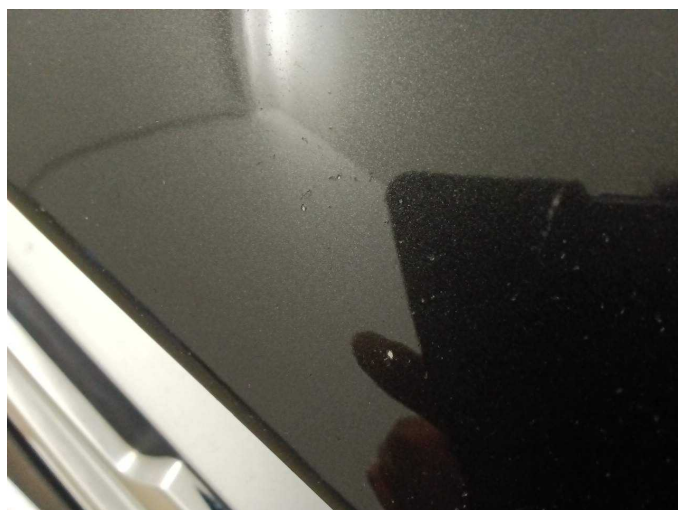
| No. | Component group | Description |
|---|---|---|
| 3 | Bonnet | Bonnet - Stone chips - No deduction |

**Wear and tear 3:** Bonnet: Bonnet - Stone chips - No deduction
