Expertise

Protocol number: 46769210  
Order No. / Reference: 26719443  
Inspection date: 29 Jul 2026

Manufacturer: Volkswagen

Model: Passat Variant 1.4 TSI Plug-In-Hybrid DSG GTE

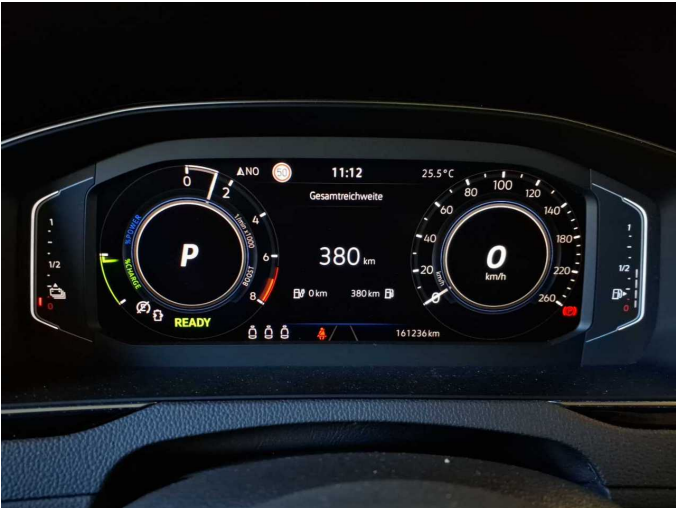
| Vehicle details | |
|---|---|
| Mileage (Read) | 161,236 km |

Figure 7: Instrument cluster

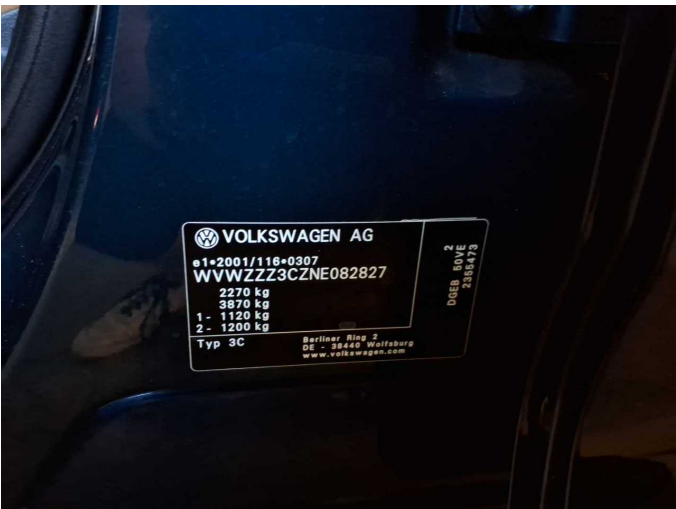
| VIN comparison | The vehicle identification number (VIN) was read from the vehicle and its conformity with the submitted documents was confirmed by the undersigned during the inspection. |

Figure 11: VIN

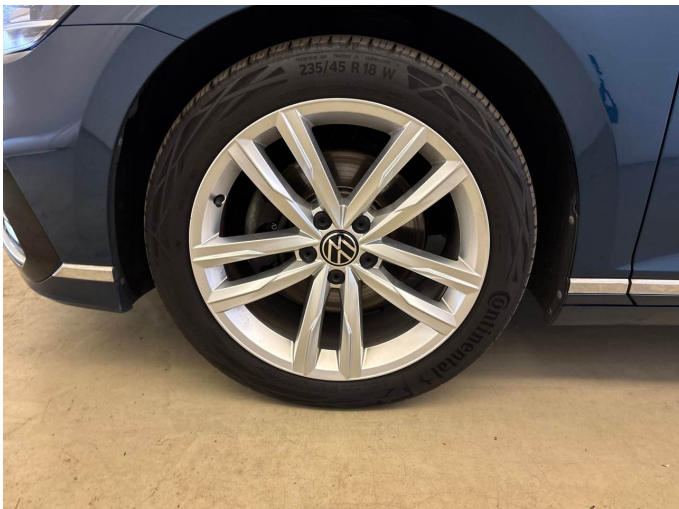
| # | Tyre size | Type of tyre | Manufacturer | Tread depth |
|---|---|---|---|---|
| 1) | 235/45 R18 94W | Summer tyres on Light alloy | Continental | 5mm / 5mm |
| 2) | 235/45 R18 94W | Summer tyres on Light alloy | Continental | 5mm / 5mm |

Figure 12: Mounted tyres

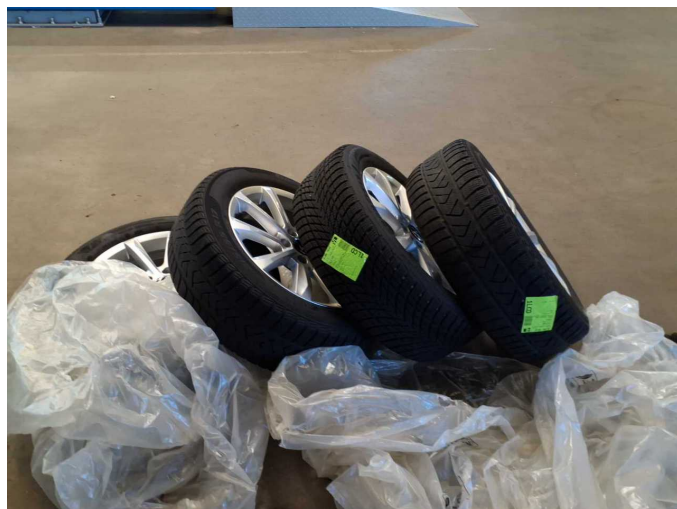
| # | Tyre size | Type of tyre | Manufacturer | Tread depth |
|---|---|---|---|---|
| 1) | 215/55 R17 94H | Winter tyres on Light alloy | Pirelli | 5mm / 5mm |
| 2) | 215/55 R17 94H | Winter tyres on Light alloy | Goodyear | 5mm / 5mm |

Figure 14: Additional tyres

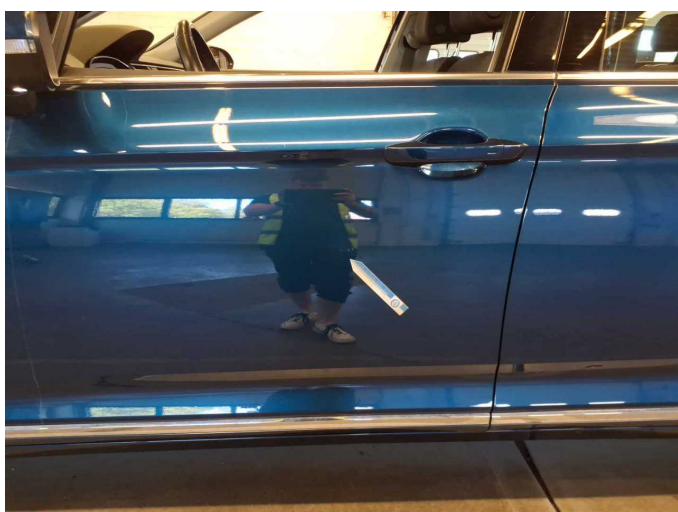
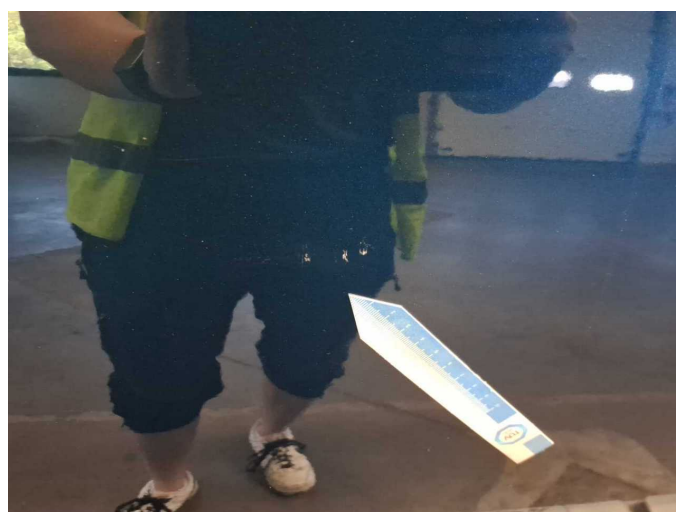
| No. | Component group | Description |
|---|---|---|
| 1 | Door - front left side | Door - Scratch(es) - Smart repair |

**Damage 1:** Door - front left side: Door - Scratch(es) - Smart repair

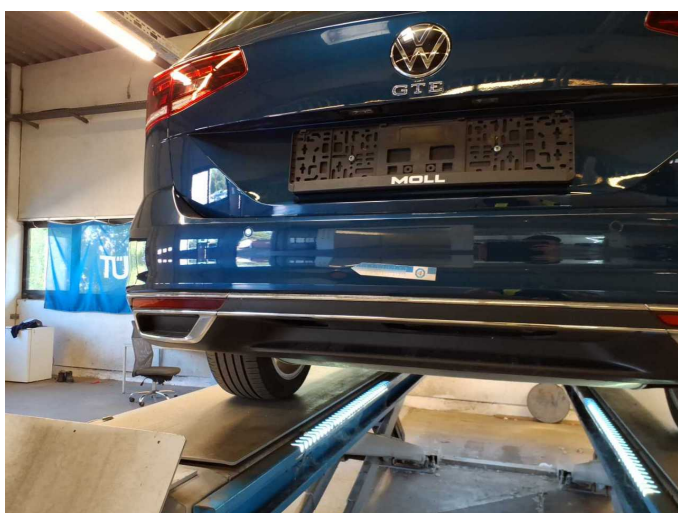
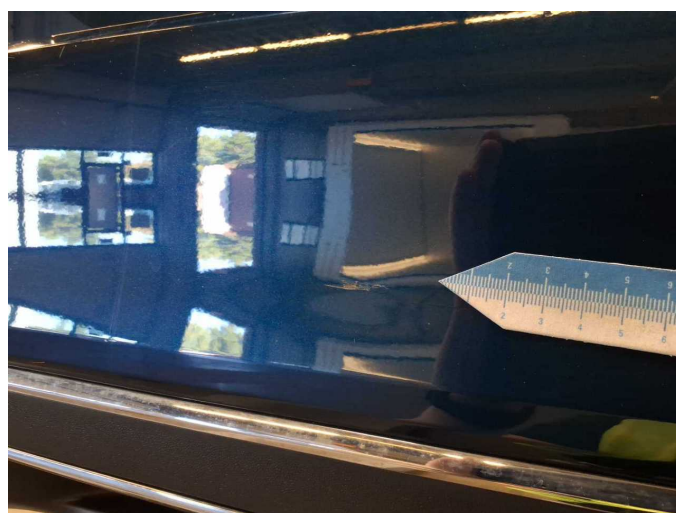
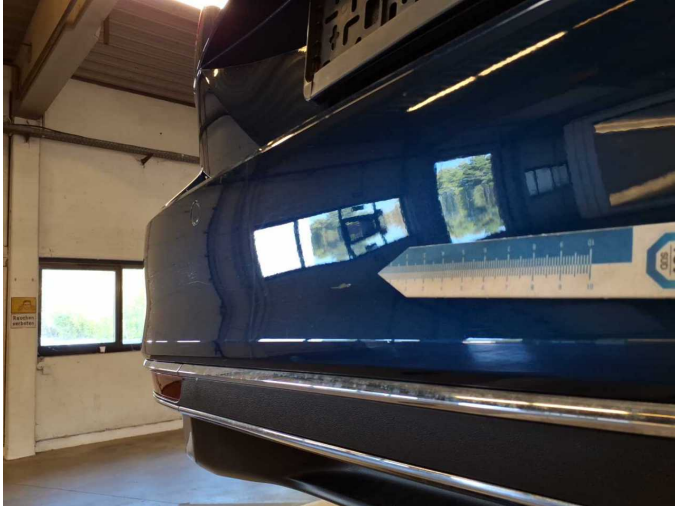
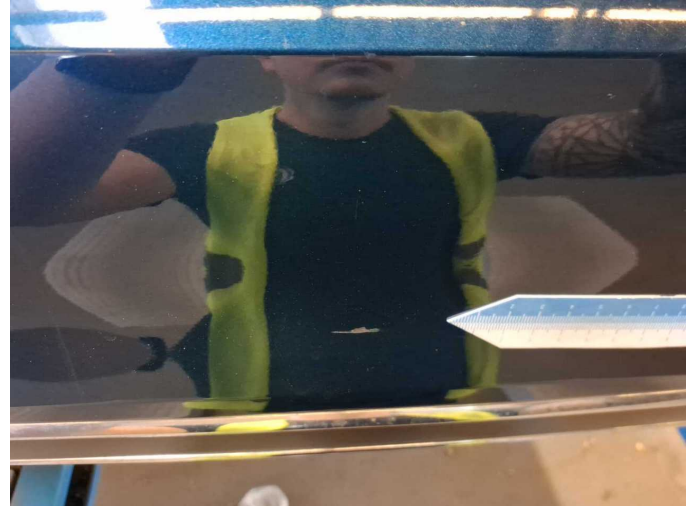
| No. | Component group | Description |
|---|---|---|
| 2 | Rear bumper | Rear bumper - Dent / paintcoat damage - Repair and paint |

**Damage 2:** Rear bumper: Rear bumper - Dent / paintcoat damage - Repair and paint

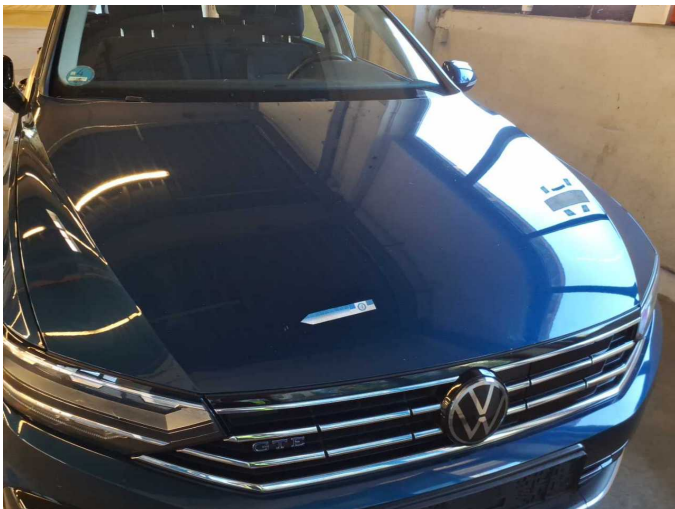
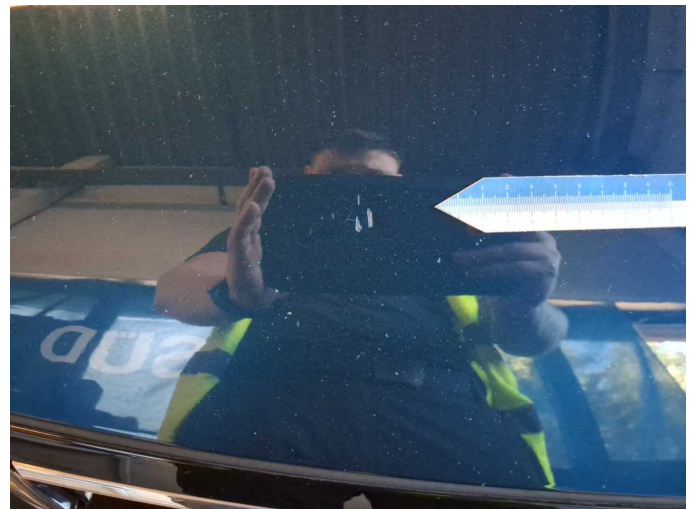
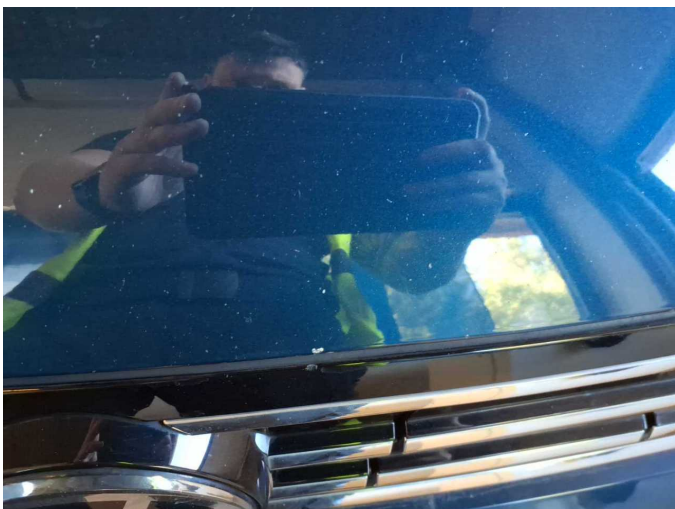
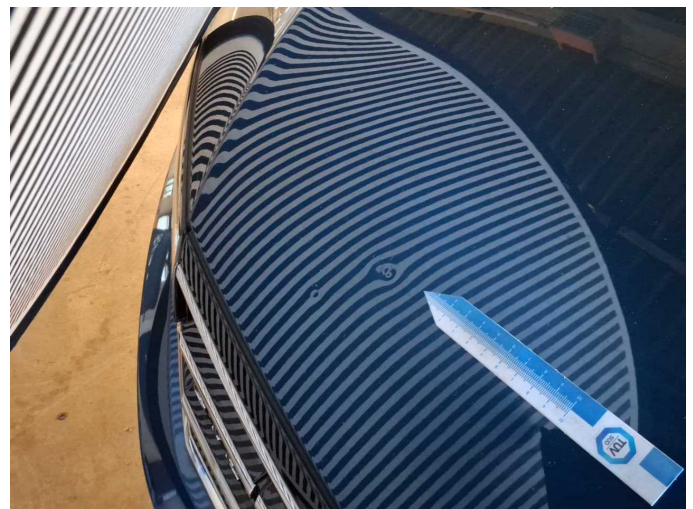
| No. | Component group | Description |
|---|---|---|
| 3 | Bonnet | Bonnet - Dent / paintcoat damage - Repair and paint |

**Damage 3:** Bonnet: Bonnet - Dent / paintcoat damage - Repair and paint

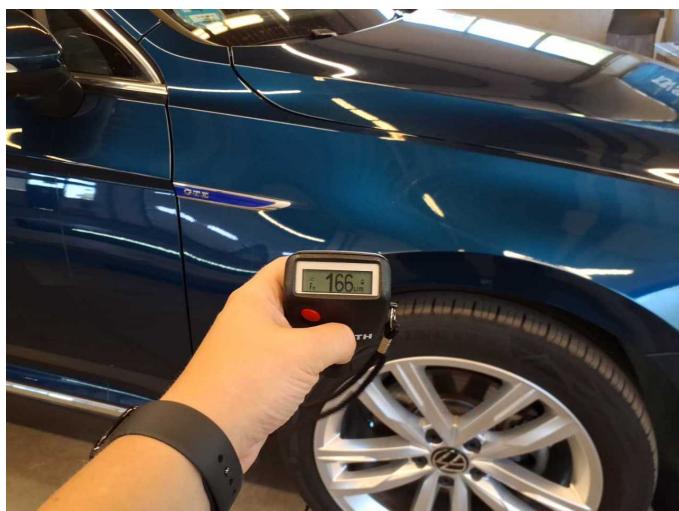
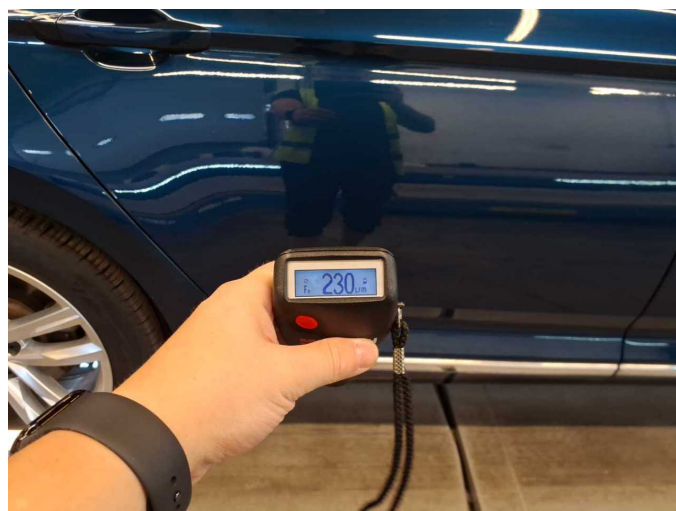
1 Mudguard - right side, Door - rear right side, Professionally carried out, Invoice of repair done Non-existent

| Mudguard - right side | 166 µm | Door - rear right side | 230 µm |

**Repainting 1:** Mudguard - right side, Door - rear right side
