Expertise

Protocol number: 46294442  
Order No. / Reference: 26605426  
Inspection date: 30 Jun 2026

Manufacturer: Audi  
VIN: WAUZZZF53NA026983

Model: A5 Sportback 40 TDI S tronic

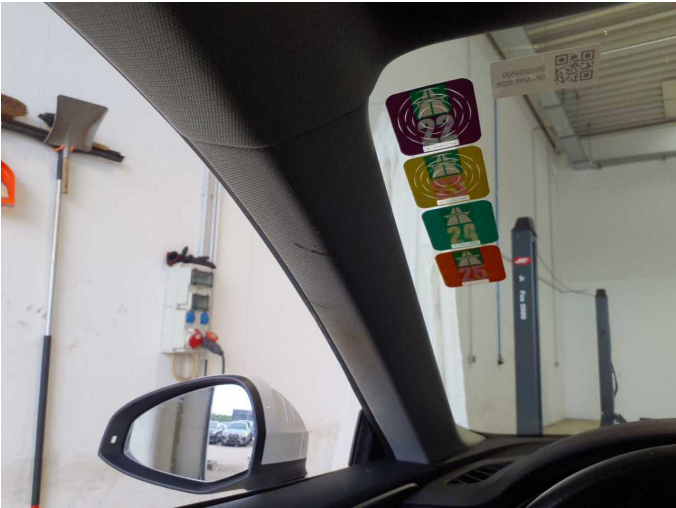
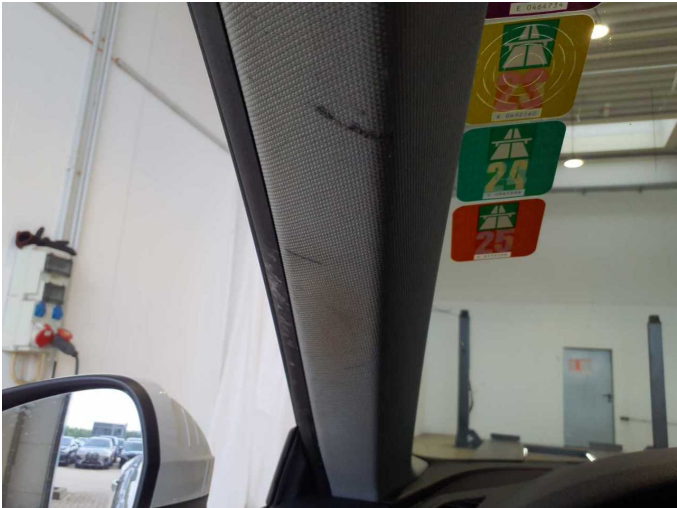
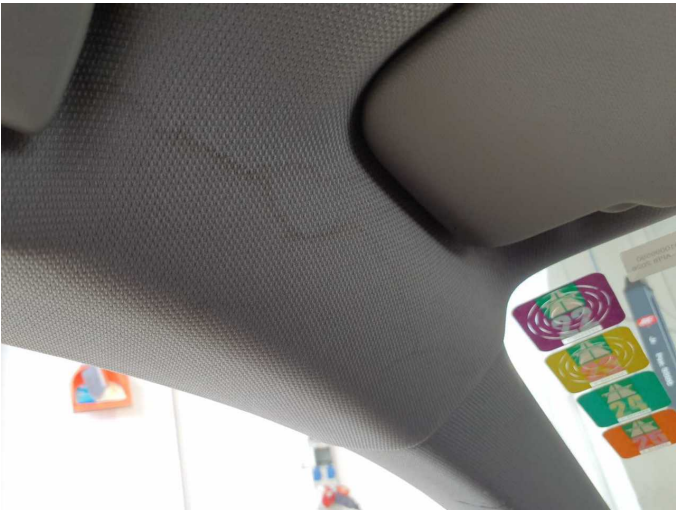
| No. | Component group | Description |
|---|---|---|
| 1 | Trim / covers | A-pillar - trim - interior, left side - Soiled - Clean |

Damage 1: Trim / covers: A-pillar - trim - interior, left side - Soiled - Clean

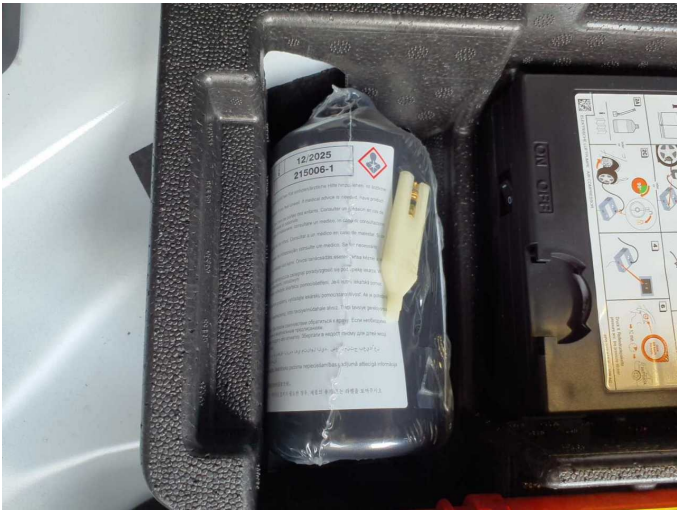
| No. | Component group | Description |
|---|---|---|
| 2 | Equipment | Tirefit filler - Expired - Replace |

Damage 2: Equipment: Tirefit filler - Expired - Replace

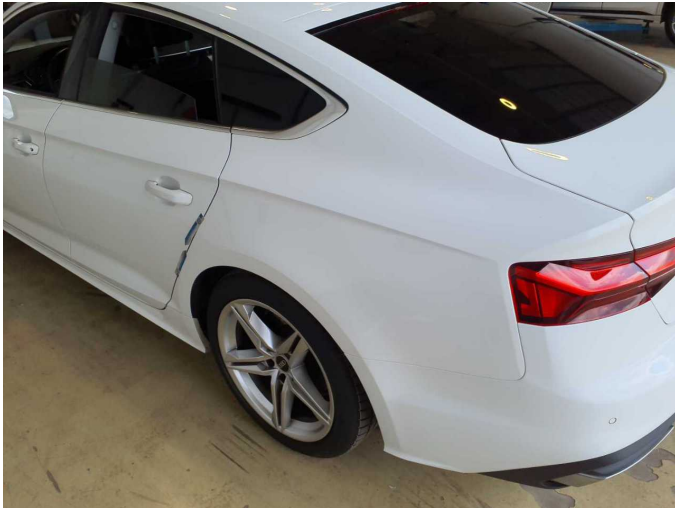
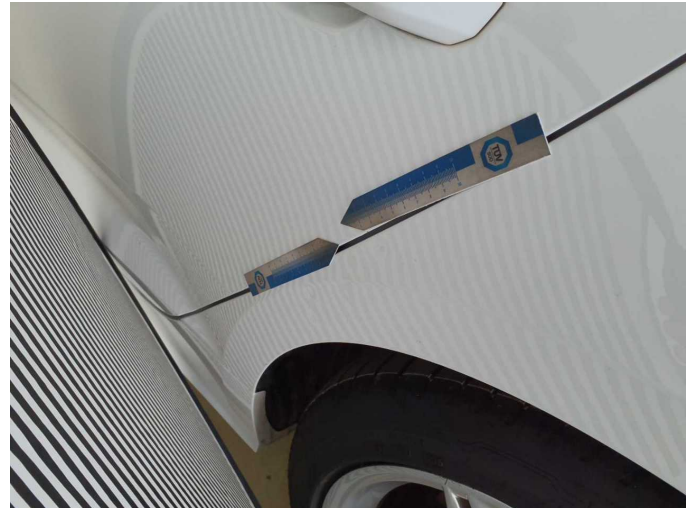
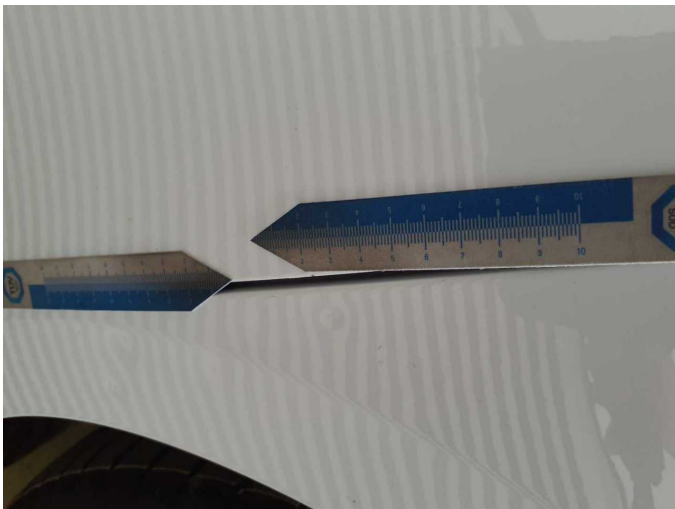
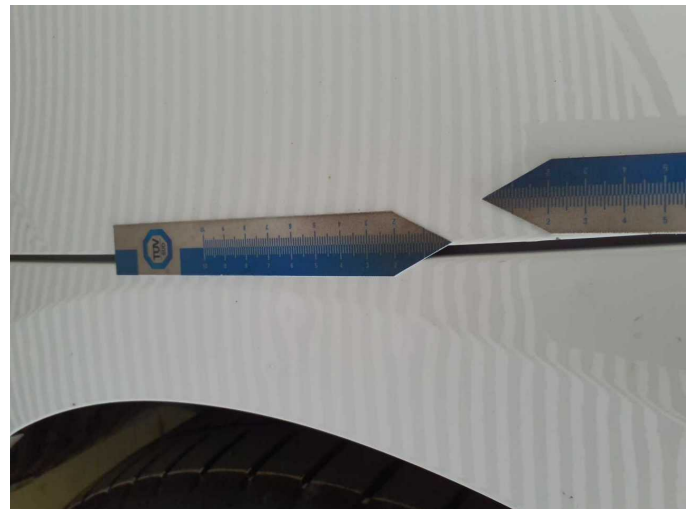
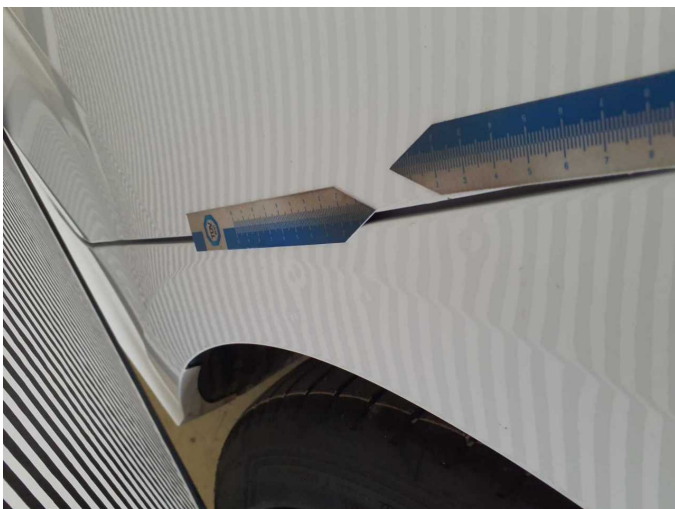
| No. | Component group | Description |
|---|---|---|
| 4 | Side panel - rear left side | Side panel - dent(s) - Repair and paint |

**Damage 4:** Side panel - rear left side: Side panel - dent(s) - Repair and paint

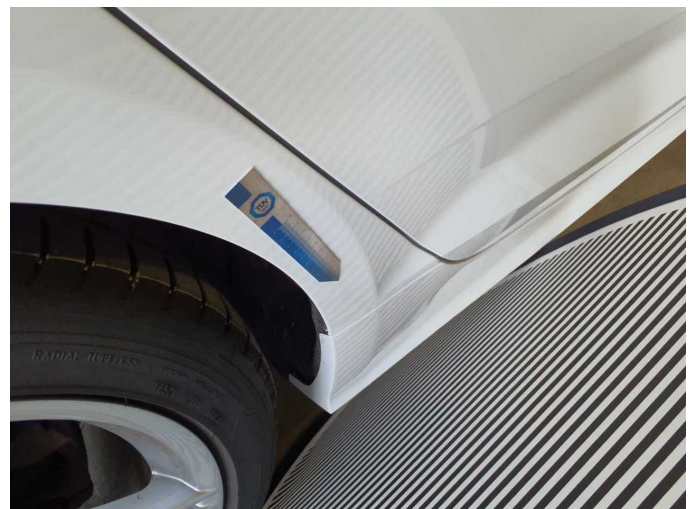
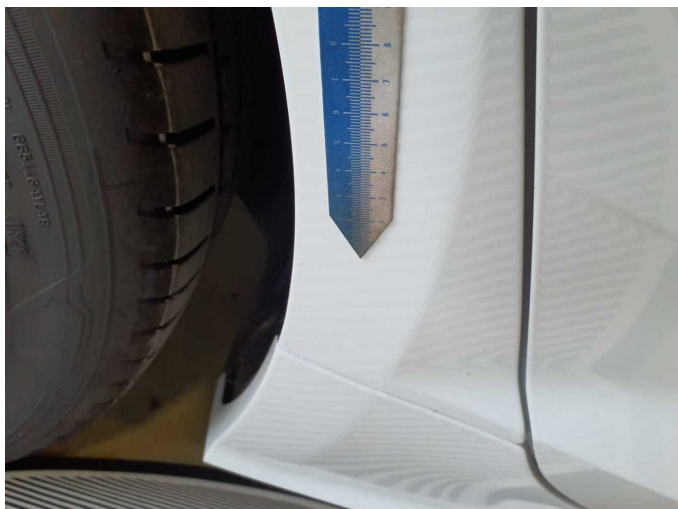
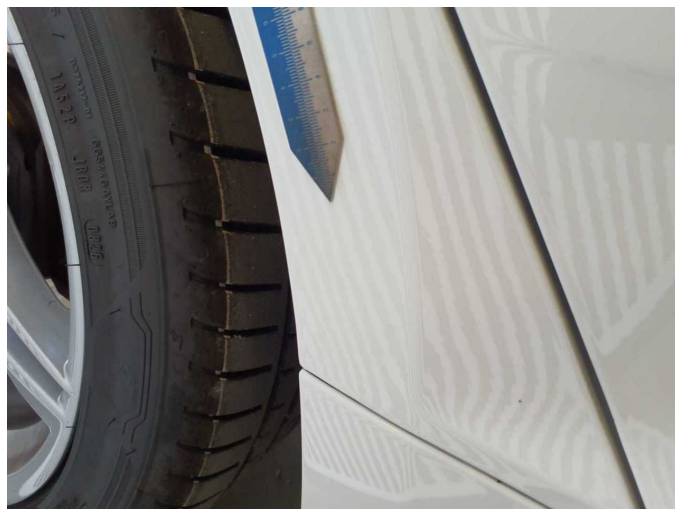
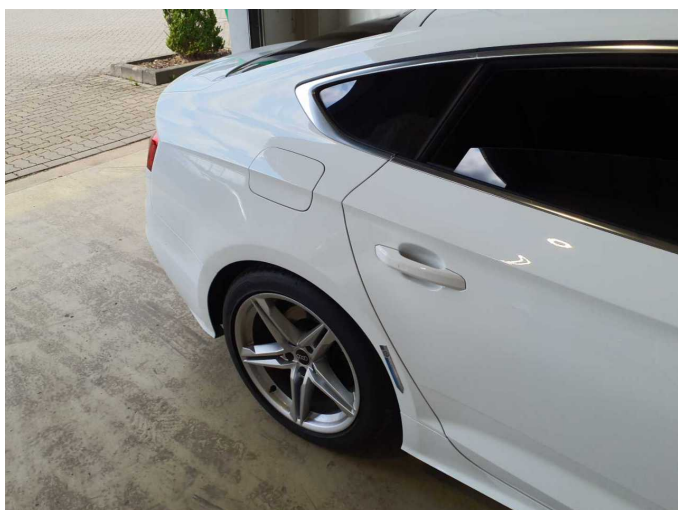
| No. | Component group | Description |
|---|---|---|
| 5 | Side panel - rear right side | Side panel (Wellig) - Unprofessionally repaired - Repair and paint |

| No. | Repainting |
|---|---|
| 2 | Side panel - rear right side, Unprofessionally carried out, Invoice of repair done Non-existent |

| Side panel - rear right side | 300 µm | Door - rear right side | 233 µm |

**Damage 5:** Side panel - rear right side: Side panel (Wellig) - Unprofessionally repaired - Repair and paint

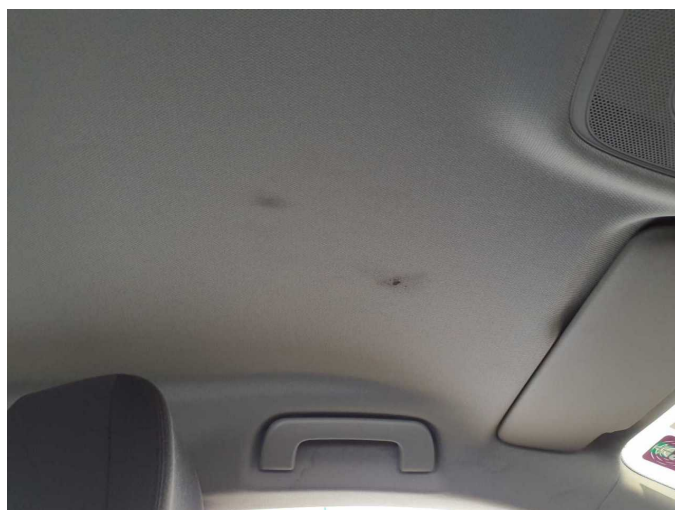
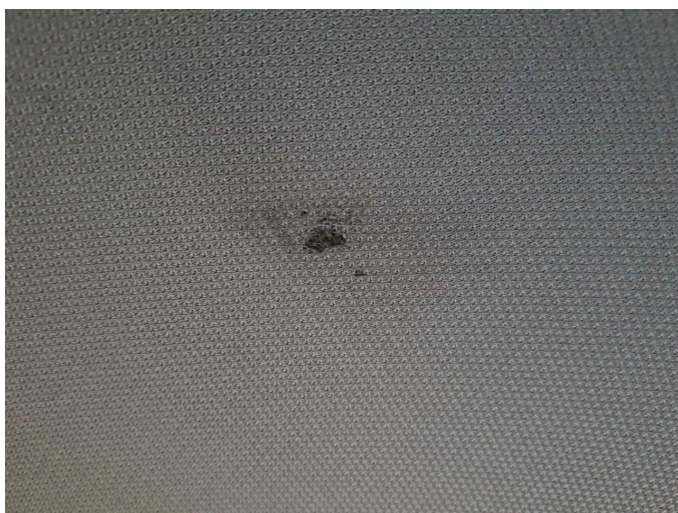
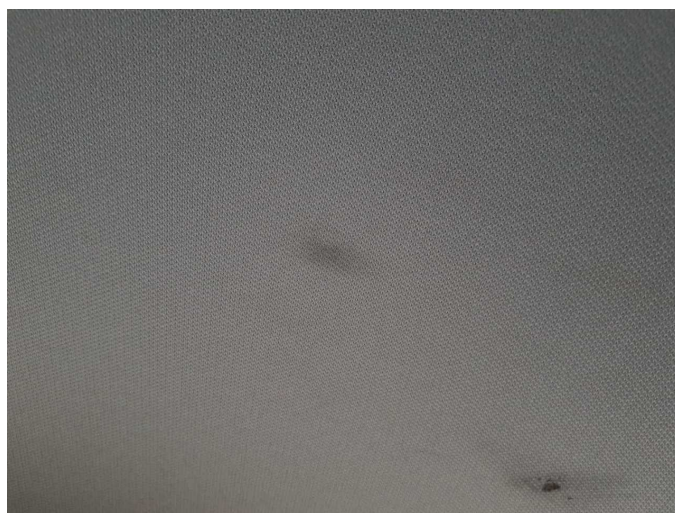
| No. | Component group | Description |
|---|---|---|
| 6 | Trim / covers | Roof lining - Holes - Replace |

**Damage 6:** Trim / covers: Roof lining - Holes - Replace

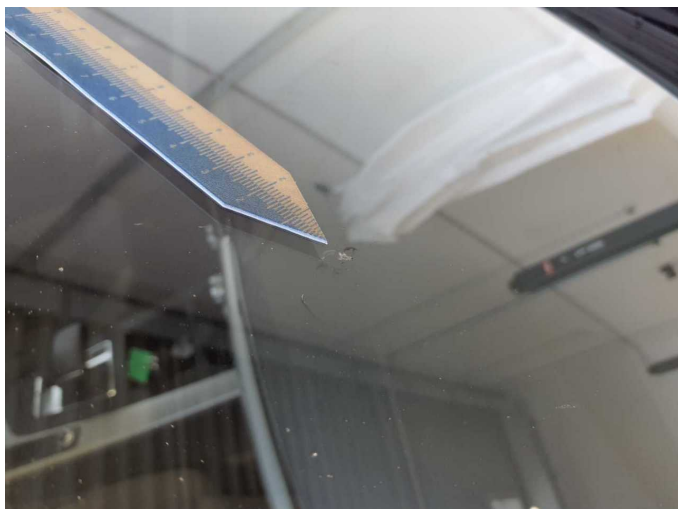
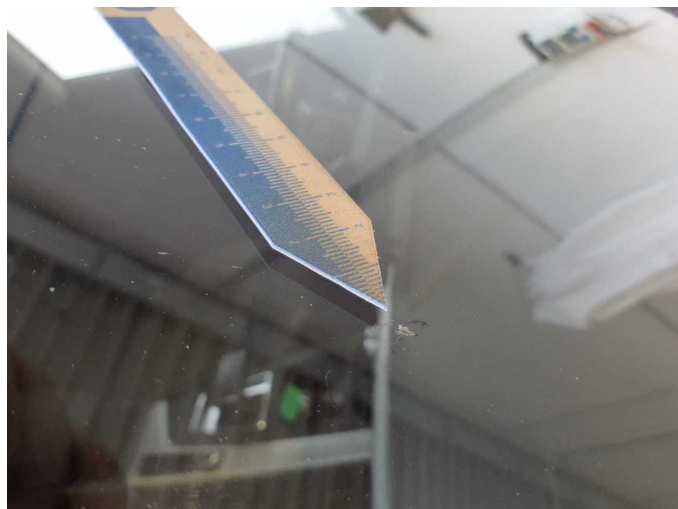
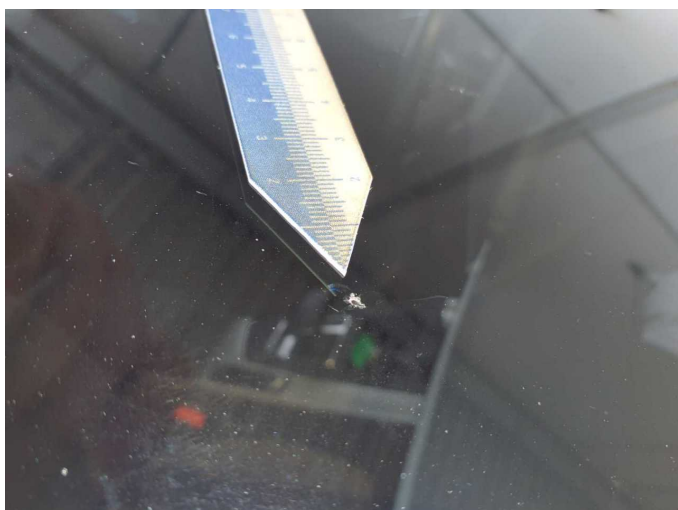
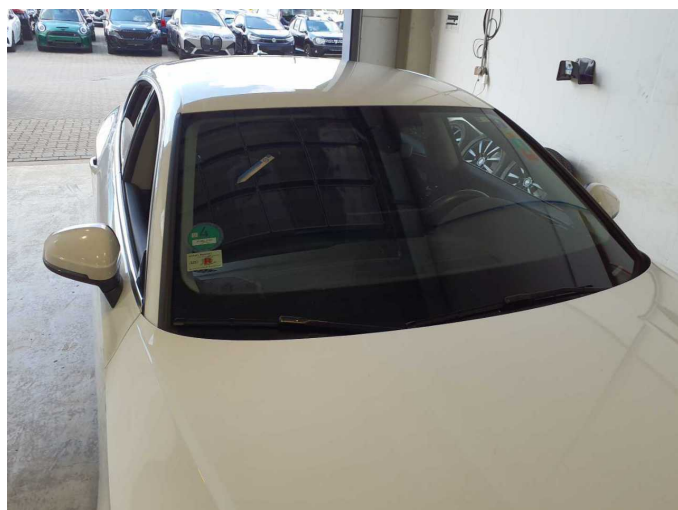
| No. | Component group | Description |
|---|---|---|
| 7 | Vehicle glazing | Windscreen - Broken / torn - Replace |

**Damage 7:** Vehicle glazing: Windscreen - Broken / torn - Replace

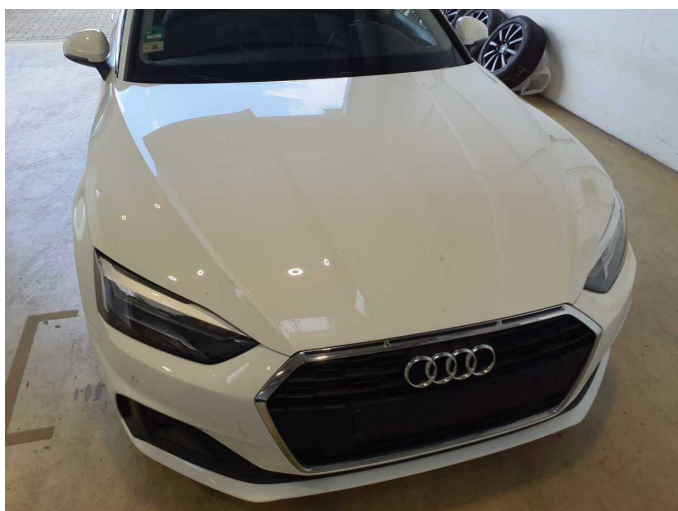
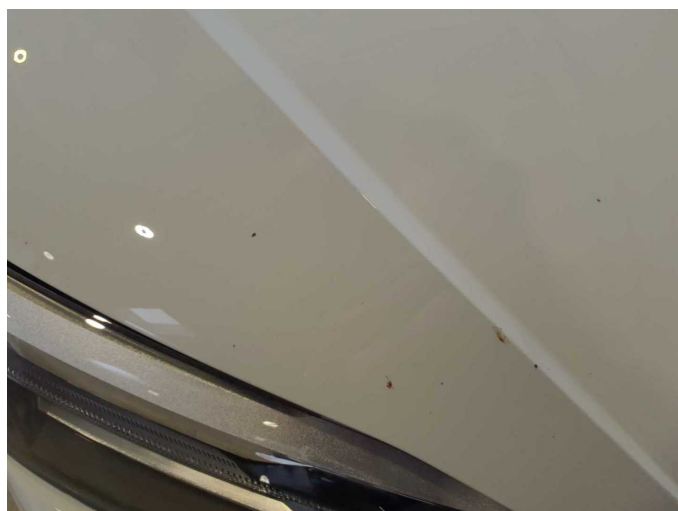
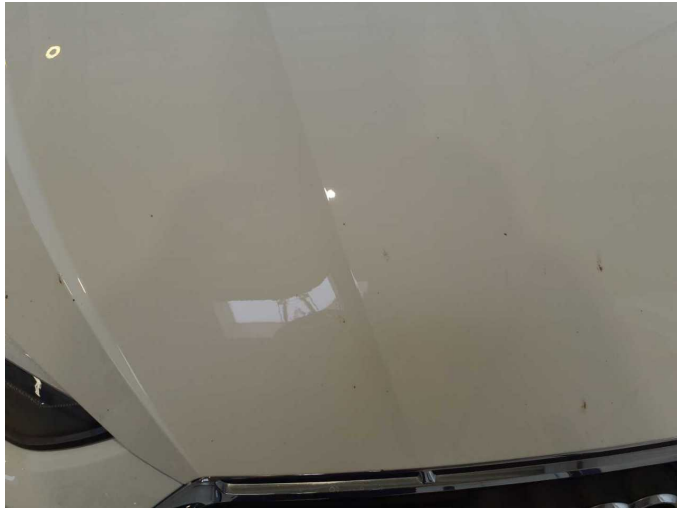
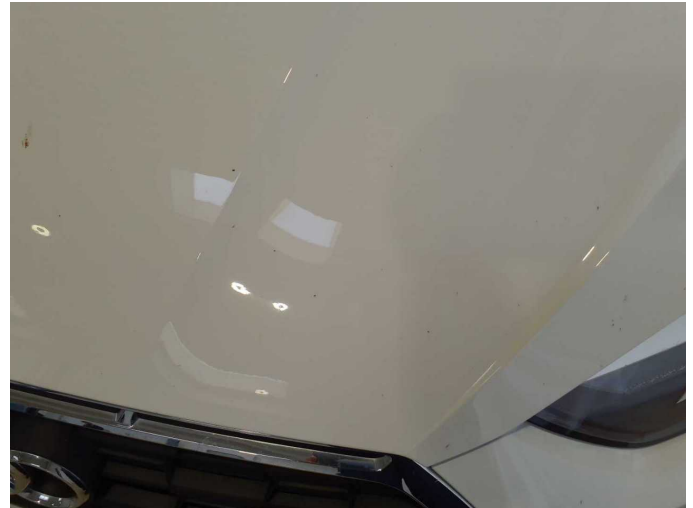
| No. | Component group | Description |
|---|---|---|
| 2 | Bonnet | Bonnet - Stone chips - No deduction |

**Wear and tear 2:** Bonnet: Bonnet - Stone chips - No deduction

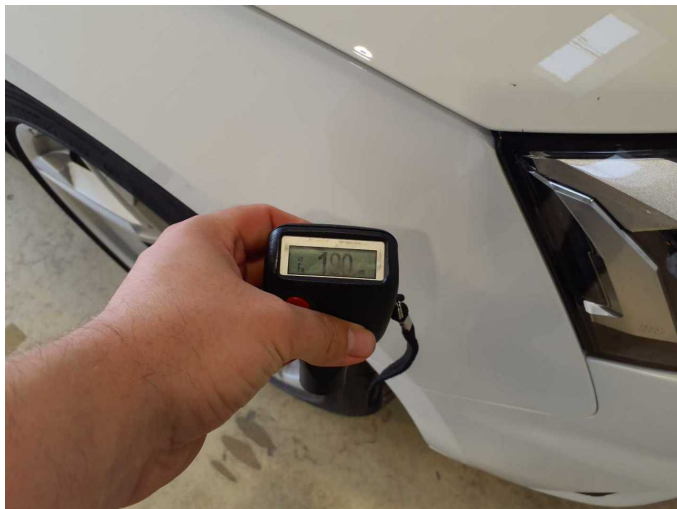
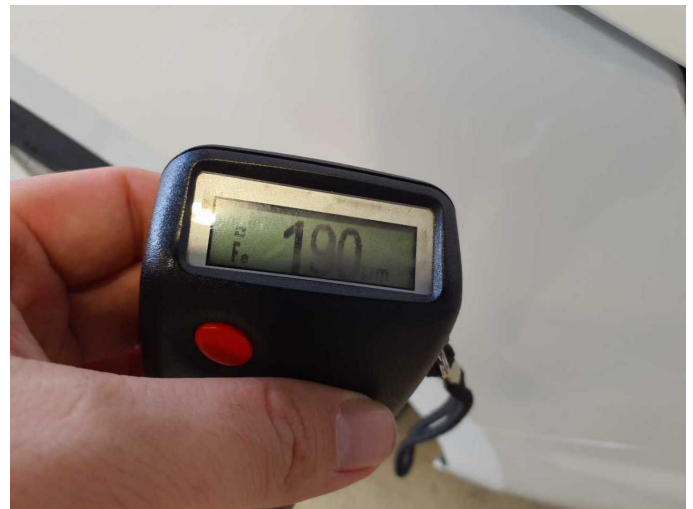
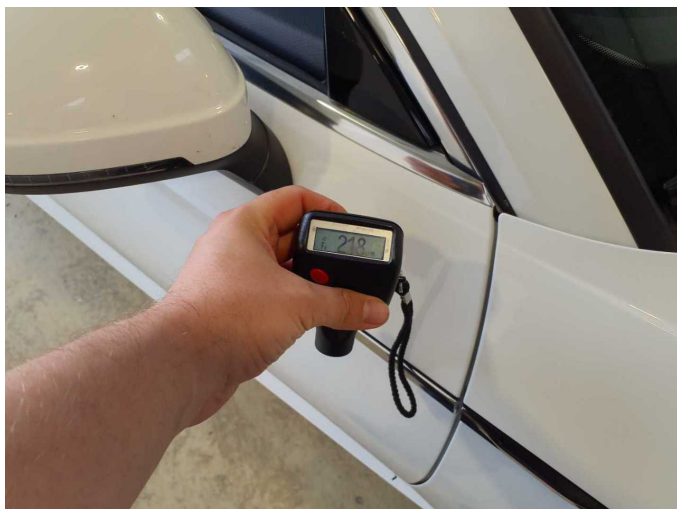
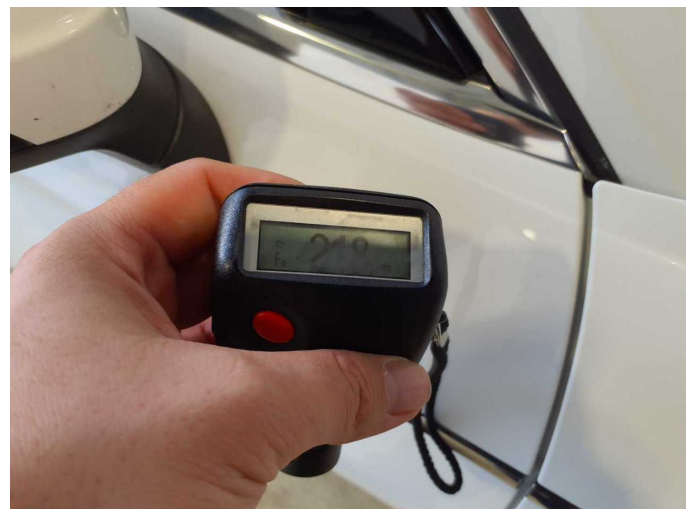
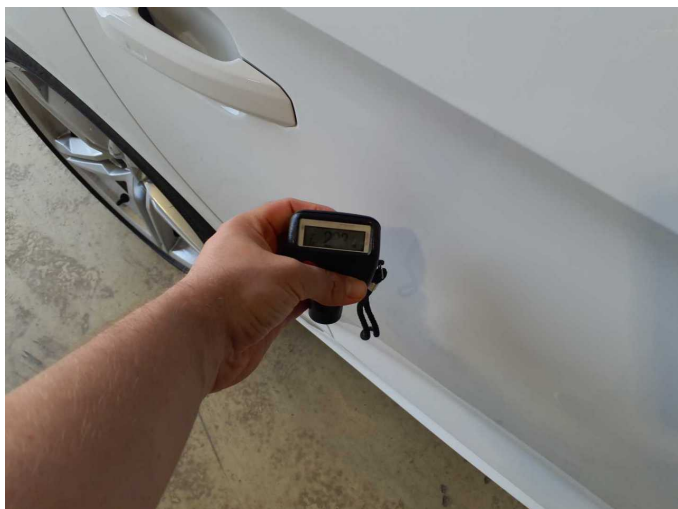
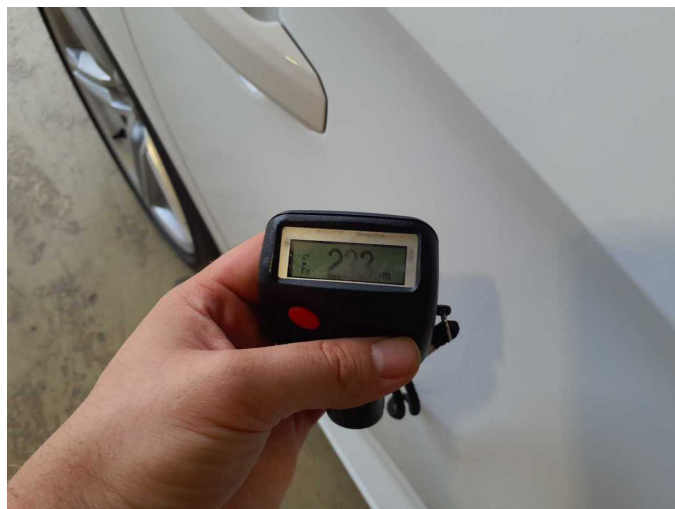
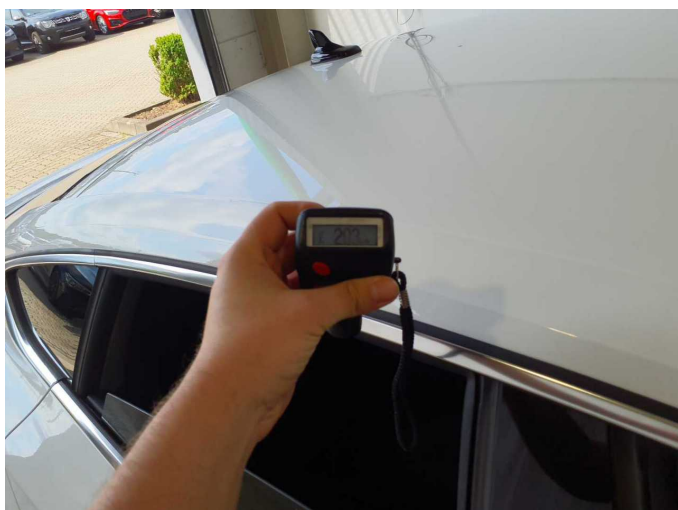
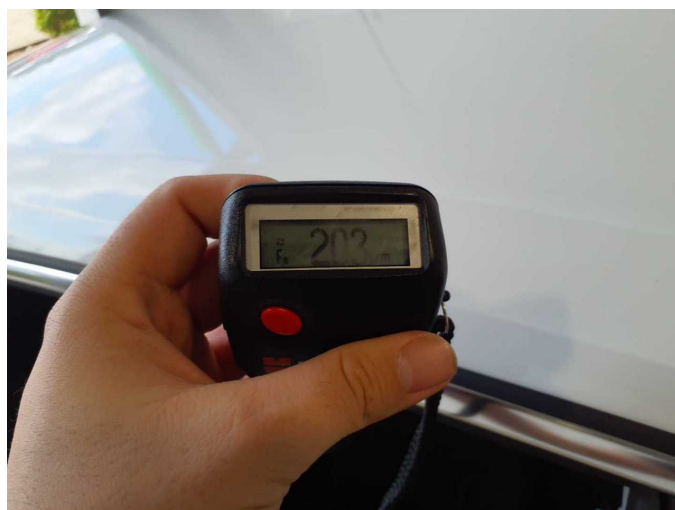
| No. | Repainting |
|---|---|
| 1 | Roof rail - right side, Mudguard - right side, Door - rear right side, Door - front right side, Professionally carried out, Invoice of repair done Non-existent |

| Roof rail - right side | 203 µm | Mudguard - right side | 190 µm |
| Door - front right side | 218 µm | | |

**Repainting 1:** Roof rail - right side, Mudguard - right side, Door - rear right side, Door - front right side

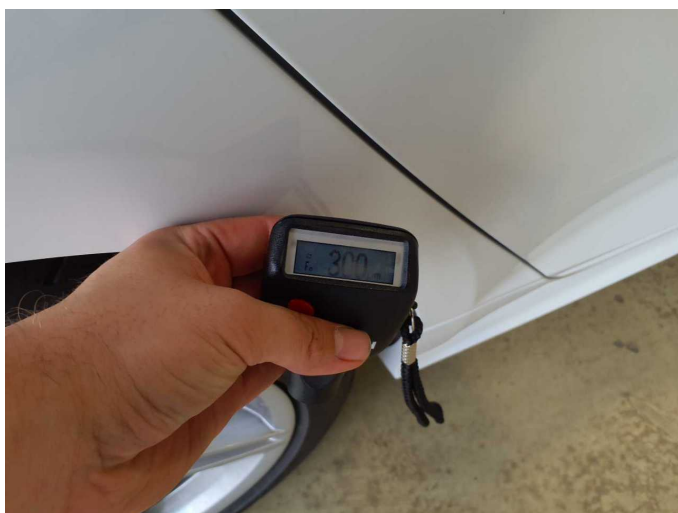
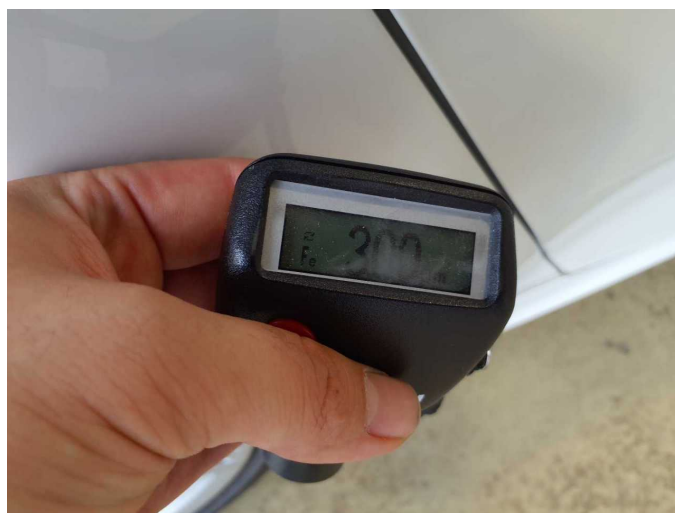
**Repainting 2:** Side panel - rear right side
