Expertise

Protocol number: 46515629  
Order No. / Reference: 26570169  
Inspection date: 15 Jul 2026

Manufacturer: Skoda  
VIN: TMBJJ9NX7MY161786

Model: Octavia Combi 2.0 TDI DSG Style

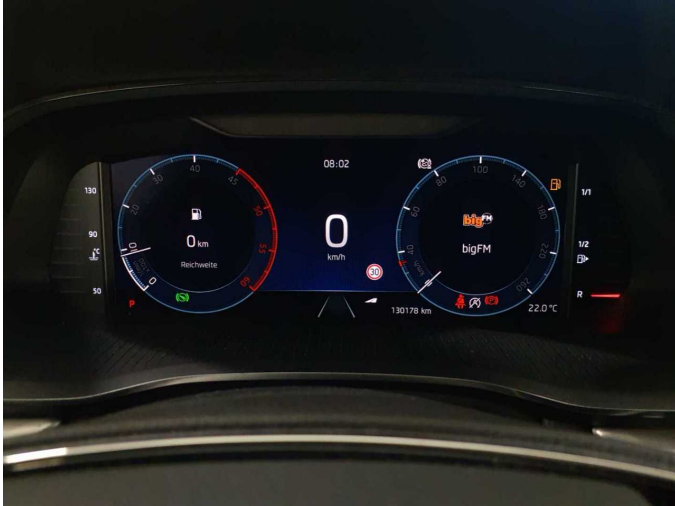
Figure 7: Instrument cluster

| Vehicle details | |
|---|---|
| Mileage (Read) | 130,178 km |

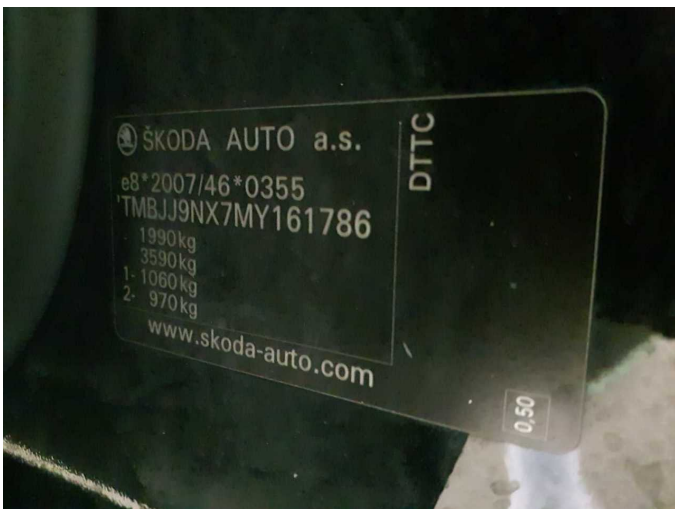
Figure 11: VIN

| VIN comparison | The vehicle identification number (VIN) was read from the vehicle and its conformity with the submitted documents was confirmed by the undersigned during the inspection. |

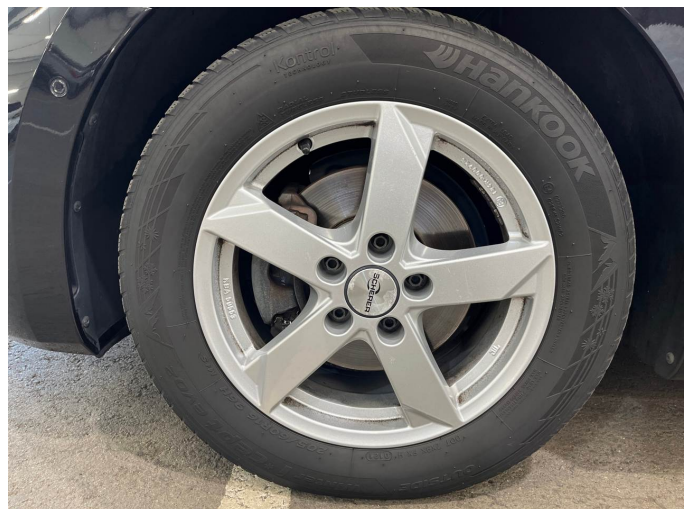
Figure 12: Mounted tyres

| # | Tyre size | Type of tyre | Manufacturer | Tread depth |
|---|---|---|---|---|
| 1) | 205/60 R16 96H | Winter tyres on Light alloy | Hankook | 4mm / 4mm |
| 2) | 205/60 R16 96H | Winter tyres on Light alloy | Hankook | 5mm / 5mm |

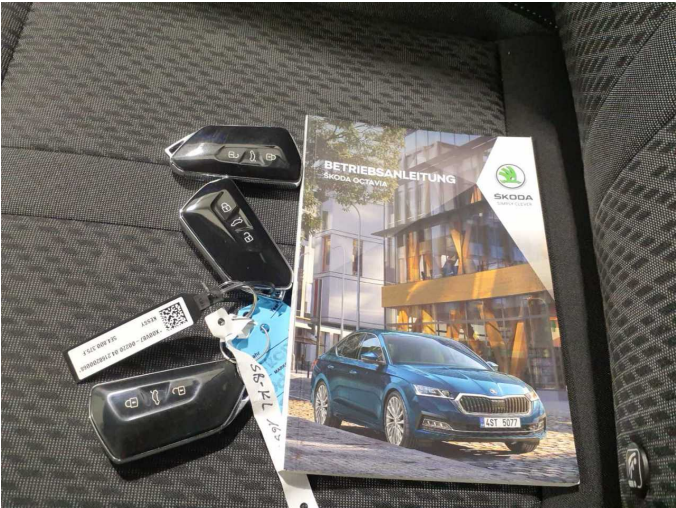
Figure 13: Documents

| <b>Key is / should be</b> | 3 / 3 | <b>FZG documents</b> | ZB#2 (B) was available (copy), ZB#1 (S) was not available. |

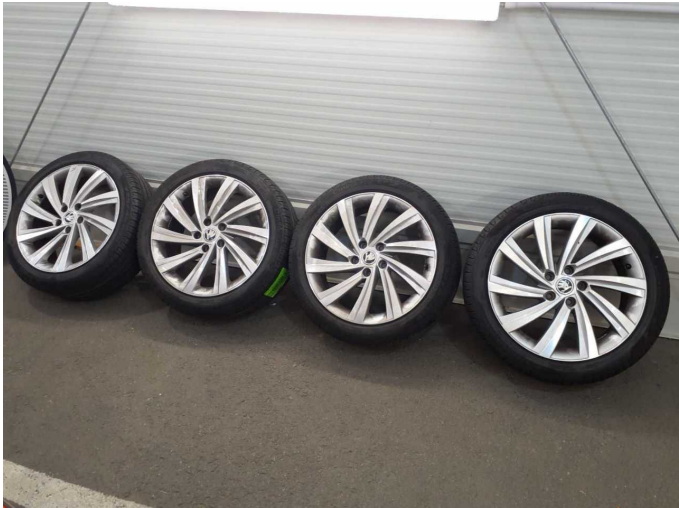
Figure 16: Additional tyres

| # | Tyre size | Type of tyre | Manufacturer | Tread depth |
|---|---|---|---|---|
| 1) | 225/45 R18 91W | Summer tyres on Light alloy | Pirelli | 5mm / 5mm |
| 2) | 225/45 R18 91W | Summer tyres on Light alloy | Pirelli | 5mm / 5mm |

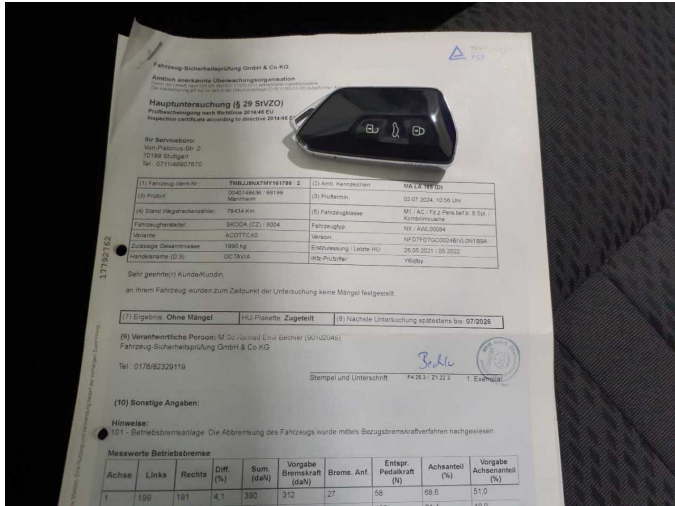
**Damage 1:** Misc.: Main inspection (diesen Monat) - Due - No deduction

| No. | Component group | Description |
|---|---|---|
| 1 | Misc. | Main inspection (diesen Monat) - Due - No deduction |

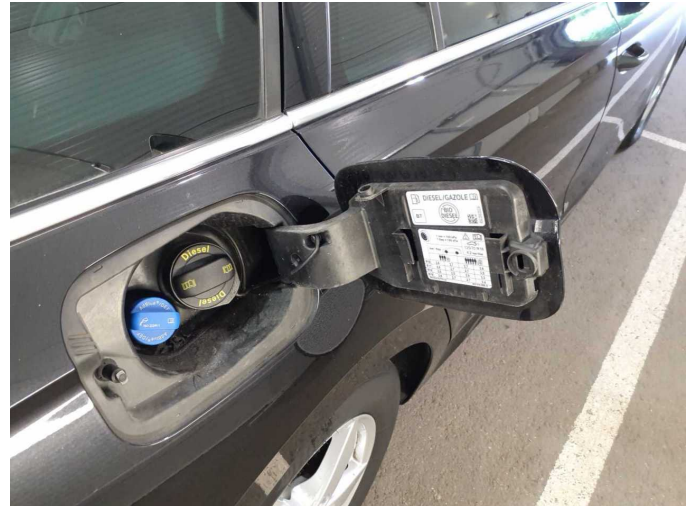
**Damage 2:** Fuel system: Tank flap (Eiskratzer) - Missing - Replace

| No. | Component group | Description |
|---|---|---|
| 2 | Fuel system | Tank flap (Eiskratzer) - Missing - Replace |

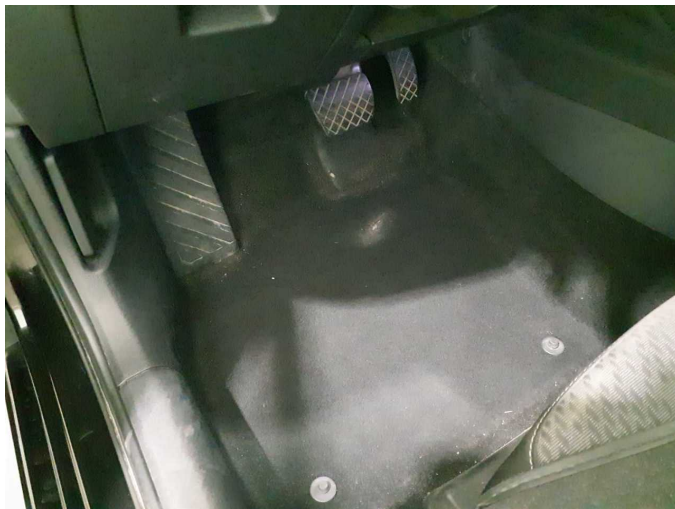
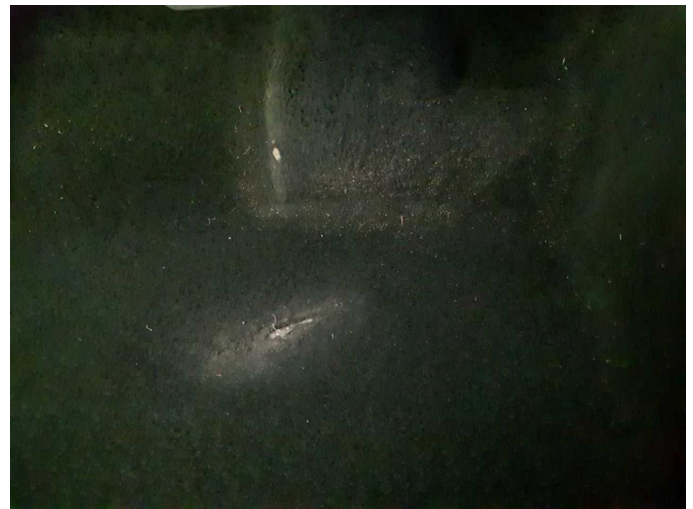
**Damage 3:** Trim / covers: Carpet - front left side - Broken / torn - Loss in value

| No. | Component group | Description |
|---|---|---|
| 3 | Trim / covers | Carpet - front left side - Broken / torn - Loss in value |

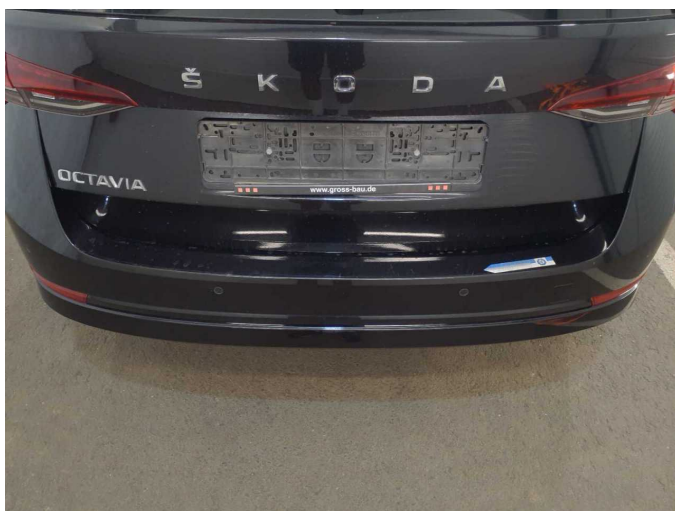
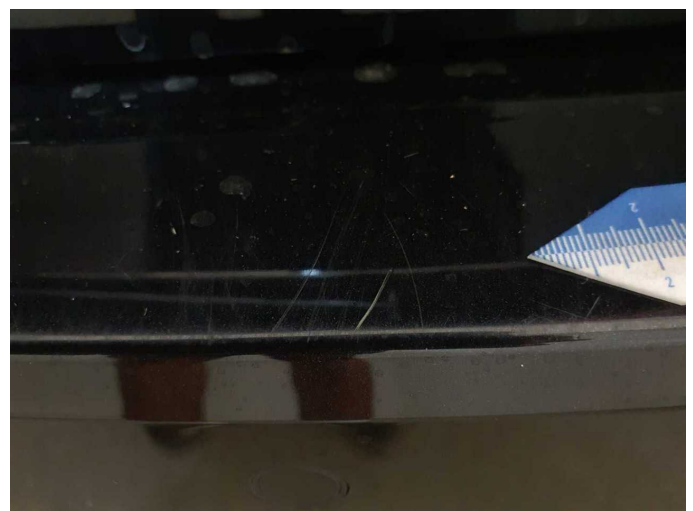
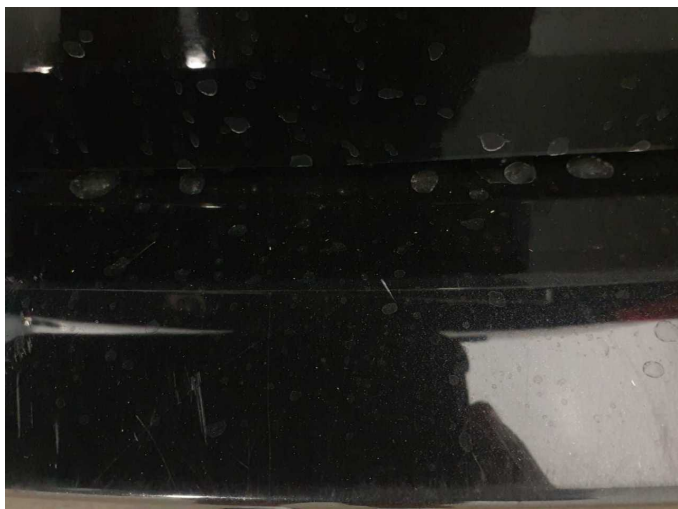
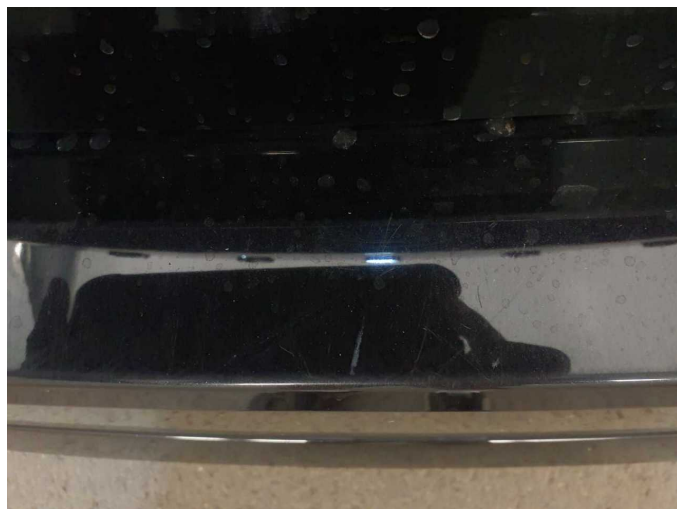
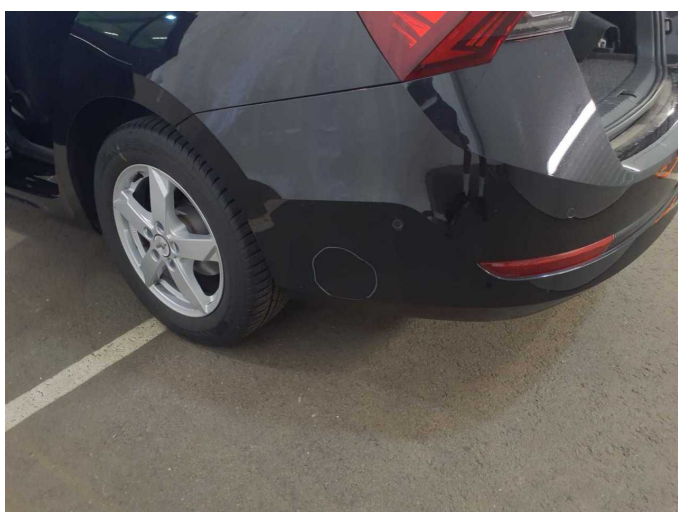
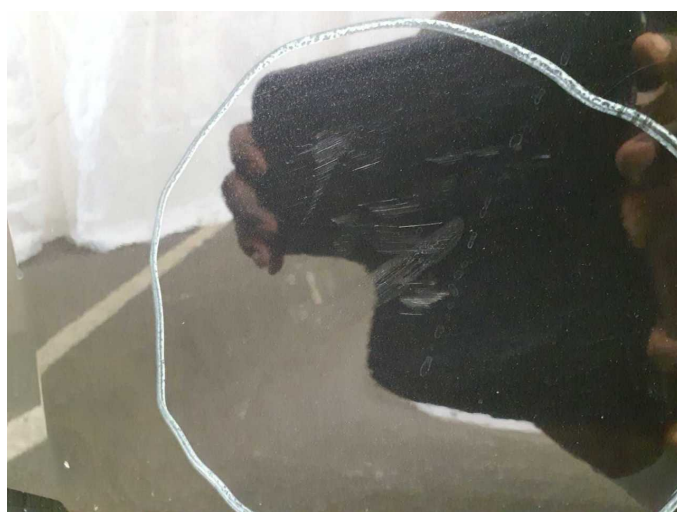
**Damage 4:** Rear bumper: Rear bumper - Scratch(es) - Smart repair

| No. | Component group | Description |
|---|---|---|
| 4 | Rear bumper | Rear bumper - Scratch(es) - Smart repair |

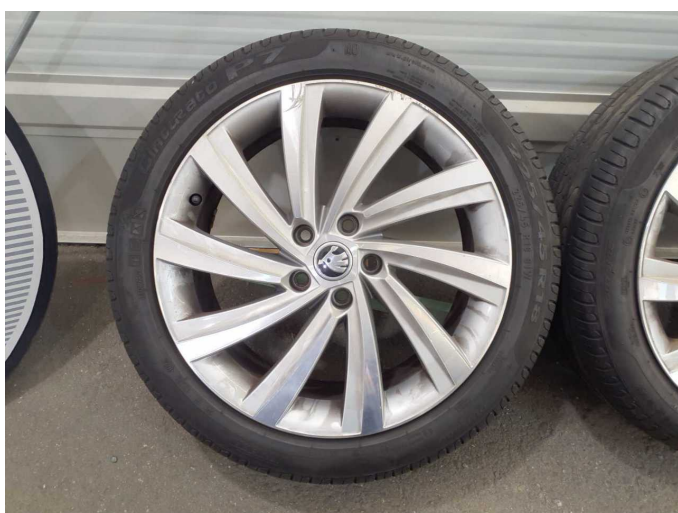
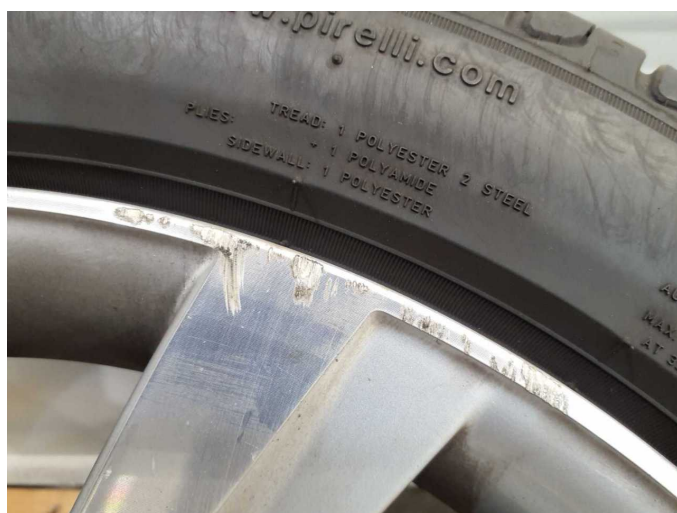
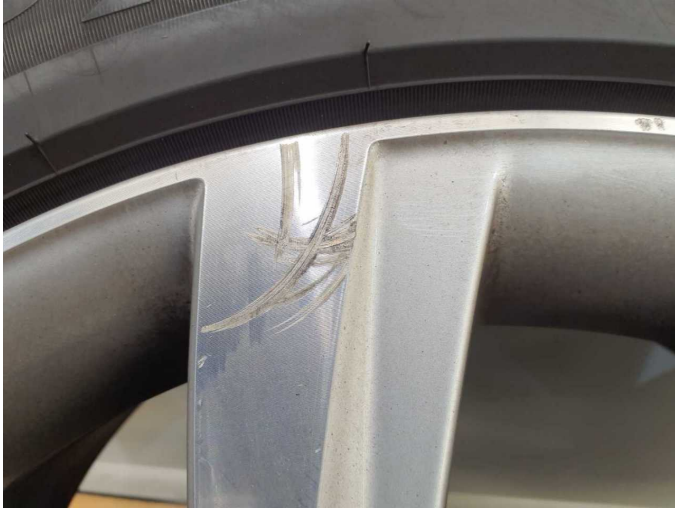
**Damage 5:** 2nd wheel set: 1 alloy rim - Scratched - Loss in value

| No. | Component group | Description |
|---|---|---|
| 5 | 2nd wheel set | 1 alloy rim - Scratched - Loss in value |

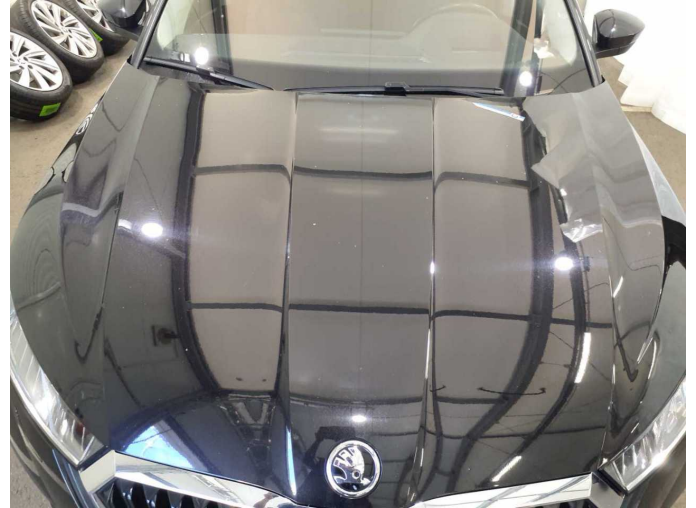
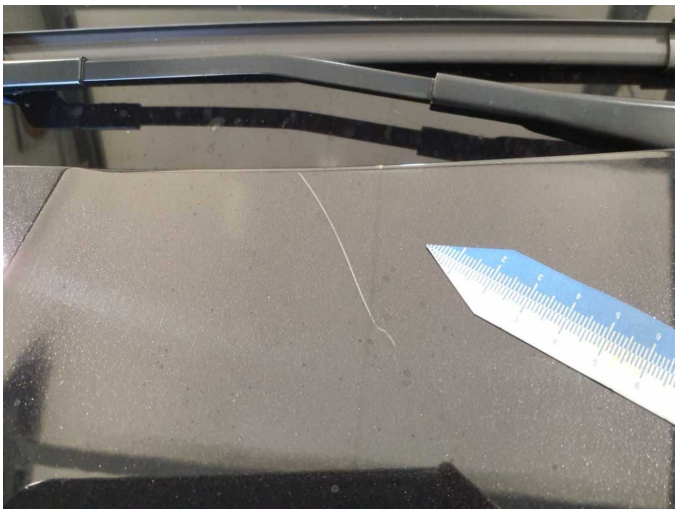
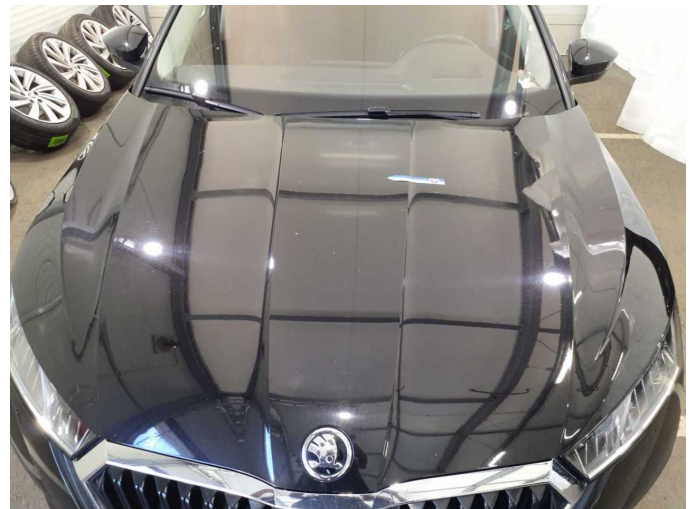
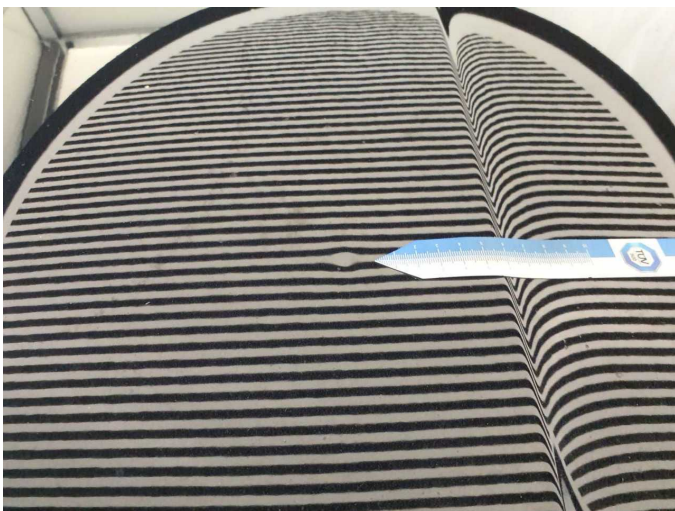
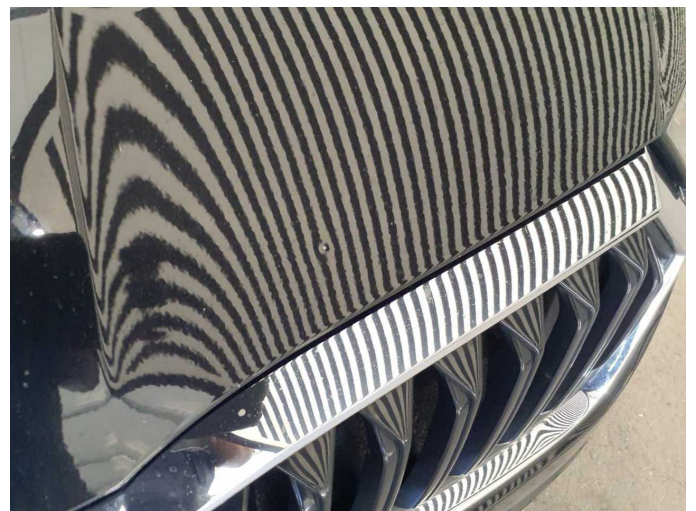
**Damage 6:** Bonnet: Bonnet - Dent / paintcoat damage - Repair and paint

| No. | Component group | Description |
|---|---|---|
| 6 | Bonnet | Bonnet - Dent / paintcoat damage - Repair and paint |

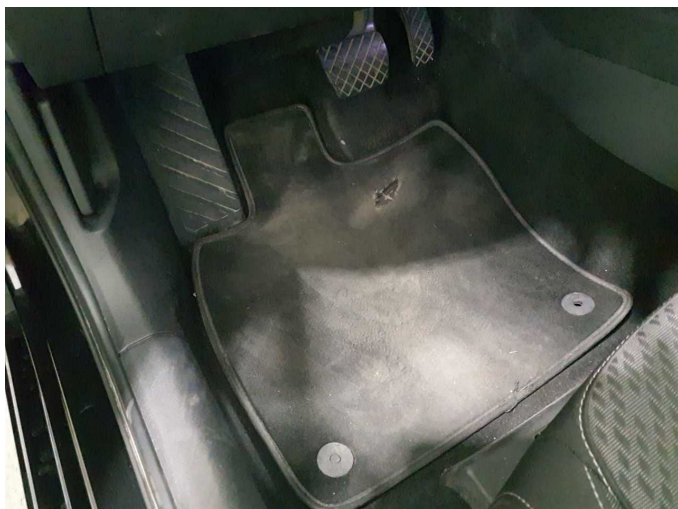
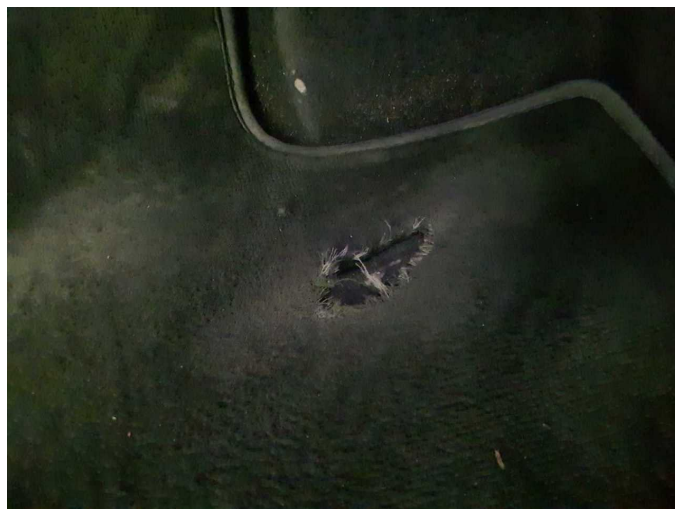
**Wear and tear 1:** Trim / covers: Floor mats - Broken / torn - Replace

| No. | Component group | Description |
|---|---|---|
| 1 | Trim / covers | Floor mats - Broken / torn - Replace |
