Expertise

Protocol number: 46434818  
Order No. / Reference: 26663290  
Inspection date: 2 Jul 2026

Manufacturer: Skoda  
VIN: TMBLE9NY7PF053092

Model: ENYAQ iV 80X

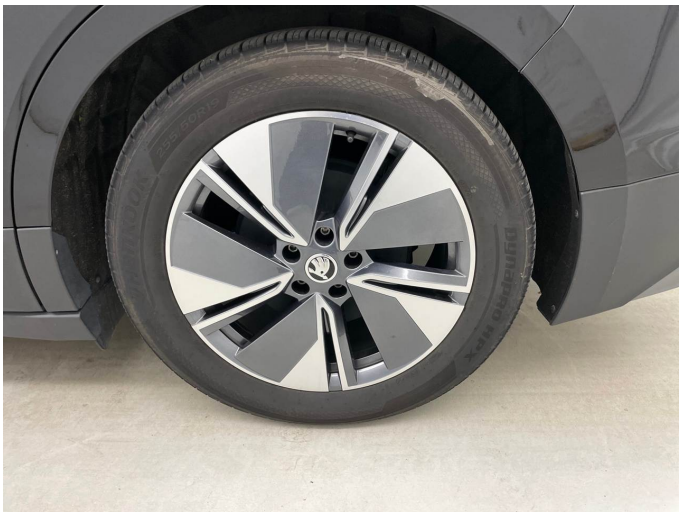
Figure 12: Mounted tyres

| # | Tyre size | Type of tyre | Manufacturer | Tread depth |
|---|---|---|---|---|
| 1) | 235/55 R19 105V | All-season tyres on Light alloy | Hankook | 6mm / 6mm |
| 2) | 255/50 R19 107V | All-season tyres on Light alloy | Hankook | 7mm / 7mm |

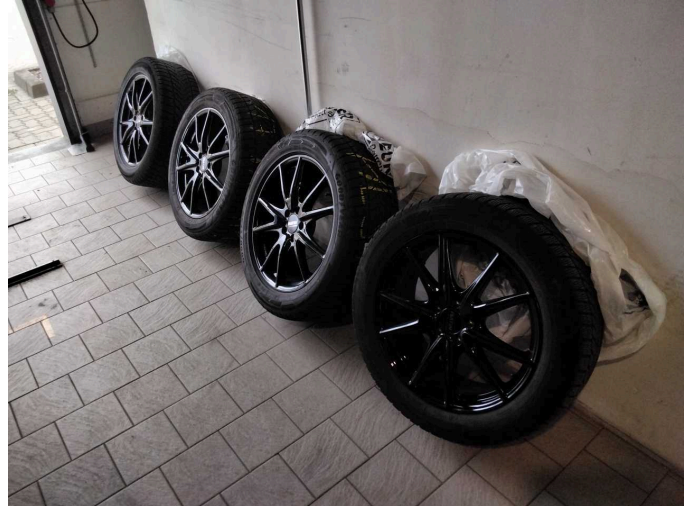
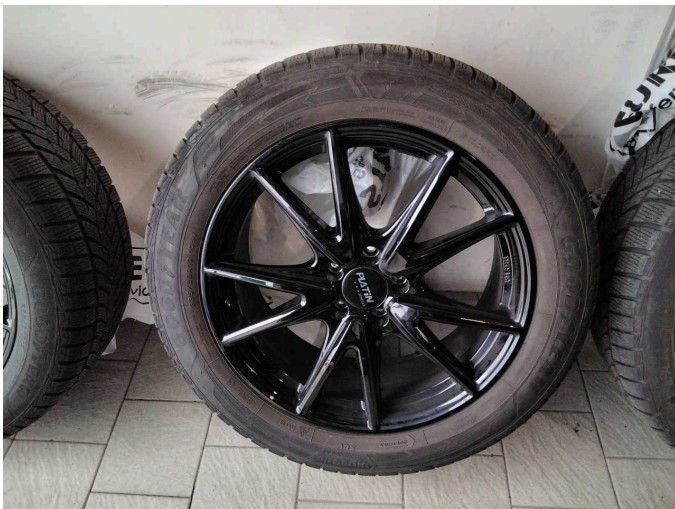
Figure 14: Additional tyres

| # | Tyre size | Type of tyre | Manufacturer | Tread depth |
|---|---|---|---|---|
| 1) | 235/55 R19 105V | Winter tyres on Light alloy | Goodyear | 5mm / 5mm |
| 2) | 255/50 R19 107V | Winter tyres on Light alloy | Goodyear | 6mm / 6mm |

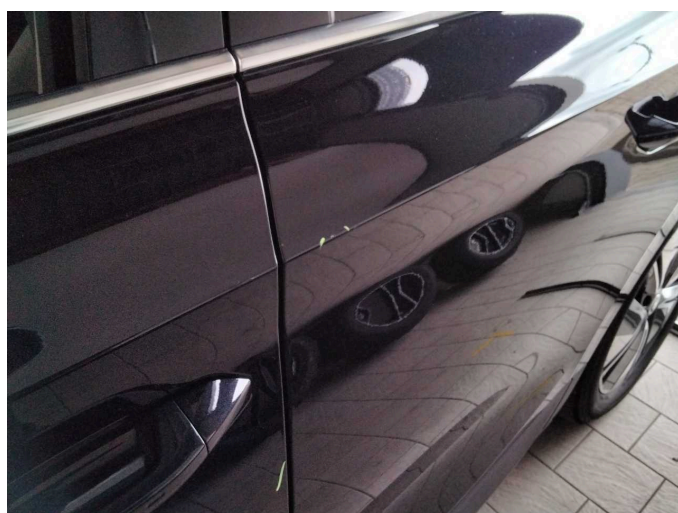
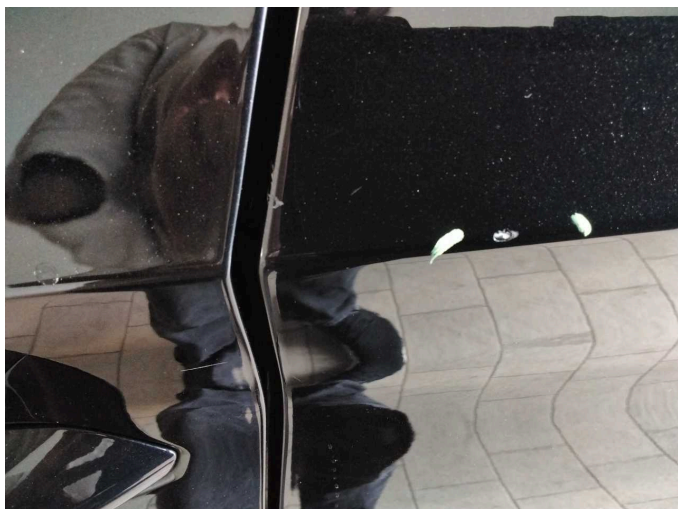
| No. | Component group | Description |
|---|---|---|
| 1 | Door - rear left side | Door - Scratch(es) - Smart repair |

Damage 1: Door - rear left side: Door - Scratch(es) - Smart repair

**Damage 1:** Door - rear left side: Door - Scratch(es) - Smart repair

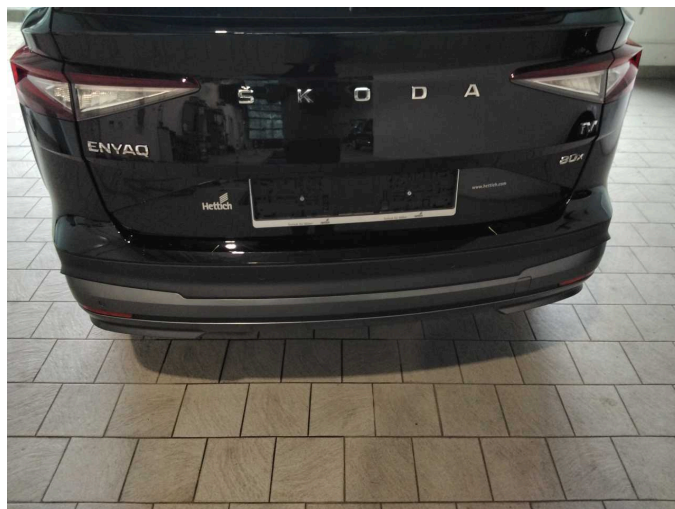
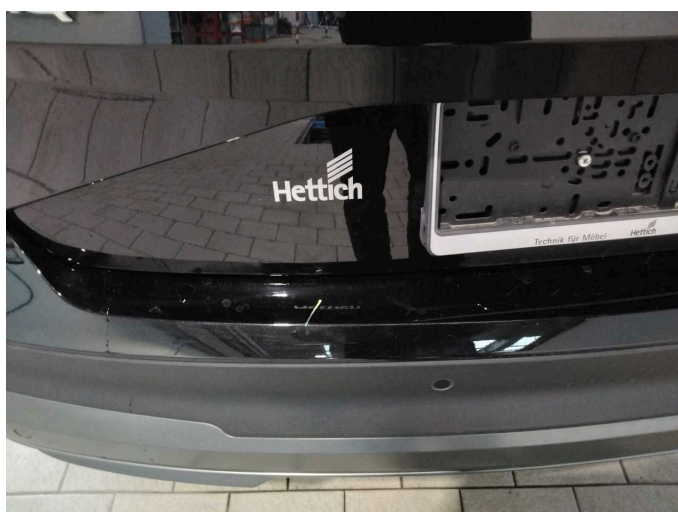
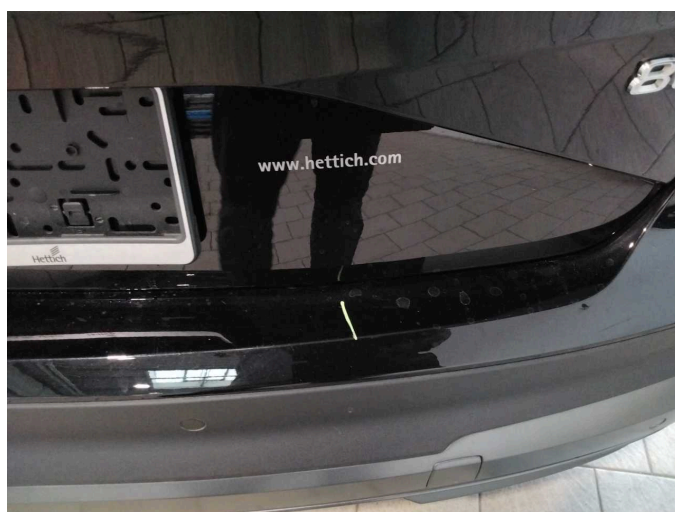
| No. | Component group | Description |
|---|---|---|
| 2 | Boot lid / rear door | Boot lid - Glued / labelled - De-glue / neutralise |

**Damage 2:** Boot lid / rear door: Boot lid - Glued / labelled - De-glue / neutralise

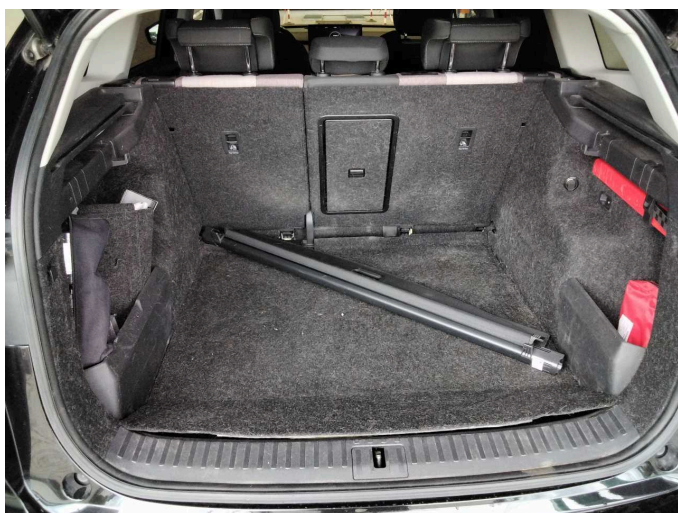
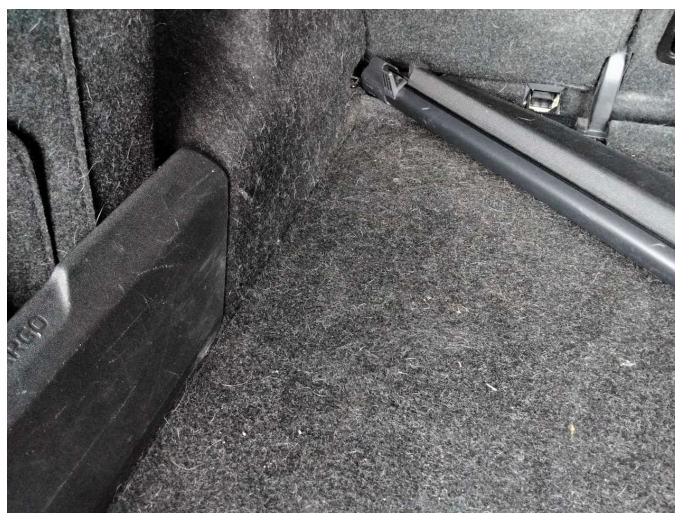
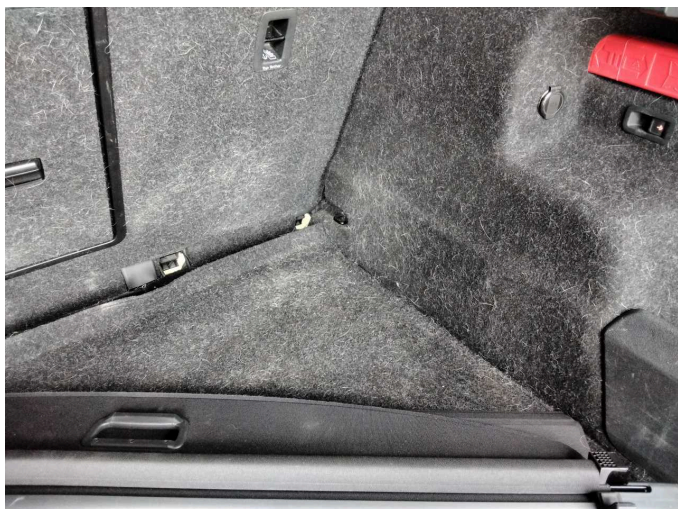
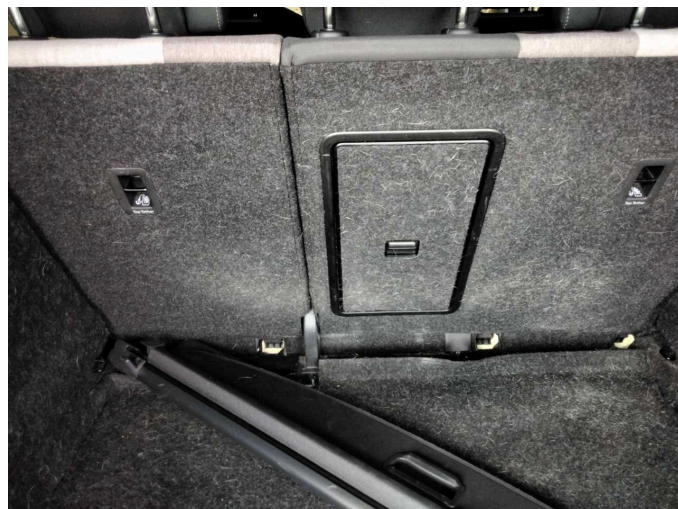
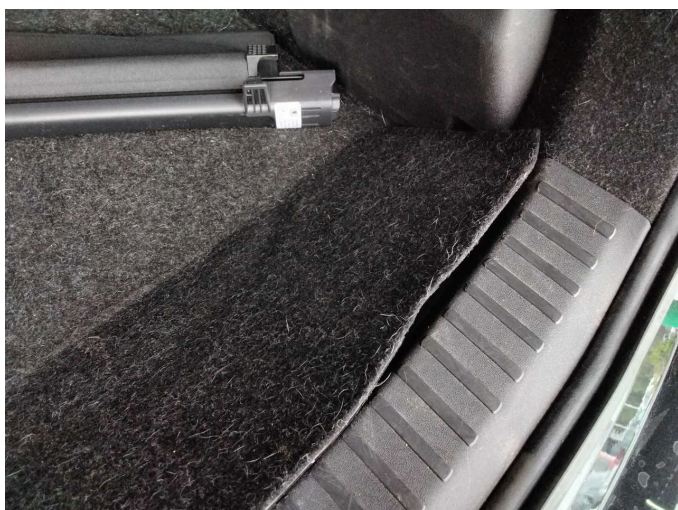
| No. | Component group | Description |
|---|---|---|
| 3 | Interior | Interior (Tierhaare) - Soiled - Clean |

**Damage 3:** Interior: Interior (Tierhaare) - Soiled - Clean

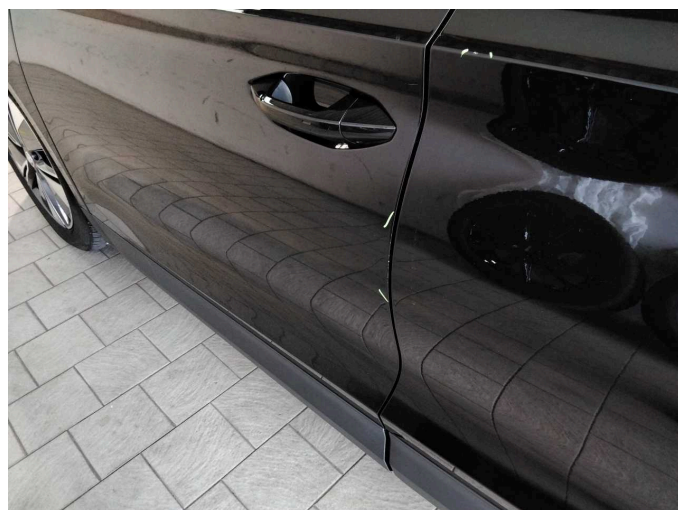
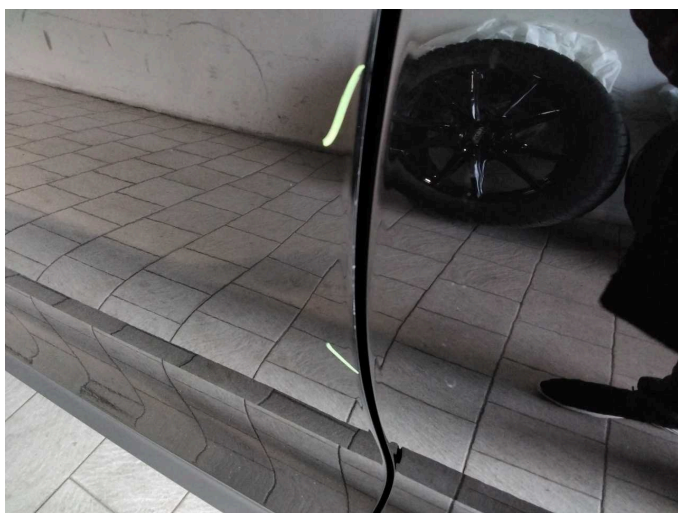
| No. | Component group | Description |
|---|---|---|
| 4 | Door - front left side | Door edge - Scratch(es) - Smart repair |

**Damage 4:** Door - front left side: Door edge - Scratch(es) - Smart repair

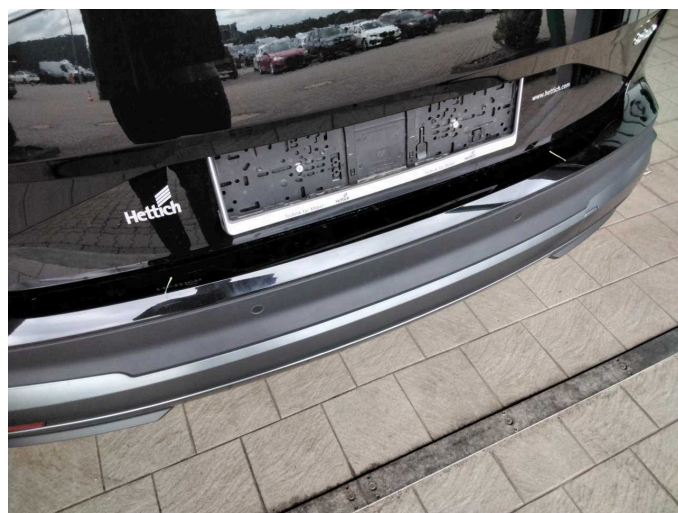
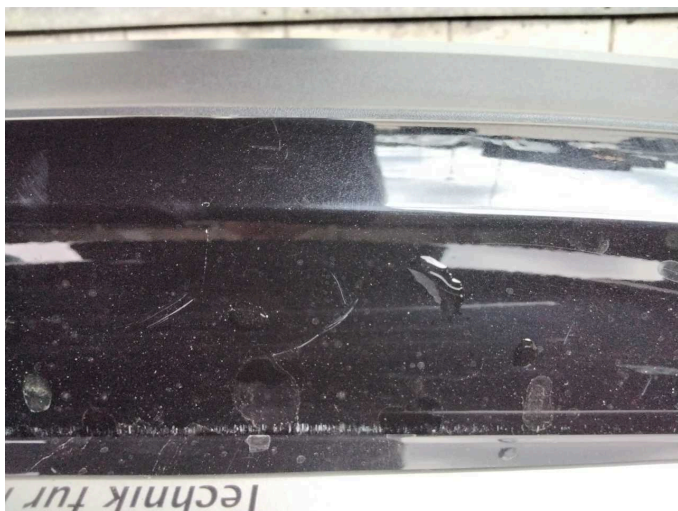
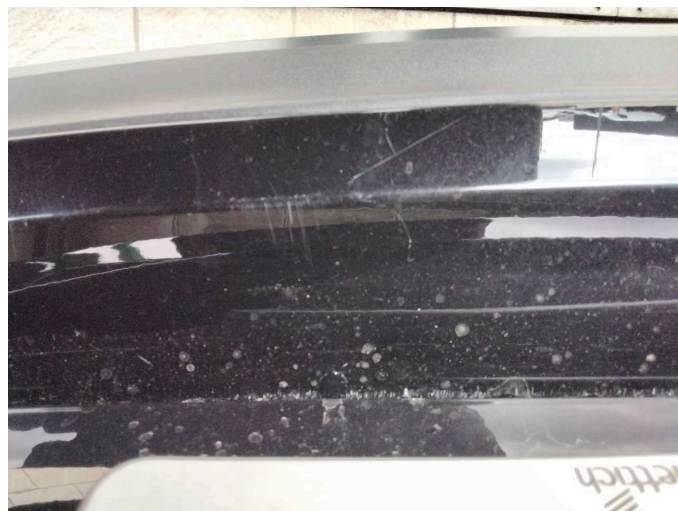
| No. | Component group | Description |
|---|---|---|
| 5 | Rear bumper | Rear bumper - Scratch(es) - Smart repair |

**Damage 5:** Rear bumper: Rear bumper - Scratch(es) - Smart repair

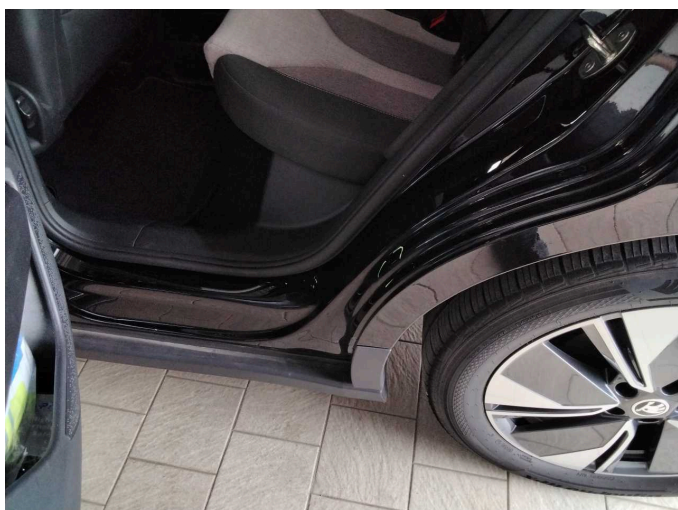
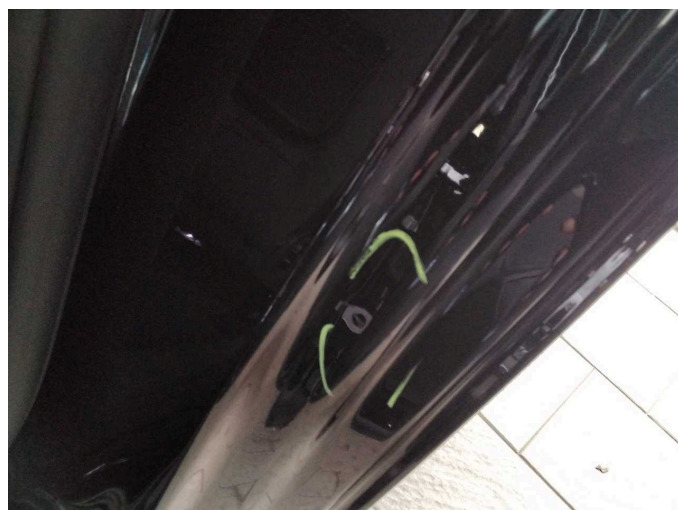
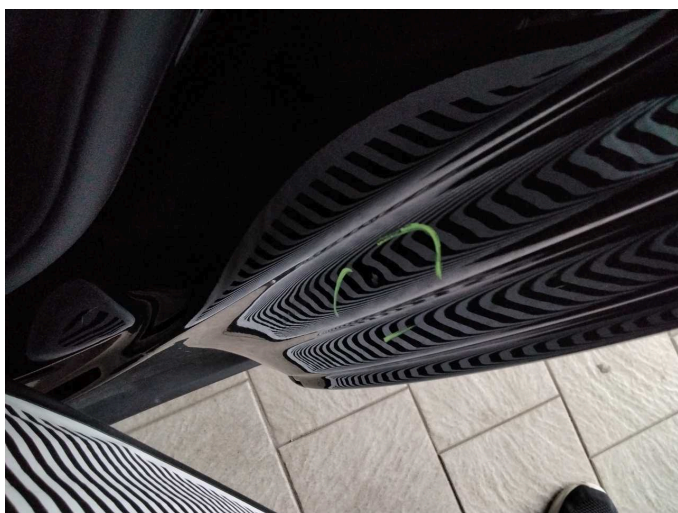
| No. | Component group | Description |
|---|---|---|
| 6 | Body | C-pillar - left side - Dent / paintcoat damage - Smart repair |

**Damage 6:** Body: C-pillar - left side - Dent / paintcoat damage - Smart repair

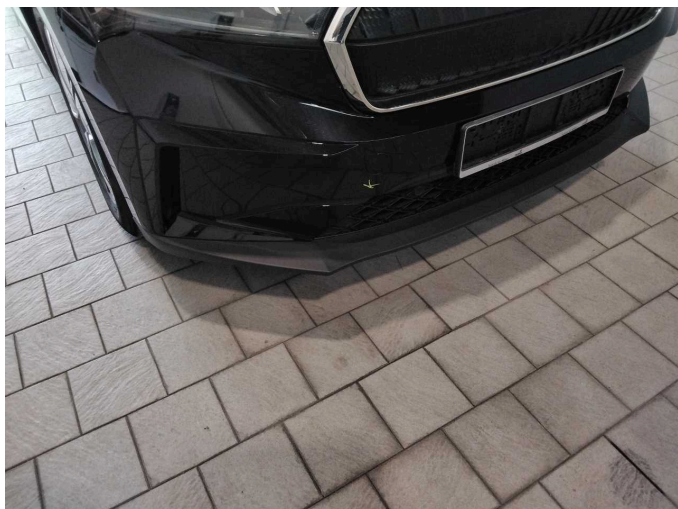
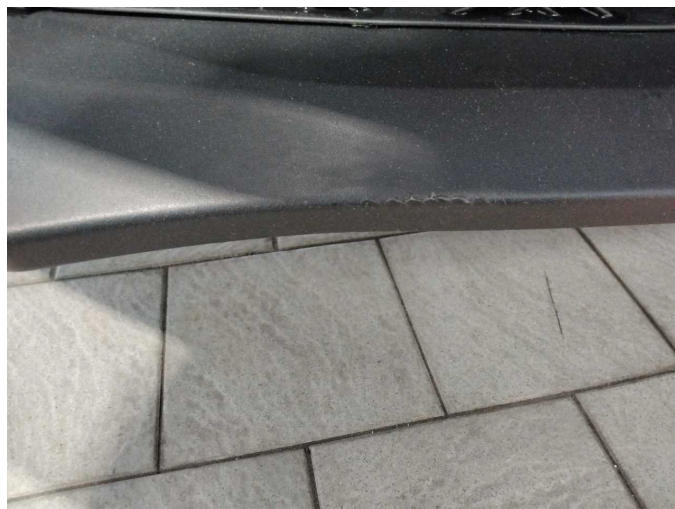
| No. | Component group | Description |
|---|---|---|
| 4 | Front bumper | Spoiler - Scratch(es) - No deduction |

**Wear and tear 4:** Front bumper: Spoiler - Scratch(es) - No deduction

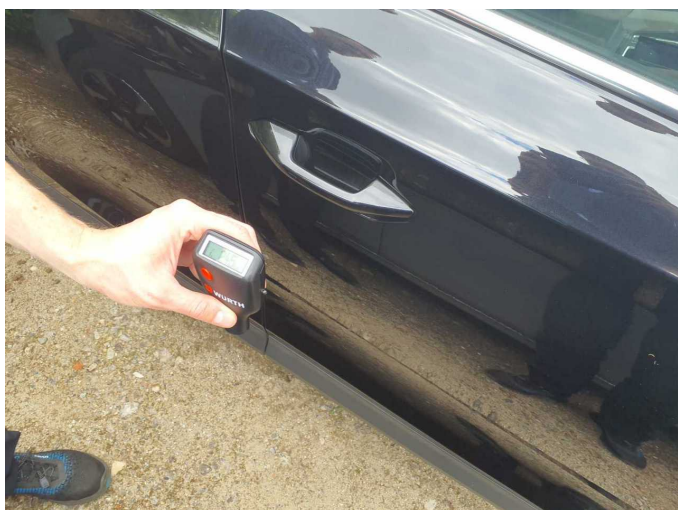
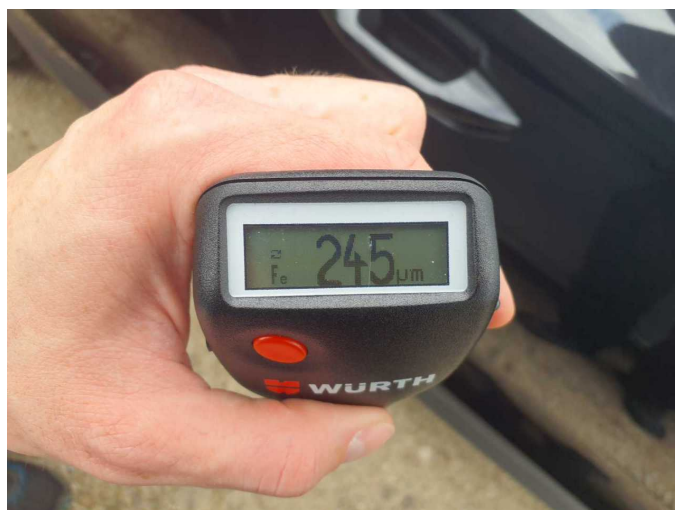
- 1 Door - front right side, Professionally carried out, Invoice of repair done Non-existent

Door - front right side 245 µm |

**Repainting 1:** Door - front right side
