Expertise

Protocol number: 46564453  
Order No. / Reference: 26621712  
Inspection date: 13 Jul 2026

| Manufacturer: Volvo | Model: XC60 T8 AWD Recharge Geartronic RDesign |

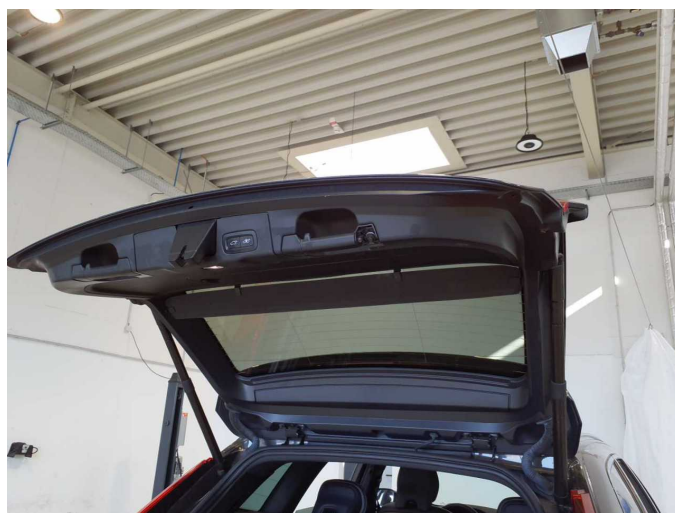
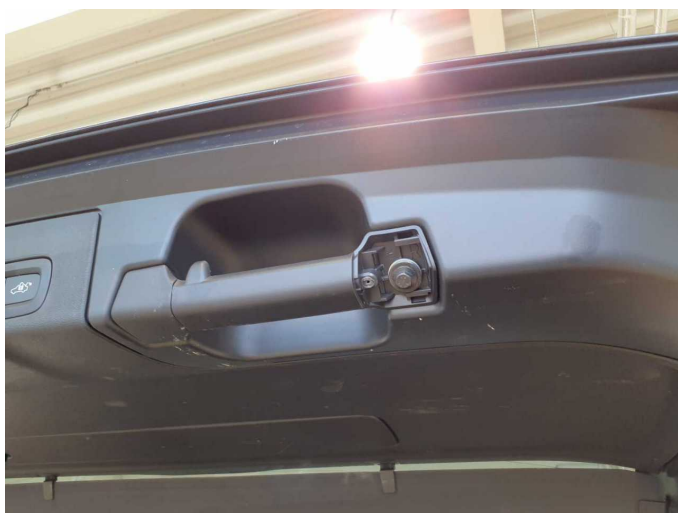
| No. | Component group | Description |
|---|---|---|
| 2 | Trim / covers | Boot lid - interior trim (Abdeckkappe) - Missing - Replace |

Damage 2: Trim / covers: Boot lid - interior trim (Abdeckkappe) - Missing - Replace

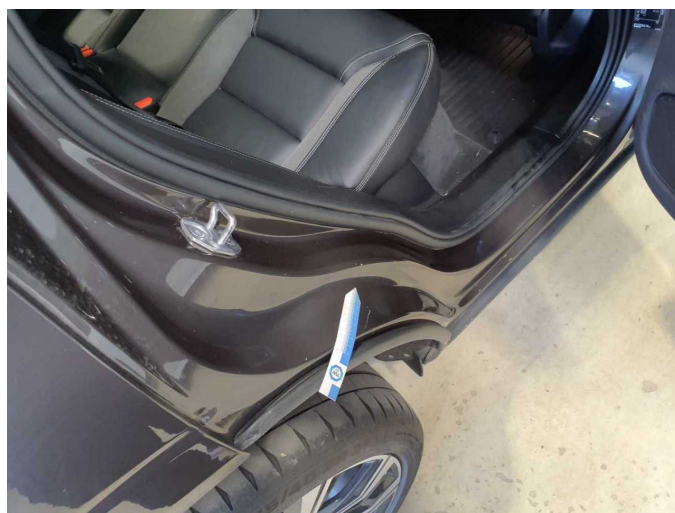
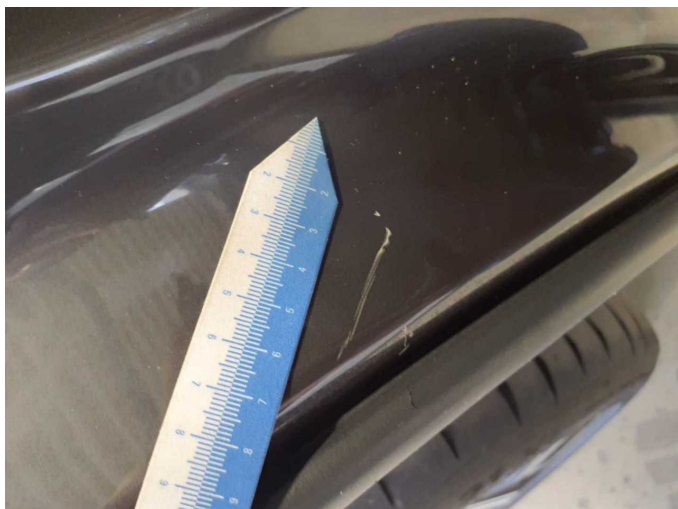
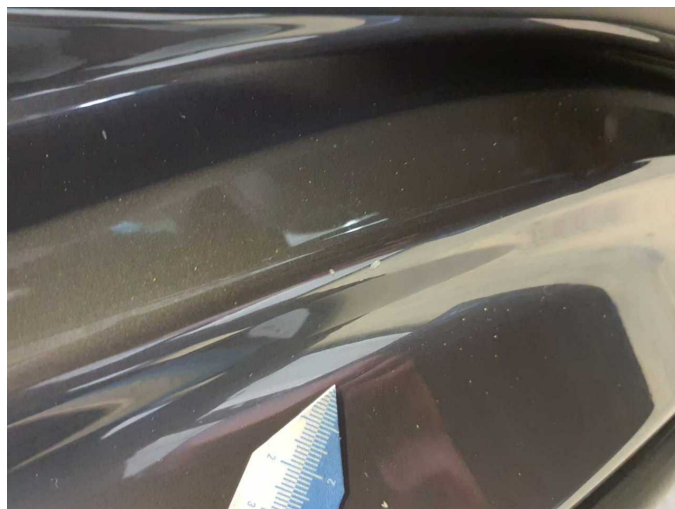
| No. | Component group | Description |
|---|---|---|
| 3 | Side panel - rear right side | Sill - Scratch(es) - Smart repair |

Damage 3: Side panel - rear right side: Sill - Scratch(es) - Smart repair

**Damage 3:** Side panel - rear right side: Sill - Scratch(es) - Smart repair

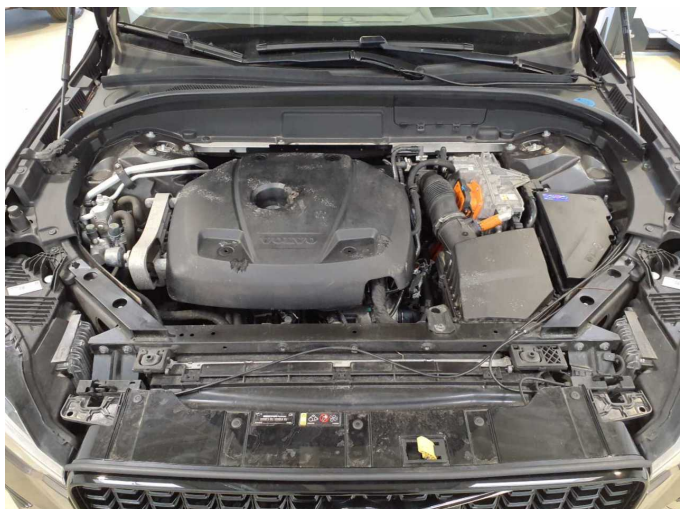
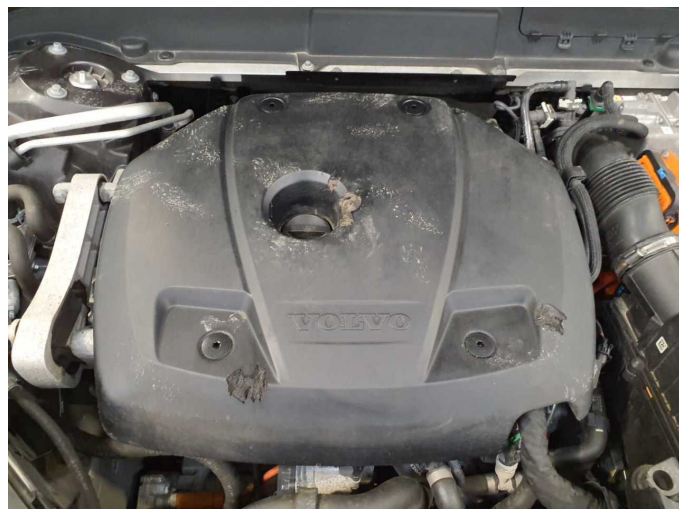
| No. | Component group | Description |
|---|---|---|
| 7 | Engine | Engine cover - Damage caused by marten / rodent - Replace |

**Damage 7:** Engine: Engine cover - Damage caused by marten / rodent - Replace

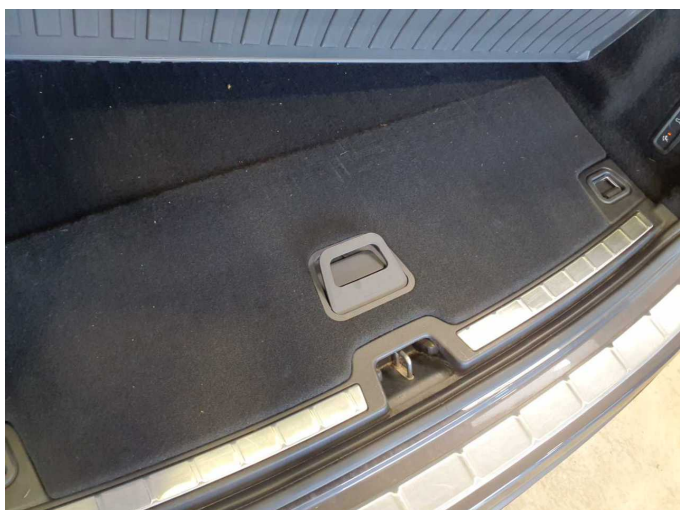
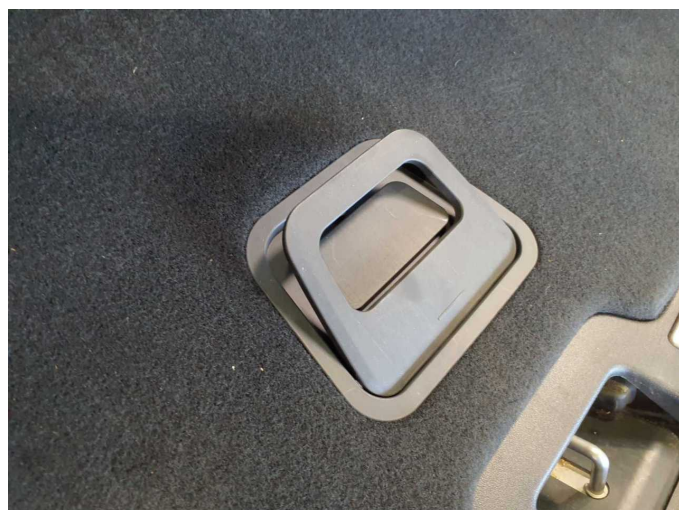
| No. | Component group | Description |
|---|---|---|
| 8 | Interior | Cargo area floor (Griff) - Broken / torn - Replace |

**Damage 8:** Interior: Cargo area floor (Griff) - Broken / torn - Replace

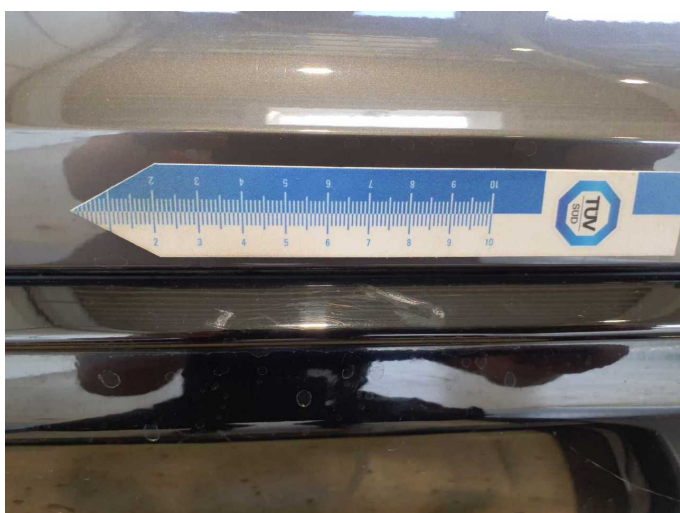
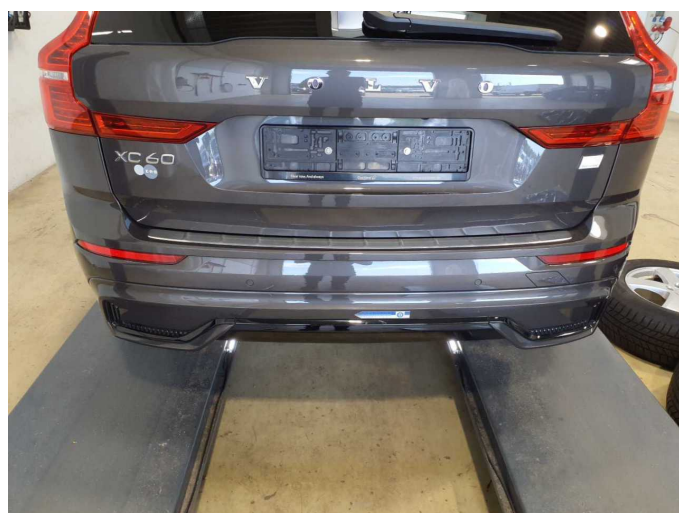
| No. | Component group | Description |
|---|---|---|
| 9 | Rear bumper | Rear bumper (Zierleiste) - Scratch(es) - Replace |

**Damage 9:** Rear bumper: Rear bumper (Zierleiste) - Scratch(es) - Replace

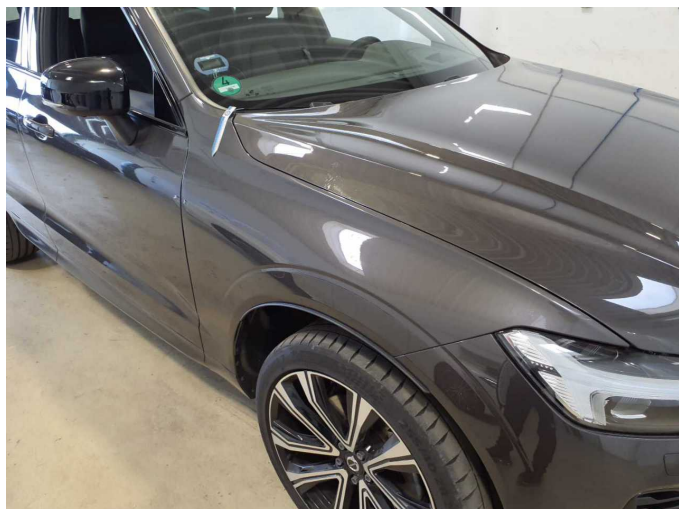
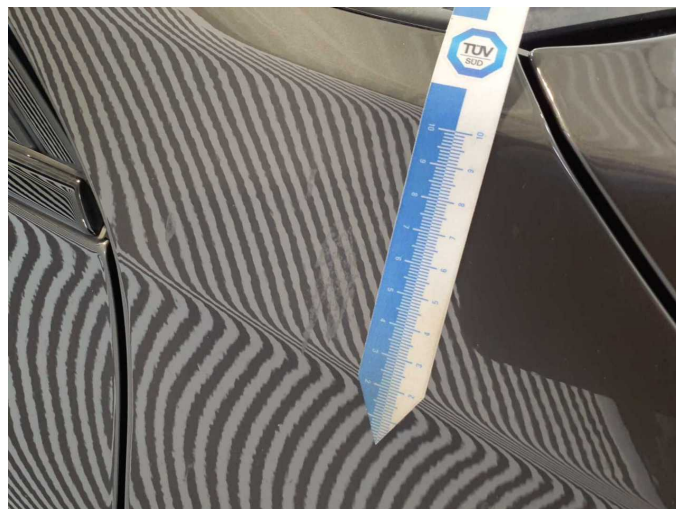
| No. | Component group | Description |
|---|---|---|
| 10 | Mudguard - right side | Mudguard - right side (Anätzung) - Paint defect - Repair and paint |

**Damage 10:** Mudguard - right side: Mudguard - right side (Anätzung) - Paint defect - Repair and paint

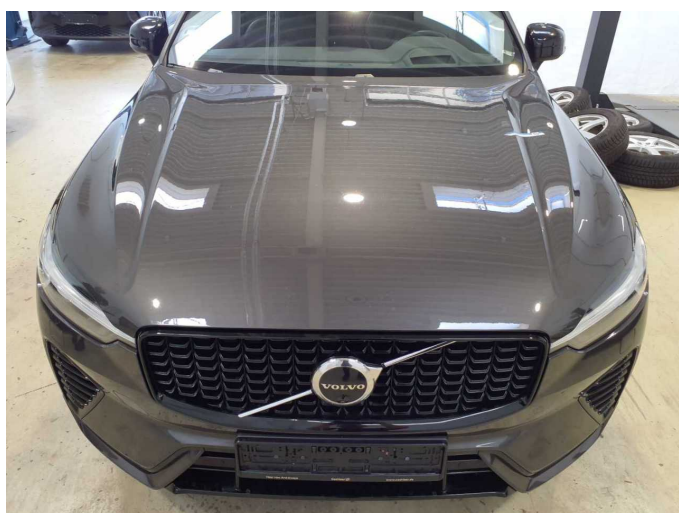
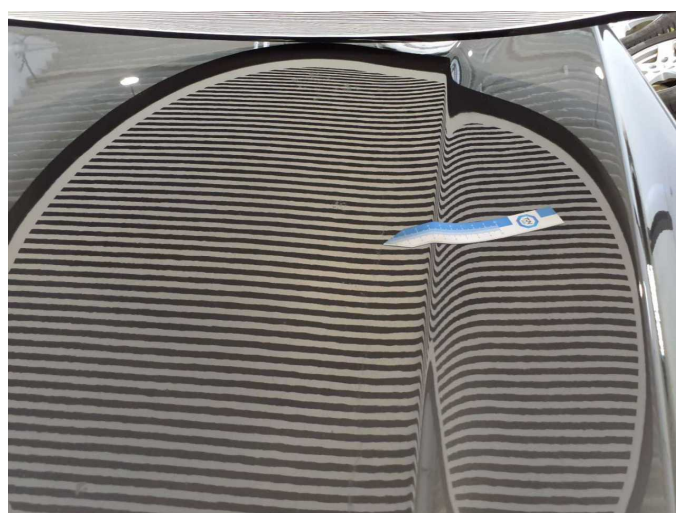
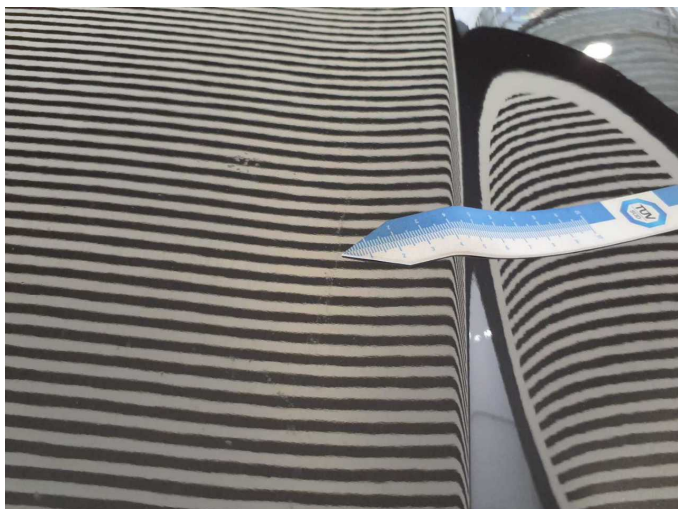
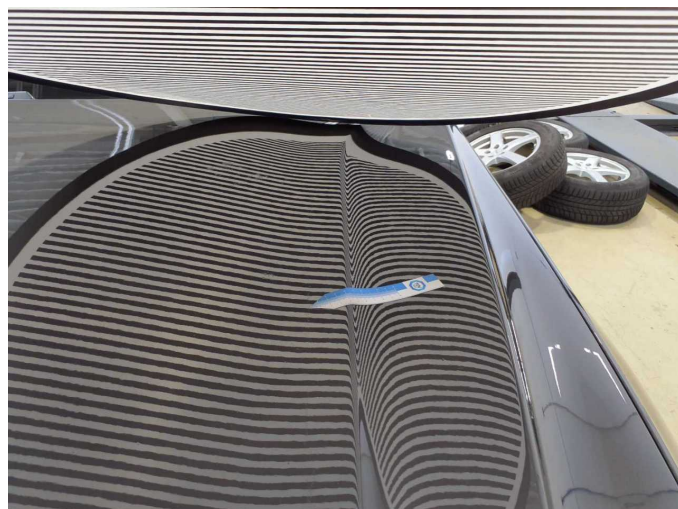
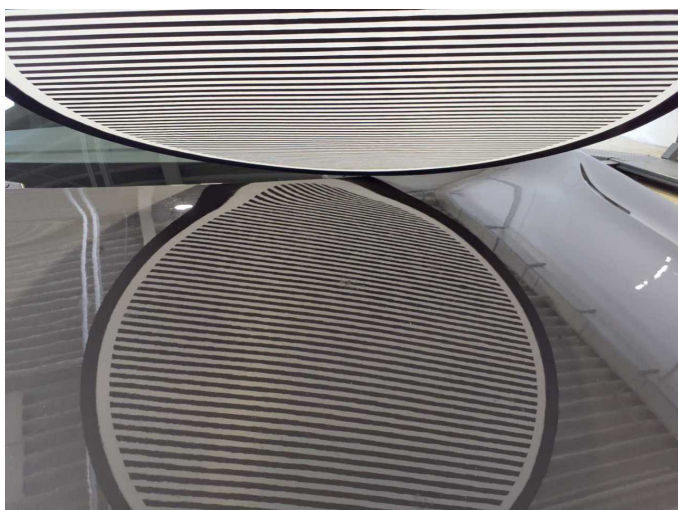
| No. | Component group | Description |
|---|---|---|
| 12 | Bonnet | Bonnet (Spachtelmasse eingefallen und wellig) - Unprofessionally repaired - Repair and paint |

| No. | Repainting |
|---|---|
| 2 | Bonnet, Unprofessionally carried out |

| Bonnet | 287 µm | Side panel - rear left side | 182 µm |

**Damage 12:** Bonnet: Bonnet (Spachtelmasse eingefallen und wellig) - Unprofessionally repaired - Repair and paint

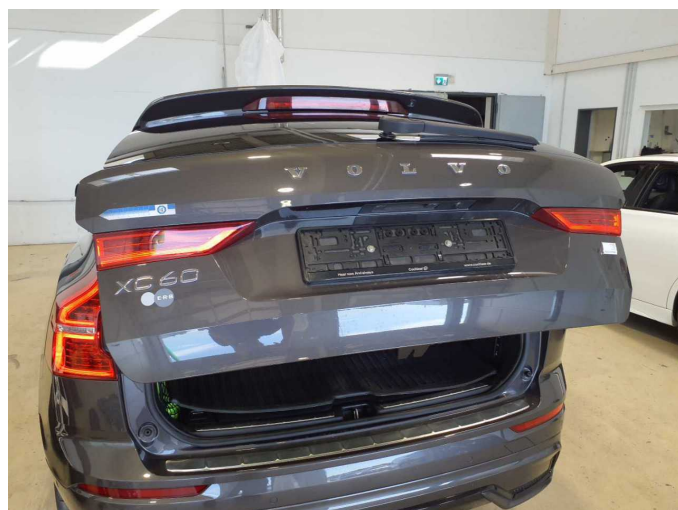
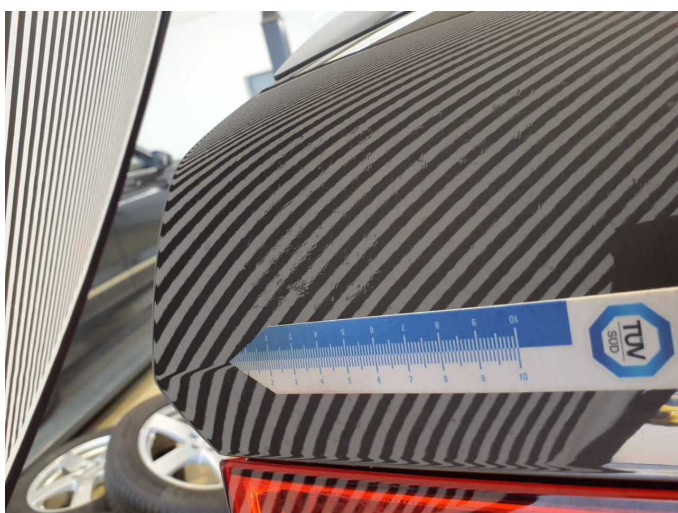
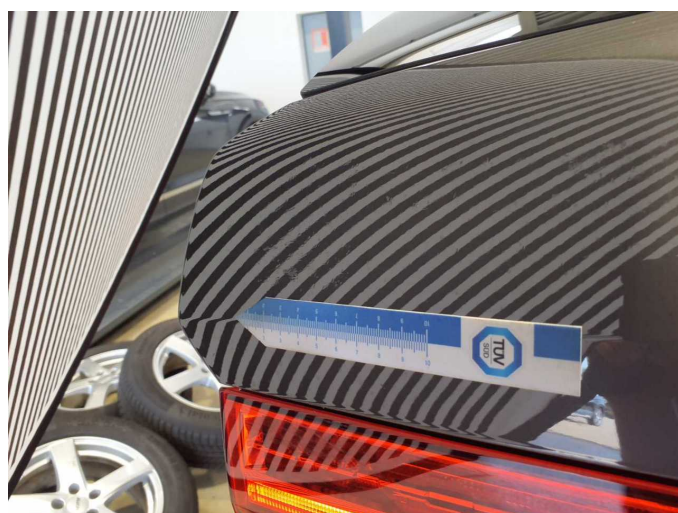
| No. | Component group | Description |
|---|---|---|
| 13 | Boot lid / rear door | Boot lid (Spachtelmasse eingefallen) - Unprofessionally repaired - Repair and paint |

**Damage 13:** Boot lid / rear door: Boot lid (Spachtelmasse eingefallen) - Unprofessionally repaired - Repair and paint

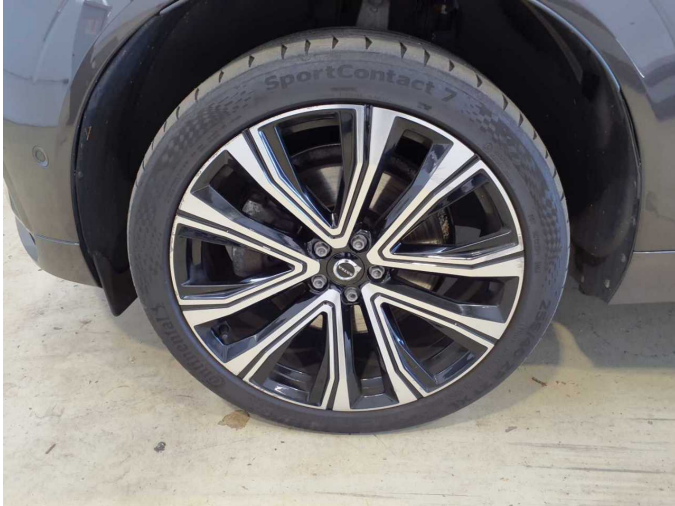
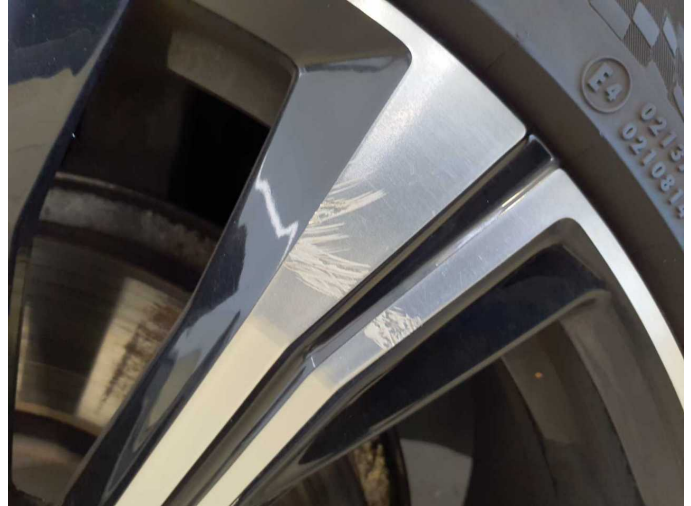
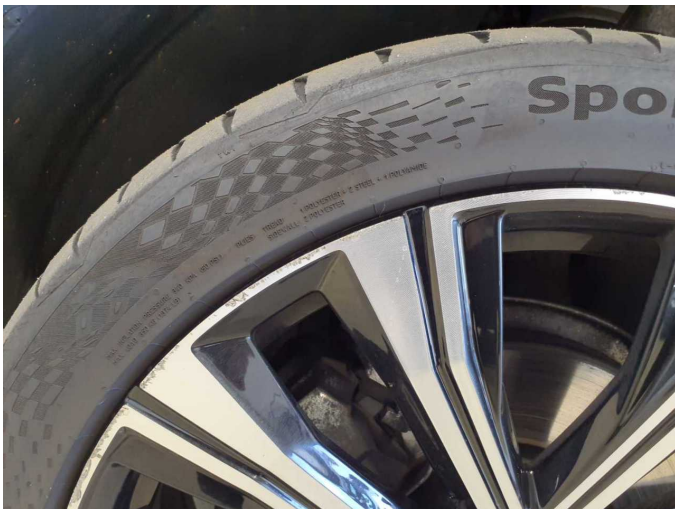
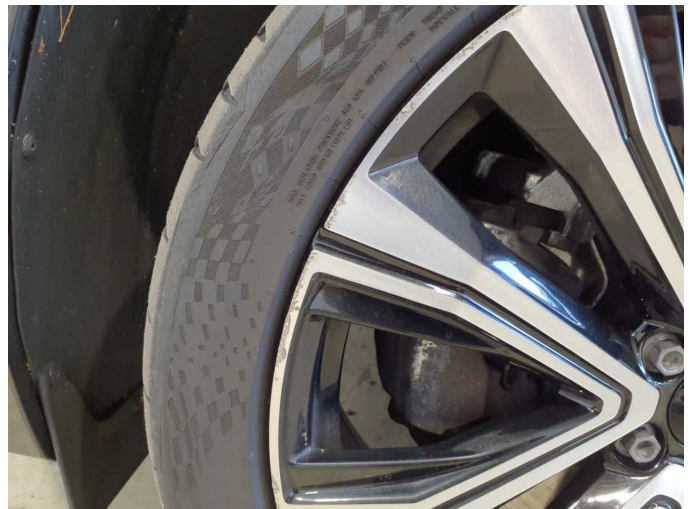
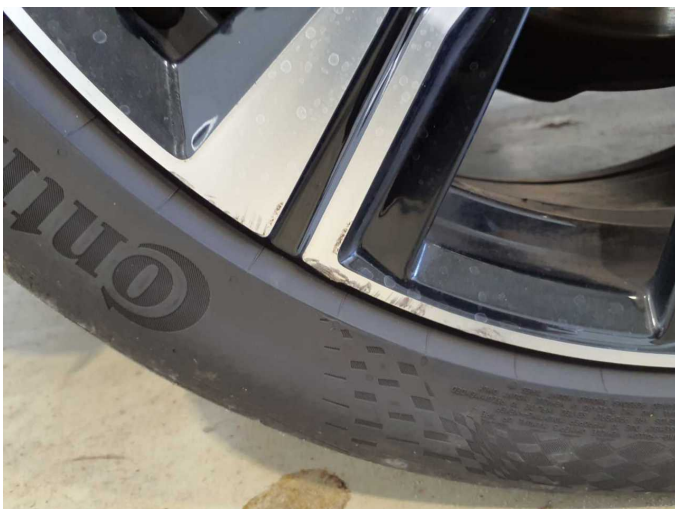
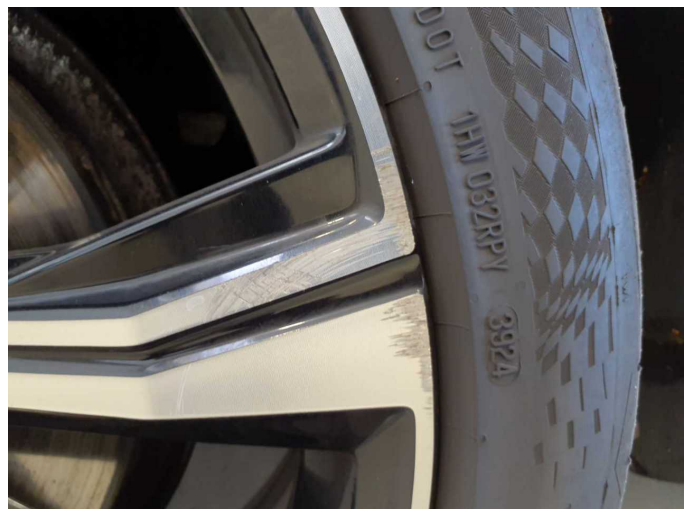
| No. | Component group | Description |
|---|---|---|
| 14 | Wheel / tyres | Alloy rim - front left side - Scratch(es) - Replace |

**Damage 14:** Wheel / tyres: Alloy rim - front left side - Scratch(es) - Replace

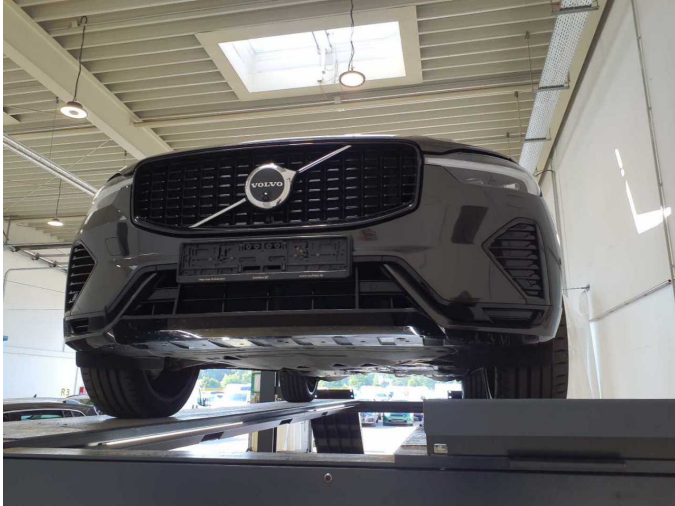
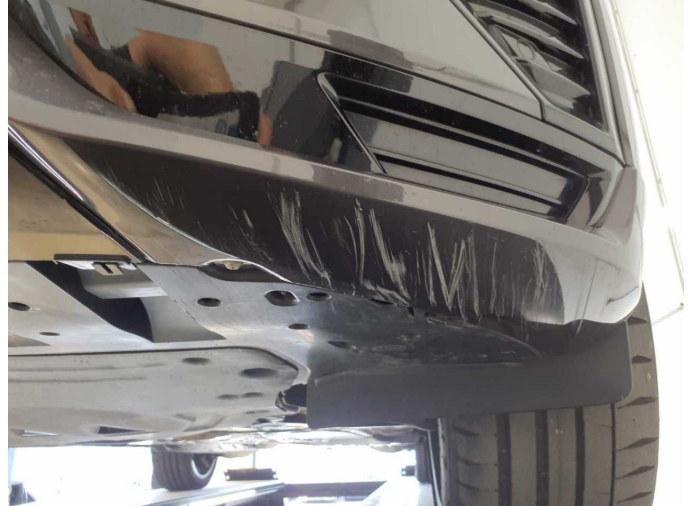
| No. | Component group | Description |
|---|---|---|
| 7 | Front bumper | Front bumper (unterhalb) - Scratch(es) - No deduction |

**Wear and tear 7:** Front bumper: Front bumper (unterhalb) - Scratch(es) - No deduction

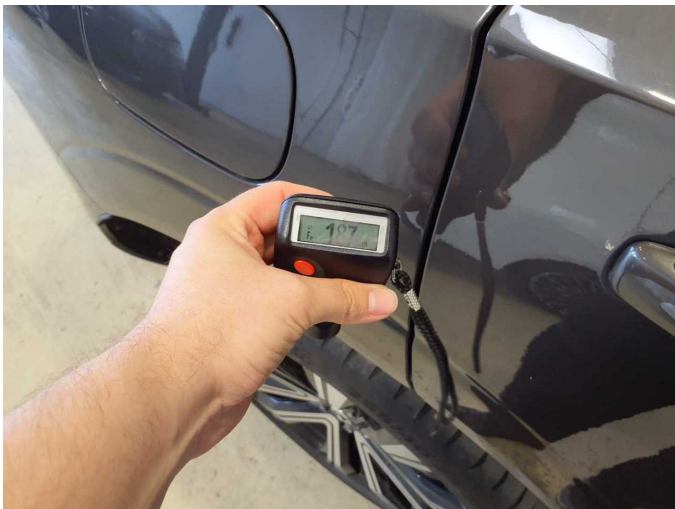
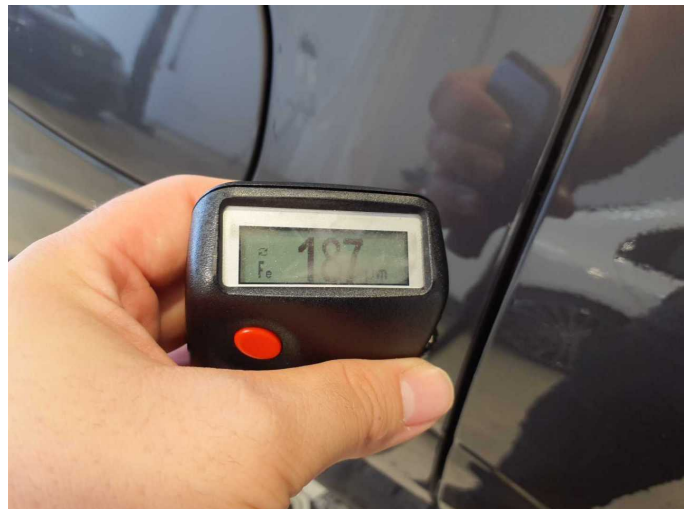
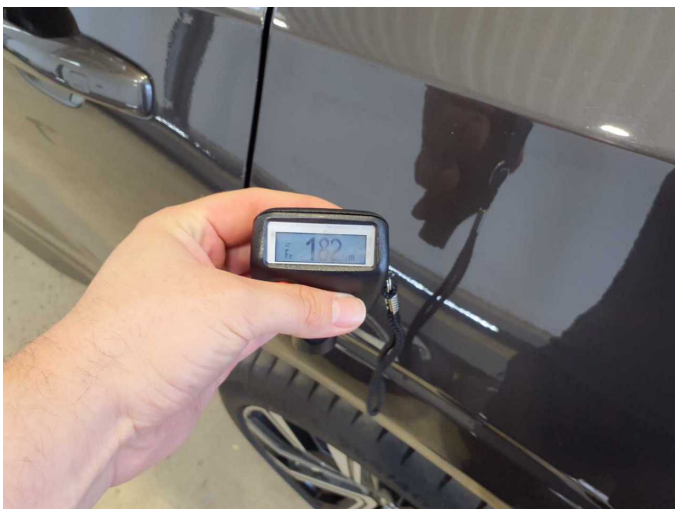
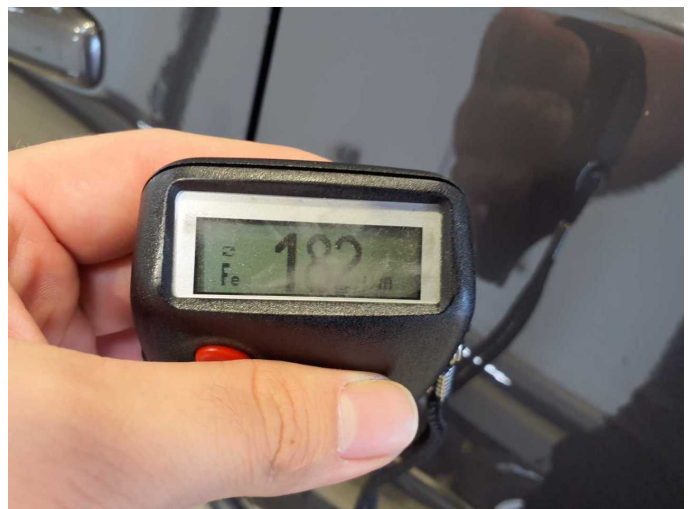
| No. | Repainting |
|---|---|
| 1 | Side panel - rear left side, Side panel - rear right side, Professionally carried out |

| Side panel - rear right side | 187 µm | | |

**Repainting 1:** Side panel - rear left side, Side panel - rear right side

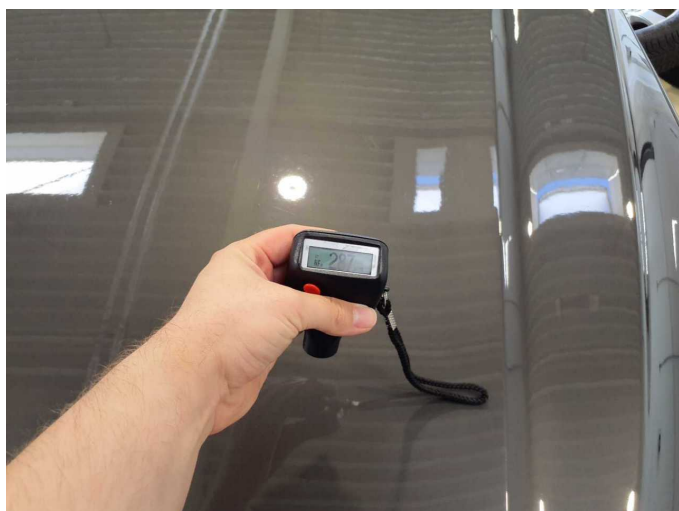
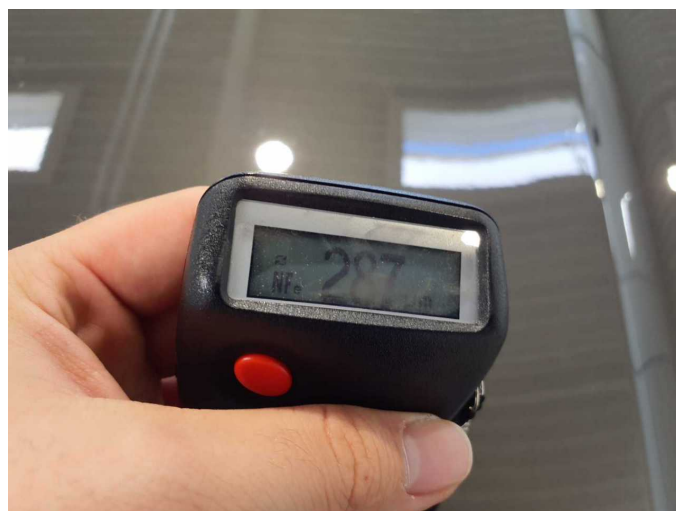
**Repainting 2: Bonnet**
