Expertise

Protocol number: 47179695  
Order No. / Reference: 26884713  
Inspection date: 21 Aug 2026

Model: XC90 T8 AWD Recharge Geartronic RDesign Edition

VIN: YV1LFH5UDN1867106

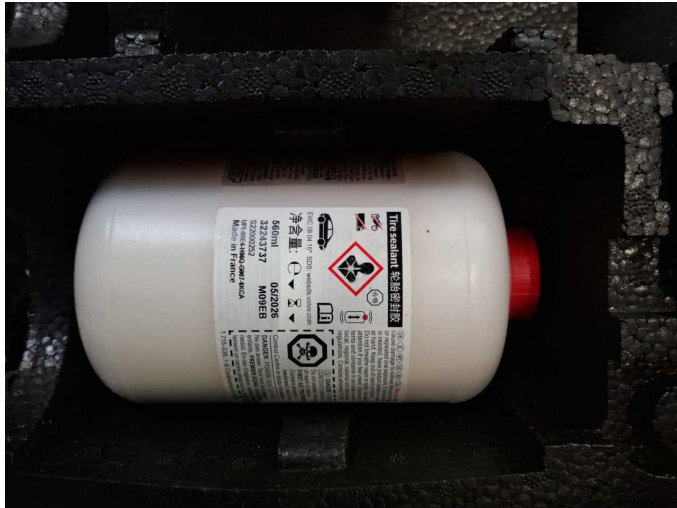
**Damage 1:** Equipment: Tirefit filler - Due - Replace

| No. | Component group | Description |
|---|---|---|
| 1 | Equipment | Tirefit filler - Due - Replace |

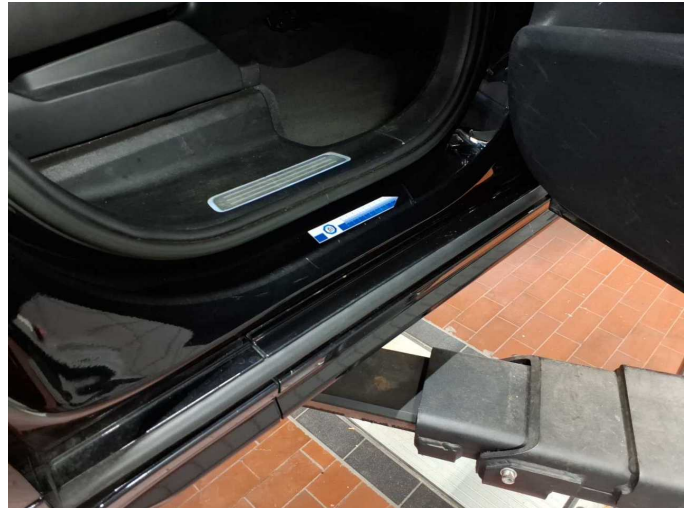
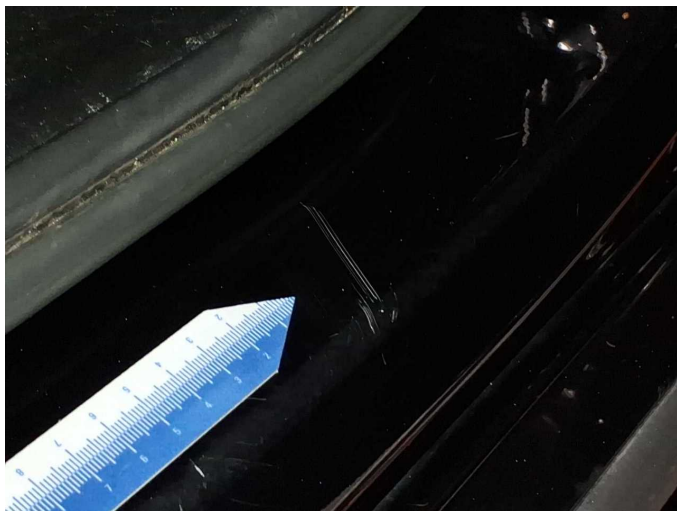
**Damage 2:** Side panel - rear right side: Sill - Scratch(es) - Smart repair

| No. | Component group | Description |
|---|---|---|
| 2 | Side panel - rear right side | Sill - Scratch(es) - Smart repair |

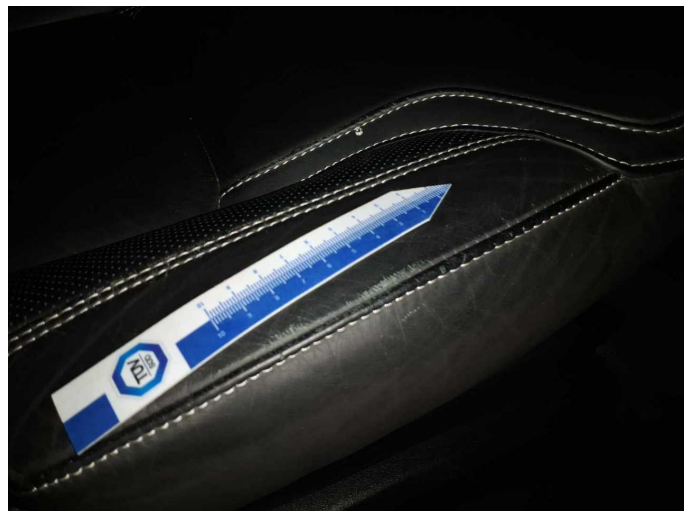
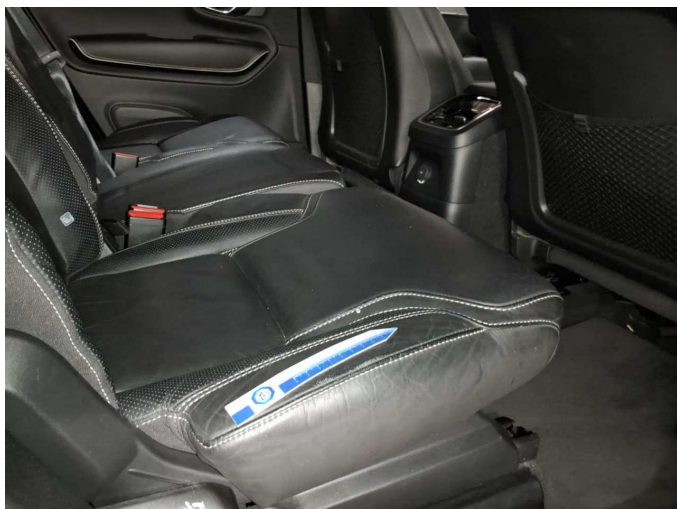
**Damage 3:** Seat - rear: Seat cover - 3 seater bench - Scratch(es) - Smart repair

| No. | Component group | Description |
|---|---|---|
| 3 | Seat - rear | Seat cover - 3 seater bench - Scratch(es) - Smart repair |

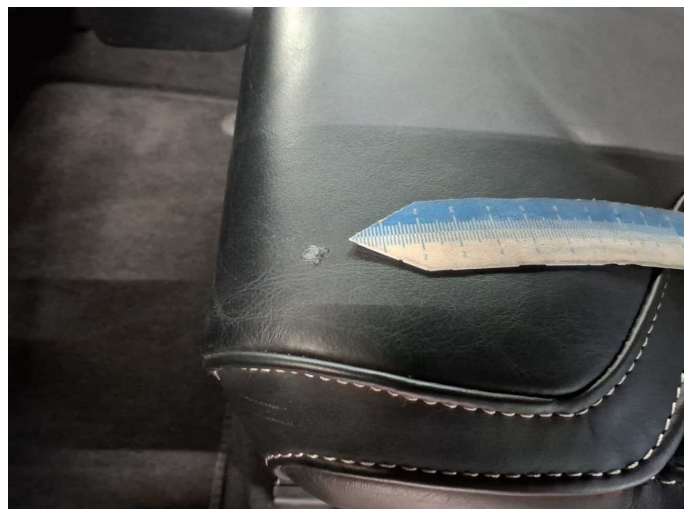
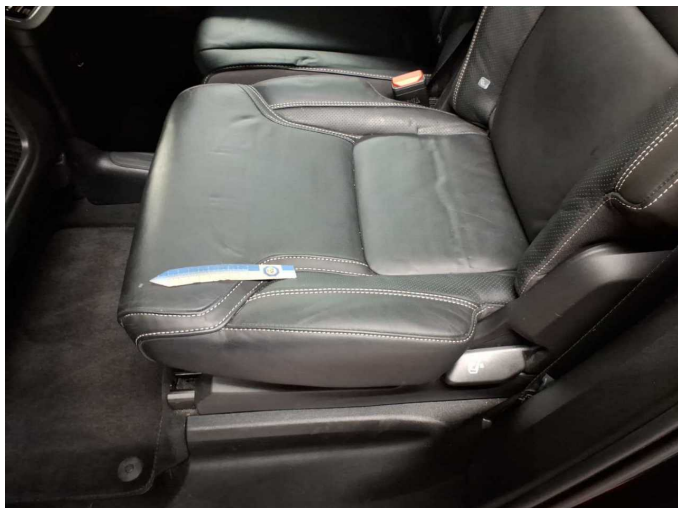
**Damage 4:** Seat - rear: Upholstery - Scratch(es) - Smart repair

| No. | Component group | Description |
|---|---|---|
| 4 | Seat - rear | Upholstery - Scratch(es) - Smart repair |

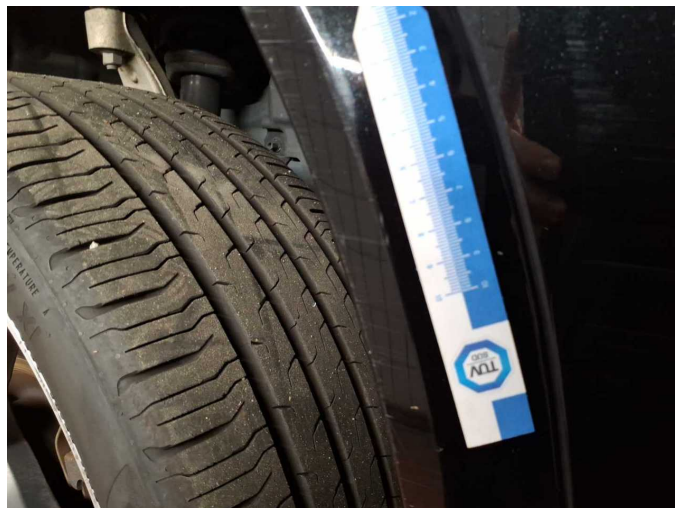
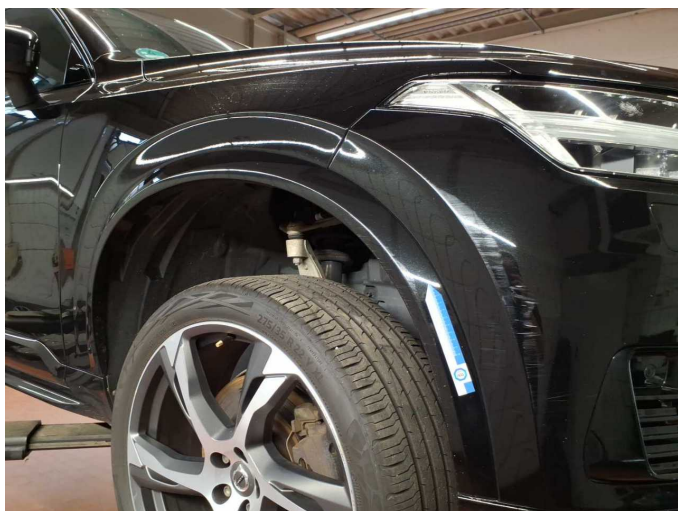
**Damage 5:** Mudguard - right side: Wheel well extension - Scratch(es) - Smart repair

| No. | Component group | Description |
|---|---|---|
| 5 | Mudguard - right side | Wheel well extension - Scratch(es) - Smart repair |

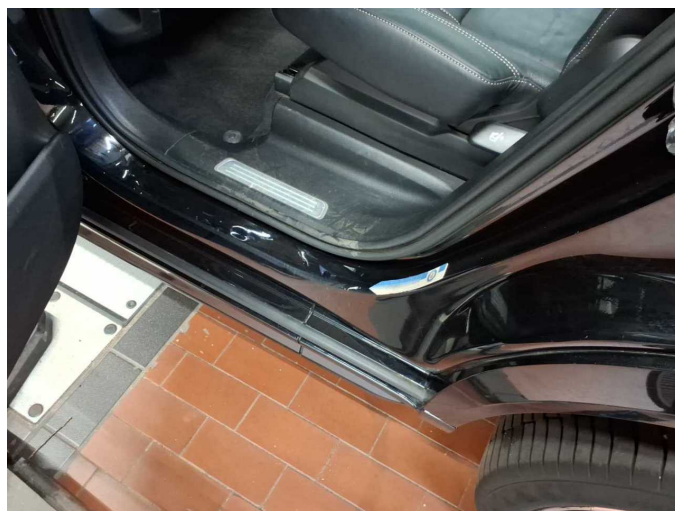
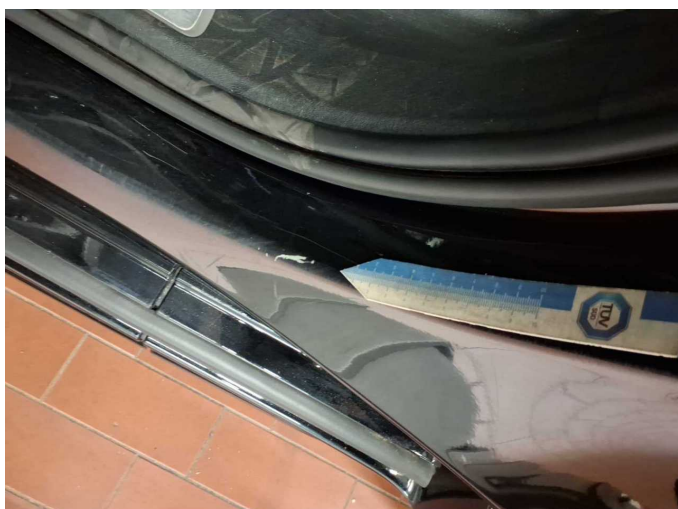
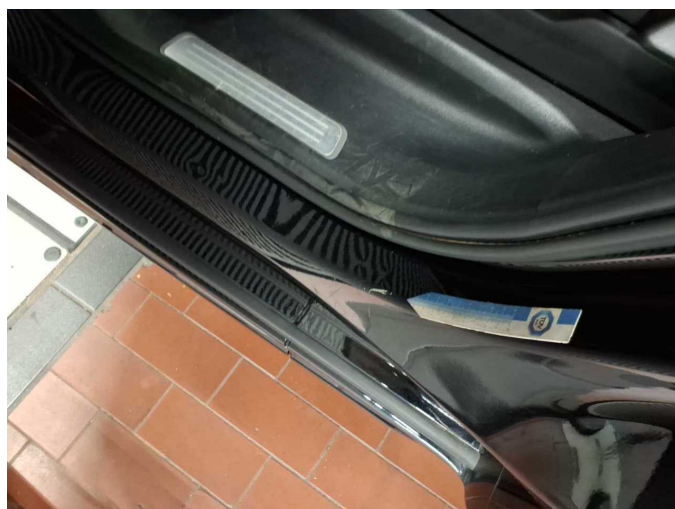
**Damage 6:** Side panel - rear left side: Sill - Dent / paintcoat damage - Smart repair

| No. | Component group | Description |
|---|---|---|
| 6 | Side panel - rear left side | Sill - Dent / paintcoat damage - Smart repair |

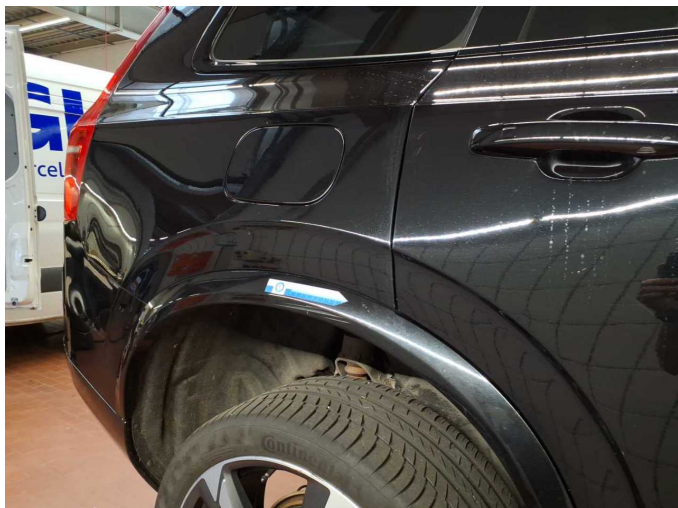
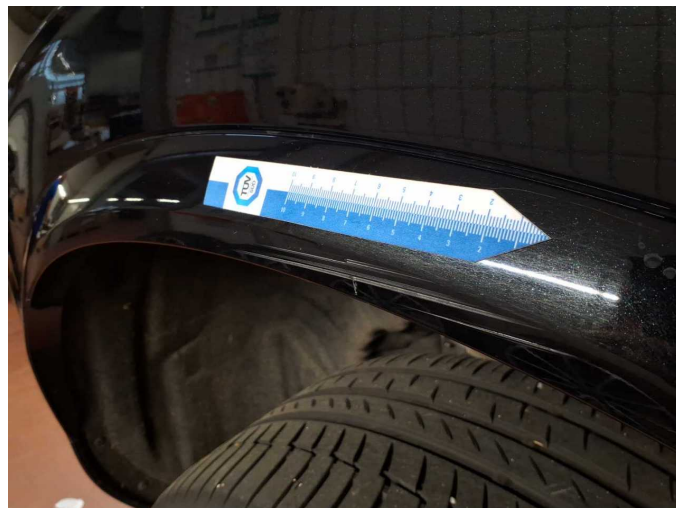
**Damage 7:** Side panel - rear right side: Wheel well extension - Scratch(es) - Smart repair

| No. | Component group | Description |
|---|---|---|
| 7 | Side panel - rear right side | Wheel well extension - Scratch(es) - Smart repair |

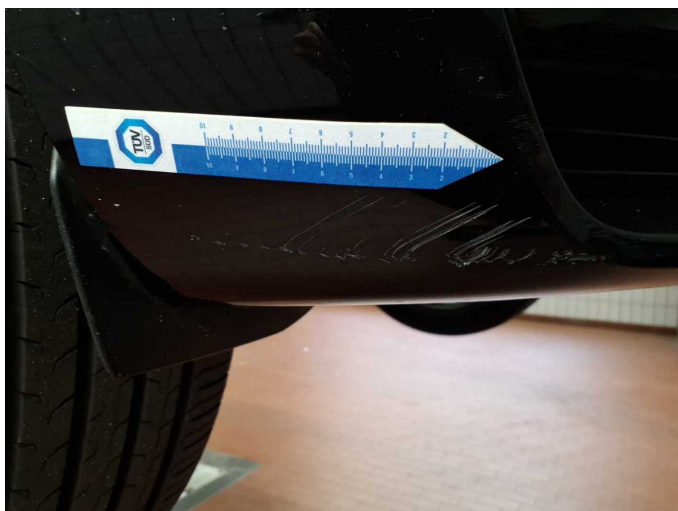
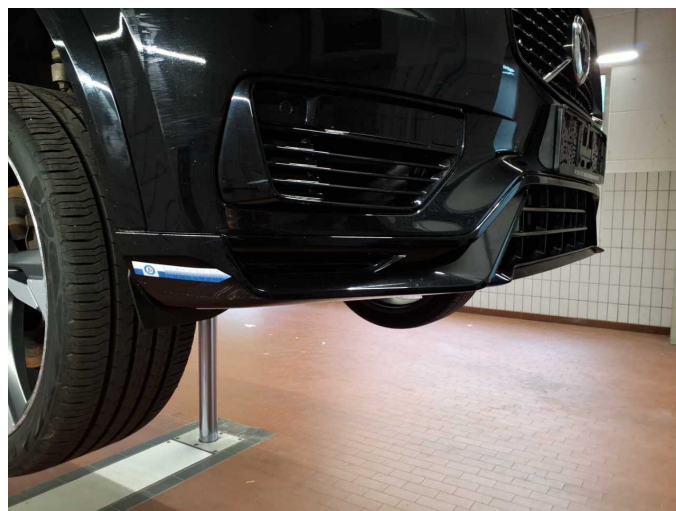
**Damage 8:** Front bumper: Spoiler - Scratched - Smart repair

| No. | Component group | Description |
|---|---|---|
| 8 | Front bumper | Spoiler - Scratched - Smart repair |

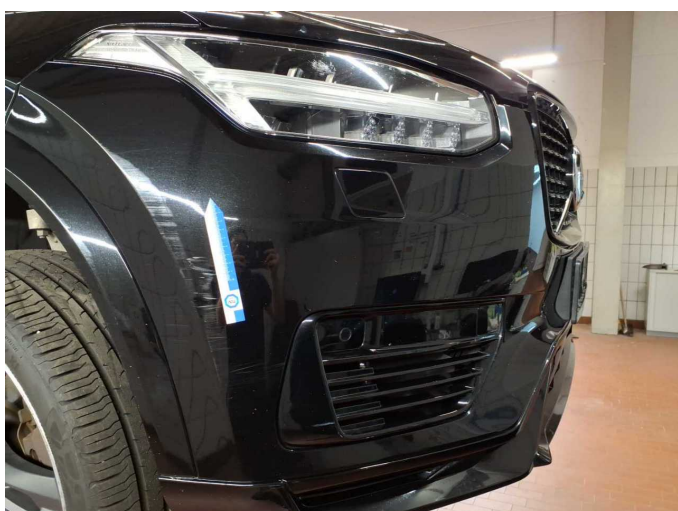
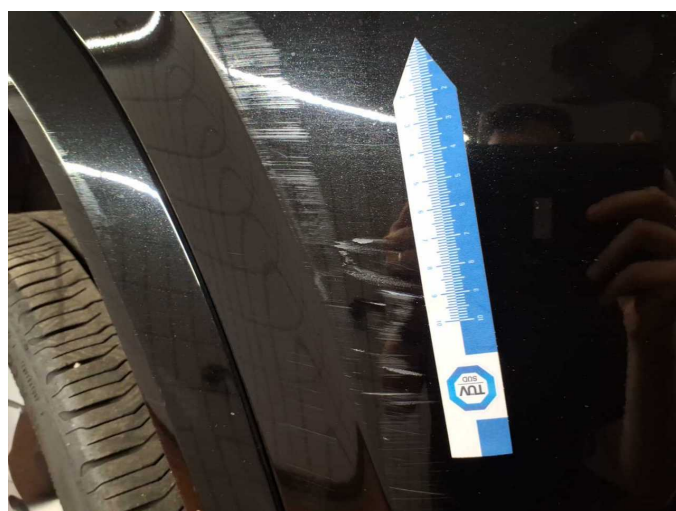
**Damage 10:** Front bumper: Front bumper - Scratched - Smart repair

| No. | Component group | Description |
|---|---|---|
| 10 | Front bumper | Front bumper - Scratched - Smart repair |

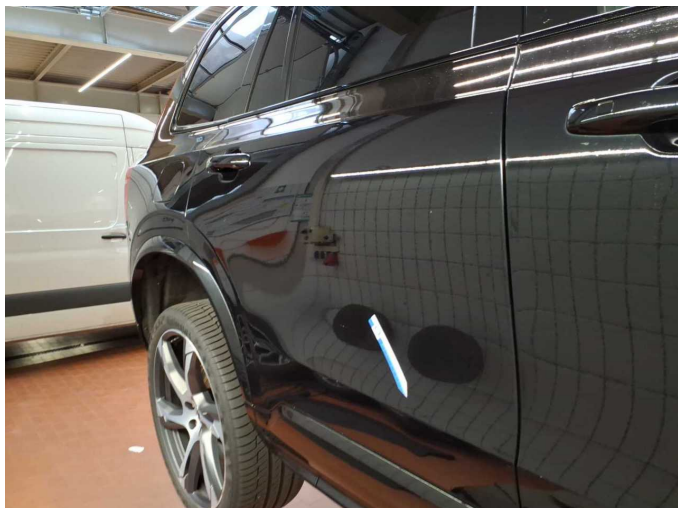
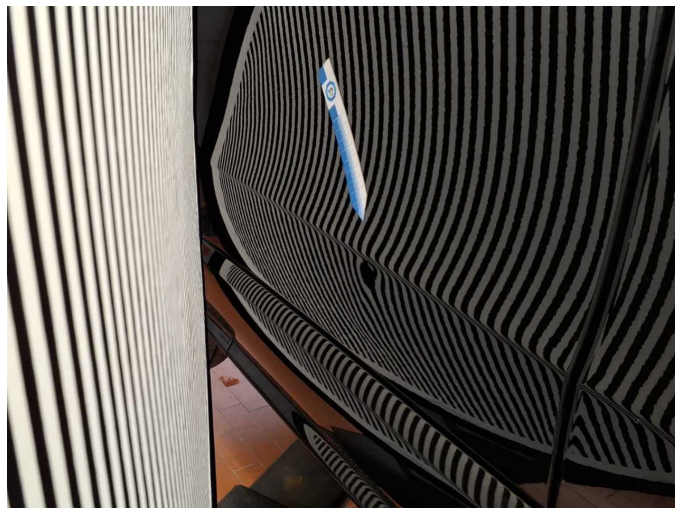
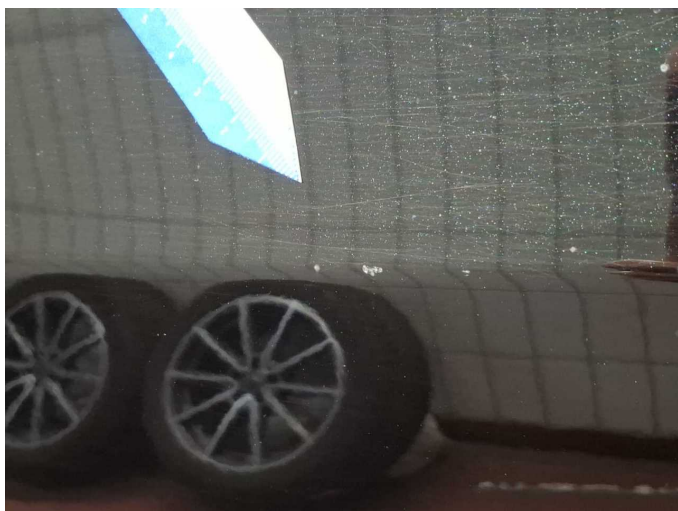
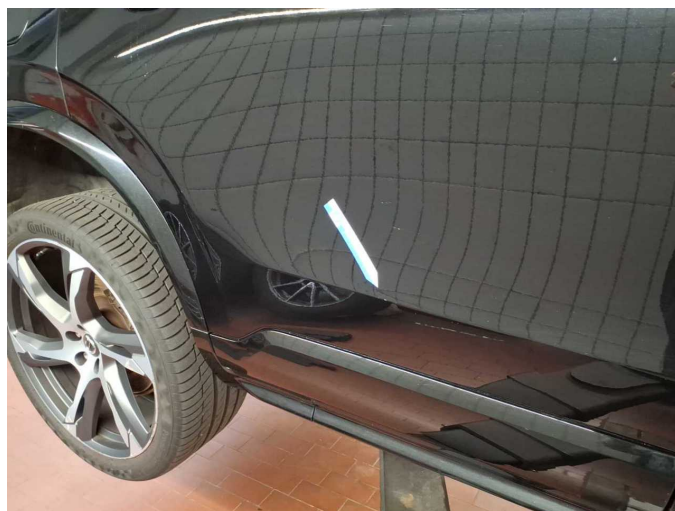
**Damage 11:** Door - rear right side: Door - Dent / paintcoat damage - Smart repair

| No. | Component group | Description |
|---|---|---|
| 11 | Door - rear right side | Door - Dent / paintcoat damage - Smart repair |

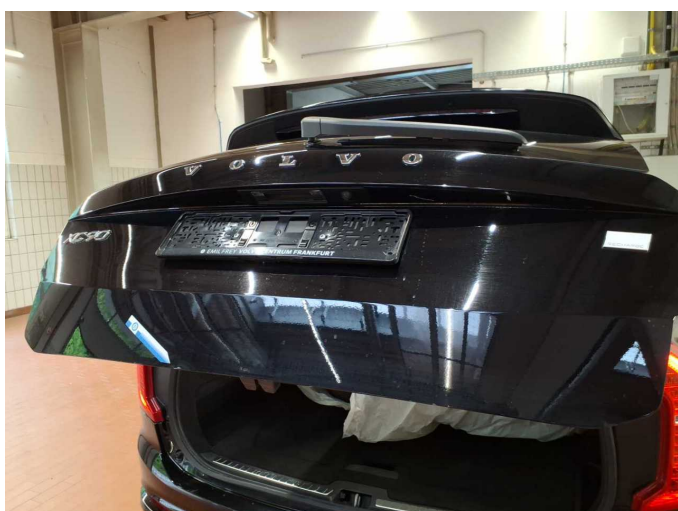
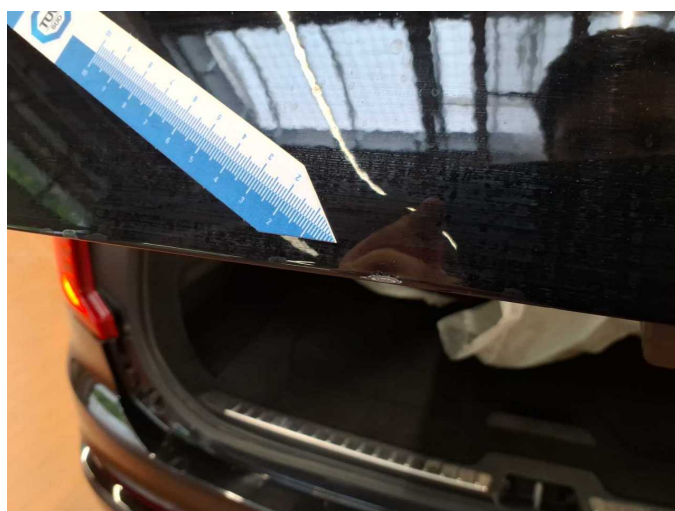
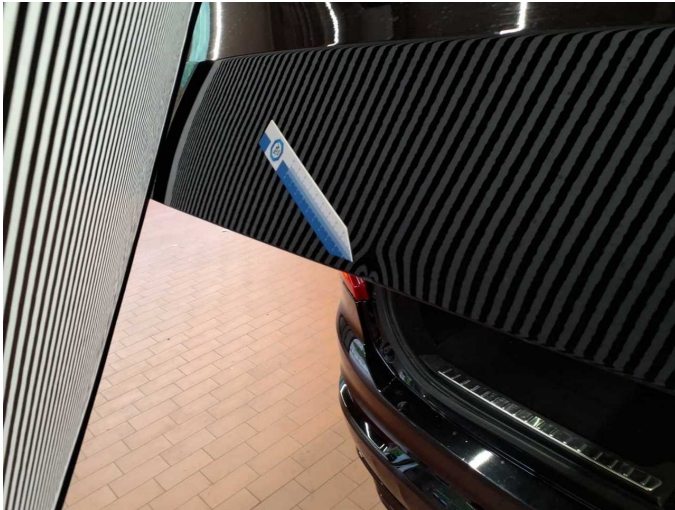
**Damage 12:** Boot lid / rear door: Boot lid - Dent / paintcoat damage - Smart repair

| No. | Component group | Description |
|---|---|---|
| 12 | Boot lid / rear door | Boot lid - Dent / paintcoat damage - Smart repair |

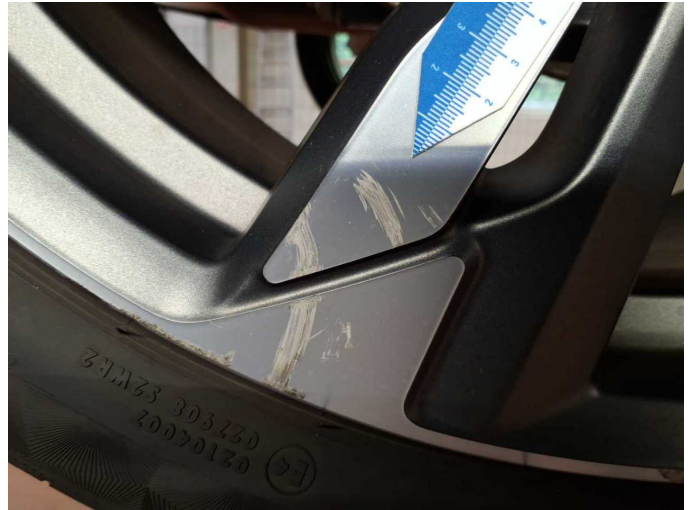
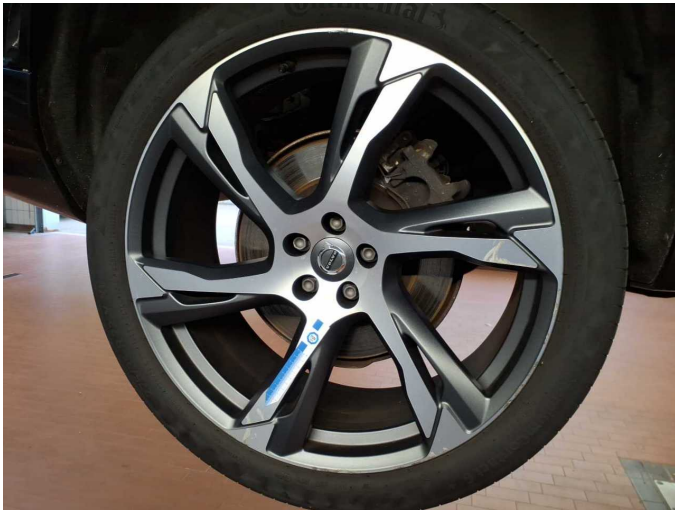
**Damage 13:** Wheel / tyres: Alloy rim - rear right side - Scratched - Loss in value

| No. | Component group | Description |
|---|---|---|
| 13 | Wheel / tyres | Alloy rim - rear right side - Scratched - Loss in value |

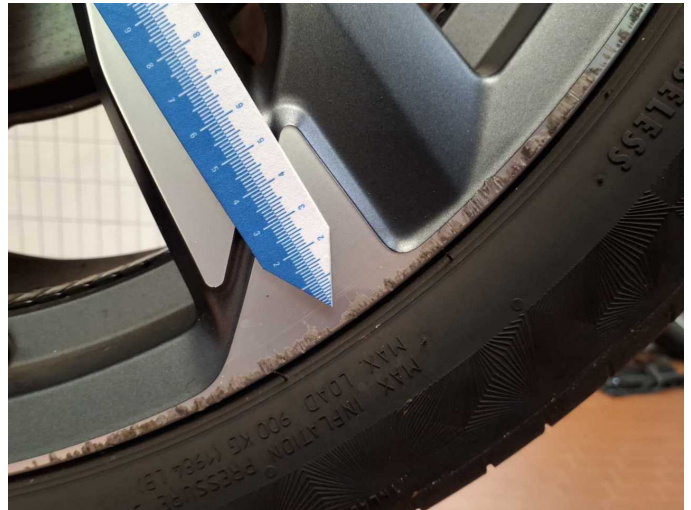
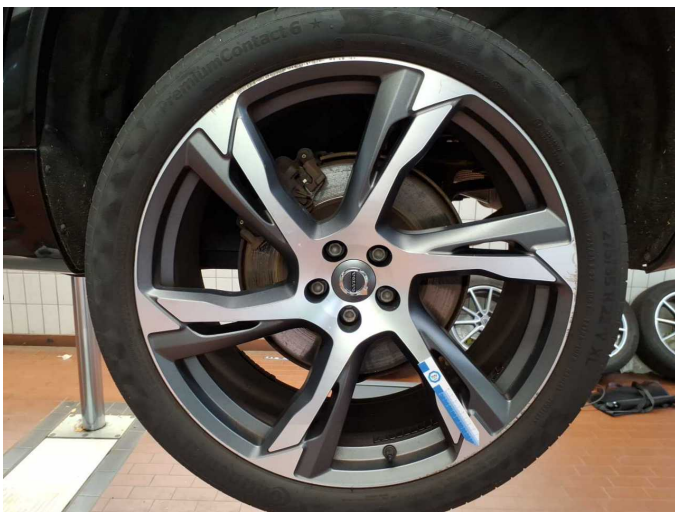
**Damage 14:** Wheel / tyres: Alloy rim - rear left side - Scratched - Loss in value

| No. | Component group | Description |
|---|---|---|
| 14 | Wheel / tyres | Alloy rim - rear left side - Scratched - Loss in value |

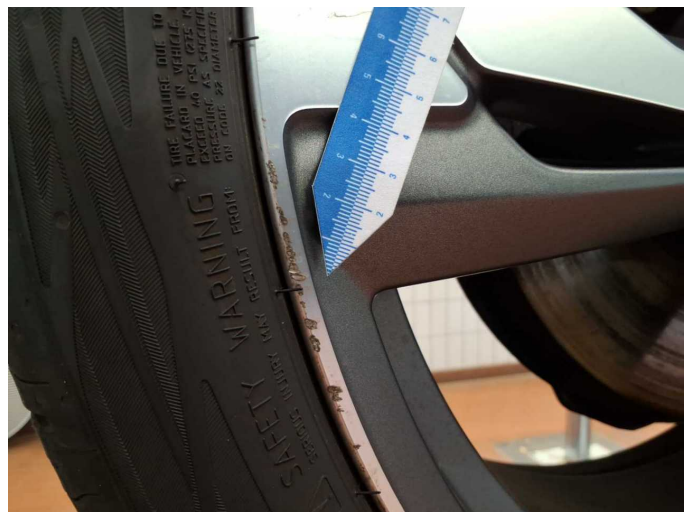
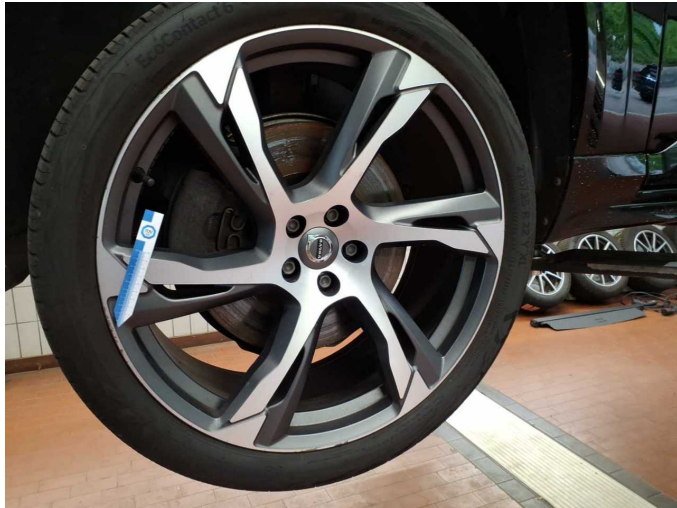
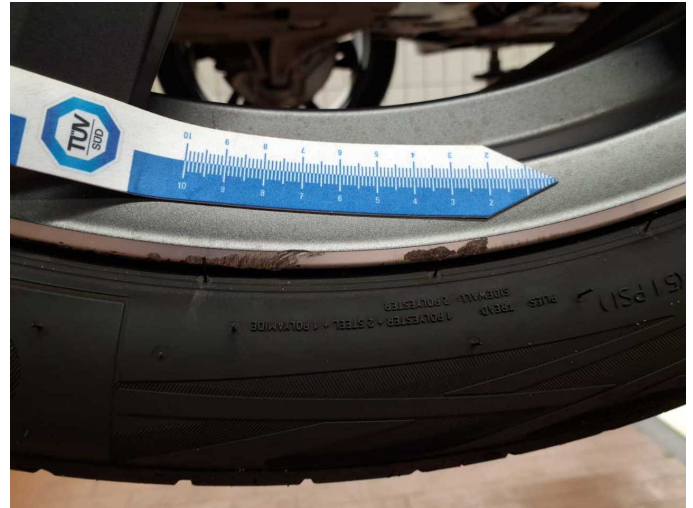
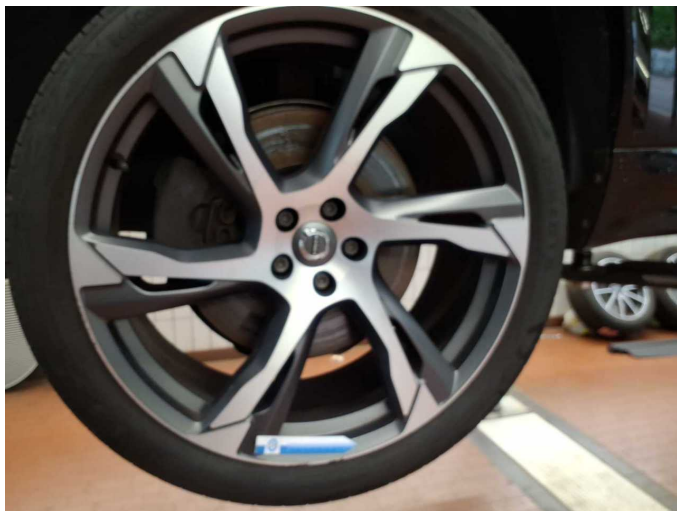
**Damage 15:** Wheel / tyres: Alloy rim - front left side - Scratched - Loss in value

| No. | Component group | Description |
|---|---|---|
| 15 | Wheel / tyres | Alloy rim - front left side - Scratched - Loss in value |

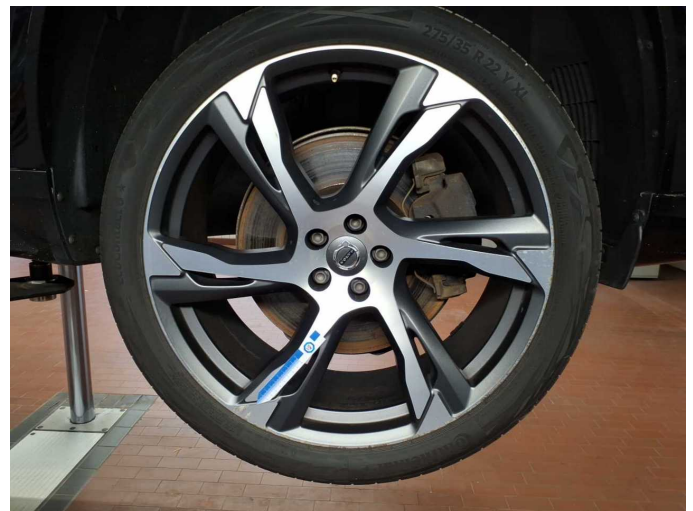
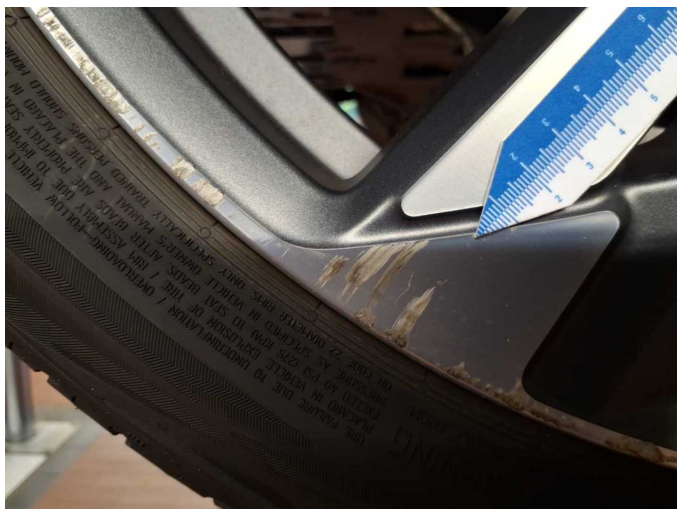
**Damage 16:** Wheel / tyres: Alloy rim - front right side - Scratched - Loss in value

| No. | Component group | Description |
|---|---|---|
| 16 | Wheel / tyres | Alloy rim - front right side - Scratched - Loss in value |

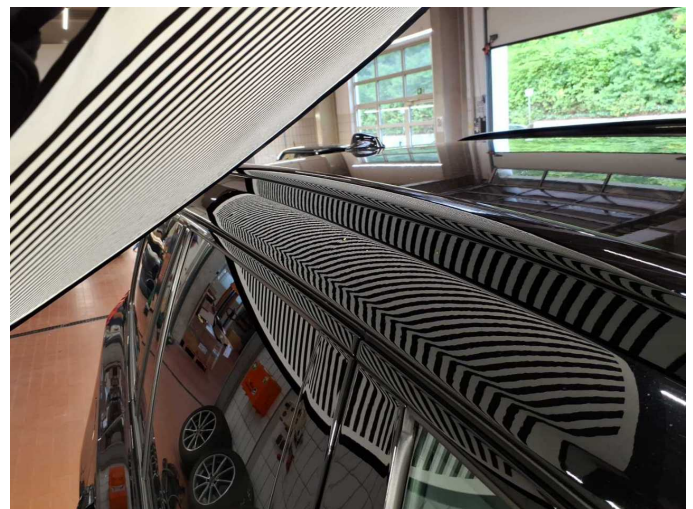
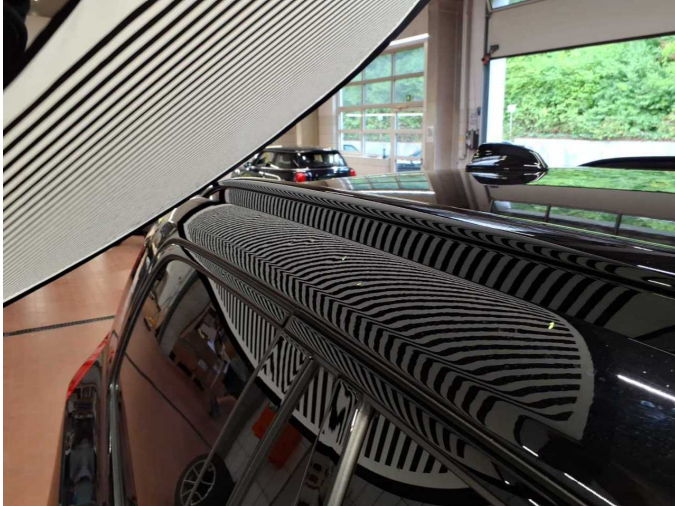
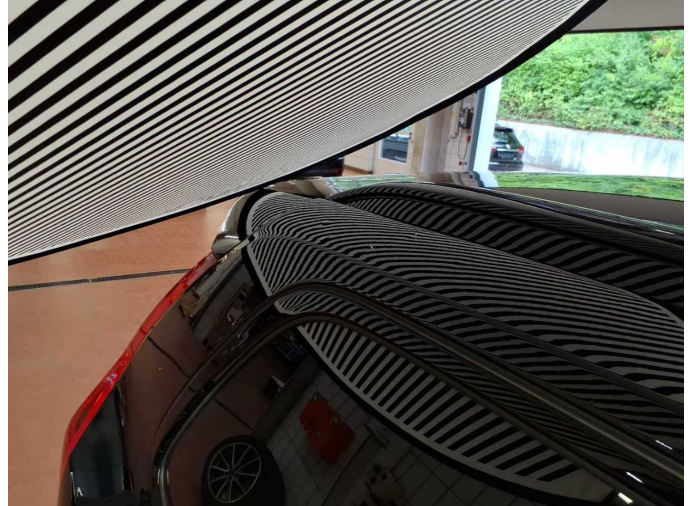
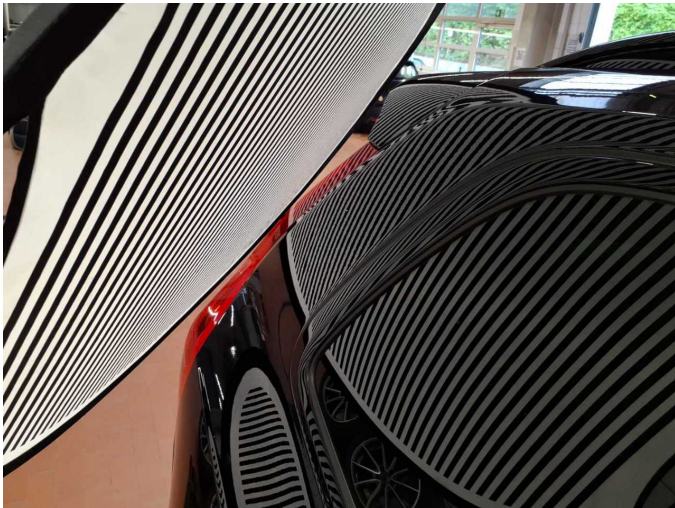
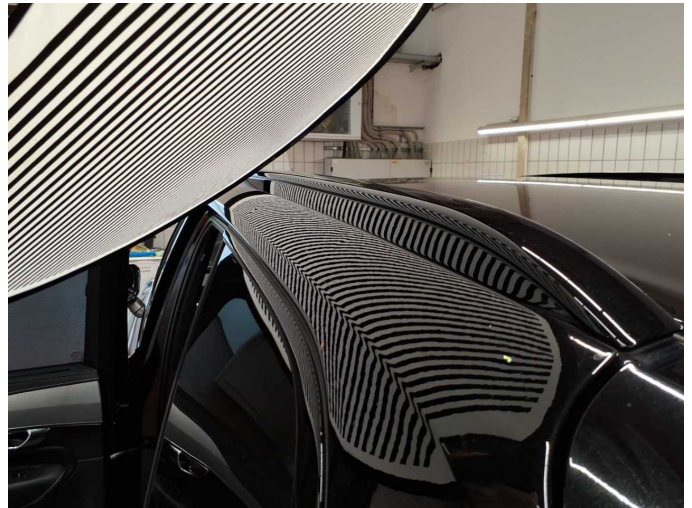
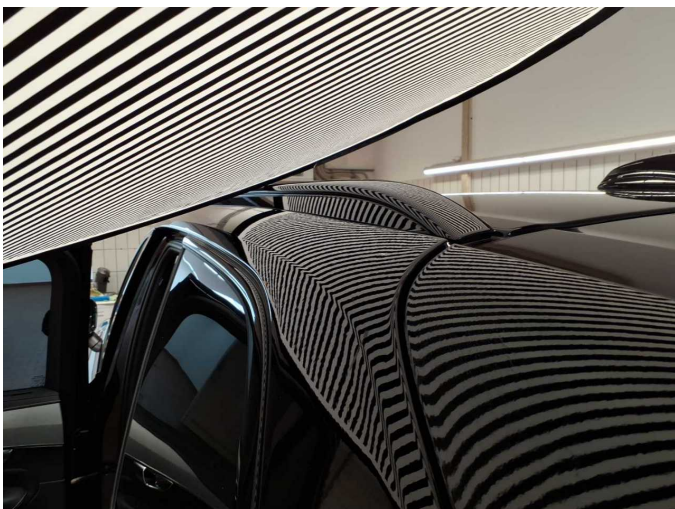
**Damage 17:** Body: Body - Damage by hail - repair according to calculation

| No. | Component group | Description |
|---|---|---|
| 17 | Body | Body - Damage by hail - repair according to calculation |

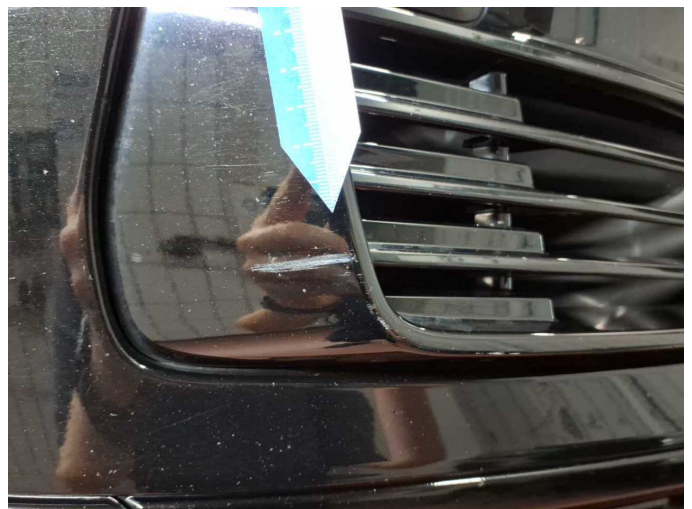
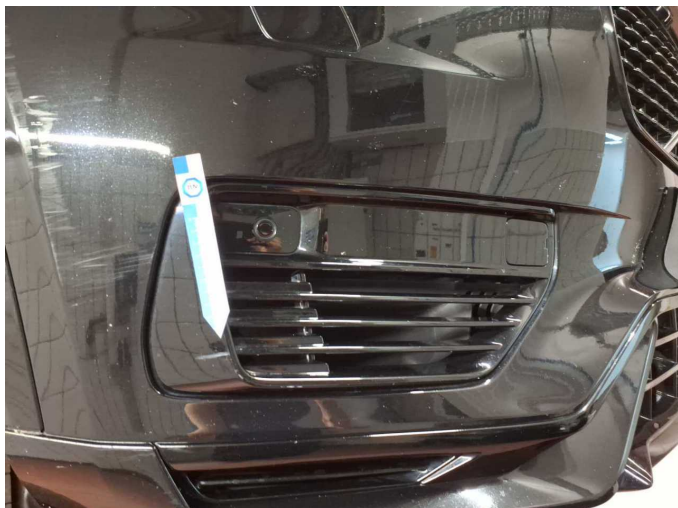
**Wear and tear 2:** Front bumper: Cover bumper - front - Scratch(es) - Cover / polish

| No. | Component group | Description |
|---|---|---|
| 2 | Front bumper | Cover bumper - front - Scratch(es) - Cover / polish |

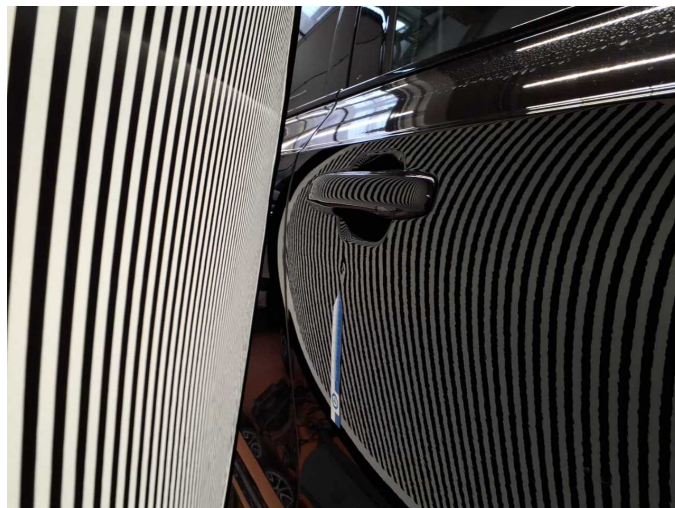
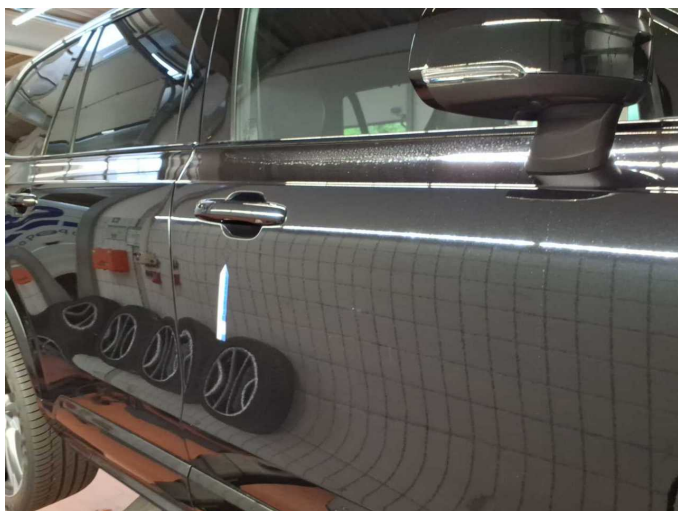
**Wear and tear 3:** Door - front right side: Door - dent(s) - Smooth repair work

| No. | Component group | Description |
|---|---|---|
| 3 | Door - front right side | Door - dent(s) - Smooth repair work |

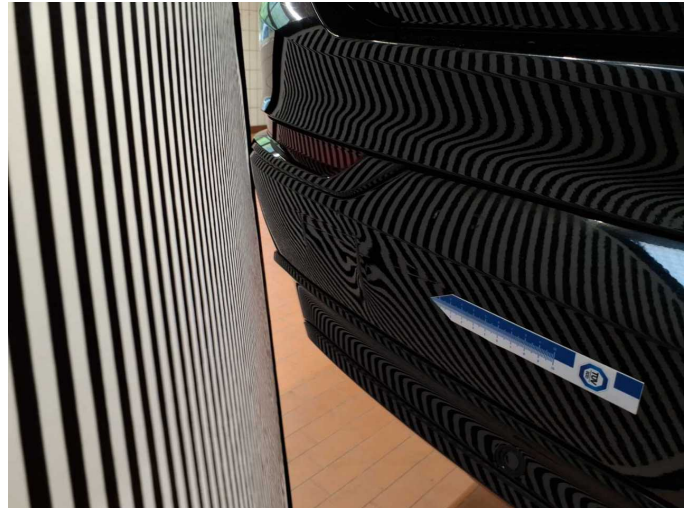
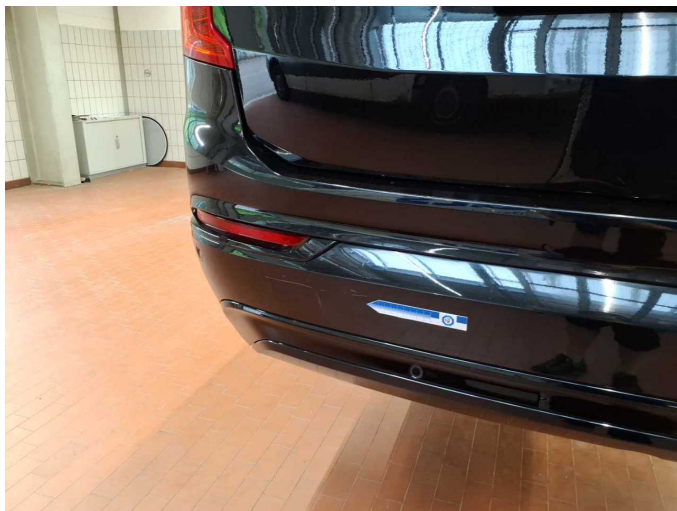
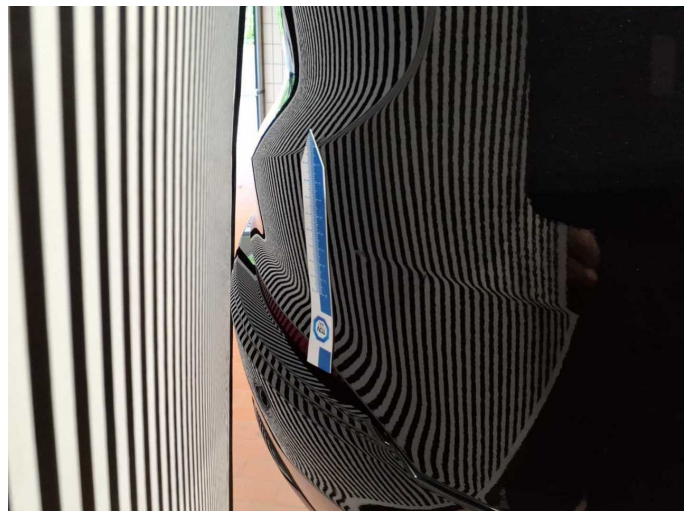
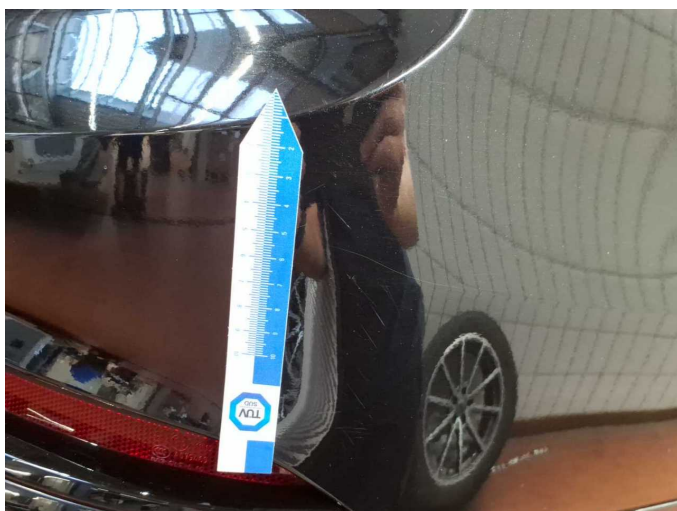
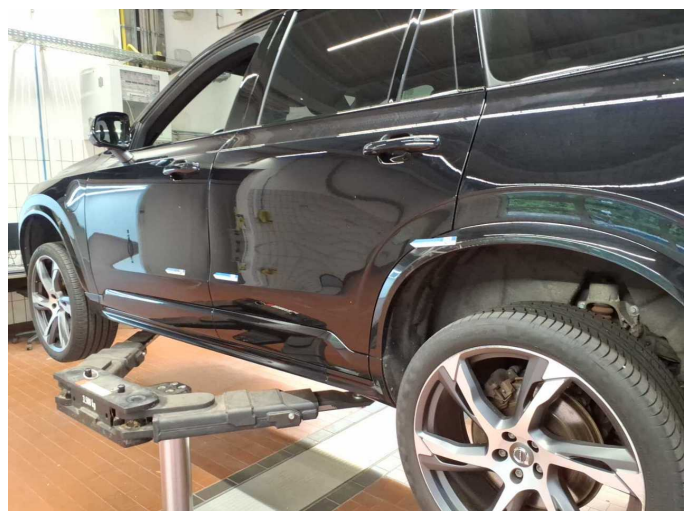
**Accident 1: Rear, Side right**

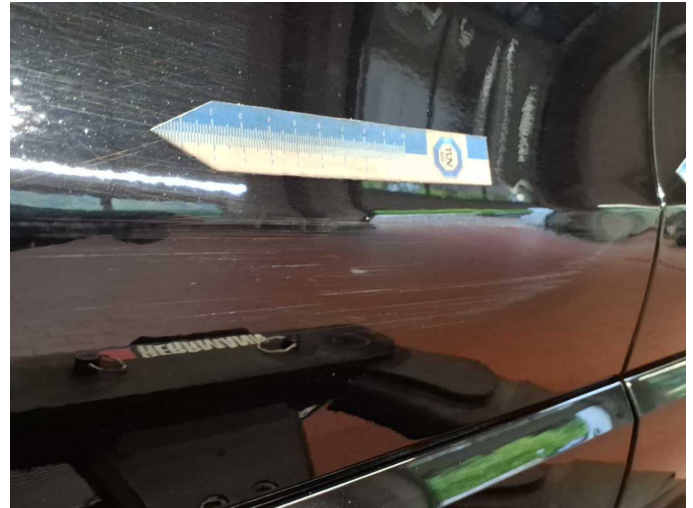
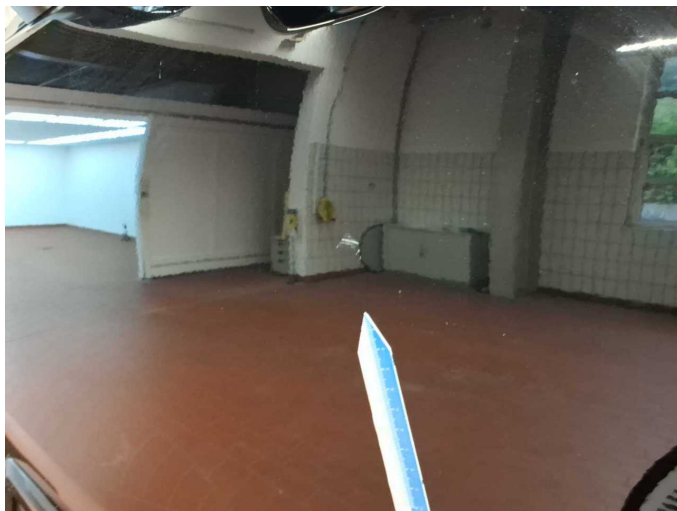
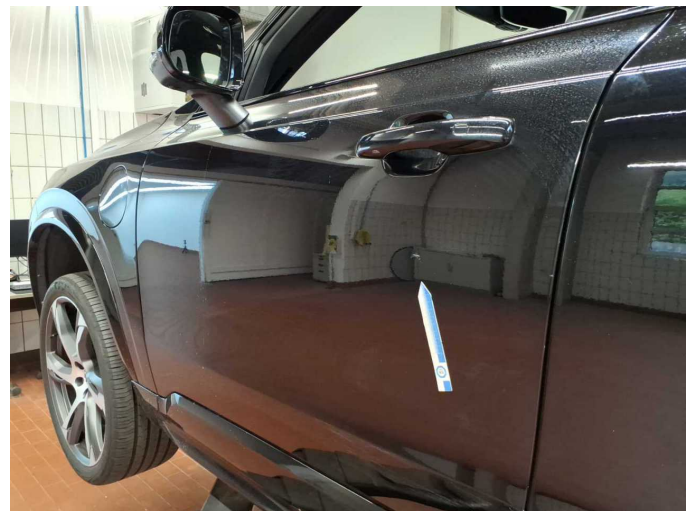
**Accident 2: Side - left**
