Expertise

Protocol number: 46425635  
Order No. / Reference: 26679716  
Inspection date: 7 Jul 2026

Manufacturer: Volkswagen

Model: Caddy 2.0 TDI BMT (5-Si.) Life

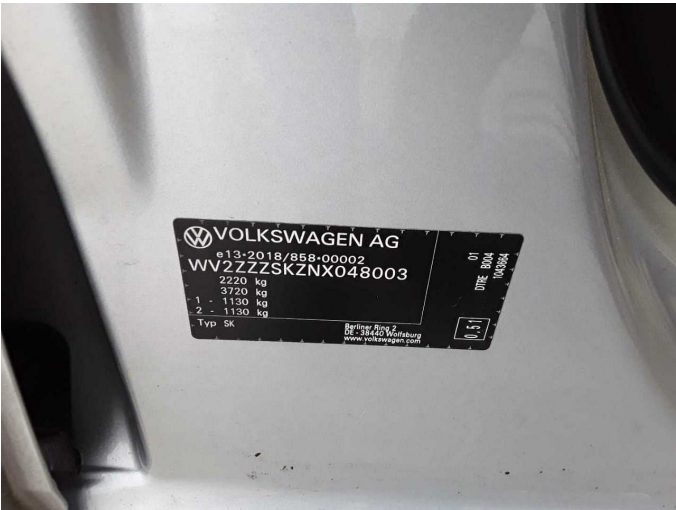
Figure 11: VIN

| VIN comparison | The vehicle identification number (VIN) was read from the vehicle and its conformity with the submitted documents was confirmed by the undersigned during the inspection. |

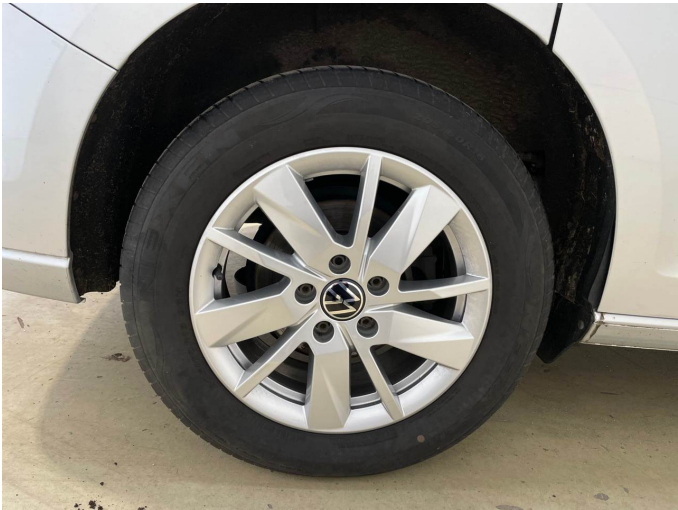
Figure 12: Mounted tyres

| # | Tyre size | Type of tyre | Manufacturer | Tread depth |
|---|---|---|---|---|
| 1) | 205/60 R16 96V | Summer tyres on Light alloy | Falken | 5mm / 5mm |
| 2) | 205/60 R16 96H | Summer tyres on Light alloy | Nexen | 6mm / 6mm |

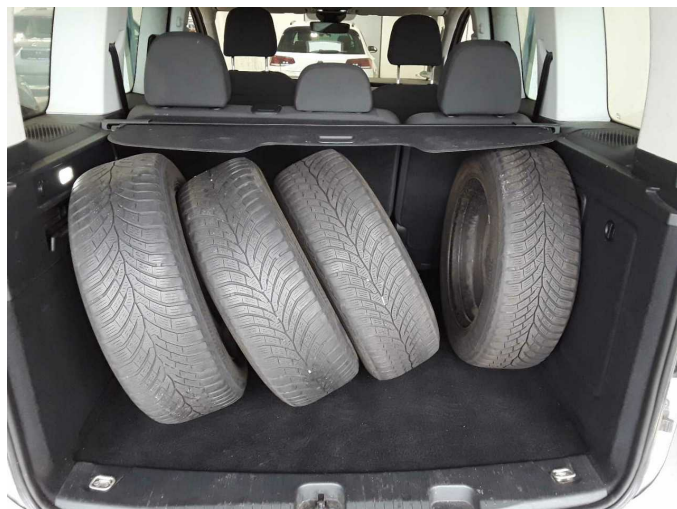
Figure 14: Additional tyres

| # | Tyre size | Type of tyre | Manufacturer | Tread depth |
|---|---|---|---|---|
| 1) | 205/60 R16 96H | Winter tyres on Steel | Continental | 4mm / 4mm |
| 2) | 205/60 R16 96H | Winter tyres on Steel | Continental | 4mm / 4mm |

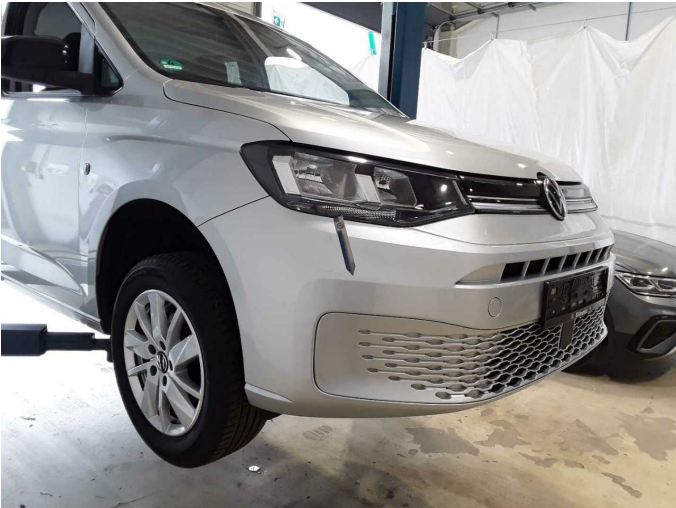
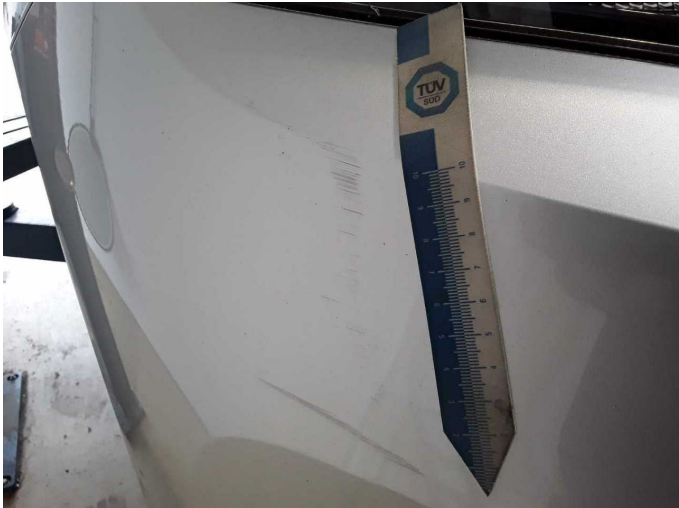
| No. | Component group | Description |
|---|---|---|
| 2 | Front bumper | Front bumper - Scratch(es) - Smart repair |

Damage 2: Front bumper: Front bumper - Scratch(es) - Smart repair

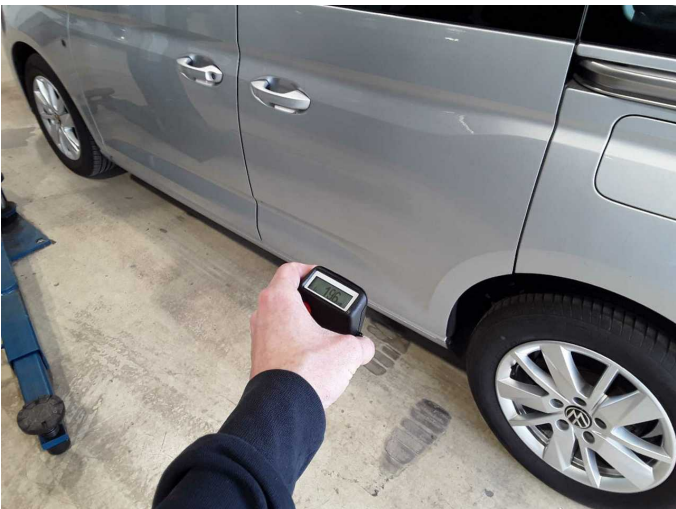
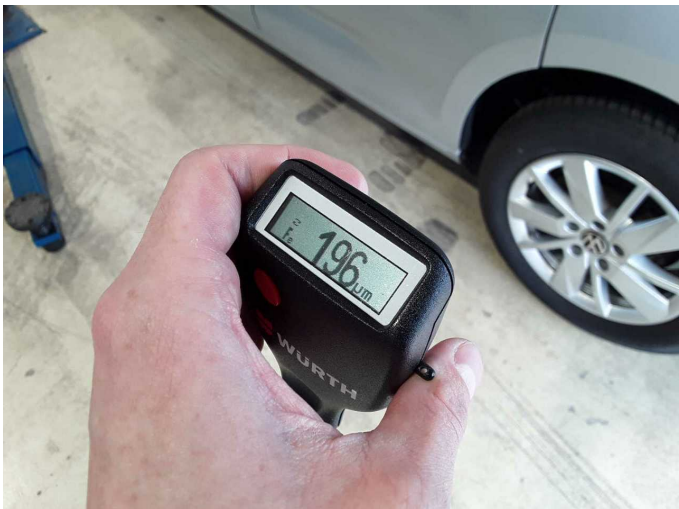
| No. | Repainting |
|---|---|
| 1 | Door - rear left side, Professionally carried out, Invoice of repair done Non-existent |

| Door - rear left side | 196 µm |

Repainting 1: Door - rear left side
