Expertise

Protocol number: 46498624  
Order No. / Reference: 26029288  
Inspection date: 13 Jul 2026

Manufacturer: Mercedes-Benz  
VIN: W1VVLFEZXT4548326

Model: Vito 116 CDI Tourer Lang Aut. SELECT

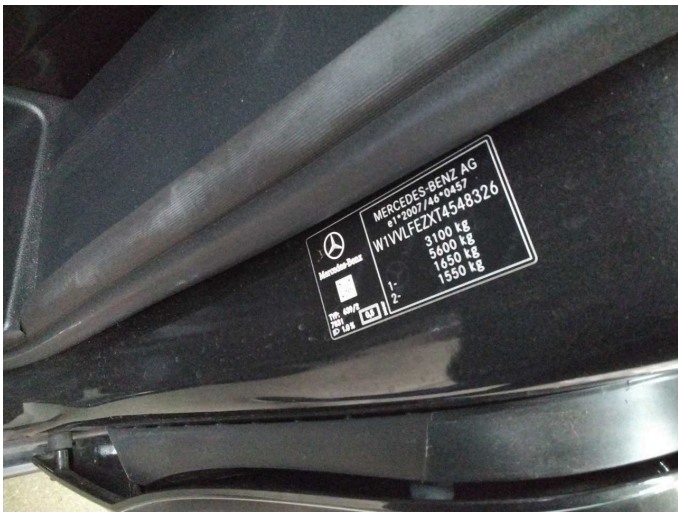
Figure 11: VIN

| VIN comparison | The vehicle identification number (VIN) was read from the vehicle and its conformity with the submitted documents was confirmed by the undersigned during the inspection. |

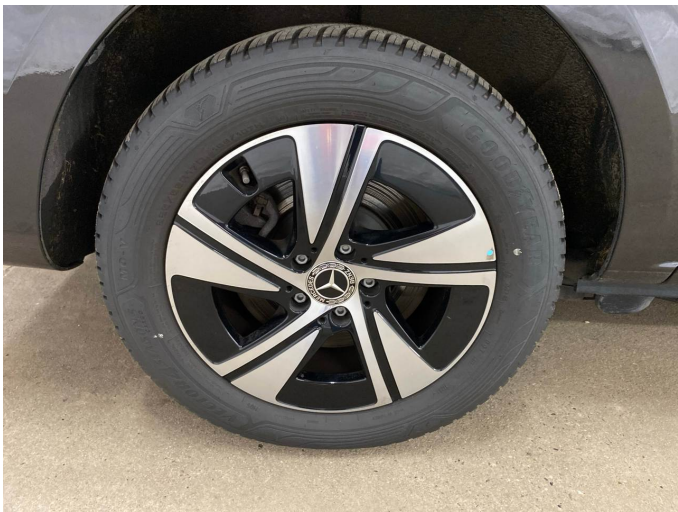
Figure 12: Mounted tyres

| # | Tyre size | Type of tyre | Manufacturer | Tread depth |
|---|---|---|---|---|
| 1) | 225/55 R17 109H | All-season tyres on Steel rim with wheel cover | Goodyear | 7mm / 7mm |
| 2) | 225/55 R17 109H | All-season tyres on Steel rim with wheel cover | Goodyear | 7mm / 7mm |

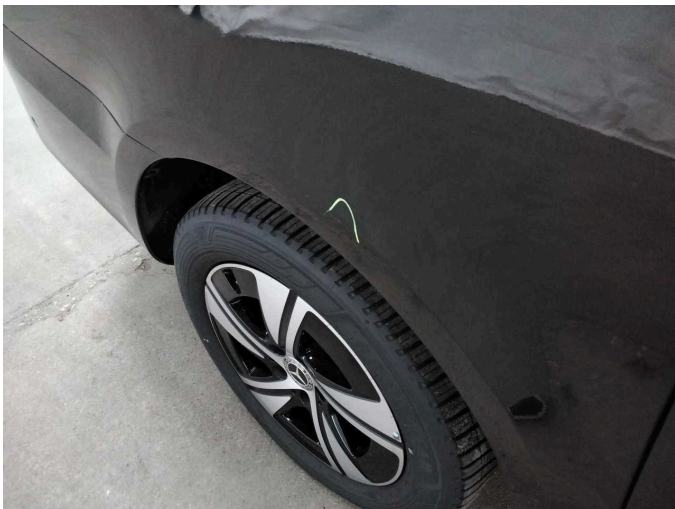
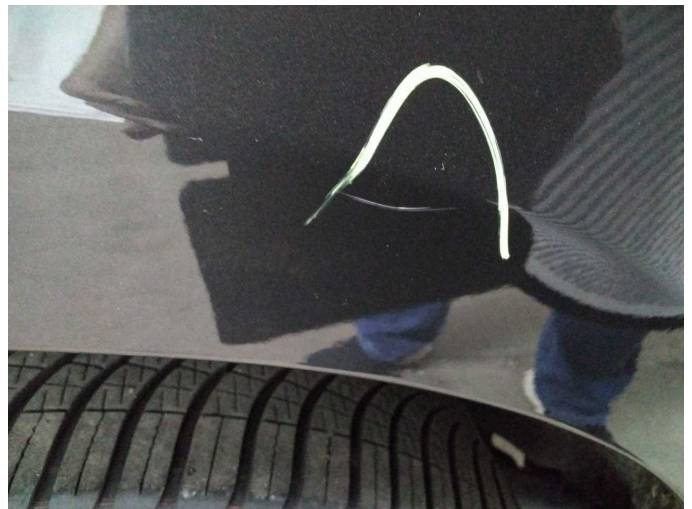
| No. | Component group | Description |
|---|---|---|
| 2 | Side panel - rear right side | Side panel - Scratch(es) - Smart repair |

**Damage 2:** Side panel - rear right side: Side panel - Scratch(es) - Smart repair

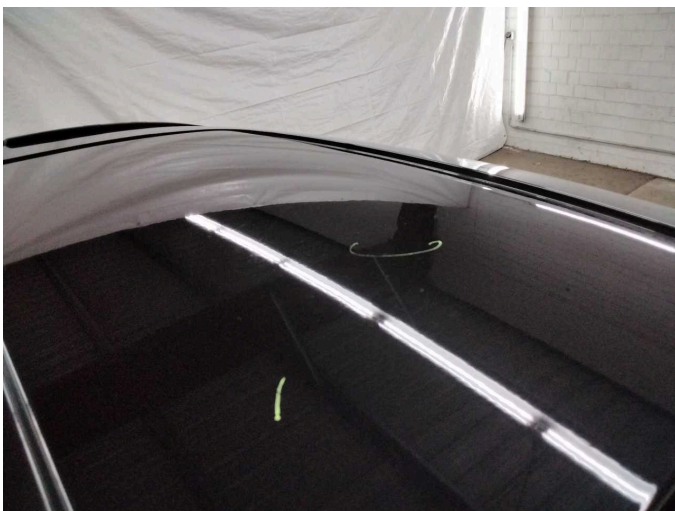
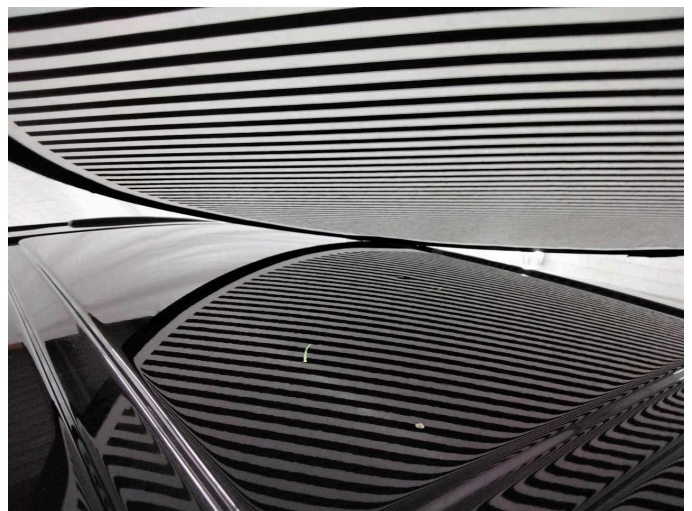
| No. | Component group | Description |
|---|---|---|
| 3 | Roof | Roof - dent(s) - Smooth repair work |

**Damage 3:** Roof: Roof - dent(s) - Smooth repair work

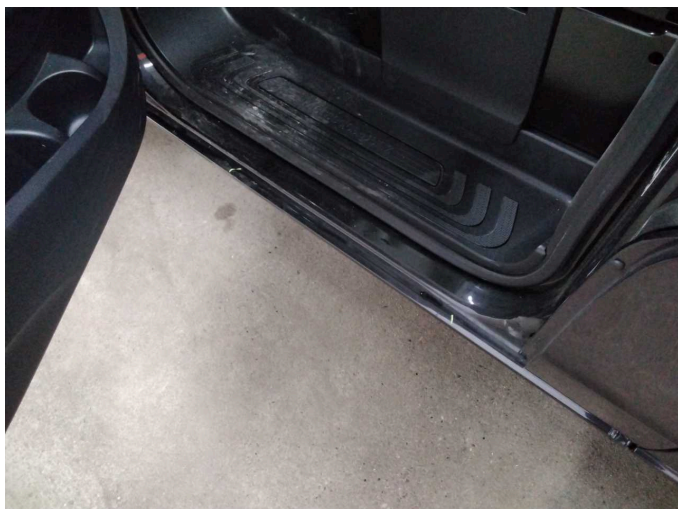
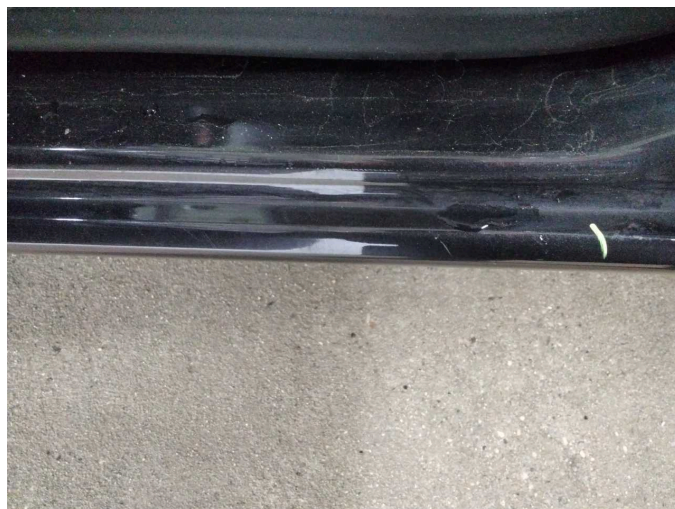
| No. | Component group | Description |
|---|---|---|
| 4 | Sill - left side | Sill - Scratch(es) - Smart repair |

**Damage 4:** Sill - left side: Sill - Scratch(es) - Smart repair

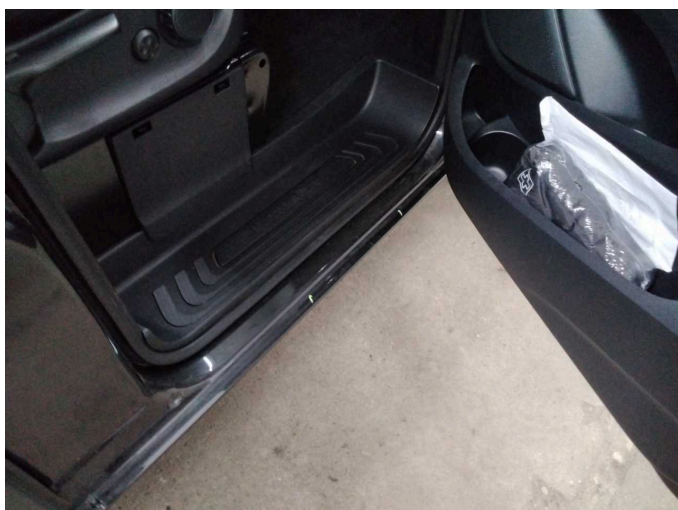
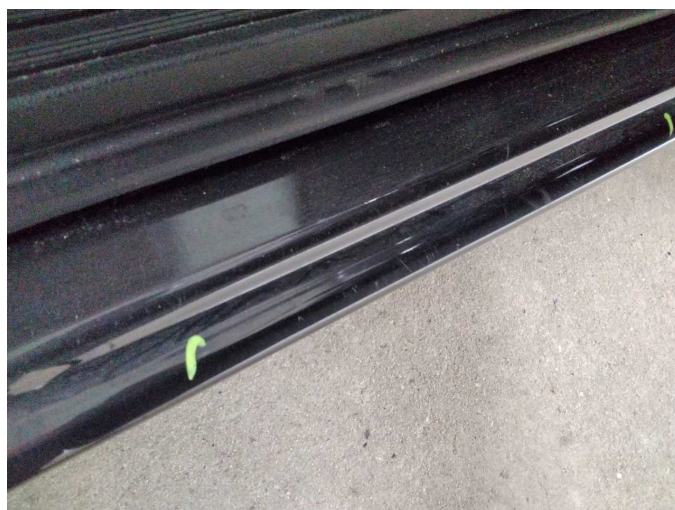
| No. | Component group | Description |
|---|---|---|
| 5 | Sill - right side | Sill - Scratch(es) - Smart repair |

**Damage 5:** Sill - right side: Sill - Scratch(es) - Smart repair

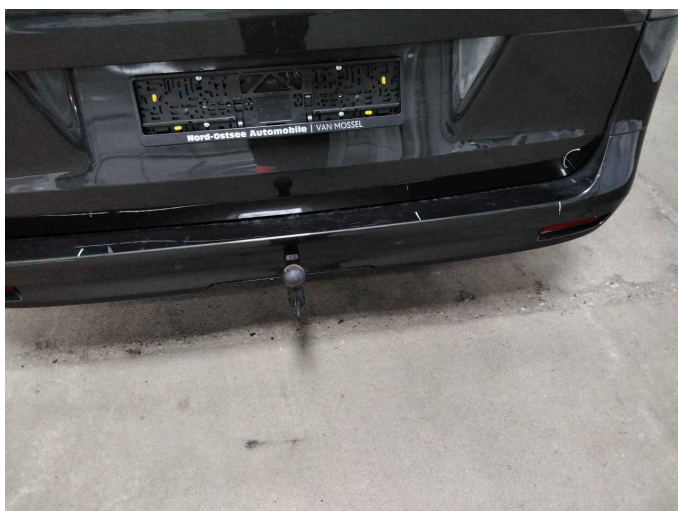
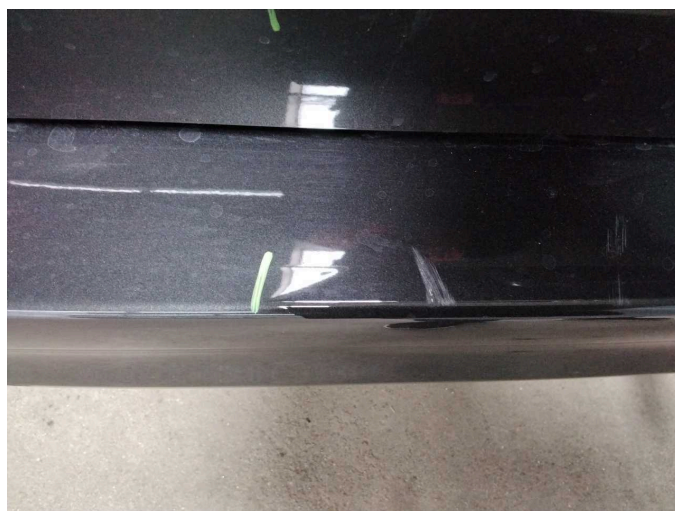
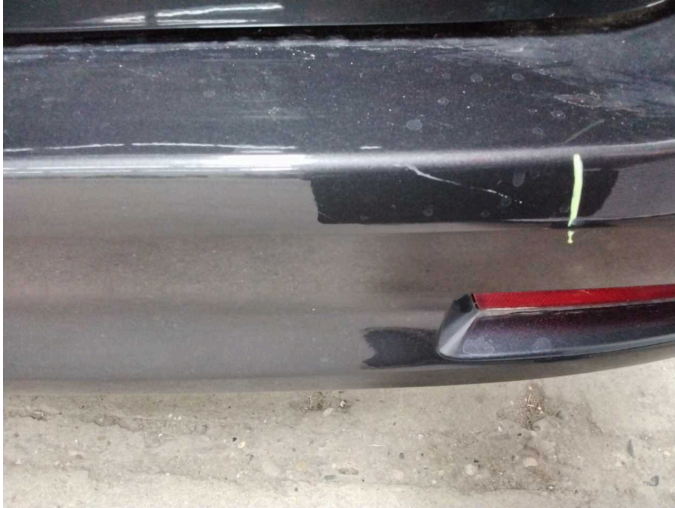
| No. | Component group | Description |
|---|---|---|
| 6 | Rear bumper | Rear bumper - Scratch(es) - Smart repair |

**Damage 6:** Rear bumper: Rear bumper - Scratch(es) - Smart repair

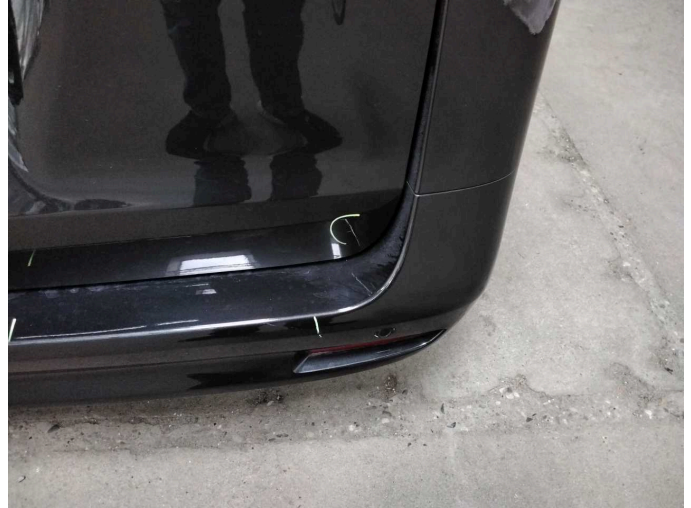
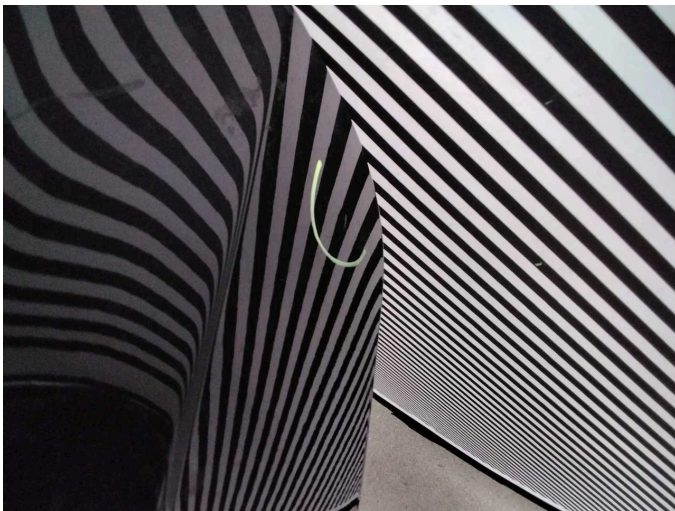
| No. | Component group | Description |
|---|---|---|
| 7 | Boot lid / rear door | Boot lid - Dent / paintcoat damage - Smart repair |

**Damage 7:** Boot lid / rear door: Boot lid - Dent / paintcoat damage - Smart repair

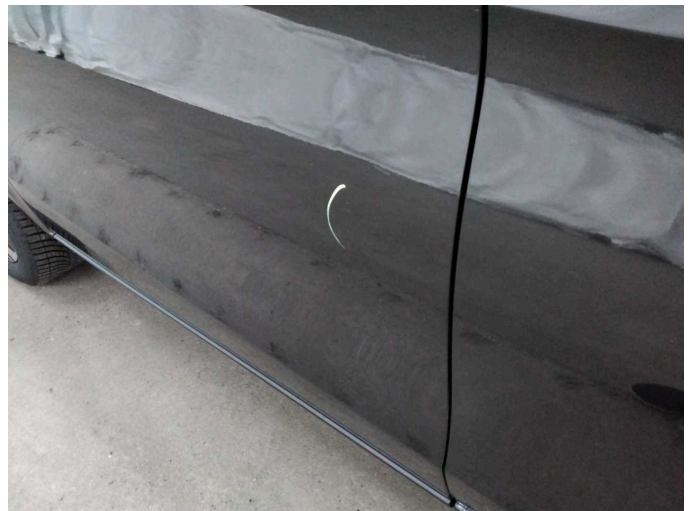
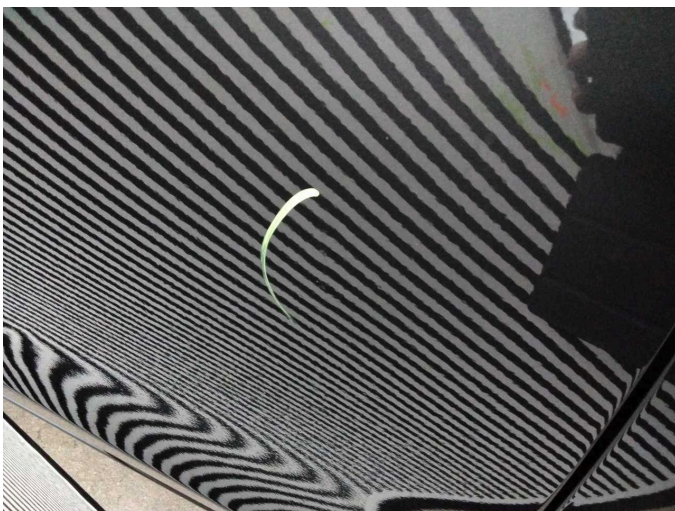
| No. | Component group | Description |
|---|---|---|
| 8 | Sliding door, right | Sliding door with glass panel - Dent / paintcoat damage - Smart repair |

**Damage 8:** Sliding door, right: Sliding door with glass panel - Dent / paintcoat damage - Smart repair

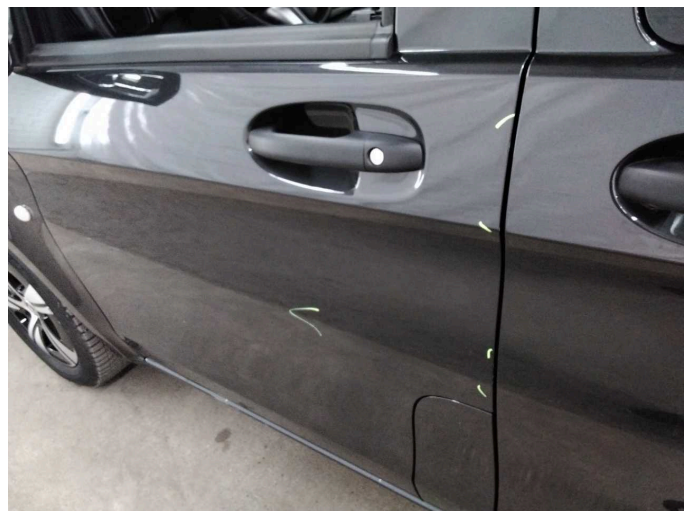
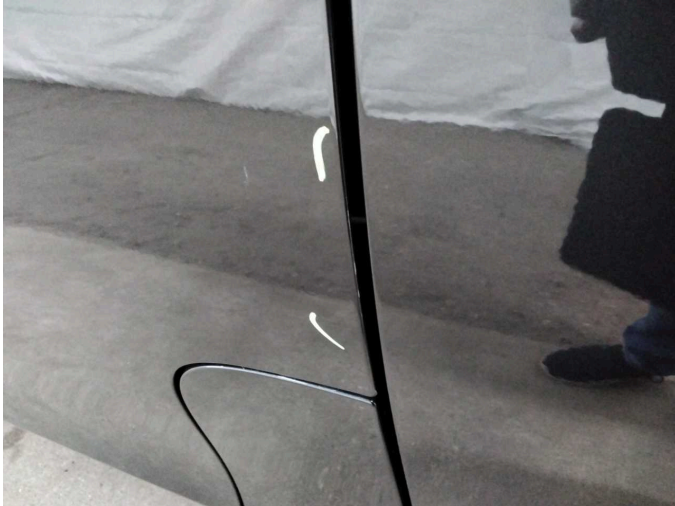
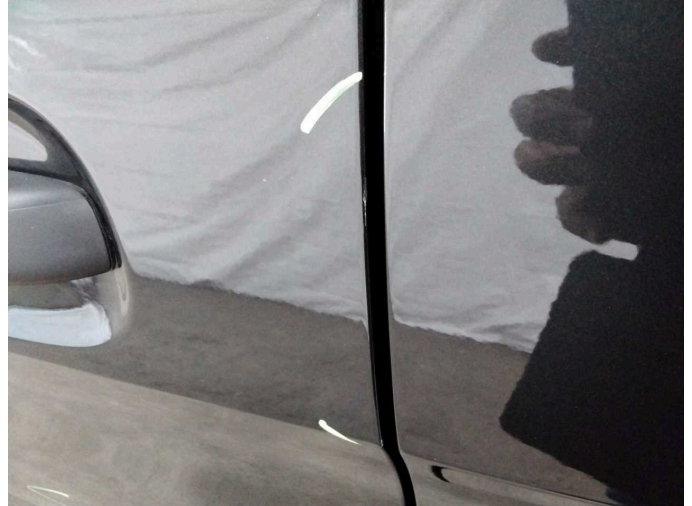
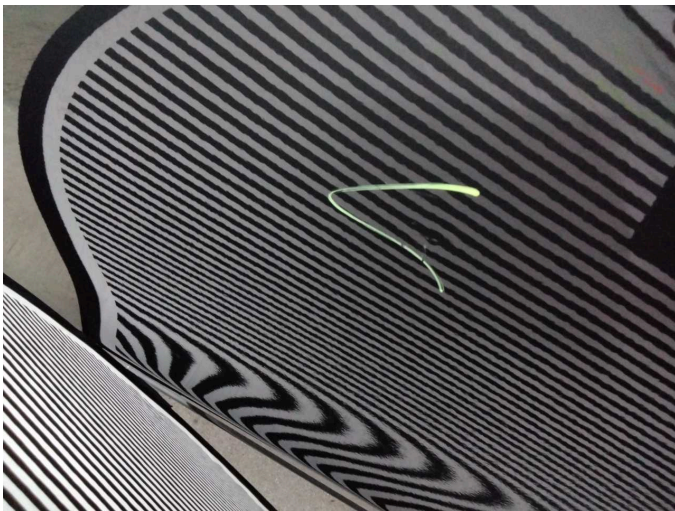
| No. | Component group | Description |
|---|---|---|
| 9 | Door - front left side | Door - Dent / paintcoat damage - Repair and paint |

**Damage 9:** Door - front left side: Door - Dent / paintcoat damage - Repair and paint
