Expertise

Protocol number: 46736459  
Order No. / Reference: 26742071  
Inspection date: 27 Jul 2026

Manufacturer: Volkswagen

Model: ID.4 4Motion Pro Infotainment-Paket "Plus"

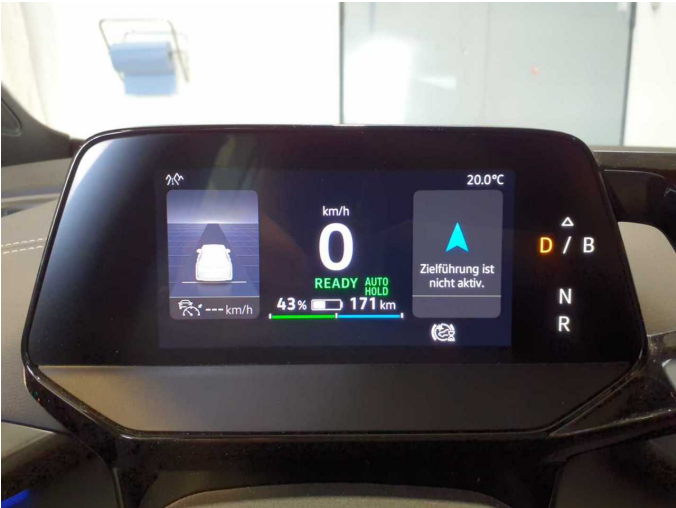
| Vehicle details | |
|---|---|
| Mileage (Read) | 129,347 km |

Figure 7: Instrument cluster

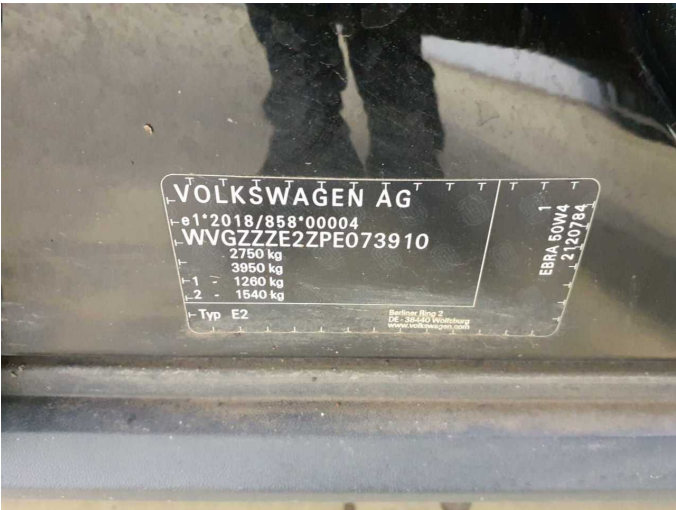
| VIN comparison | The vehicle identification number (VIN) was read from the vehicle and its conformity with the submitted documents was confirmed by the undersigned during the inspection. |

Figure 11: VIN

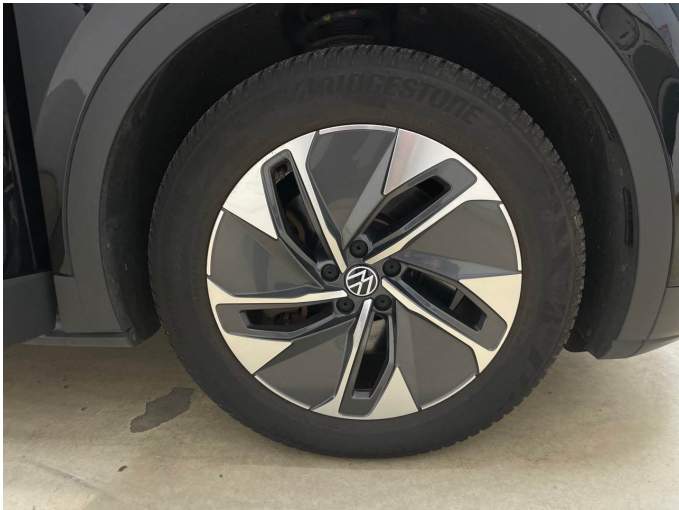
| # | Tyre size | Type of tyre | Manufacturer | Tread depth |
|---|---|---|---|---|
| 1) | 235/55 R19 101T | All-season tires (with run-flat capability) on Light alloy | Bridgestone | 5mm / 5mm |
| 2) | 255/50 R19 103T | All-season tires (with run-flat capability) on Light alloy | Bridgestone | 5mm / 5mm |

Figure 12: Mounted tyres

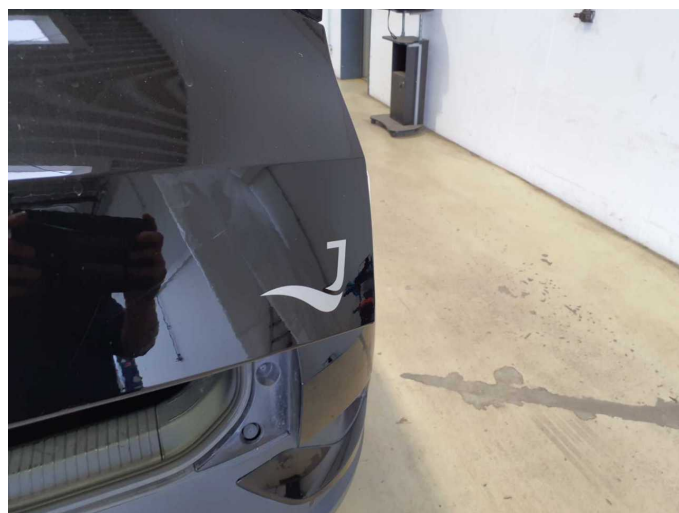
| No. | Component group | Description |
|---|---|---|
| 1 | Boot lid / rear door | Boot lid - Glued / labelled - De-glue / neutralise |

**Damage 1:** Boot lid / rear door: Boot lid - Glued / labelled - De-glue / neutralise

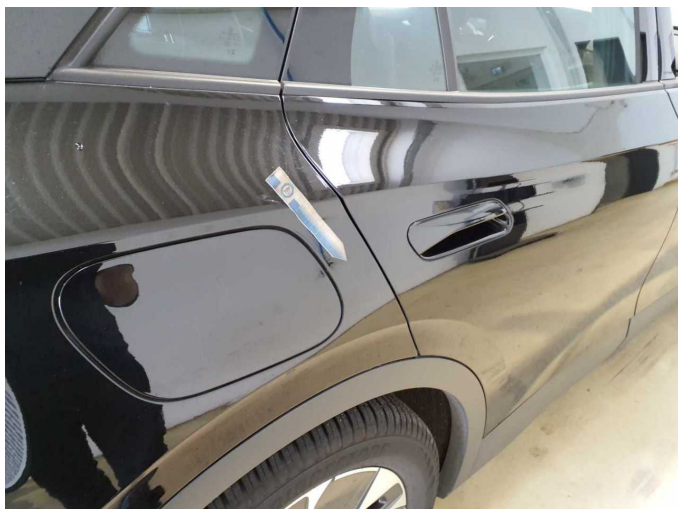
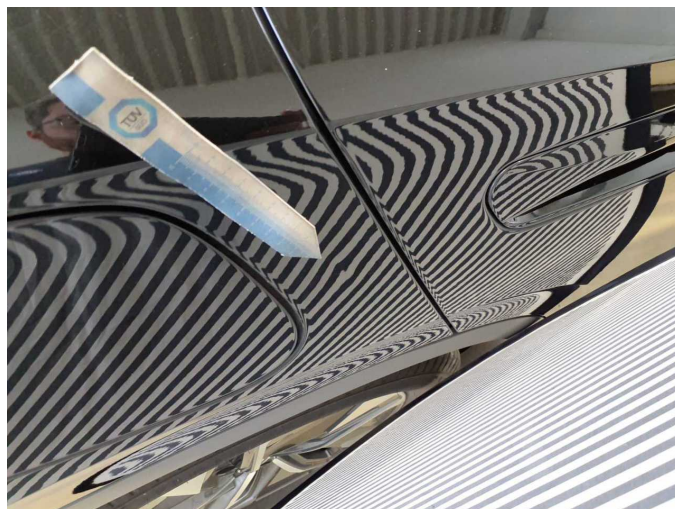
| No. | Component group | Description |
|---|---|---|
| 2 | Side panel - rear right side | Side panel - dent(s) - Smooth repair work |

**Damage 2:** Side panel - rear right side: Side panel - dent(s) - Smooth repair work

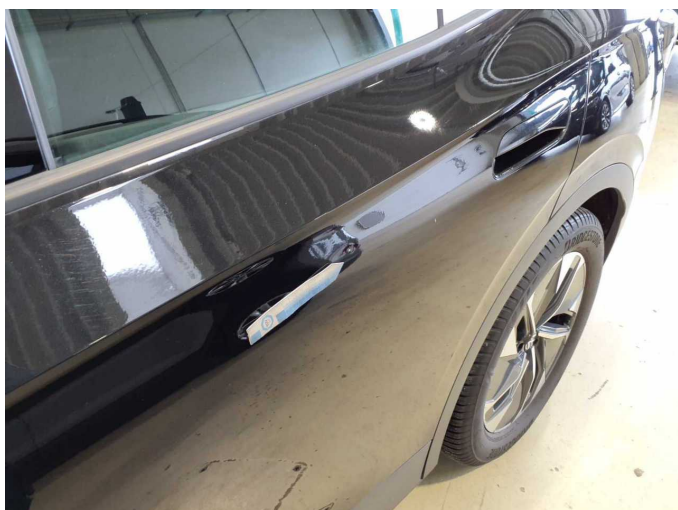
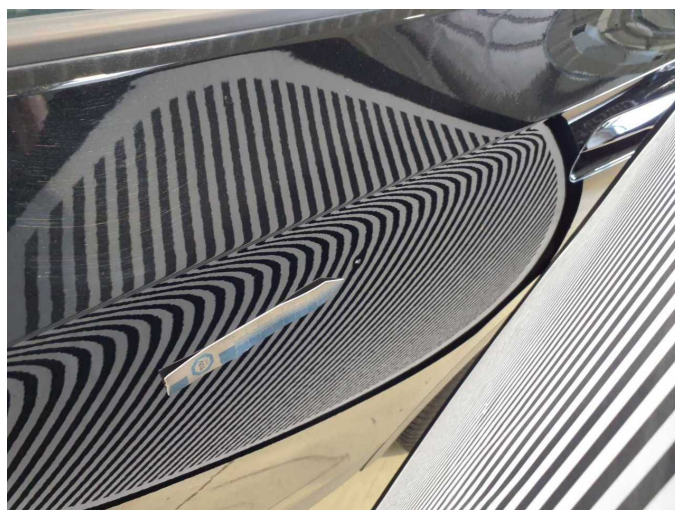
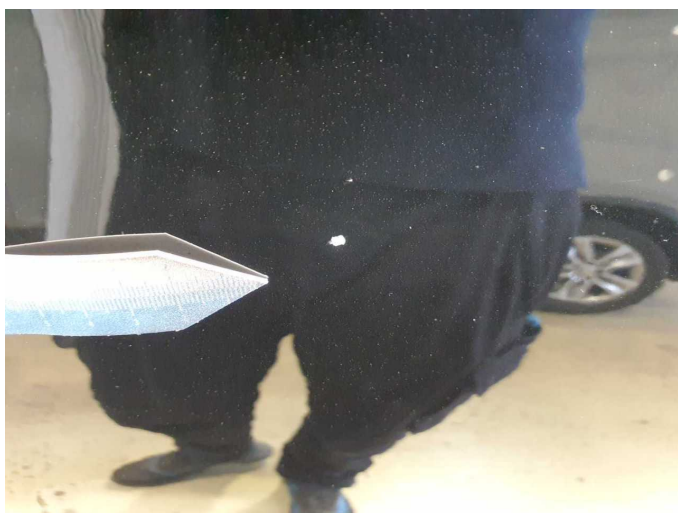
| No. | Component group | Description |
|---|---|---|
| 3 | Door - rear left side | Door - Dent / paintcoat damage - Repair and paint |

**Damage 3:** Door - rear left side: Door - Dent / paintcoat damage - Repair and paint

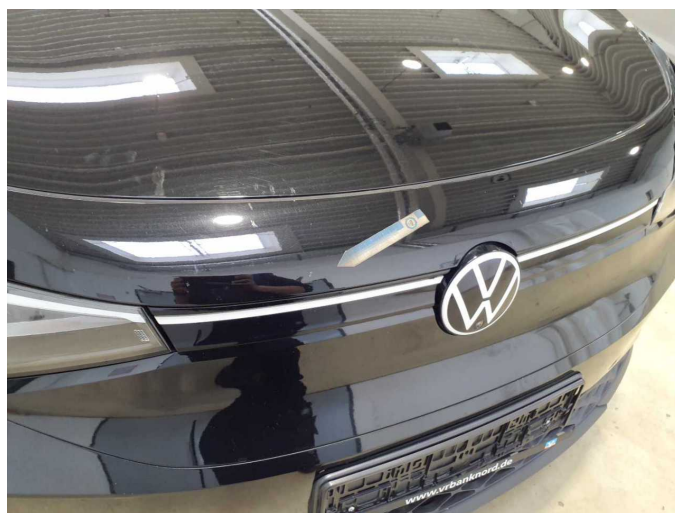
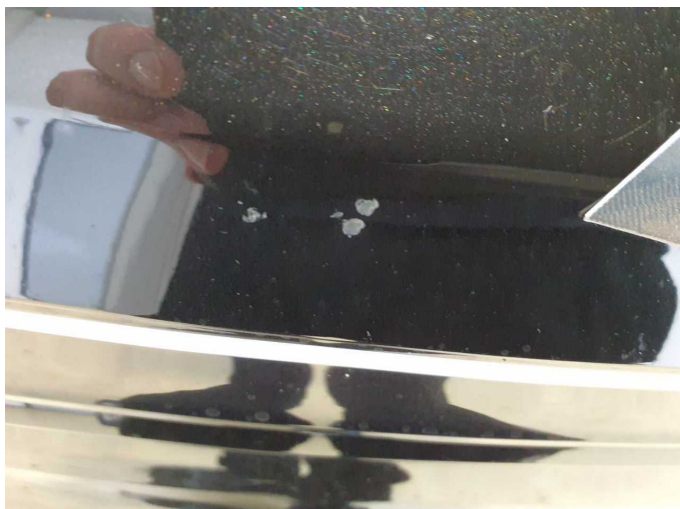
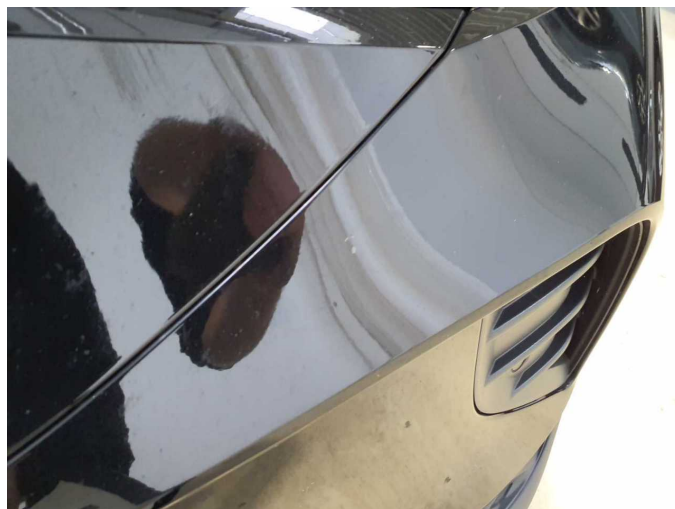
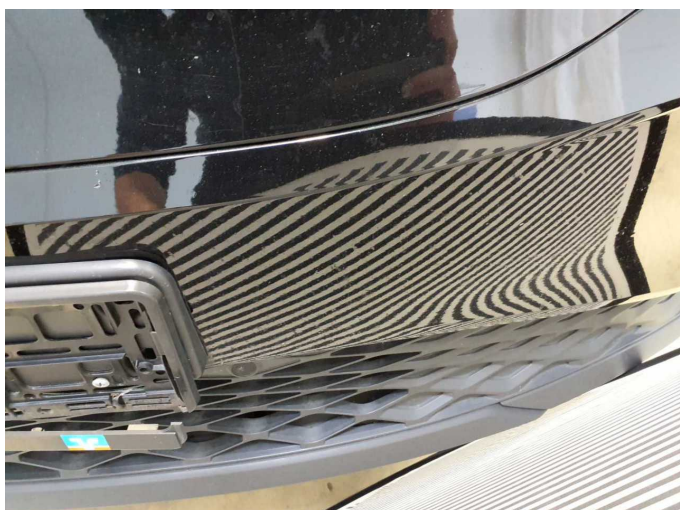
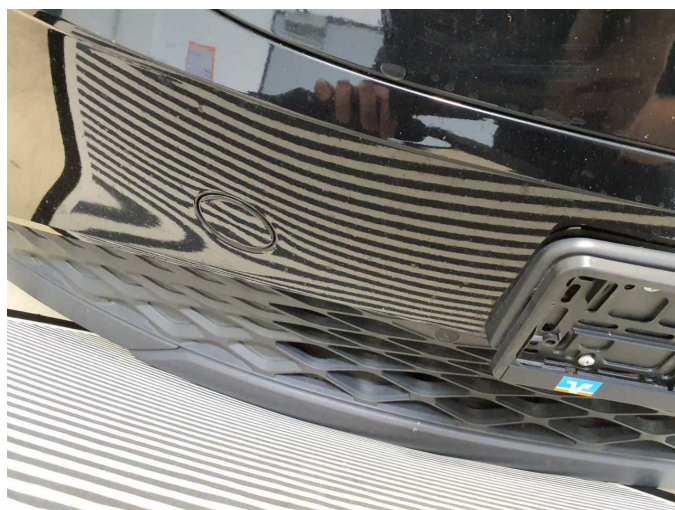
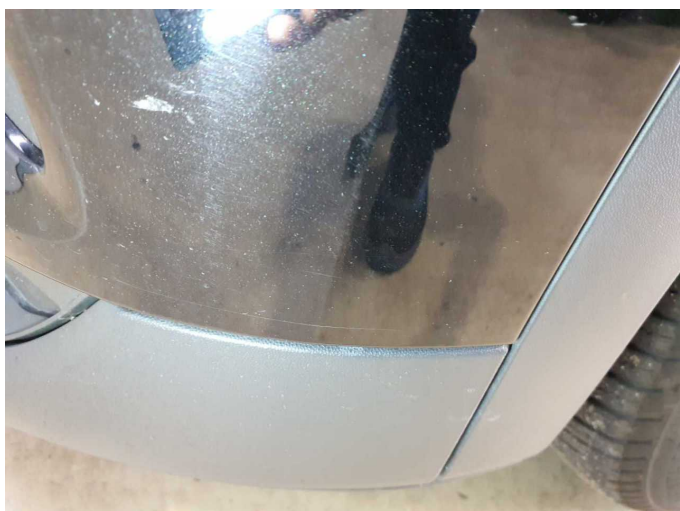
| No. | Component group | Description |
|---|---|---|
| 4 | Front bumper | Front bumper - Stone chips - Paint |

**Damage 4:** Front bumper: Front bumper - Stone chips - Paint

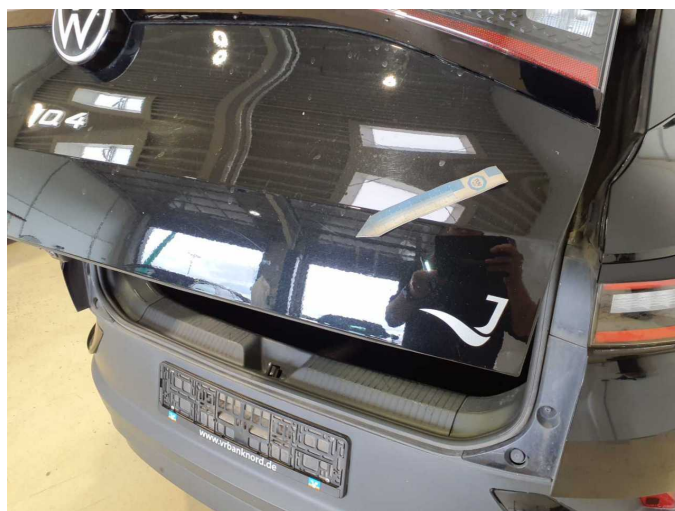
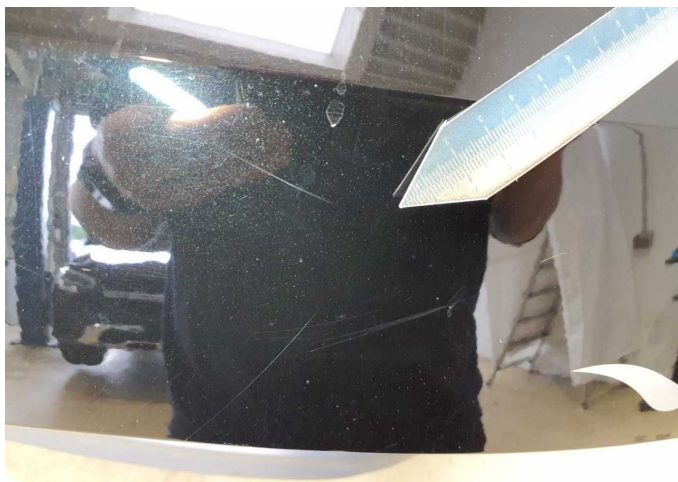
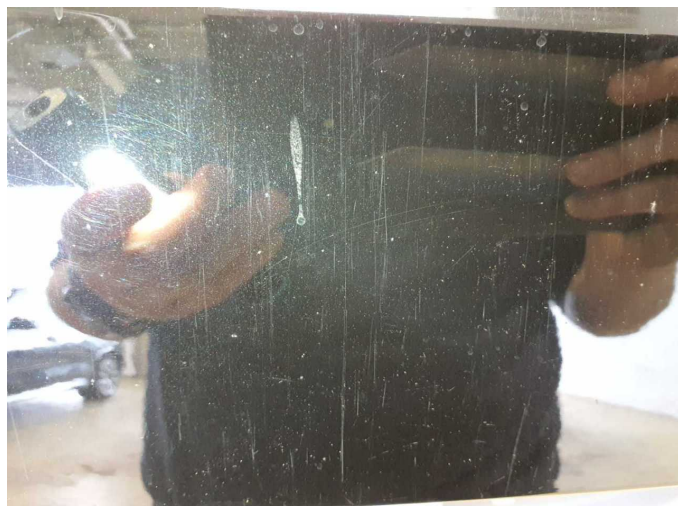
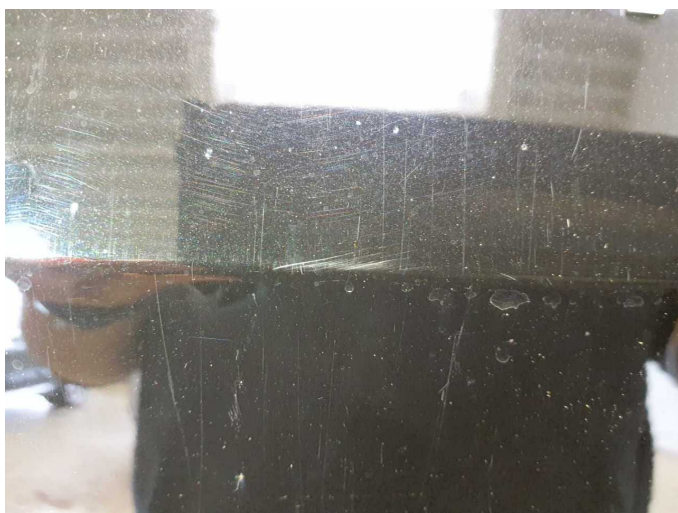
| No. | Component group | Description |
|---|---|---|
| 5 | Boot lid / rear door | Boot lid - Scratch(es) - Paint |

**Damage 5:** Boot lid / rear door: Boot lid - Scratch(es) - Paint

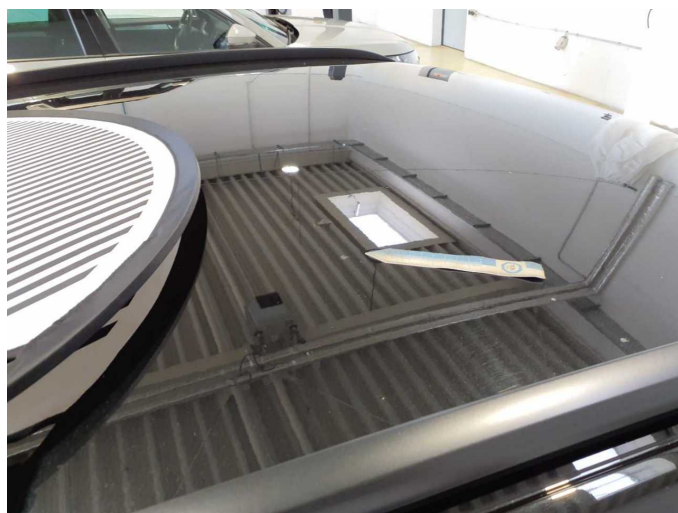
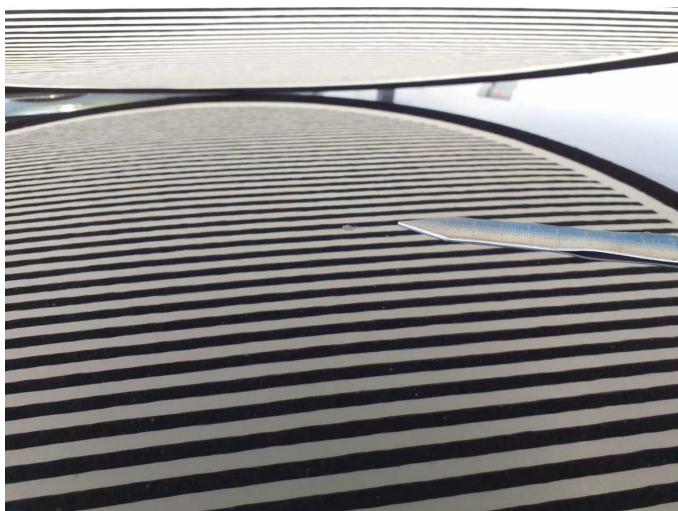
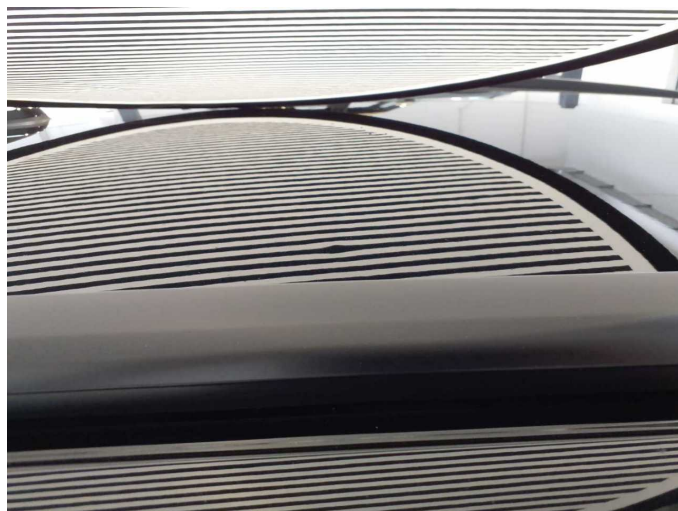
| No. | Component group | Description |
|---|---|---|
| 6 | Roof | Roof (Anätzung) - Paint defect - Repair and paint |

**Damage 6:** Roof: Roof (Anätzung) - Paint defect - Repair and paint
