Expertise

Protocol number: 46439693  
Order No. / Reference: 26638036  
Inspection date: 10 Jul 2026

| Manufacturer: Ford | Model: Focus Turnier 1.5 EcoBlue Start-Stopp-System Aut. TITANIUM |

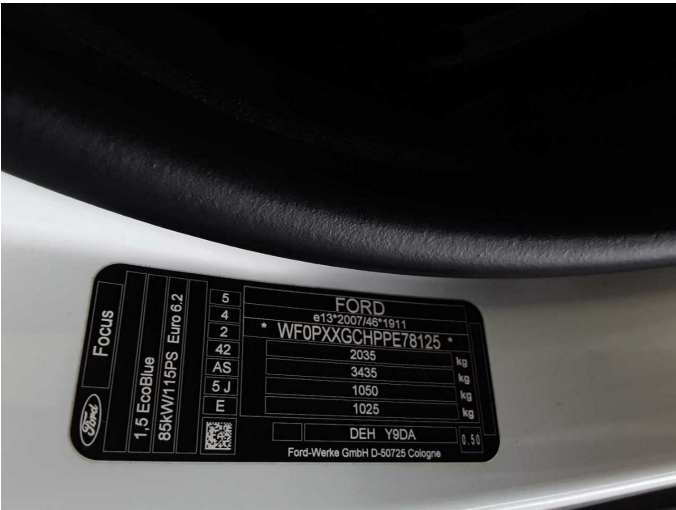
Figure 11: VIN

| VIN comparison | The vehicle identification number (VIN) was read from the vehicle and its conformity with the submitted documents was confirmed by the undersigned during the inspection. |

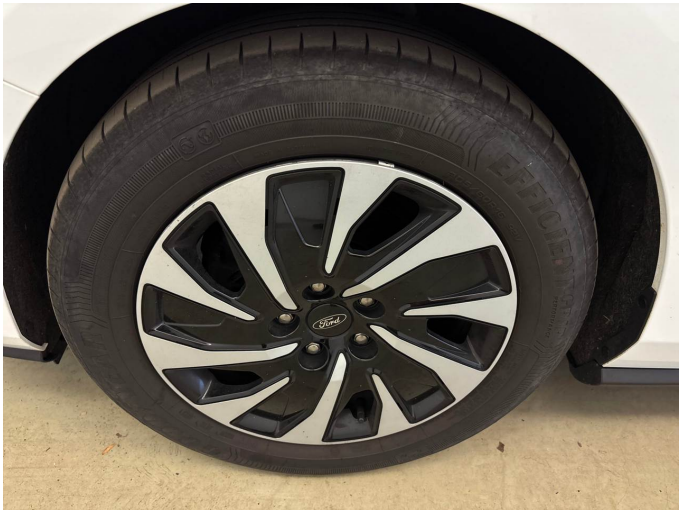
Figure 12: Mounted tyres

| # | Tyre size | Type of tyre | Manufacturer | Tread depth |
|---|---|---|---|---|
| 1) | 205/60 R16 92V | Summer tyres on Steel rim with wheel cover | Goodyear | 4mm / 4mm |
| 2) | 205/60 R16 92V | Summer tyres on Steel rim with wheel cover | Goodyear | 4mm / 4mm |

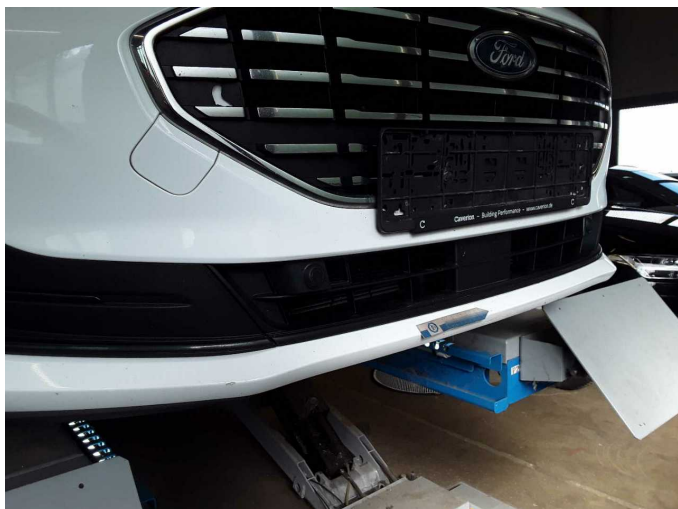
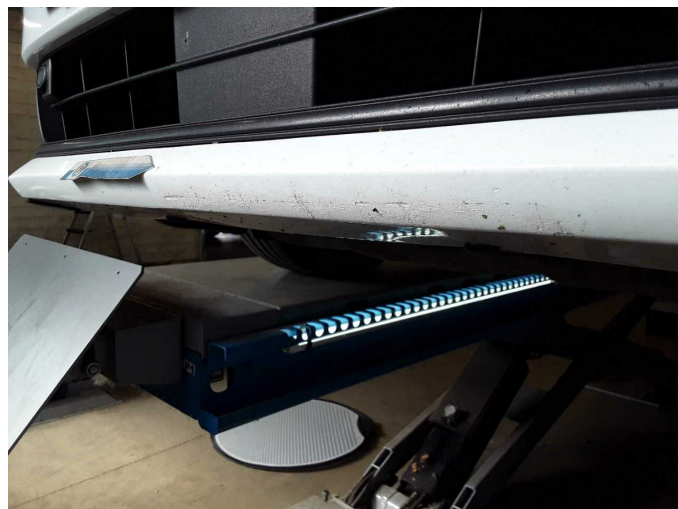
**Damage 1:** Front bumper: Front bumper - Scratched - Smart repair

| No. | Component group | Description |
|---|---|---|
| 1 | Front bumper | Front bumper - Scratched - Smart repair |

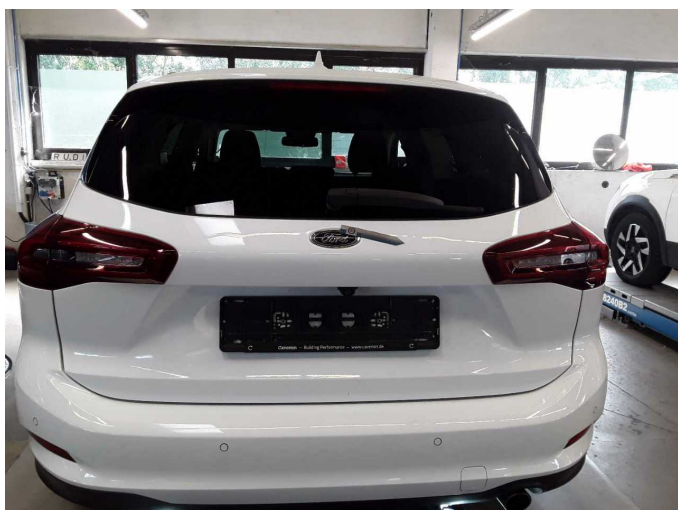
**Damage 2:** Boot lid / rear door: Boot lid - dent(s) - Smooth repair work

| No. | Component group | Description |
|---|---|---|
| 2 | Boot lid / rear door | Boot lid - dent(s) - Smooth repair work |

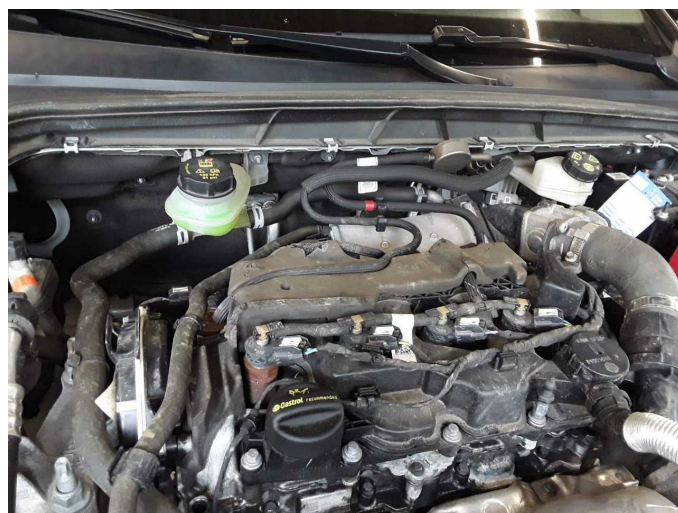
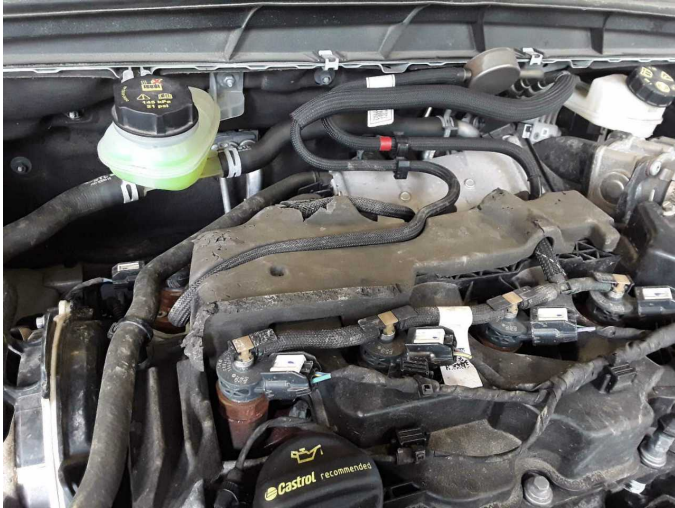
**Damage 3:** Engine: Engine cover - Damaged - Replace

| No. | Component group | Description |
|---|---|---|
| 3 | Engine | Engine cover - Damaged - Replace |

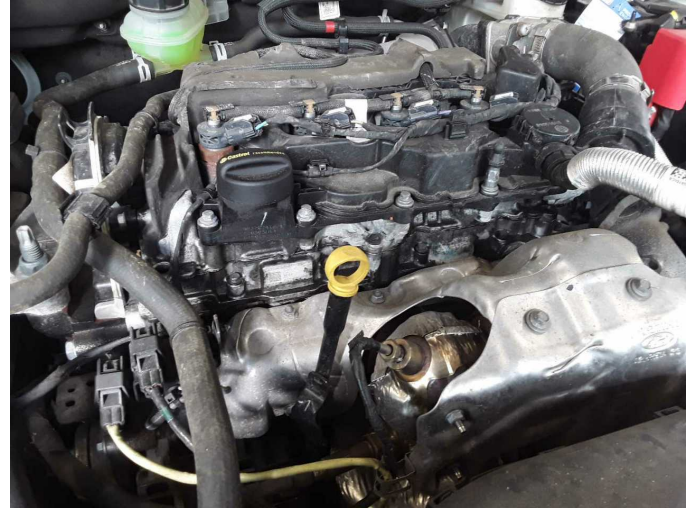
**Damage 4:** Engine: Engine - Leaking - Diagnosed and repair if necessary

| No. | Component group | Description |
|---|---|---|
| 4 | Engine | Engine - Leaking - Diagnosed and repair if necessary |
