Expertise

Protocol number: 46397574  
Order No. / Reference: 26528009-1  
Inspection date: 18 Jun 2026

| Manufacturer: Ford | Model: Focus 1.5 EcoBlue Start-Stopp-System Aut. TITANIUM X |
| VIN: WF0NXXGCHNPD64230 | |

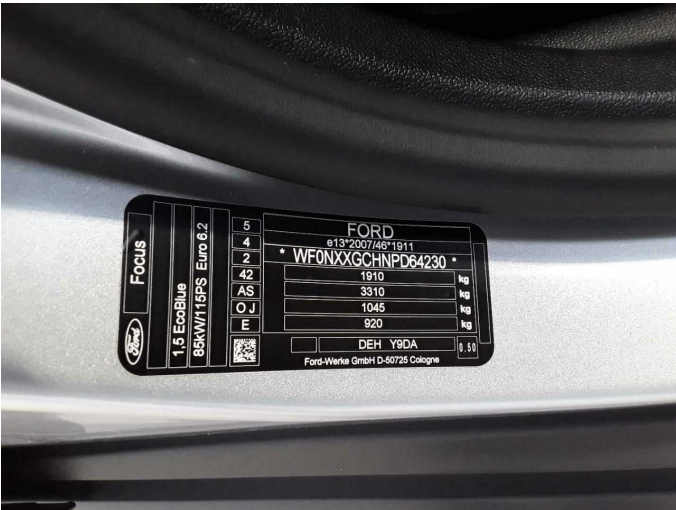
Figure 11: VIN

| VIN comparison | The vehicle identification number (VIN) was read from the vehicle and its conformity with the submitted documents was confirmed by the undersigned during the inspection. |

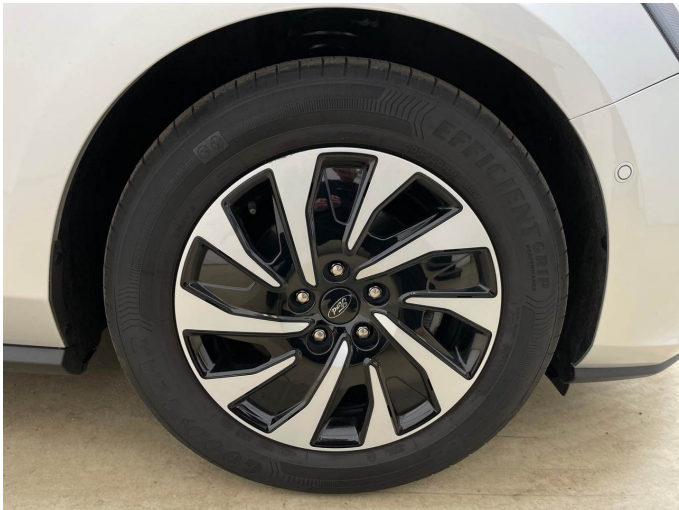
Figure 12: Mounted tyres

| Tyres | | | | |
|---|---|---|---|---|
| 1) | 205/60 R16 92V | Summer tyres on Steel rim with wheel cover | Goodyear | 5mm / 5mm |
| 2) | 205/60 R16 92V | Summer tyres on Steel rim with wheel cover | Goodyear | 5mm / 5mm |

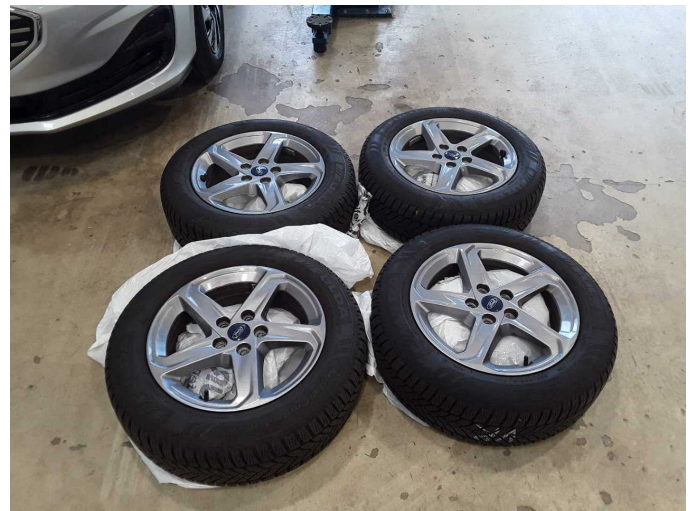
Figure 16: Additional tyres

| Tyres | | | | |
|---|---|---|---|---|
| 1) | 205/60 R16 92H | Winter tyres on Light alloy | Fulda | 7mm / 7mm |
| 2) | 205/60 R16 92H | Winter tyres on Light alloy | Fulda | 9mm / 9mm |

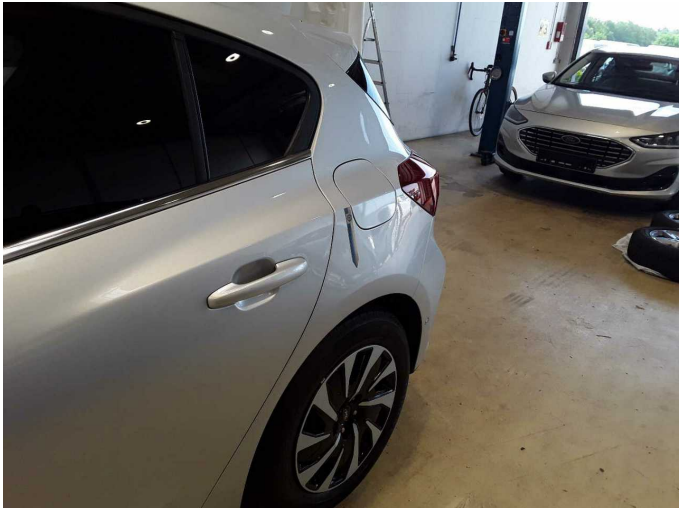
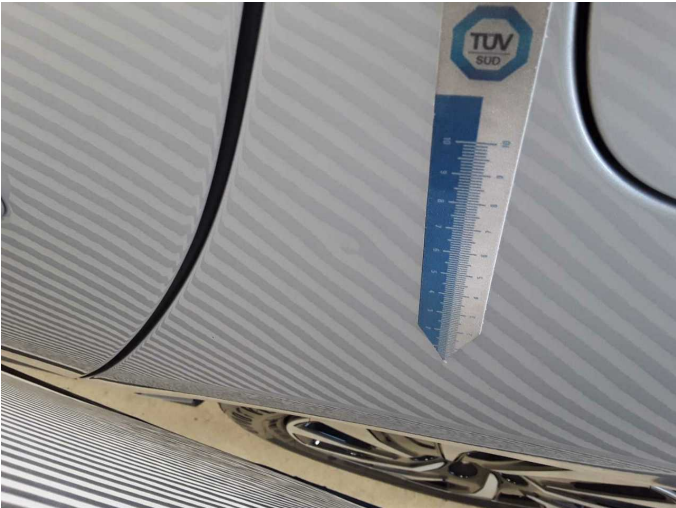
Damage 1: Side panel - rear left side: Side panel - dent(s) - Smooth repair work

| No. | Component group | Description |
|---|---|---|
| 1 | Side panel - rear left side | Side panel - dent(s) - Smooth repair work |

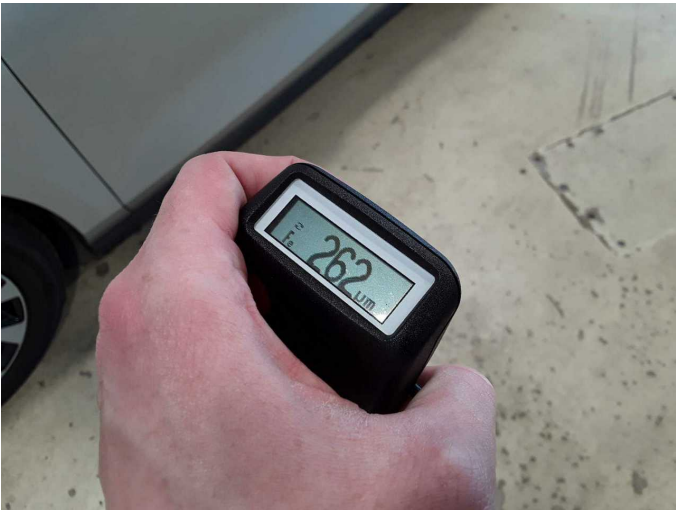
Repainting 1: Door - front left side

| No. | Repainting |
|---|---|
| 1 | Door - front left side, Professionally carried out, Invoice of repair done Non-existent |

| Door - front left side | 262 µm |
