Expertise

Protocol number: 45947127  
Order No. / Reference: 26434610  
Inspection date: 15 Jun 2026

Manufacturer: Volvo

Model: XC90 T8 AWD Recharge Plus Bright

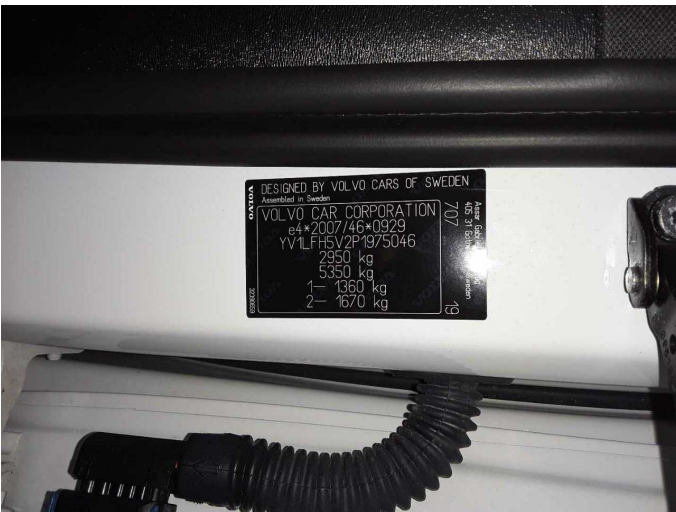
Figure 11: VIN

| VIN comparison | The vehicle identification number (VIN) was read from the vehicle and its conformity with the submitted documents was confirmed by the undersigned during the inspection. |

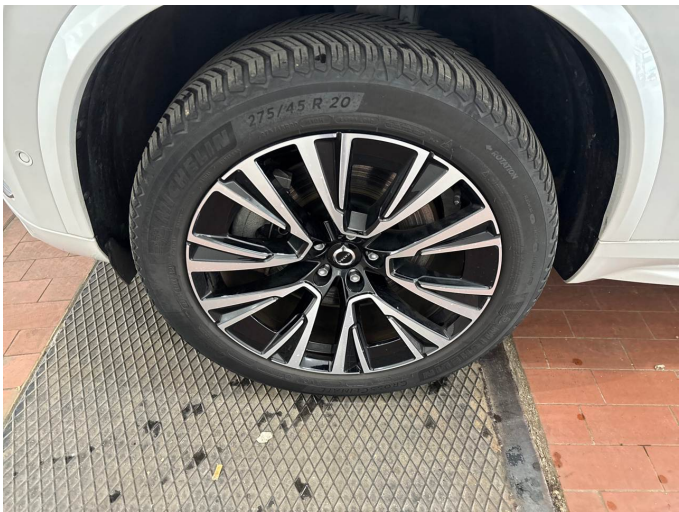
| # | Tyre size | Type of tyre | Manufacturer | Tread depth |
|---|---|---|---|---|
| 1) | 275/45 R20 110H | All-season tyres on Light alloy | Michelin | 5mm / 5mm |
| 2) | 275/45 R20 110H | All-season tyres on Light alloy | Michelin | 4mm / 4mm |

Figure 12: Mounted tyres

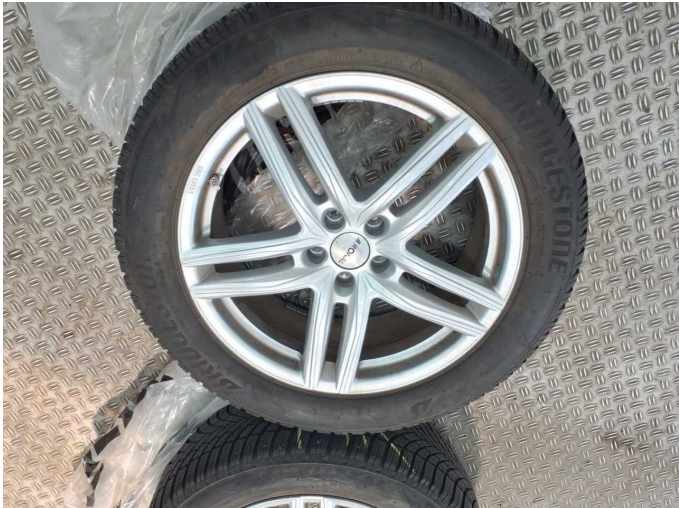
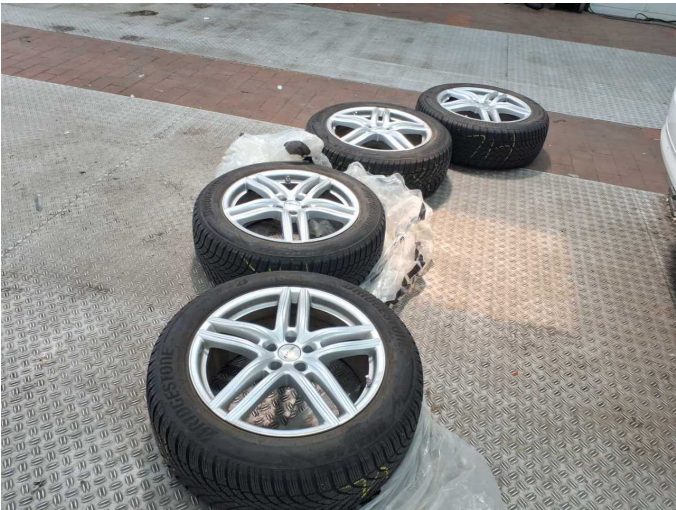
| # | Tyre size | Type of tyre | Manufacturer | Tread depth |
|---|---|---|---|---|
| 1) | 235/55 R19 105V | Winter tyres on Light alloy | Bridgestone | 6mm / 6mm |
| 2) | 235/55 R19 105V | Winter tyres on Light alloy | Bridgestone | 6mm / 6mm |

Figure 16: Additional tyres

Figure 17: Additional tyres

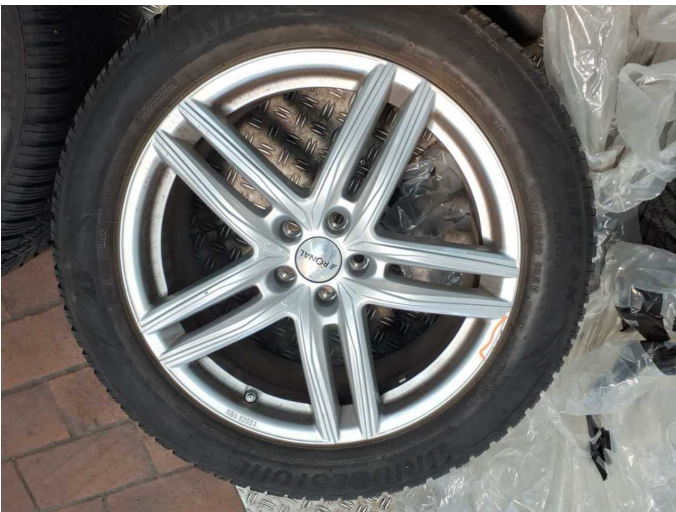
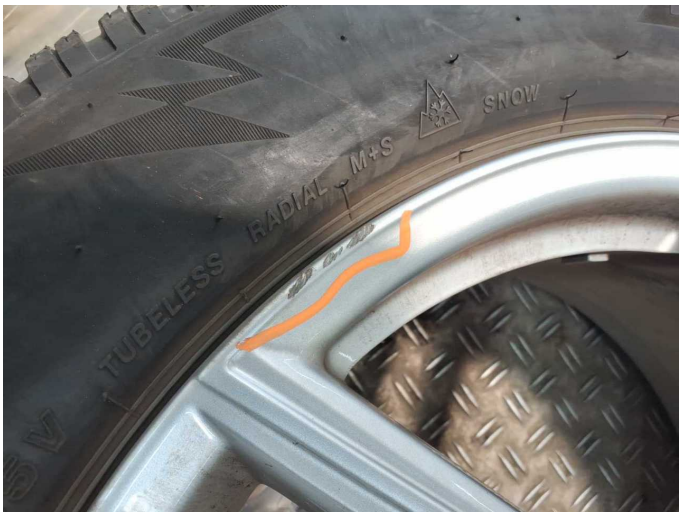
| No. | Component group | Description |
|---|---|---|
| 1 | 2nd wheel set | 1 alloy rim - Scratched - Loss in value |

Damage 1: 2nd wheel set: 1 alloy rim - Scratched - Loss in value

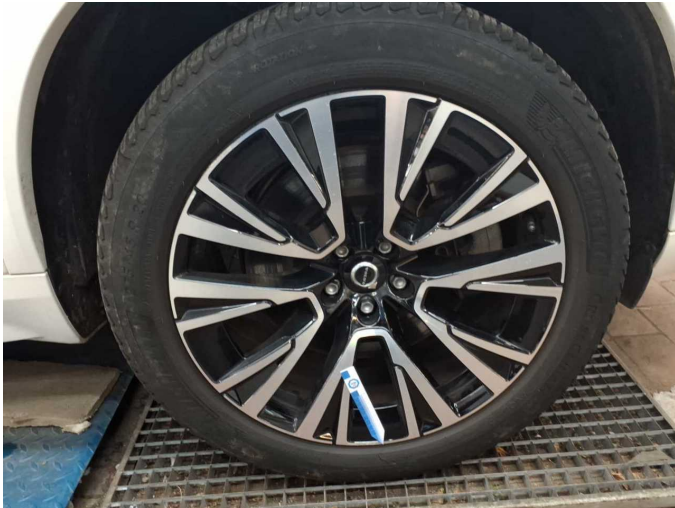
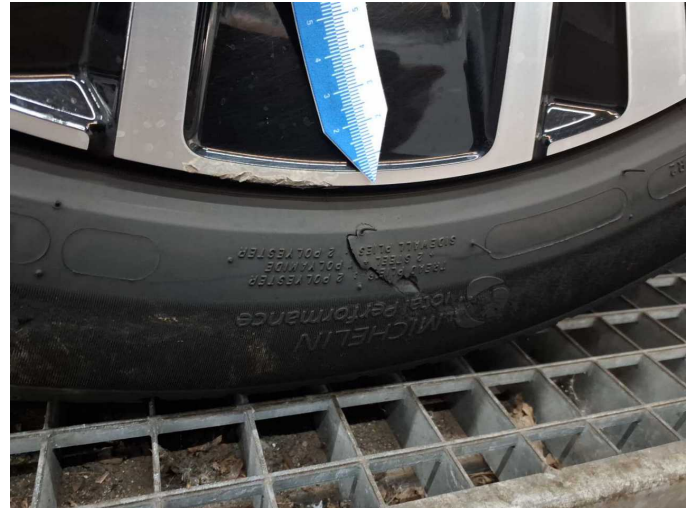
| No. | Component group | Description |
|---|---|---|
| 3 | Wheel / tyres | Tyre - front right side - Damaged - Replace |

**Damage 3:** Wheel / tyres: Tyre - front right side - Damaged - Replace

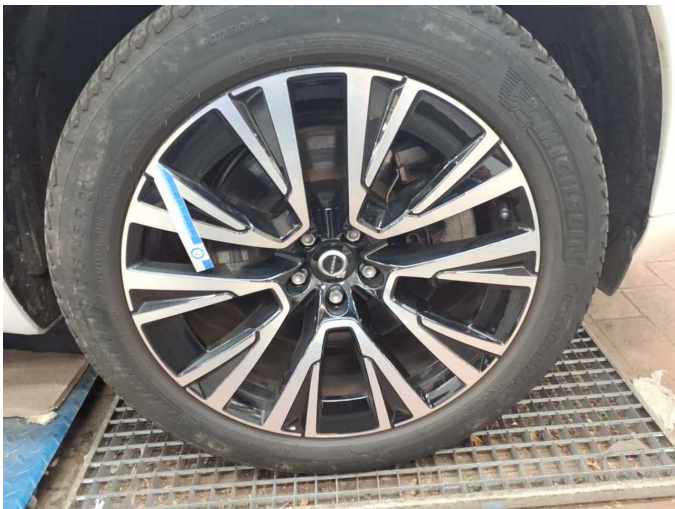
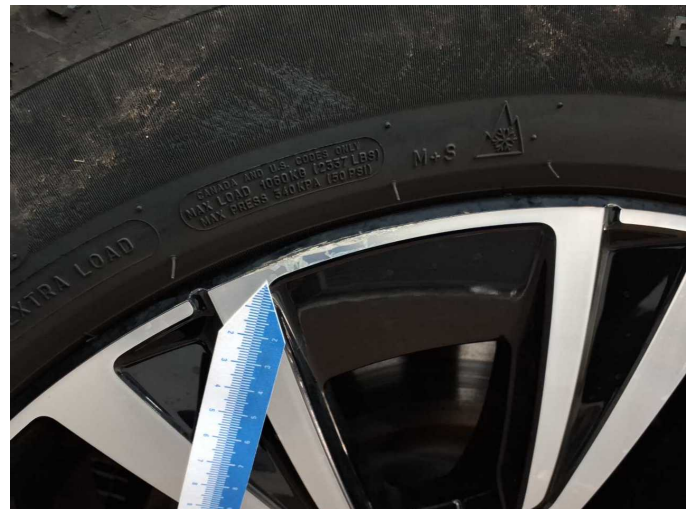
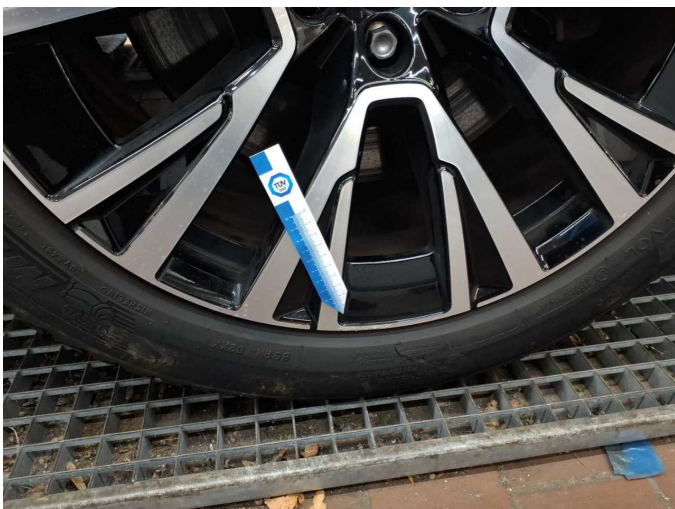
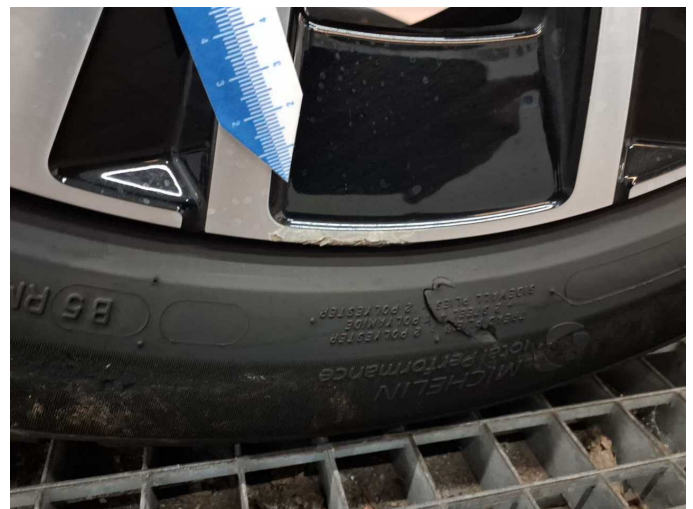
| No. | Component group | Description |
|---|---|---|
| 4 | Wheel / tyres | Alloy rim - front right side - Scratched - Loss in value |

**Damage 4:** Wheel / tyres: Alloy rim - front right side - Scratched - Loss in value
