Expertise

Protocol number: 46154749
Order No. / Reference: 26509749
Inspection date: 24 Jun 2026

Manufacturer: Mazda

Model: MX-30 e-SKYACTIV R-EV MAKOTO

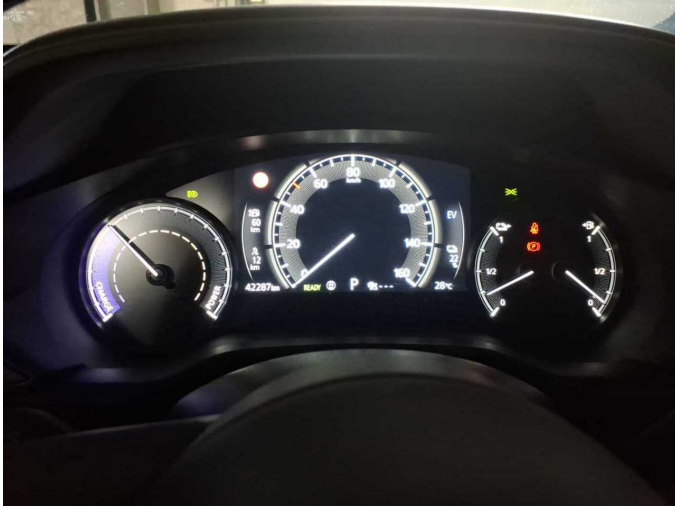
Figure 7: Instrument cluster

Vehicle Identification number	JMZDR6WJJ00217548
Mileage (Read)	42,287 km
First registration	22 Feb 2024
Number of holders	1
Next periodical technical inspection	02/2027 (Report not on hand)

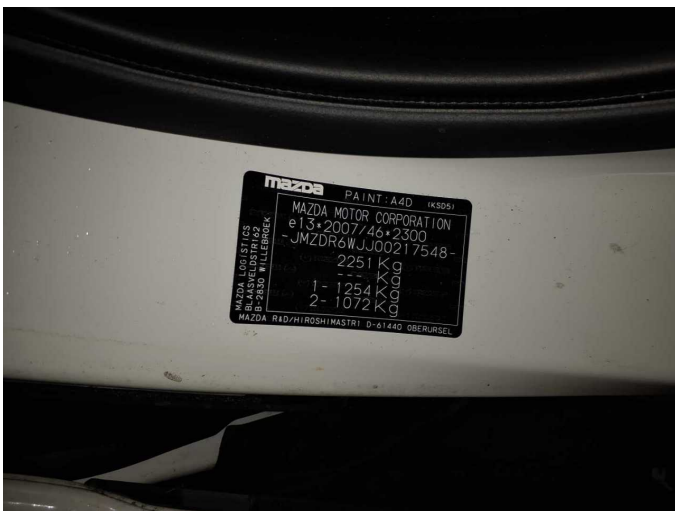
Figure 11: VIN

Documents submitted	At the time of the inspection, the vehicle registration certificate Part 2 (title) was available, but the vehicle registration certificate Part 1 (document) was not. (Copy)
VIN comparison	The vehicle identification number (VIN) was read from the vehicle and its conformity with the submitted documents was confirmed by the undersigned during the inspection.
Inspection	The inspection conditions were sufficient for the assessment of the vehicle. Lifting equipment and/or a pit were available for examining the vehicle.
Test drive	No test drive/shunting maneuver was carried out during the inspection of the vehicle.
Engine function test	An engine test run was performed.
readiness to drive	The vehicle was roadworthy at the time of inspection.

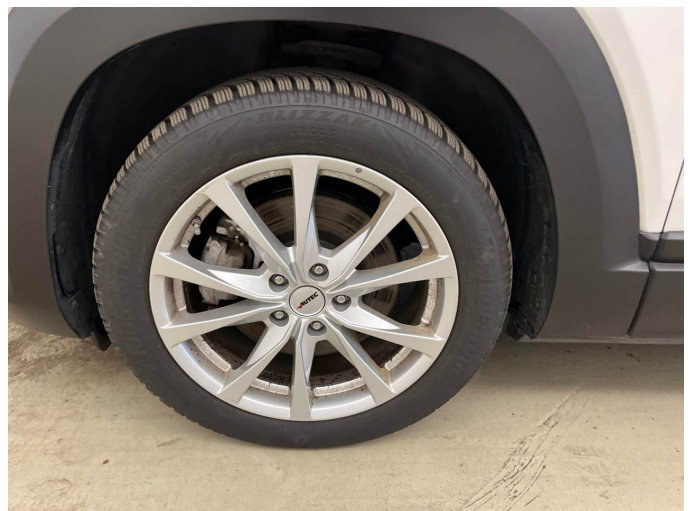
Figure 12: Mounted tyres

#	Tyre size	Type of tyre	Manufacturer	Tread depth
1)	215/55 R18 99V	Winter tyres on Light alloy	Bridgestone	7mm / 7mm
2)	215/55 R18 99V	Winter tyres on Light alloy	Bridgestone	7mm / 7mm

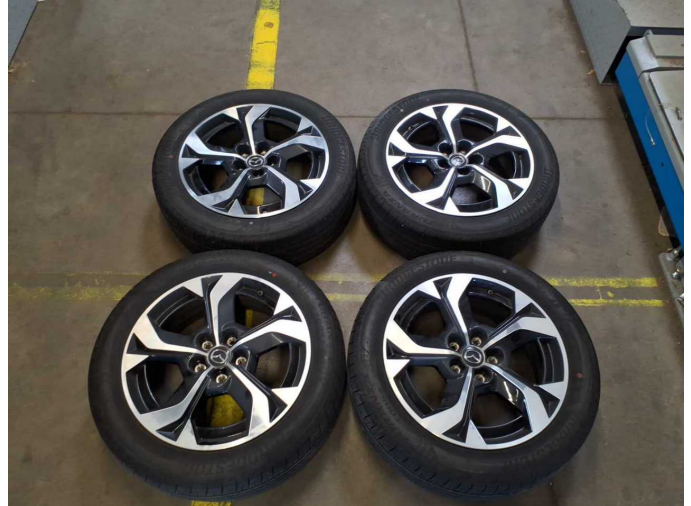
Figure 14: Additional tyres

#	Tyre size	Type of tyre	Manufacturer	Tread depth
1)	215/55 R18 95H	Summer tyres on Light alloy	Bridgestone	5mm / 5mm
2)	215/55 R18 95H	Summer tyres on Light alloy	Bridgestone	6mm / 6mm

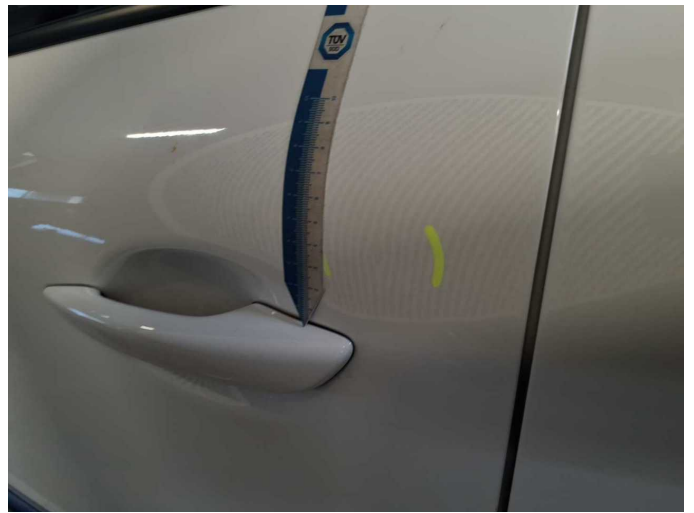
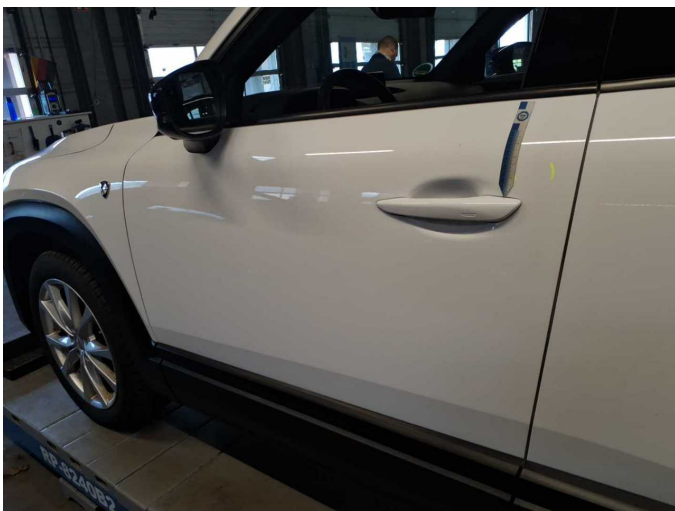
Damage 2: Door - front left side: Door - dent(s) - Smooth repair work

No.	Component group	Description
1	Misc.	Inspection / maintenance (Historie) - No evidence - No deduction
2	Door - front left side	Door - dent(s) - Smooth repair work
3	Door - front right side	Door - Scratch(es) - Smart repair
4	Trim / covers	Boot lid - interior trim - Scratch(es) - Replace
5	Vehicle glazing	Windscreen - Stone chips - Replace

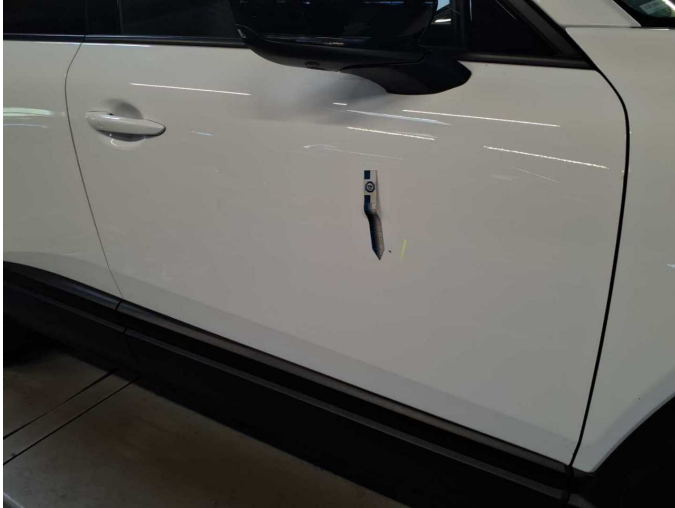
Damage 3: Door - front right side: Door - Scratch(es) - Smart repair

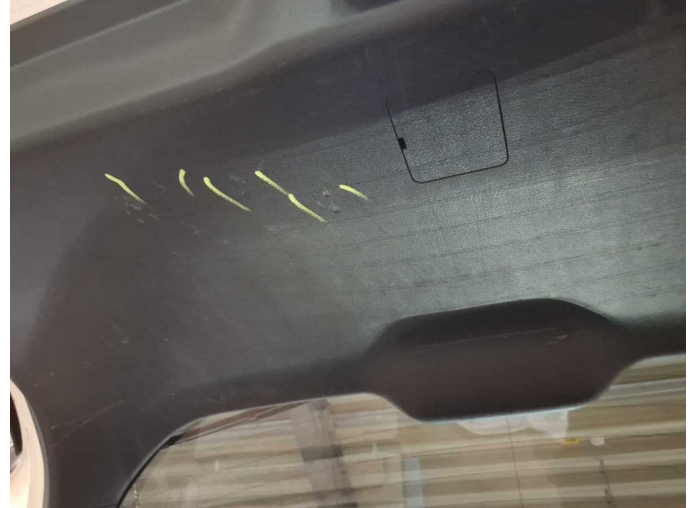
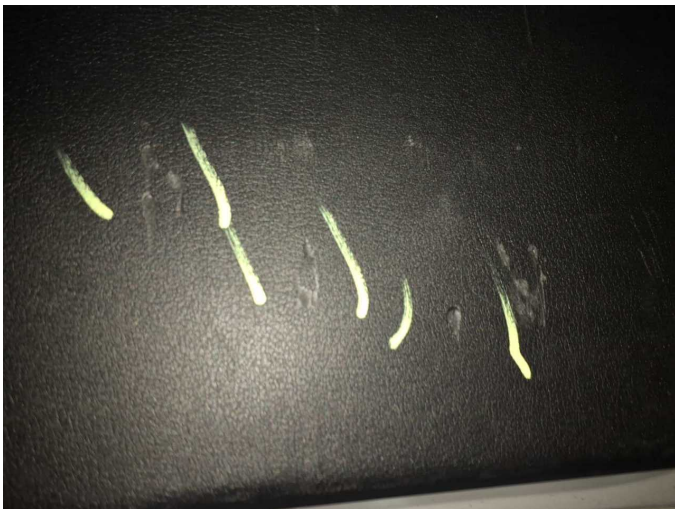
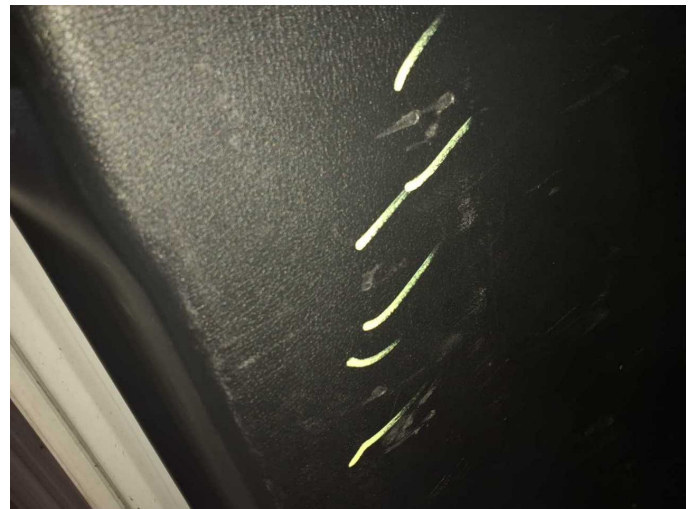
Damage 4: Trim / covers: Boot lid - interior trim - Scratch(es) - Replace

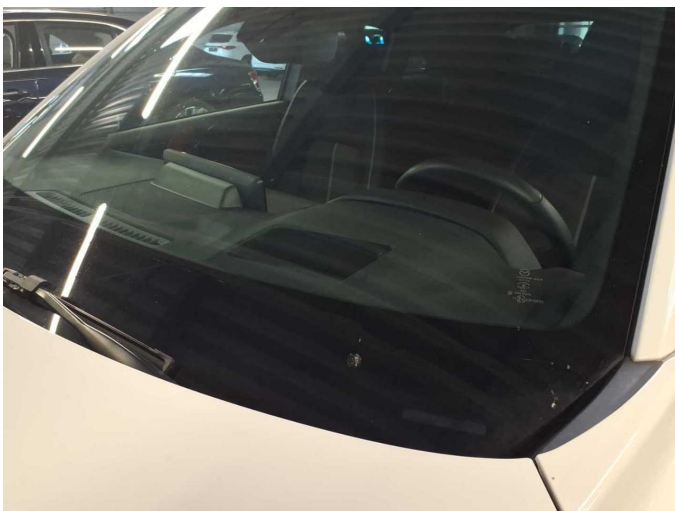
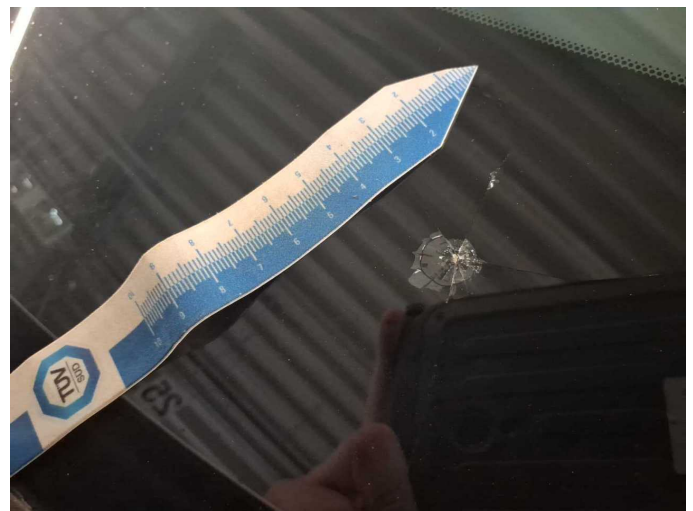
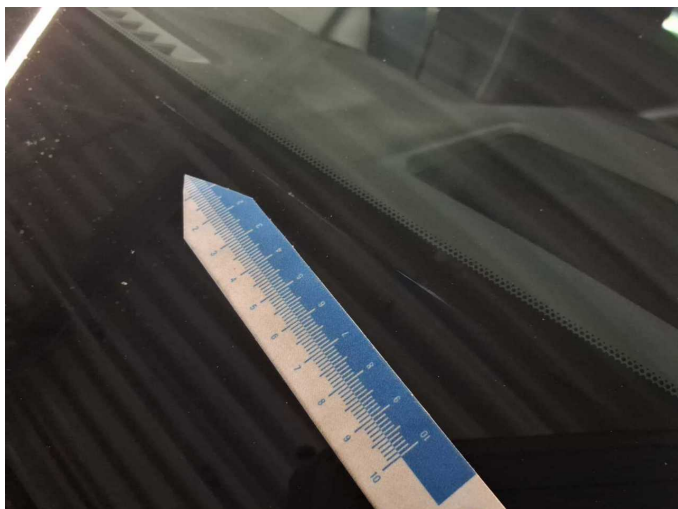
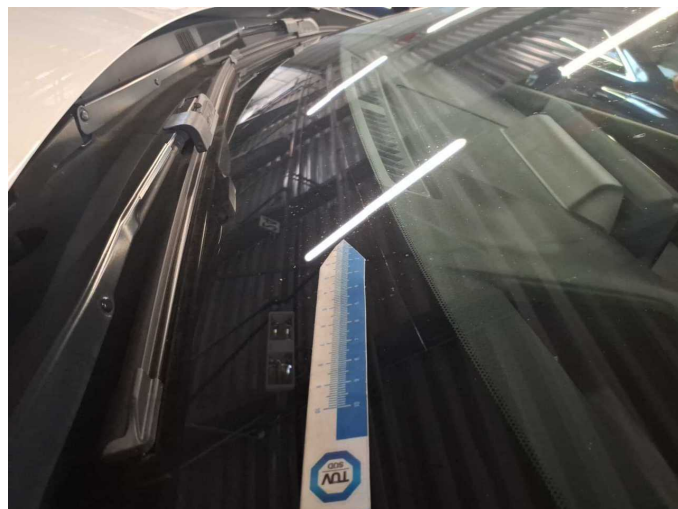
Damage 5: Vehicle glazing: Windscreen - Stone chips - Replace
