Expertise

Protocol number: 47197531  
Order No. / Reference: 26702274  
Inspection date: 21 Aug 2026

Manufacturer: Volkswagen

Model: Touran 2.0 TDI SCR DSG Comfortline

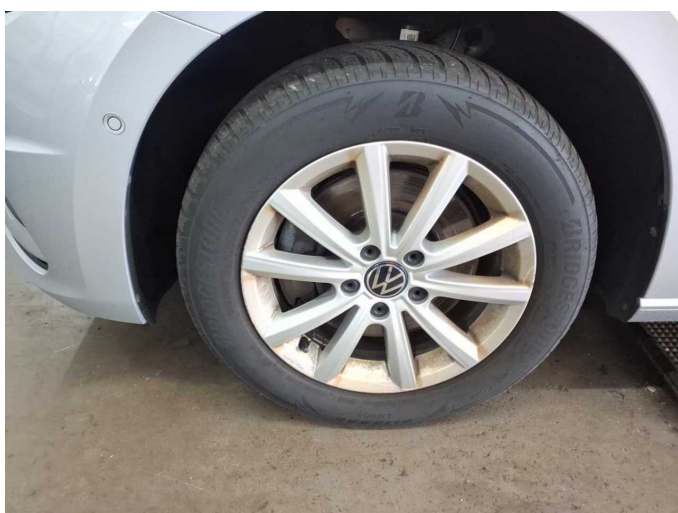
Figure 11: Mounted tyres

| # | Tyre size | Type of tyre | Manufacturer | Tread depth |
|---|---|---|---|---|
| 1) | 205/60 R16 96H | Winter tyres on Light alloy | Bridgestone | 5mm / 5mm |
| 2) | 205/60 R16 96H | Winter tyres on Light alloy | Bridgestone | 5mm / 5mm |

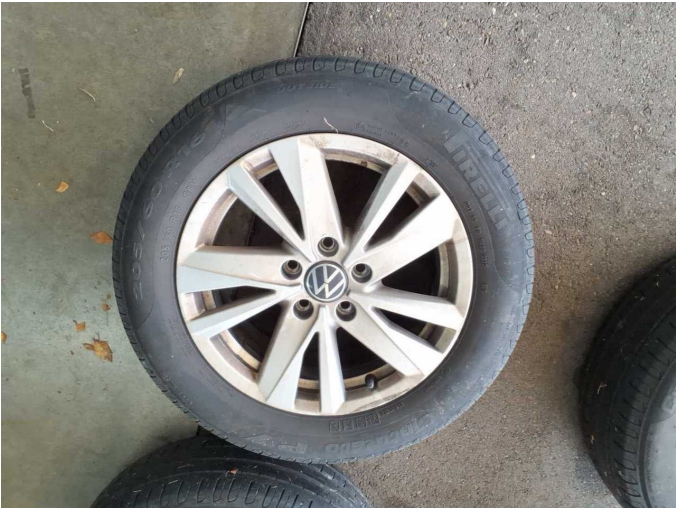
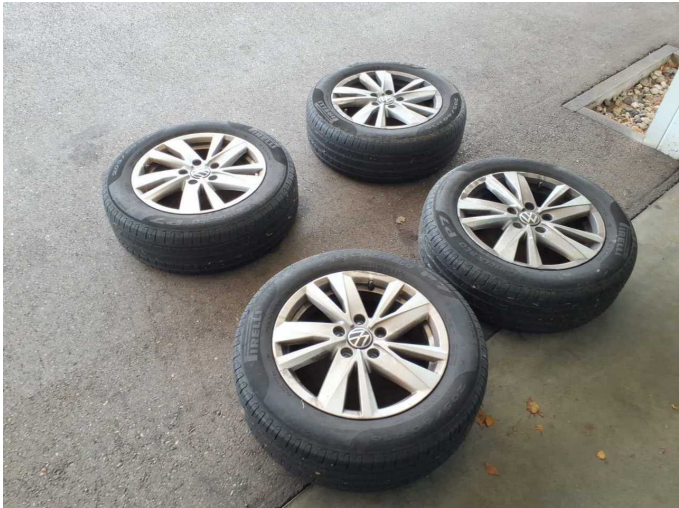
Figure 15: Additional tyres

| # | Tyre size | Type of tyre | Manufacturer | Tread depth |
|---|---|---|---|---|
| 1) | 205/60 R16 96V | Summer tyres on Light alloy | Pirelli | 3mm / 3mm |
| 2) | 205/60 R16 96V | Summer tyres on Light alloy | Pirelli | 3mm / 3mm |

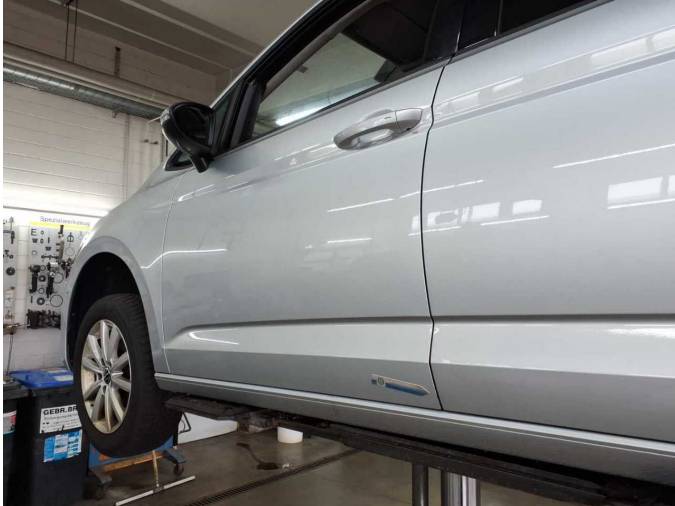
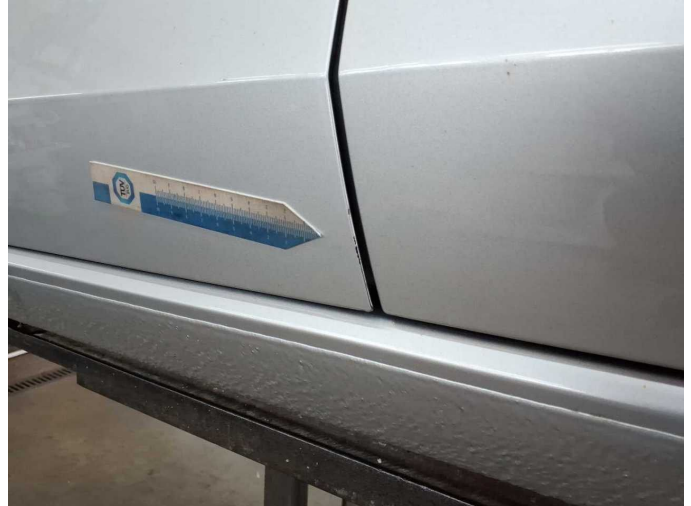
| No. | Component group | Description |
|---|---|---|
| 1 | Door - front left side | Door edge - Scratch(es) - Smart repair |

**Damage 1:** Door - front left side: Door edge - Scratch(es) - Smart repair

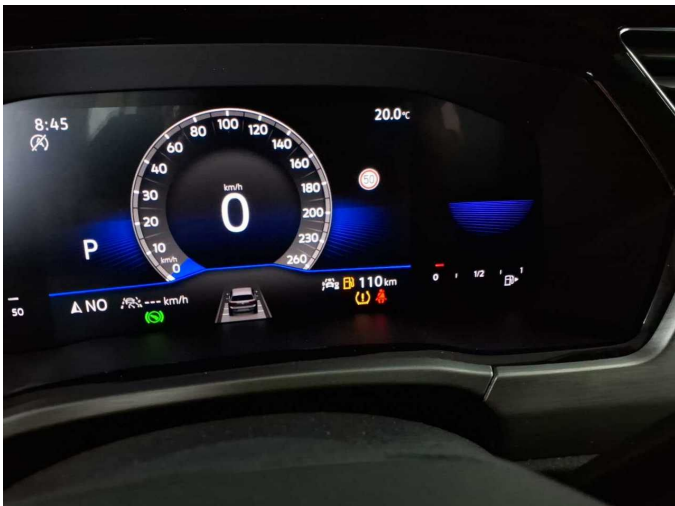
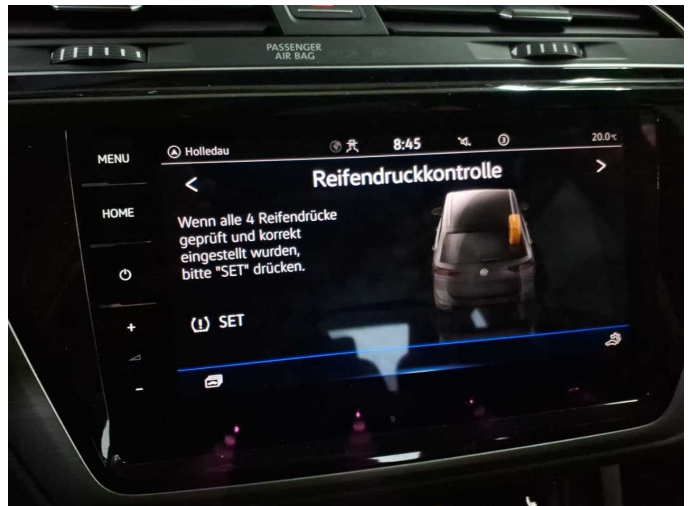
| No. | Component group | Description |
|---|---|---|
| 2 | Instrument panel | Indicator light (Reifendruck) - on - Perform diagnosis |

**Damage 2:** Instrument panel: Indicator light (Reifendruck) - on - Perform diagnosis

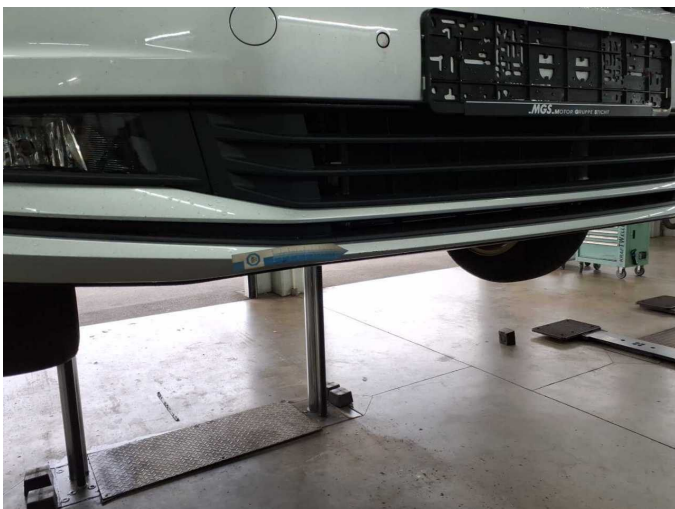
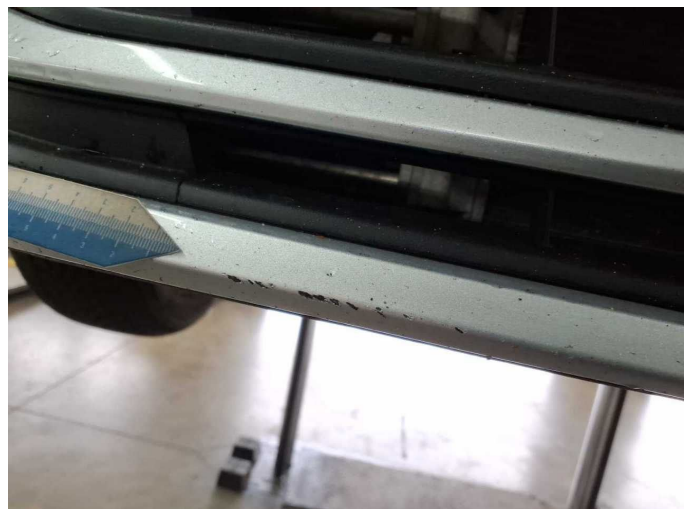
| No. | Component group | Description |
|---|---|---|
| 3 | Front bumper | Front bumper - Scratch(es) - Smart repair |

**Damage 3:** Front bumper: Front bumper - Scratch(es) - Smart repair

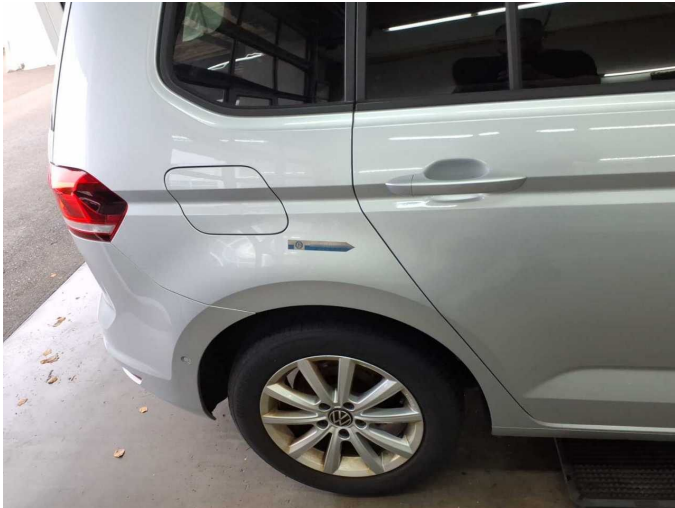
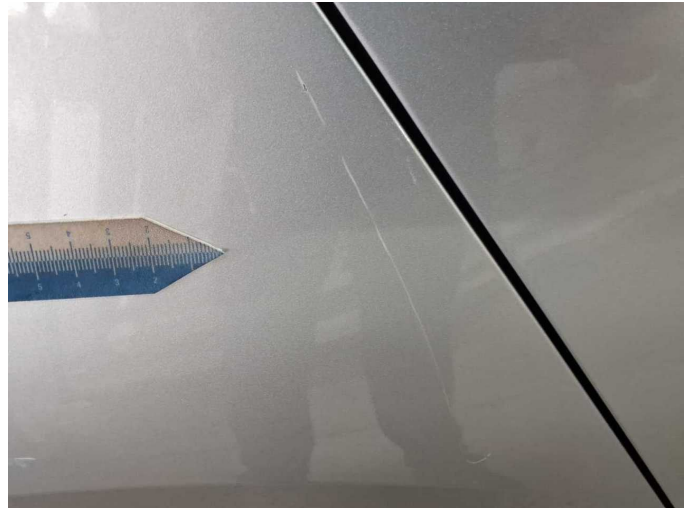
| No. | Component group | Description |
|---|---|---|
| 4 | Side panel - rear right side | Side panel - Scratch(es) - Paint |

**Damage 4:** Side panel - rear right side: Side panel - Scratch(es) - Paint

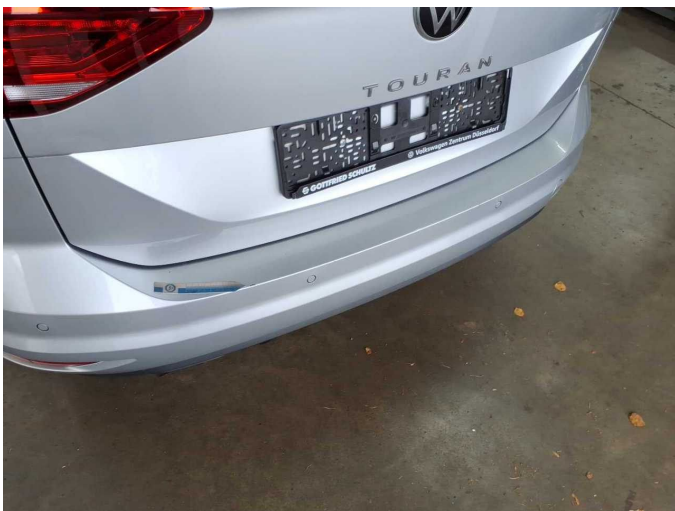
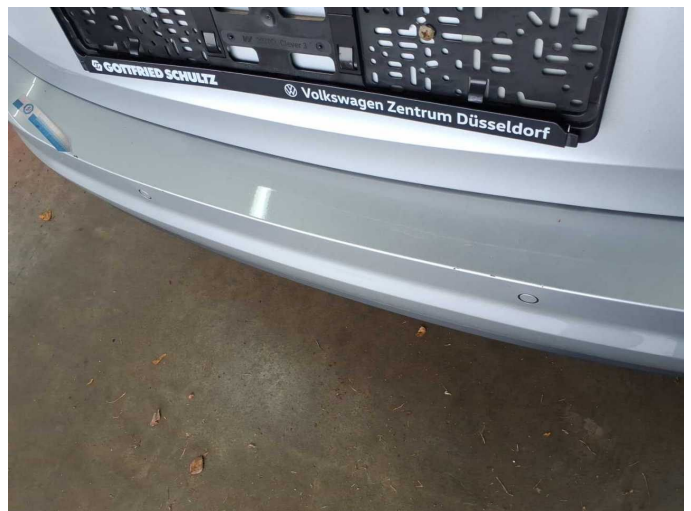
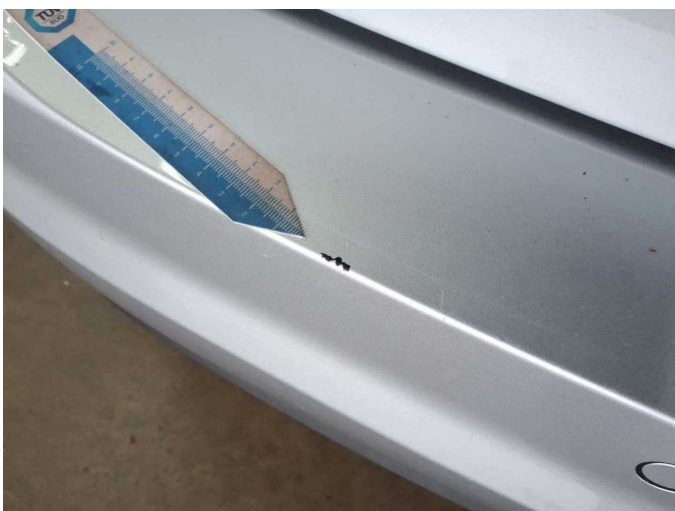
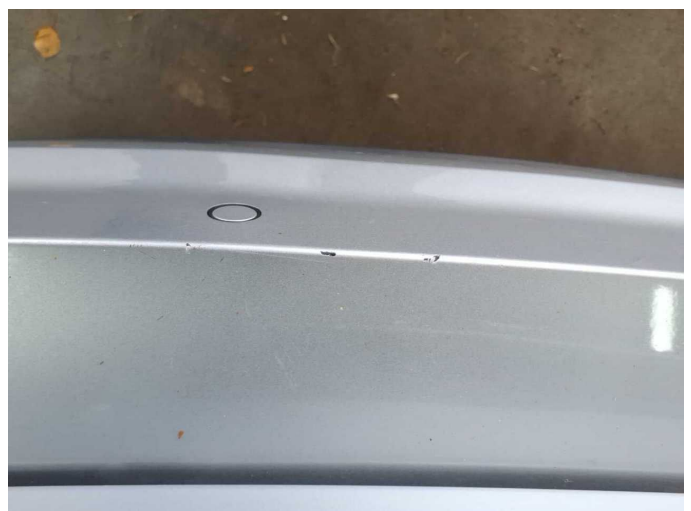
| No. | Component group | Description |
|---|---|---|
| 5 | Rear bumper | Rear bumper - Scratch(es) - Paint |

**Damage 5:** Rear bumper: Rear bumper - Scratch(es) - Paint

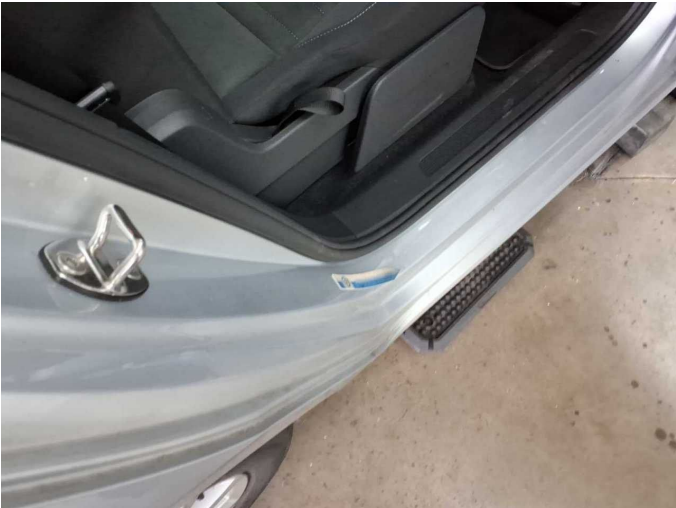
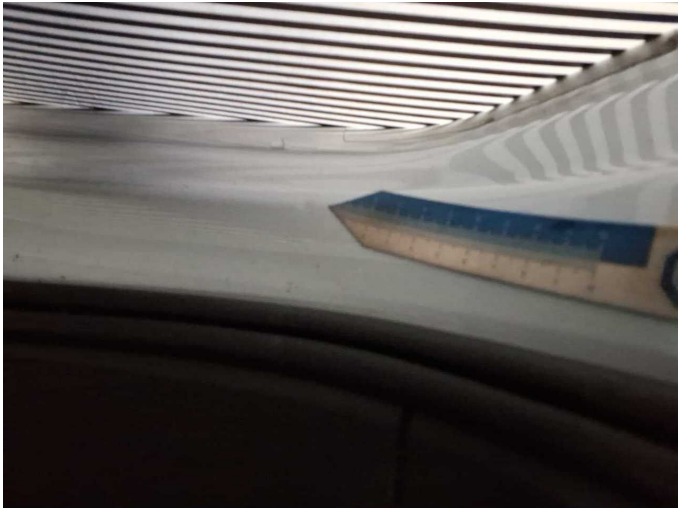
| No. | Component group | Description |
|---|---|---|
| 4 | Side panel - rear right side | Sill - dent(s) - No deduction |

Wear and tear 4: Side panel - rear right side: Sill - dent(s) - No deduction

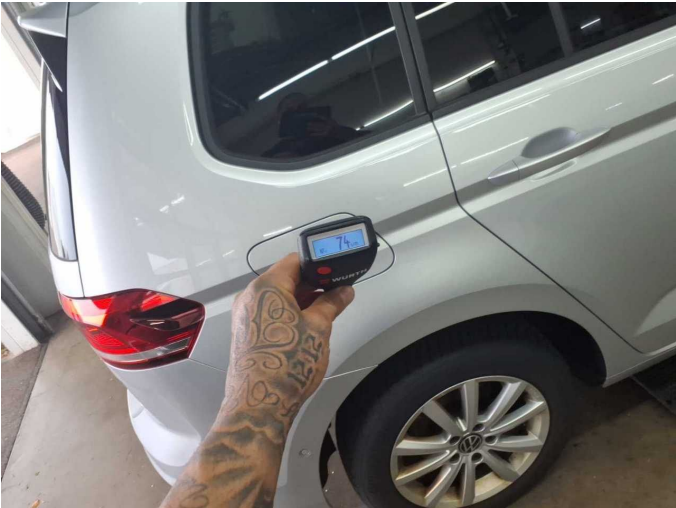
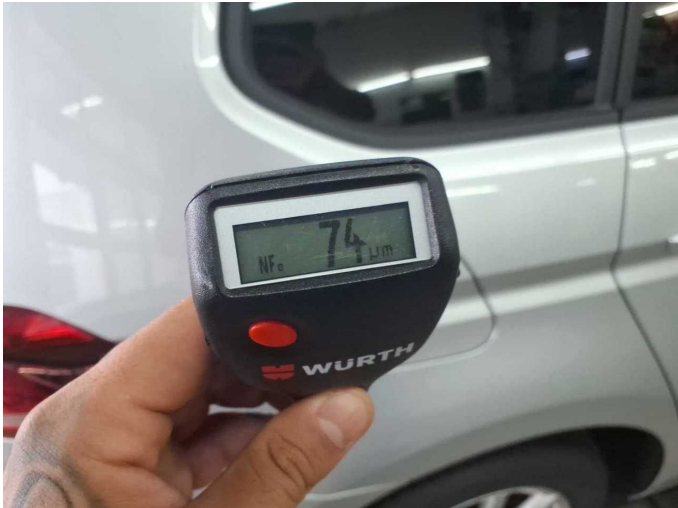
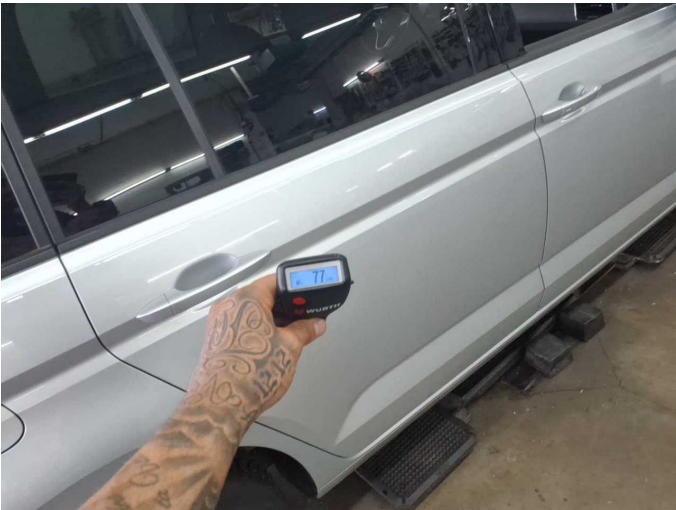
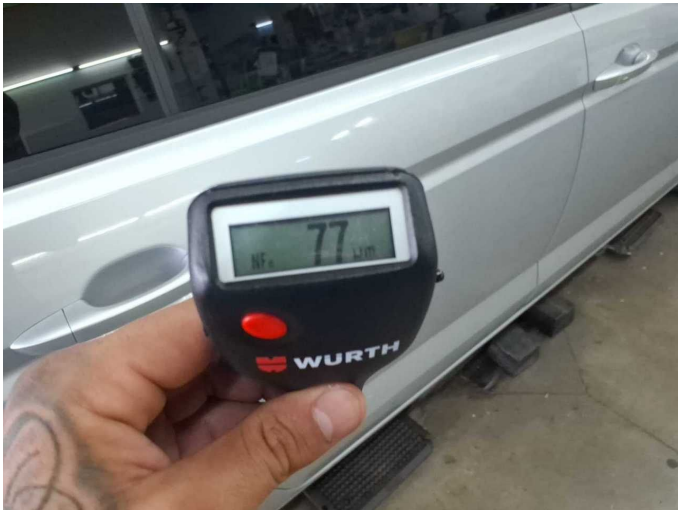
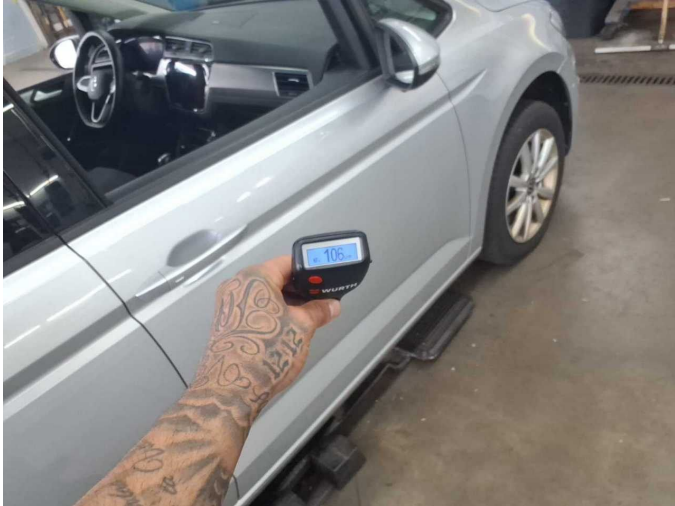
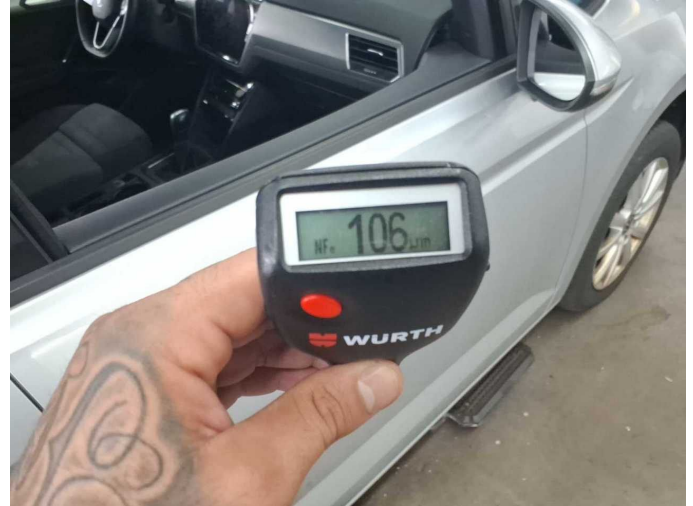
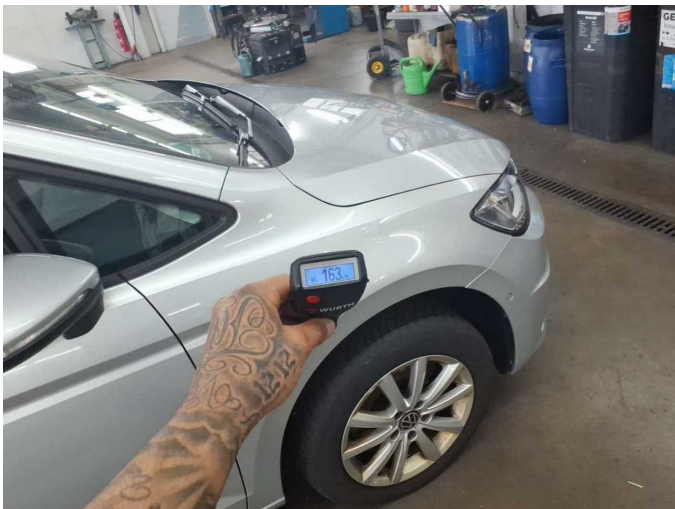
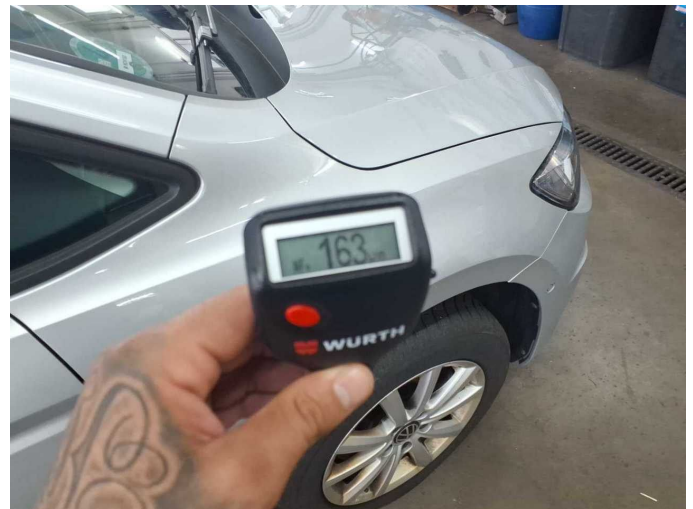
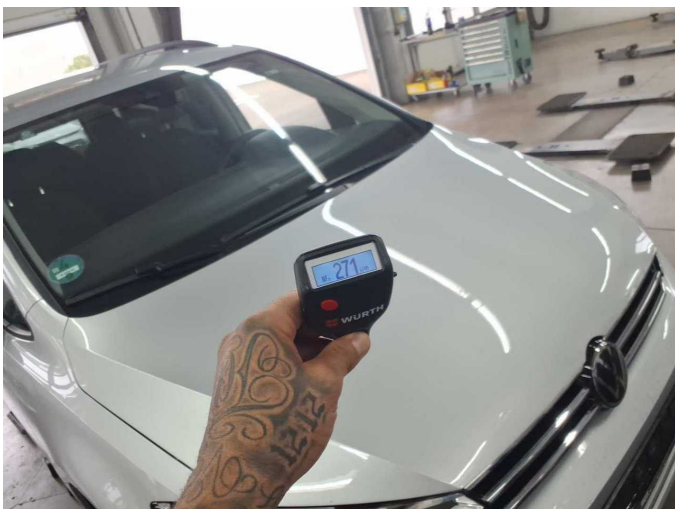
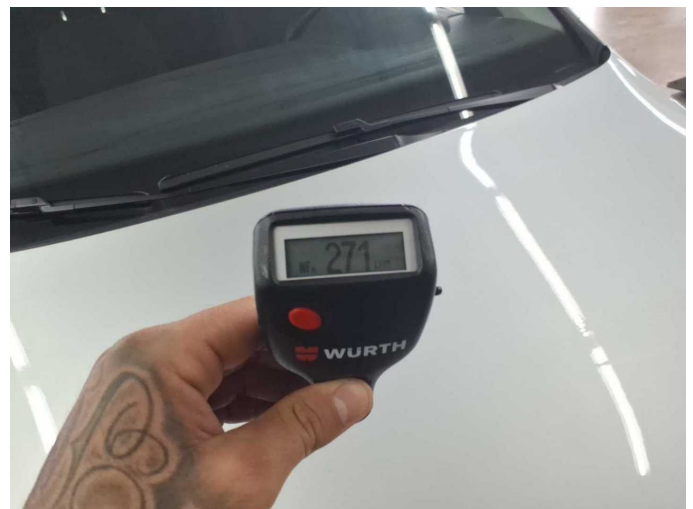
| No. | Previous damage | Extent of damage (Net) |
|---|---|---|
| 1 | Front, Side right, Provided by user / customer, from 26 Apr 2024 | 6.080,94 € |

According to available information previous damages were repaired at the vehicle. Traces of repairs, which allow conclusions about the area of repair, were not recognizable during the inspection.

Previous damage 1: Front, Side right

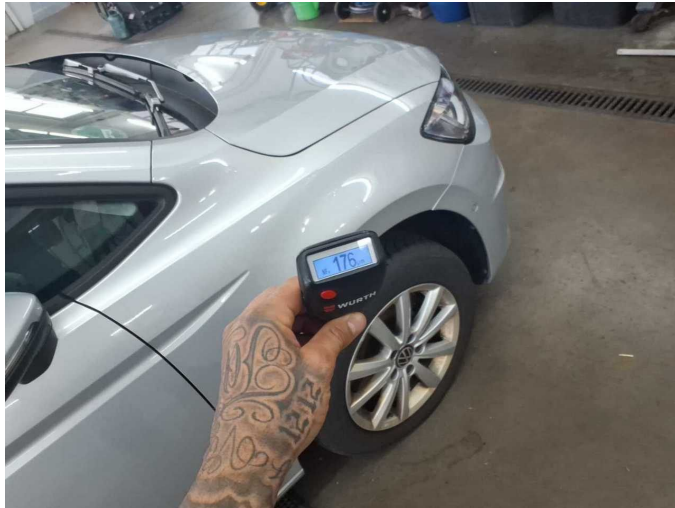
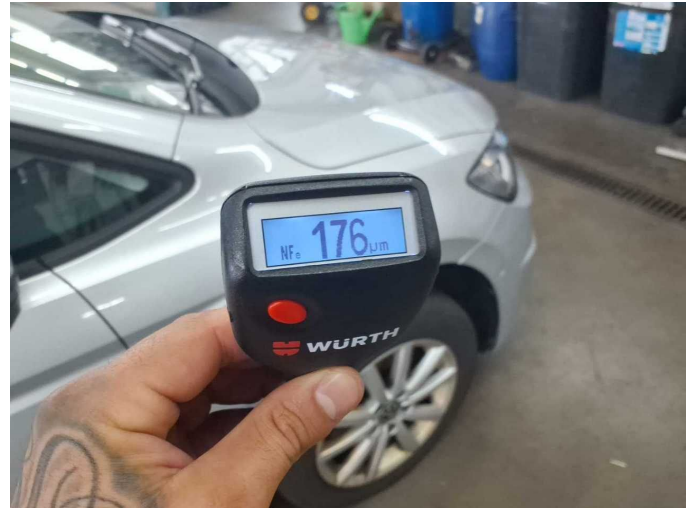
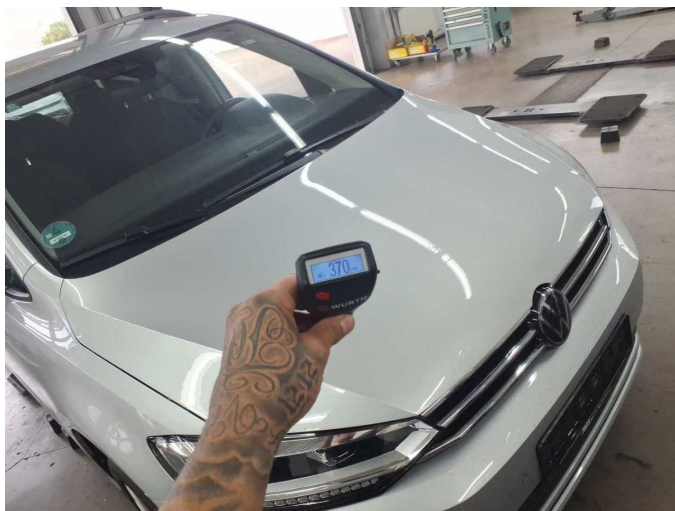
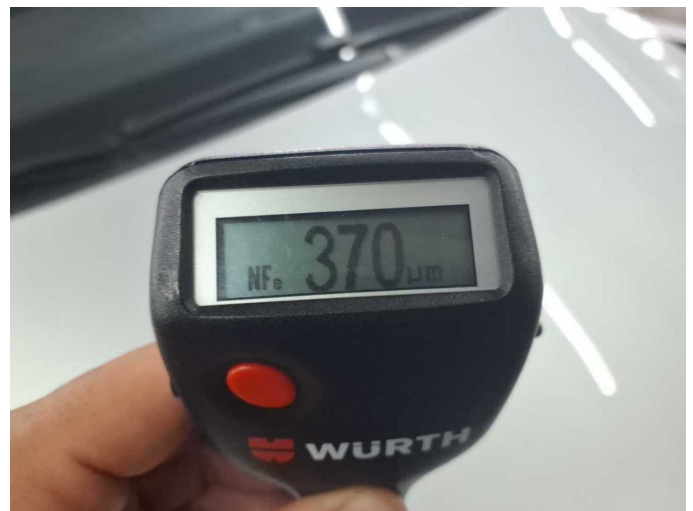
| No. | Repainting |
|---|---|
| 1 | Mudguard - right side, Bonnet, Professionally carried out |

Repainting 1: Mudguard - right side, Bonnet
