Expertise

Protocol number: 46572204  
Order No. / Reference: 26694915  
Inspection date: 16 Jul 2026

Manufacturer: Seat

Model: Leon Sportstourer 2.0 TDI DSG FR

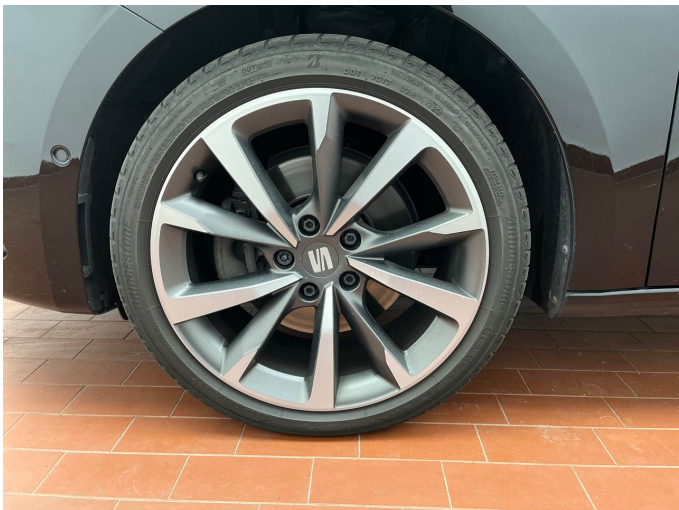
Figure 12: Mounted tyres

| Tyres | | | | |
|---|---|---|---|---|
| 1) | 225/40 R18 92Y | Summer tyres on Light alloy | Bridgestone | 5mm / 5mm |
| 2) | 225/40 R18 92Y | Summer tyres on Light alloy | Goodyear | 6mm / 6mm |

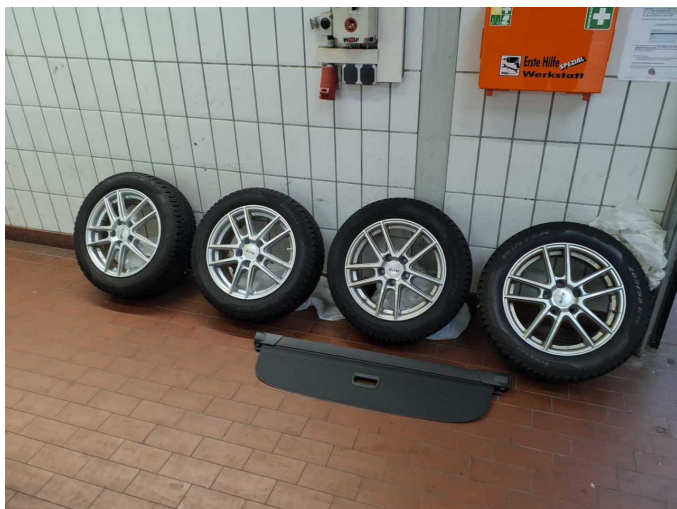
Figure 17: Additional tyres

| Tyres | | | | |
|---|---|---|---|---|
| 1) | 205/55 R16 91H | Winter tyres on Light alloy | Pirelli | 3mm / 3mm |
| 2) | 205/55 R16 91H | Winter tyres on Light alloy | Pirelli | 7mm / 7mm |

| No. | Component group | Description |
|---|---|---|
| 1 | 2nd wheel set | 2 tyres (Profiltiefe 3mm) - Does not meet the leasing specifications - No deduction |

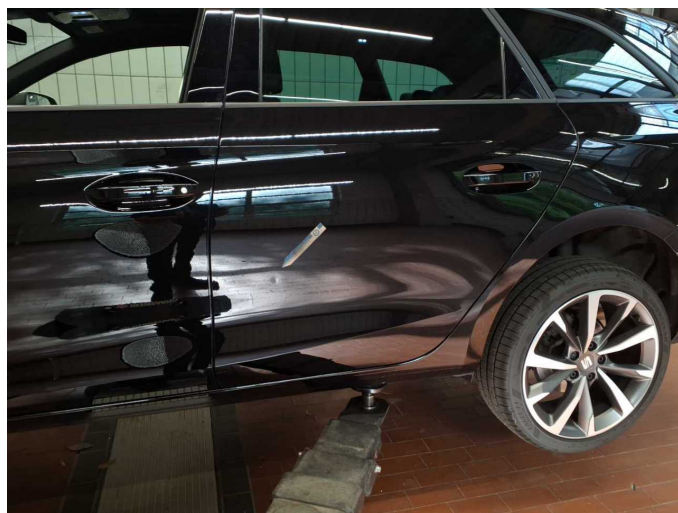
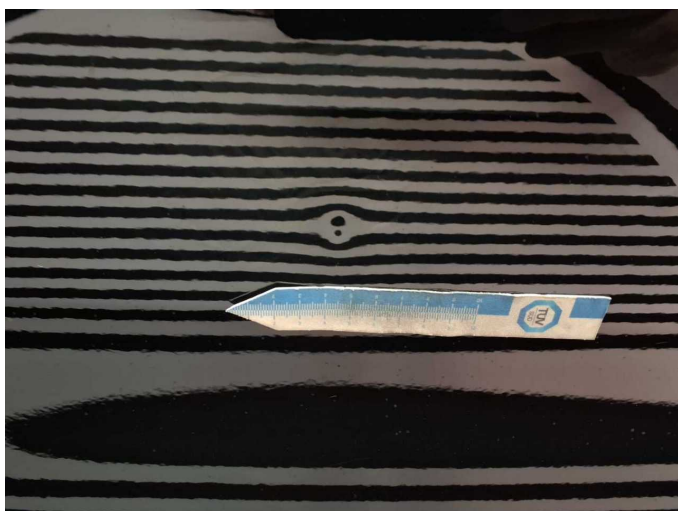
Damage 1: Door - rear left side: Door - dent(s) - Smooth repair work

| No. | Component group | Description |
|---|---|---|
| 1 | Door - rear left side | Door - dent(s) - Smooth repair work |

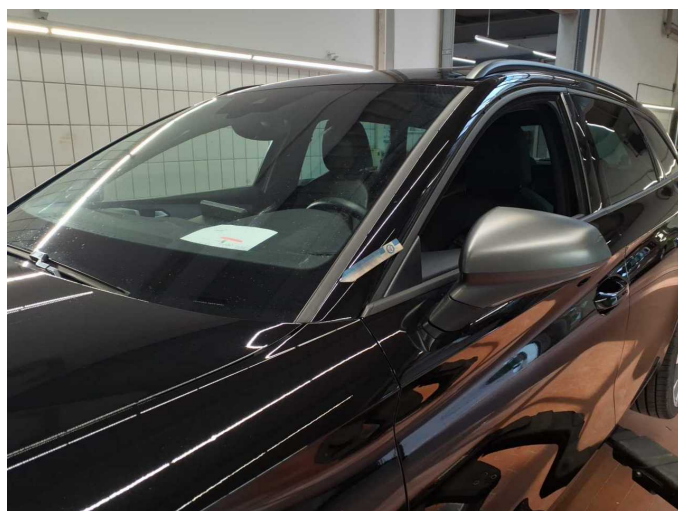
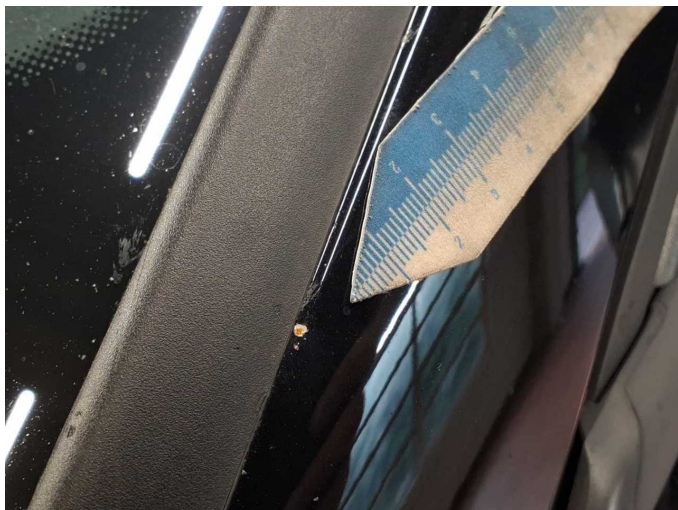
Damage 2: Roof: Roof rail - left side (leichte Korrosion) - Stone chips - Smart repair

**Damage 2:** Roof: Roof rail - left side (leichte Korrosion) - Stone chips - Smart repair

| No. | Component group | Description |
|---|---|---|
| 2 | Roof | Roof rail - left side (leichte Korrosion) - Stone chips - Smart repair |

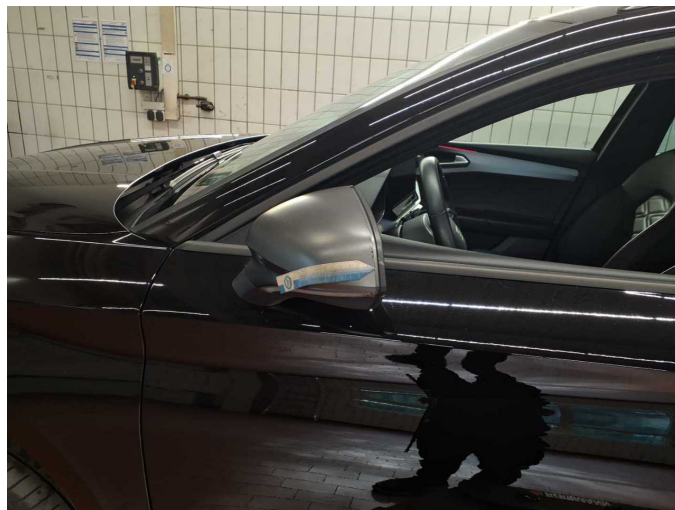
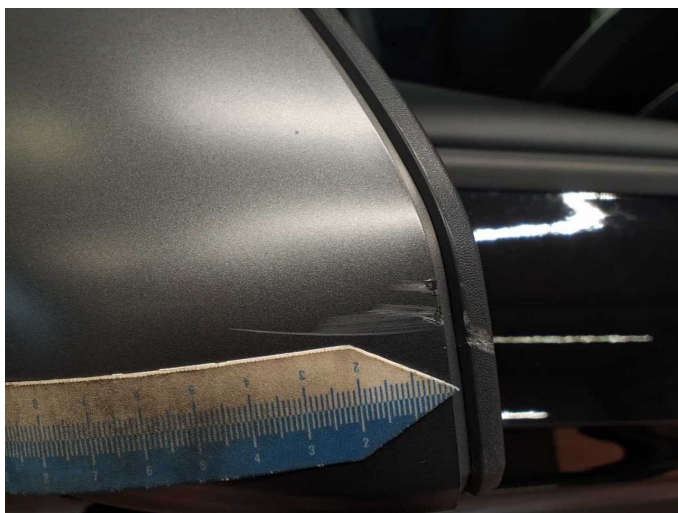
**Damage 3:** Wing mirror - left side: Cap - Scratch(es) - Smart repair

| No. | Component group | Description |
|---|---|---|
| 3 | Wing mirror - left side | Cap - Scratch(es) - Smart repair |

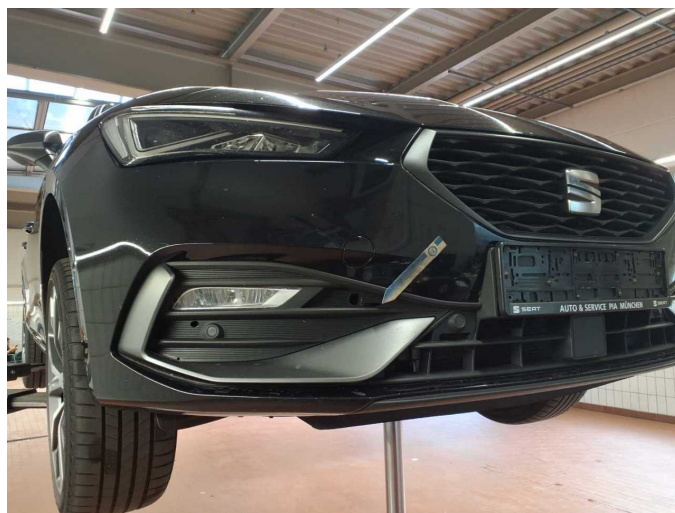
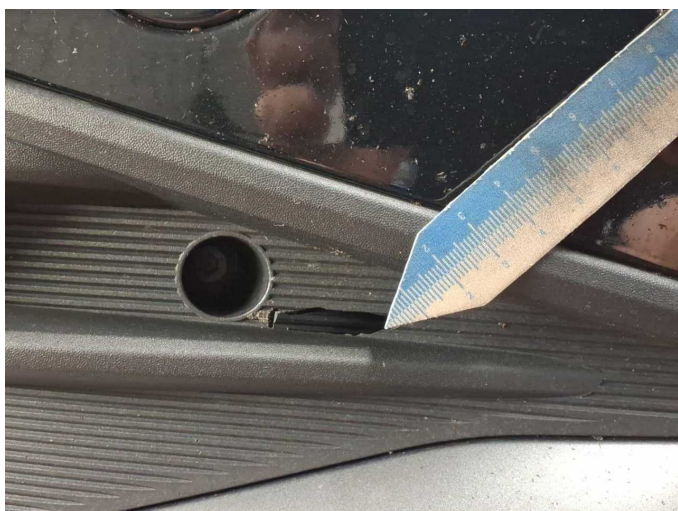
**Damage 4:** Front bumper: Cover bumper - front (Rechts) - Broken / torn - Replace

| No. | Component group | Description |
|---|---|---|
| 4 | Front bumper | Cover bumper - front (Rechts) - Broken / torn - Replace |

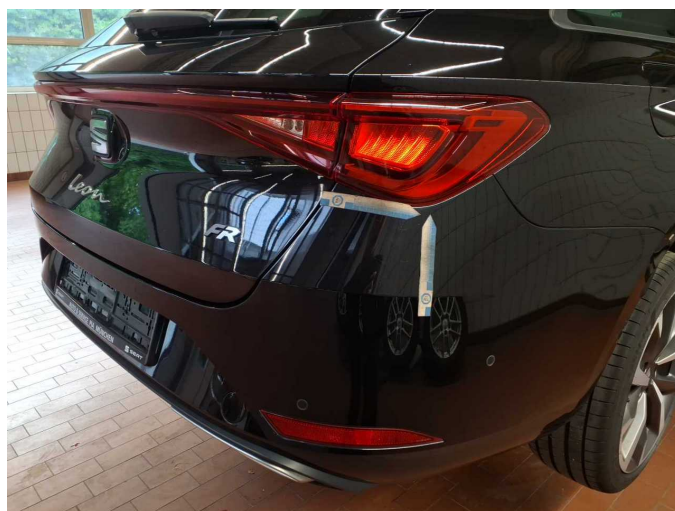
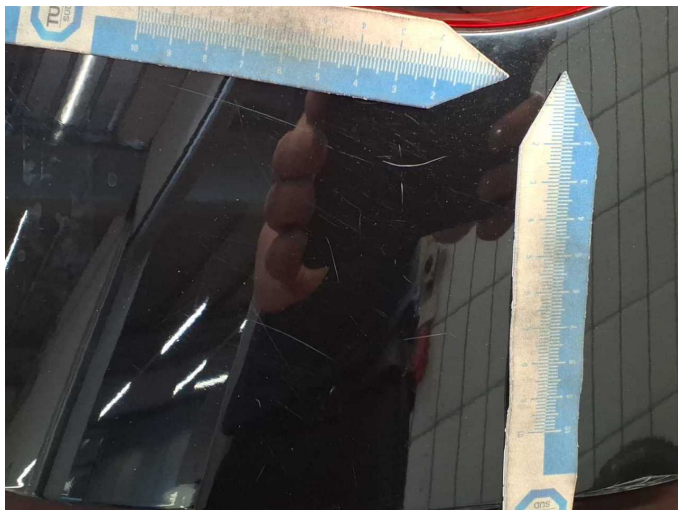
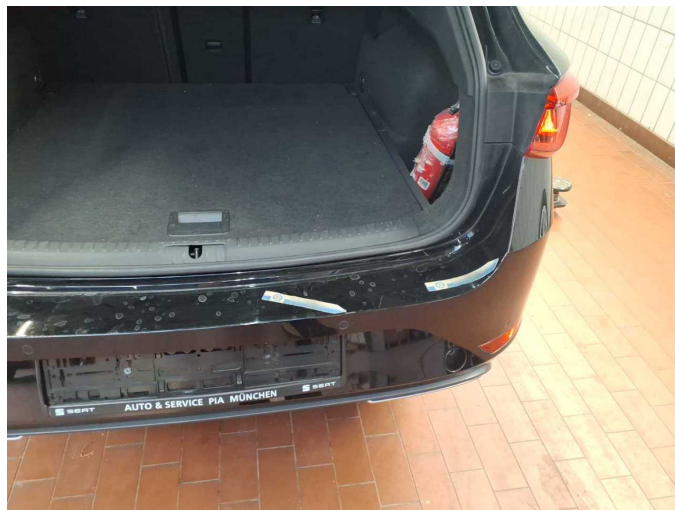
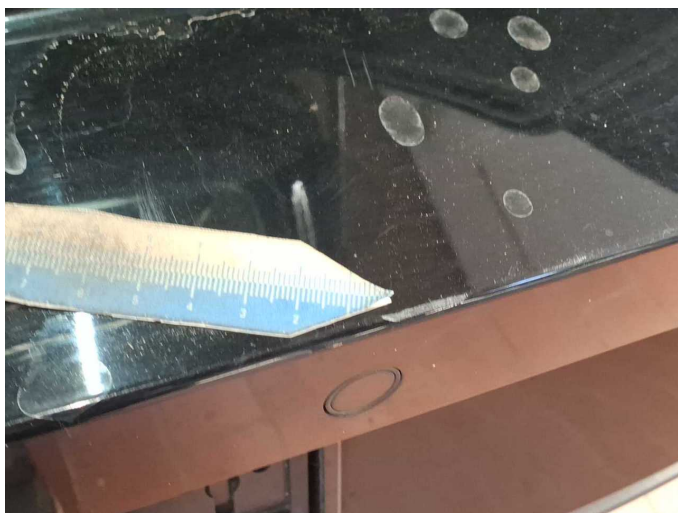
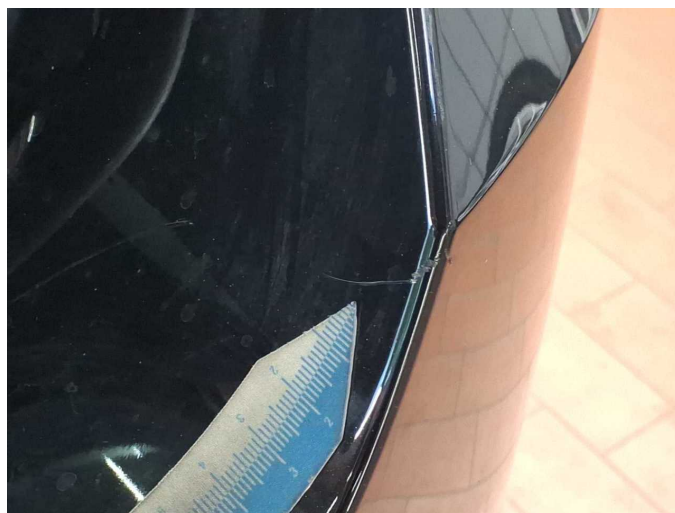
**Damage 5:** Rear bumper: Rear bumper - Scratch(es) - Paint

| No. | Component group | Description |
|---|---|---|
| 5 | Rear bumper | Rear bumper - Scratch(es) - Paint |

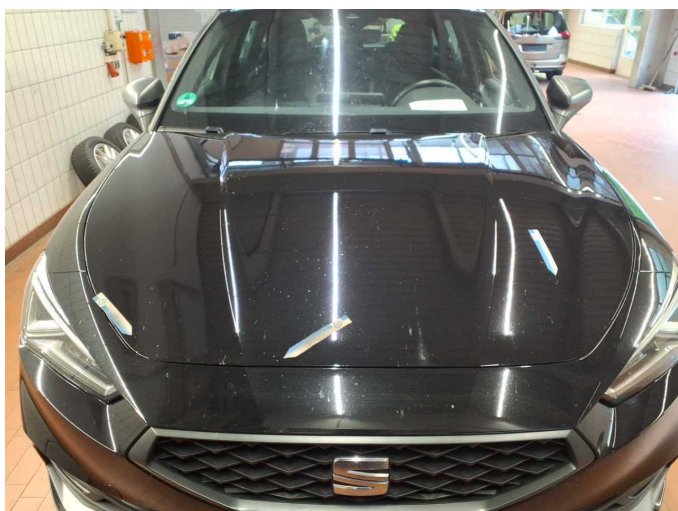
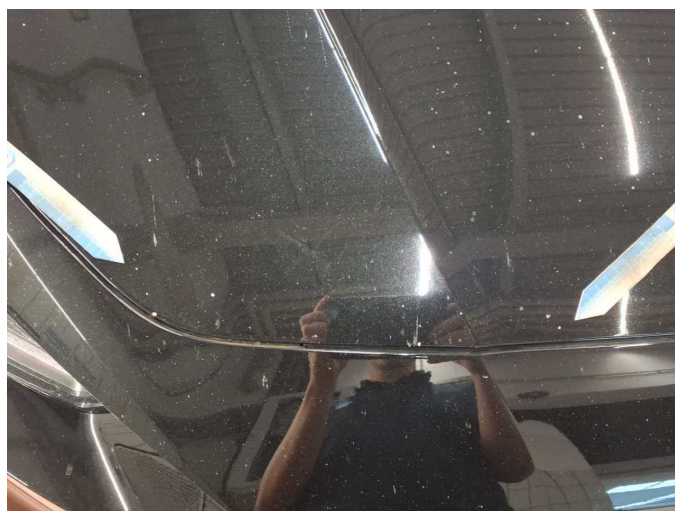
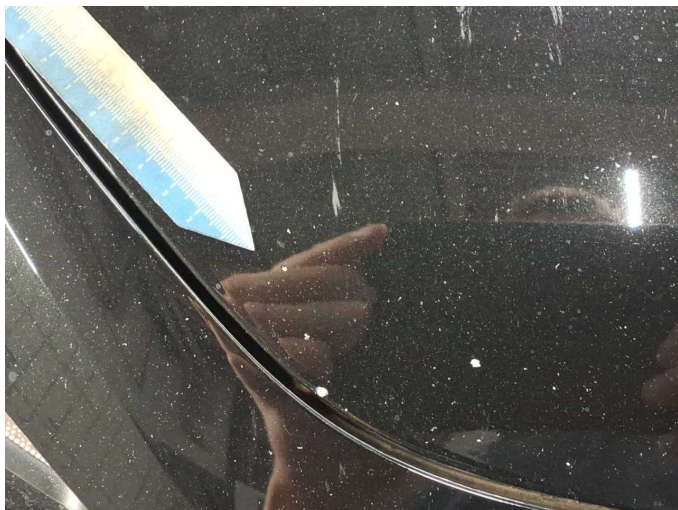
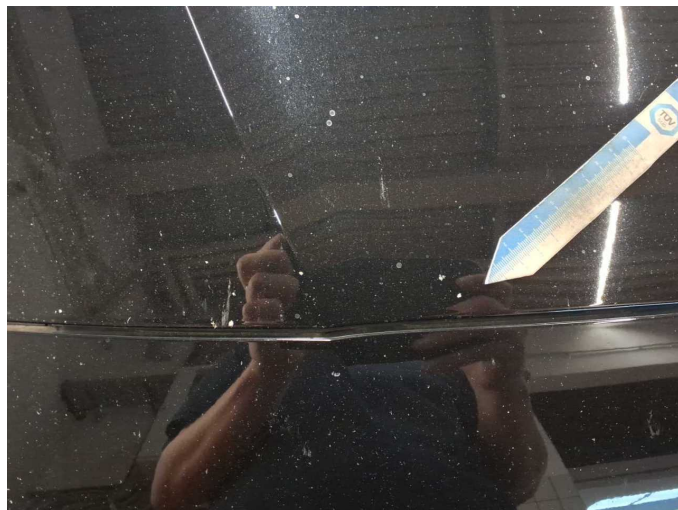
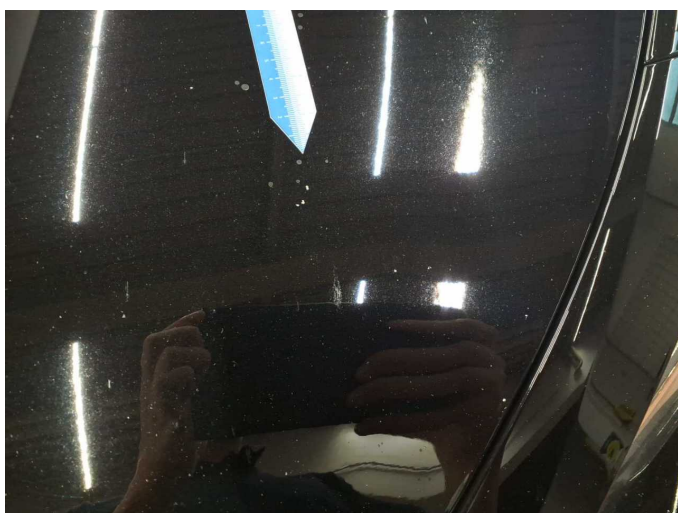
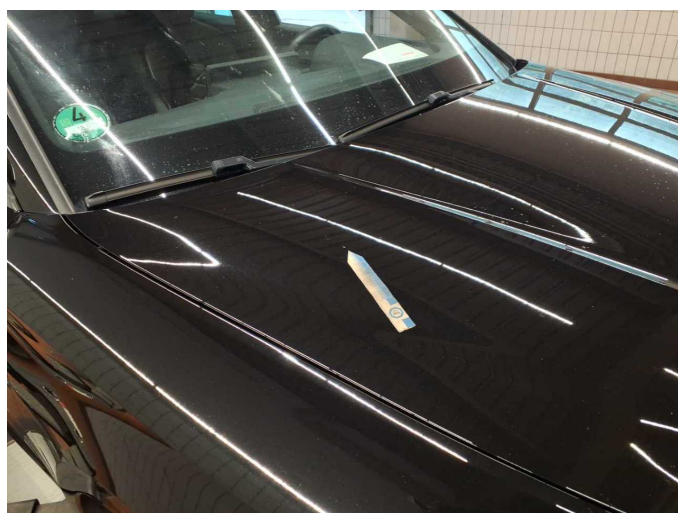
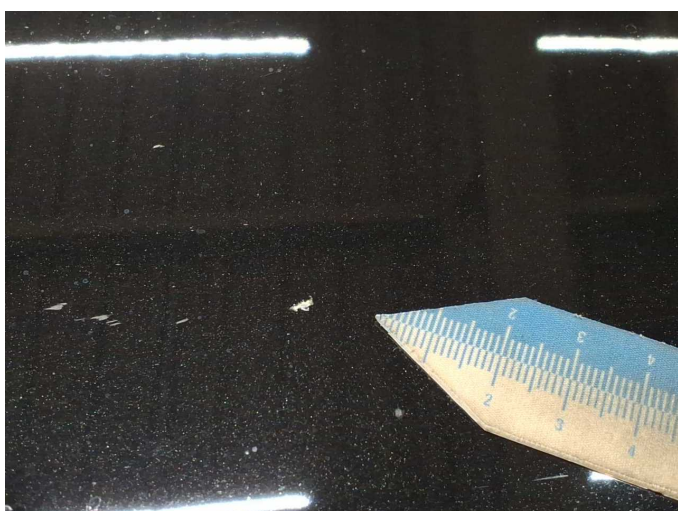
**Damage 6:** Bonnet: Bonnet - Stone chips - Paint

| No. | Component group | Description |
|---|---|---|
| 6 | Bonnet | Bonnet - Stone chips - Paint |

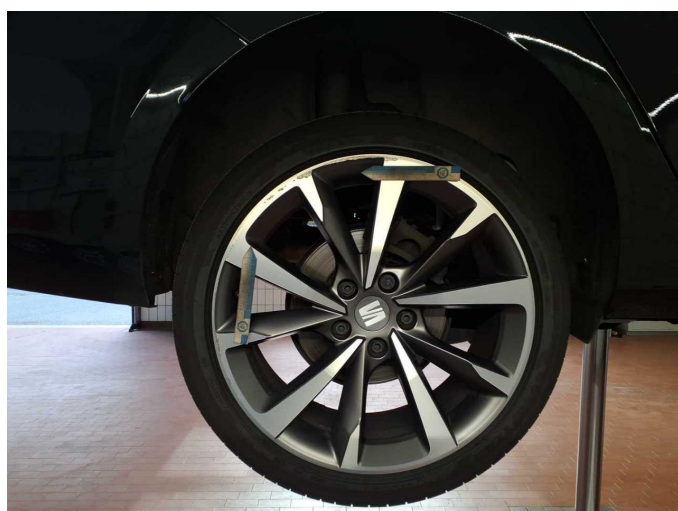
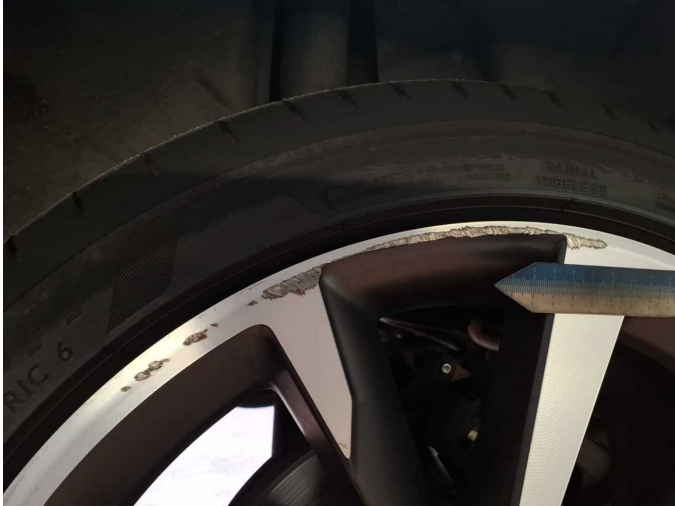
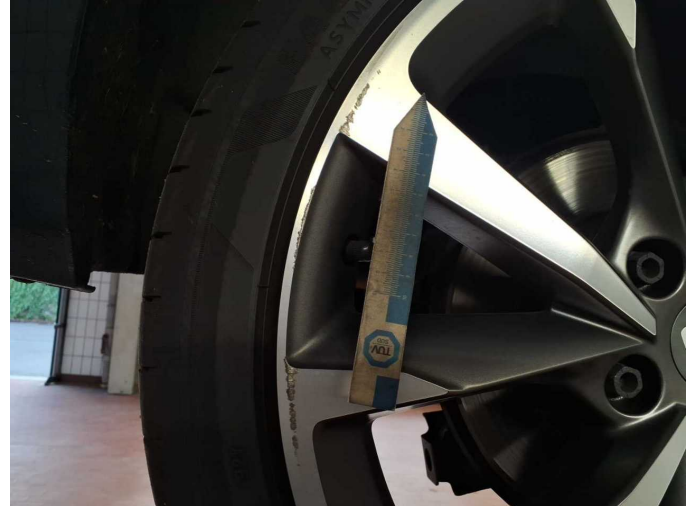
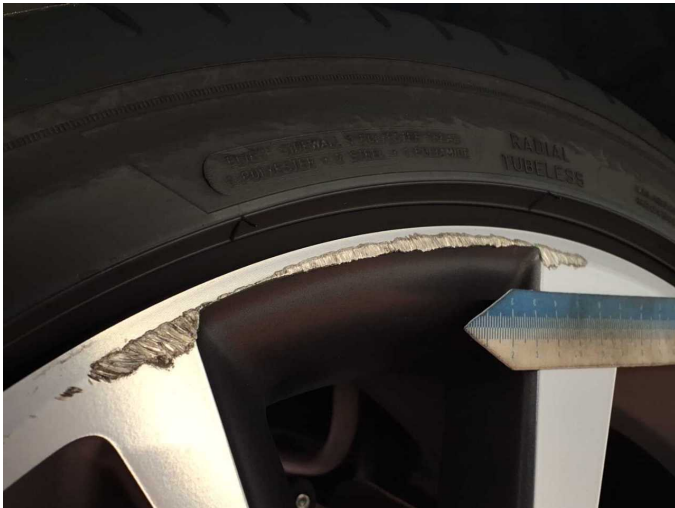
**Damage 7:** Wheel / tyres: Alloy rim - rear right side - Scratched - Replace

| No. | Component group | Description |
|---|---|---|
| 7 | Wheel / tyres | Alloy rim - rear right side - Scratched - Replace |

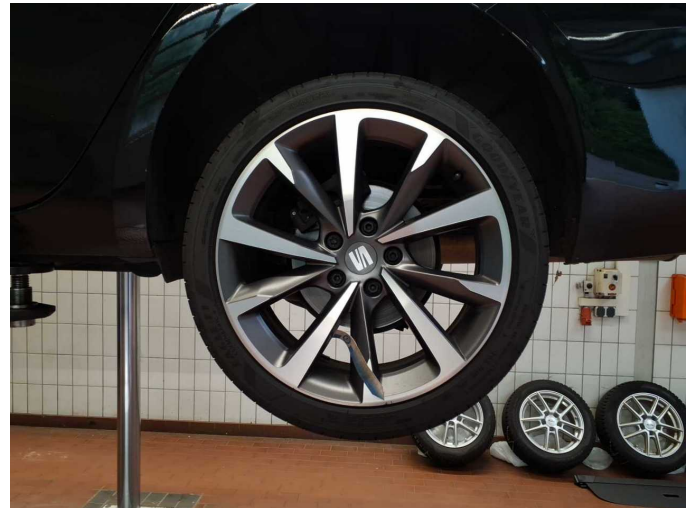
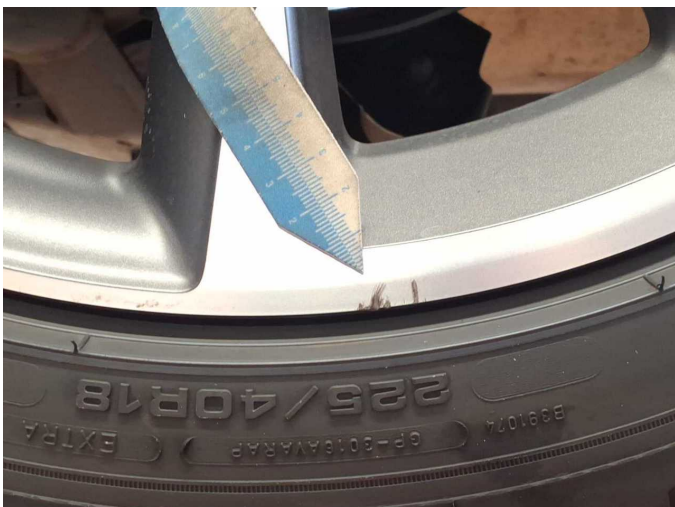
| No. | Component group | Description |
|---|---|---|
| 2 | Wheel / tyres | Alloy rim - rear left side - Scratch(es) - No deduction |

**Wear and tear 2:** Wheel / tyres: Alloy rim - rear left side - Scratch(es) - No deduction

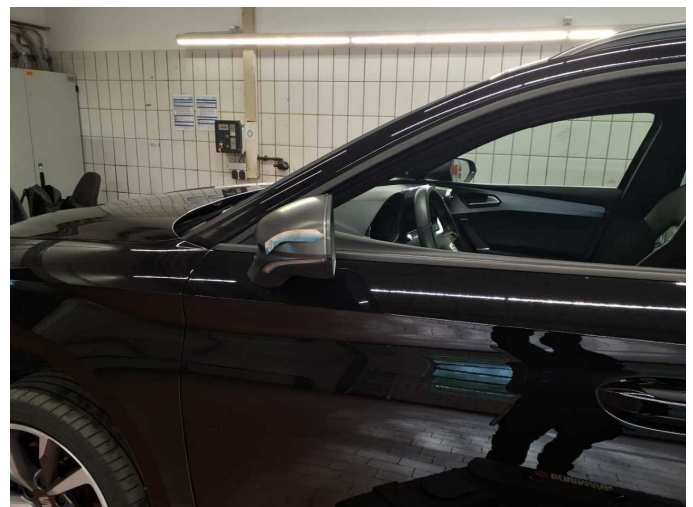
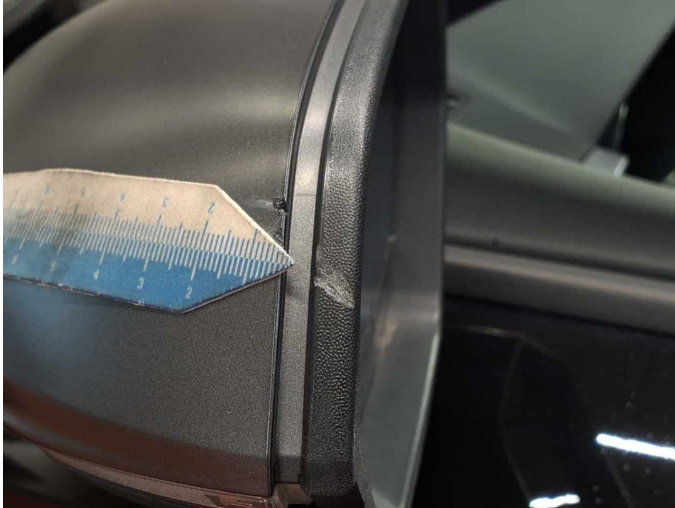
| No. | Component group | Description |
|---|---|---|
| 6 | Wing mirror - left side | Mirror housing - Scratch(es) - No deduction |

**Wear and tear 6:** Wing mirror - left side: Mirror housing - Scratch(es) - No deduction

**Wear and tear 6:** Wing mirror - left side: Mirror housing - Scratch(es) -  
No deduction
