Expertise

Protocol number: 46627029  
Order No. / Reference: 26426382  
Inspection date: 15 Jul 2026

Manufacturer: Ford

Model: Transit Connect 230 L2 S&S Trend

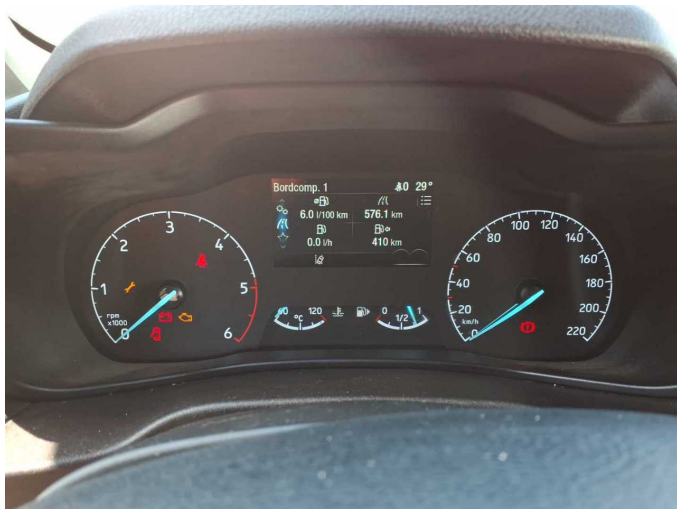
Figure 5: Instrument cluster

| Mileage (Read) | 220,589 km |

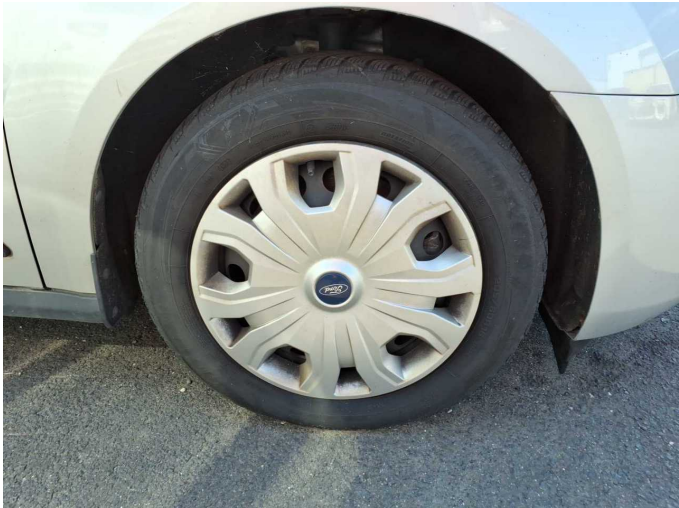
Figure 10: Mounted tyres

| # | Tyre size | Type of tyre | Manufacturer | Tread depth |
|---|---|---|---|---|
| 1) | 205/60 R16 96H | Winter tyres on Steel rim with wheel cover | Goodyear | 3mm / 3mm |
| 2) | 205/60 R16 96H | Winter tyres on Steel rim with wheel cover | Goodyear | 4mm / 4mm |

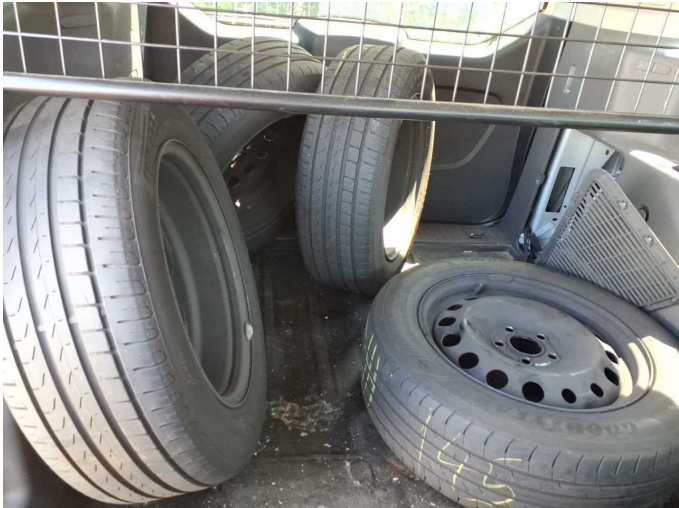
Figure 14: Additional tyres

| # | Tyre size | Type of tyre | Manufacturer | Tread depth |
|---|---|---|---|---|
| 1) | 205/60 R16 96V | Summer tyres on Steel | Pirelli | 4mm / 4mm |
| 2) | 205/60 R16 96V | Summer tyres on Steel | Pirelli | 4mm / 4mm |

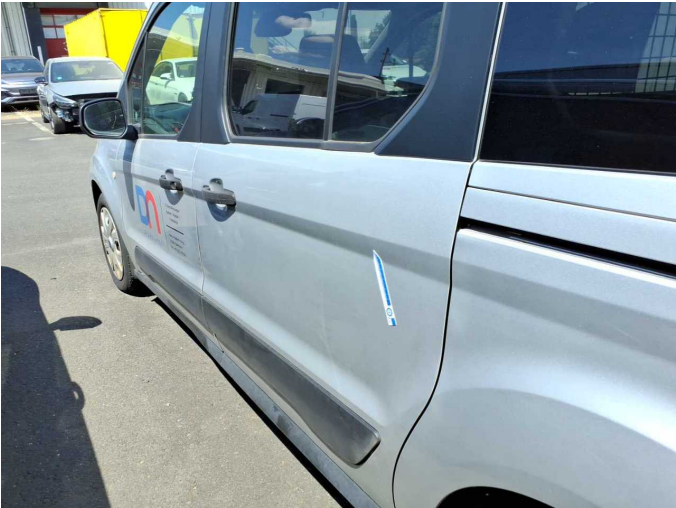
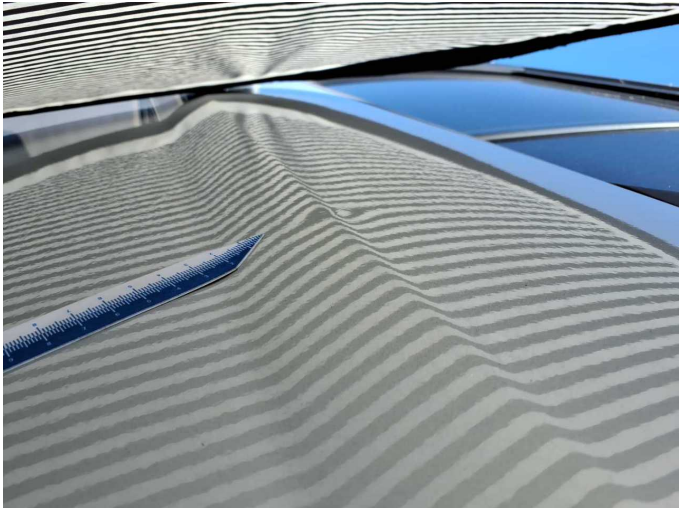
| No. | Component group | Description |
|---|---|---|
| 1 | Sliding door - left side | Sliding door with glass panel - dent(s) - Smooth repair work |

Damage 1: Sliding door - left side: Sliding door with glass panel - dent(s)  
- Smooth repair work

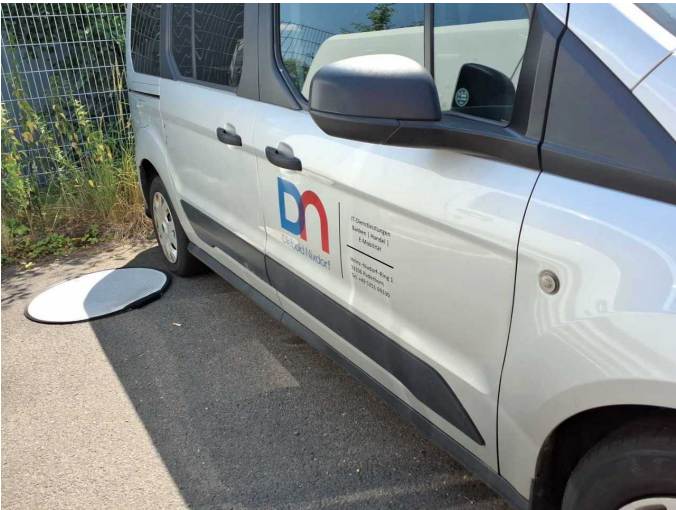
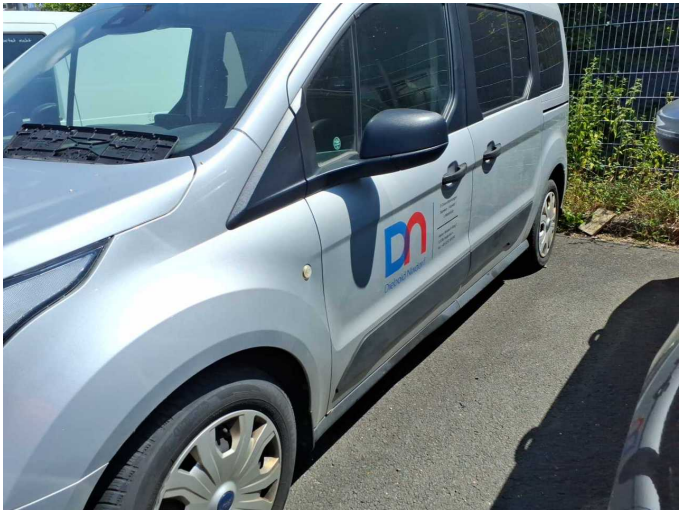
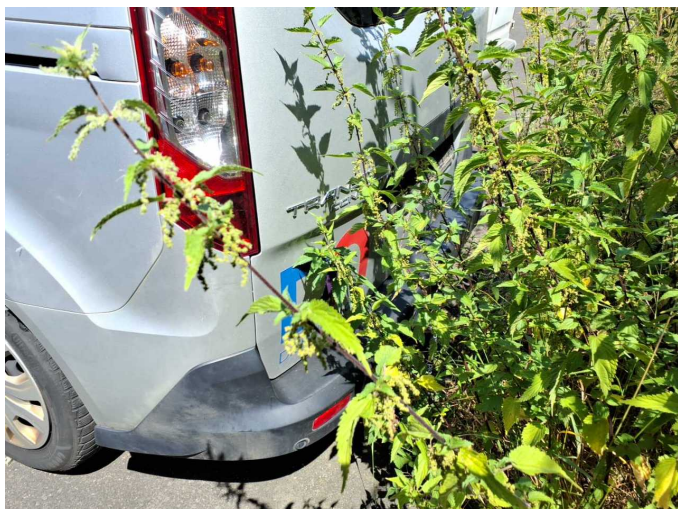
| No. | Component group | Description |
|---|---|---|
| 2 | Body | Body - Glued / labelled - De-glue / neutralise |

Damage 2: Body: Body - Glued / labelled - De-glue / neutralise

**Damage 2:** Body: Body - Glued / labelled - De-glue / neutralise

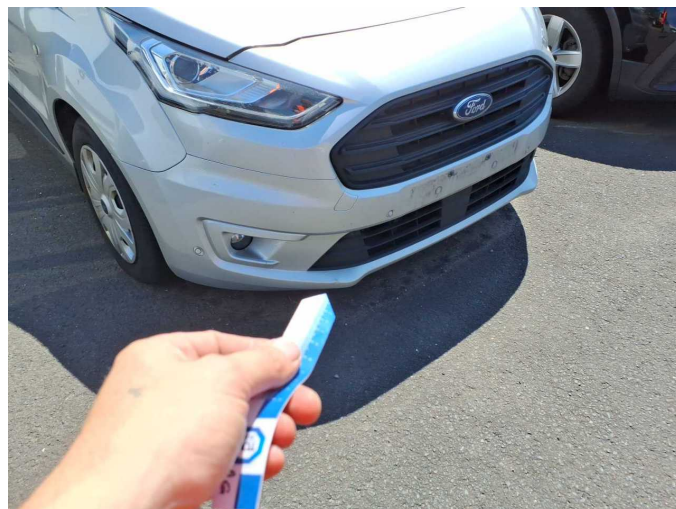
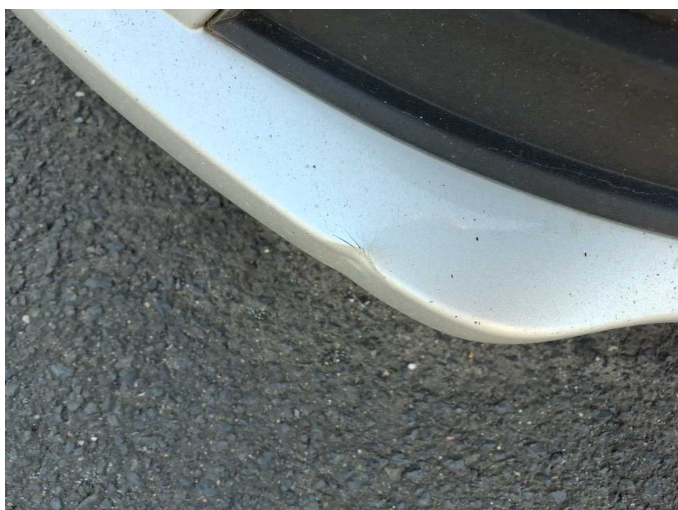
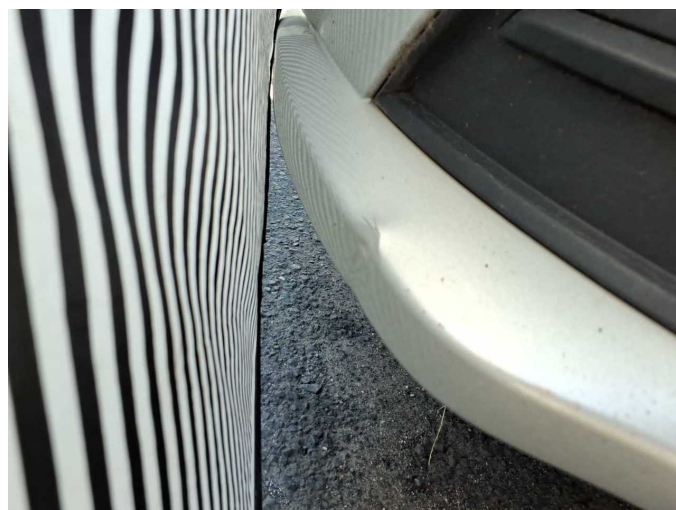
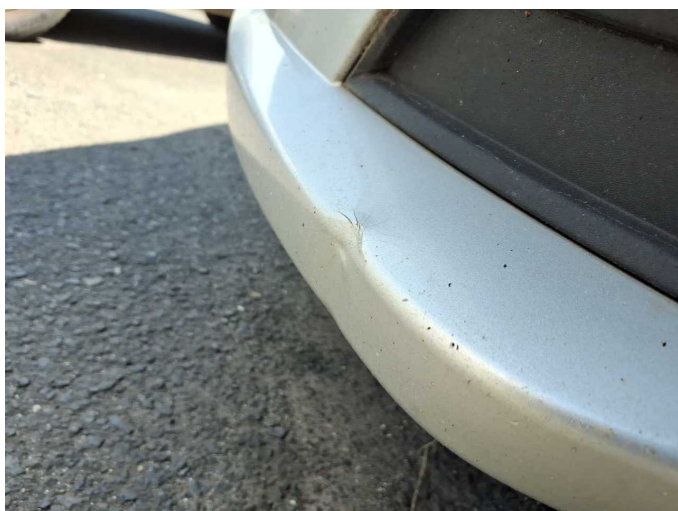
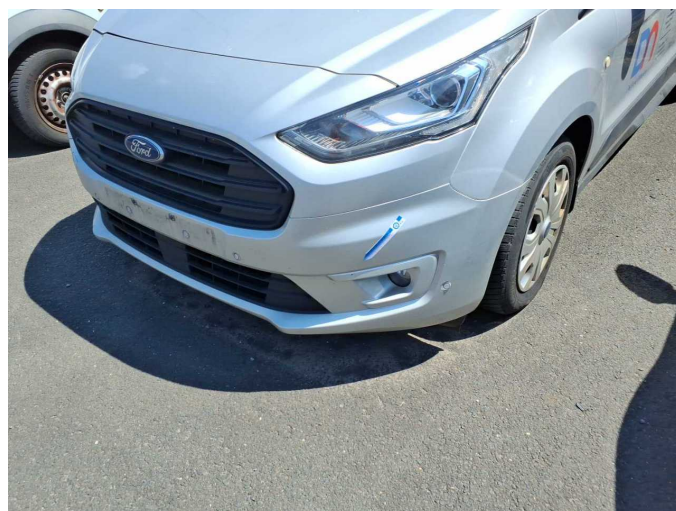
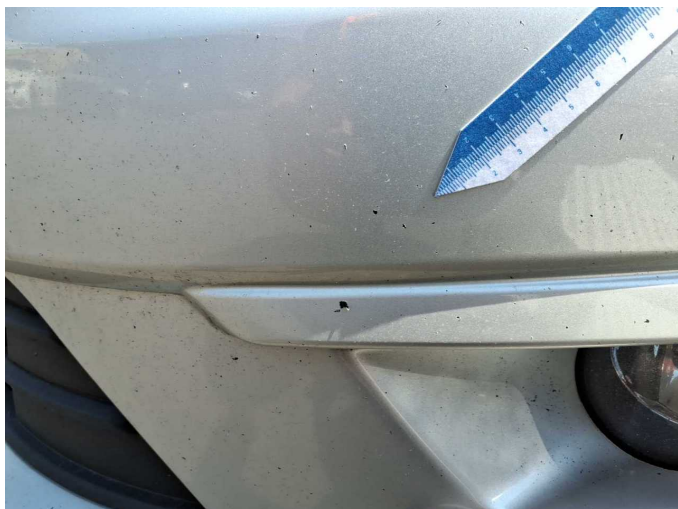
| No. | Component group | Description |
|---|---|---|
| 3 | Front bumper | Front bumper (Steinschlag) - Deformed - Repair and paint |

**Damage 3:** Front bumper: Front bumper (Steinschlag) - Deformed - Repair and paint

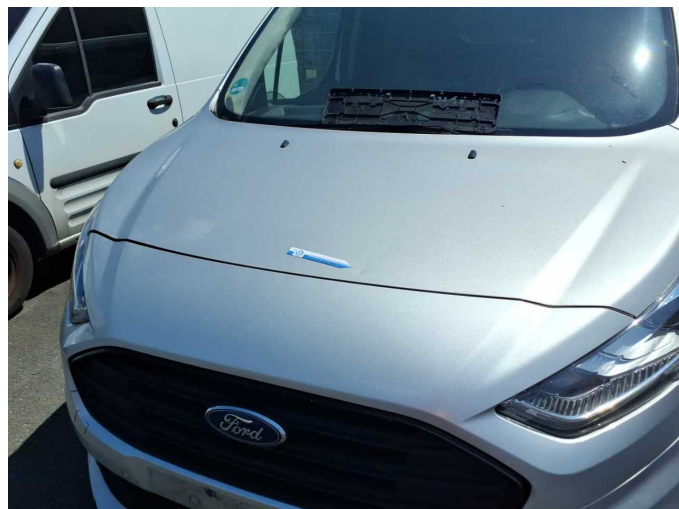
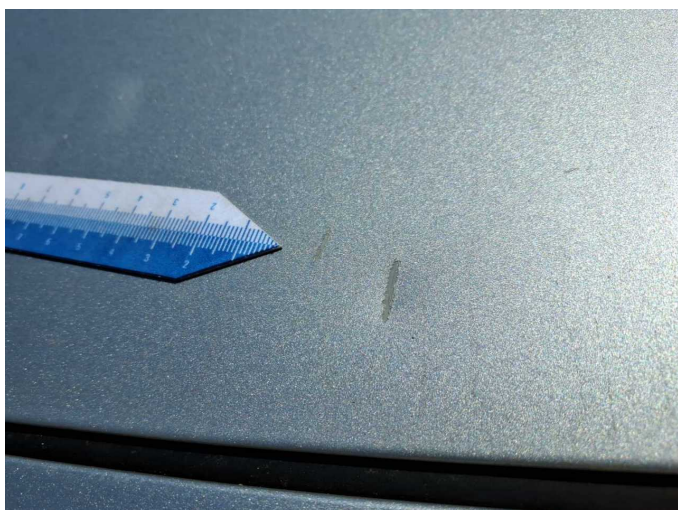
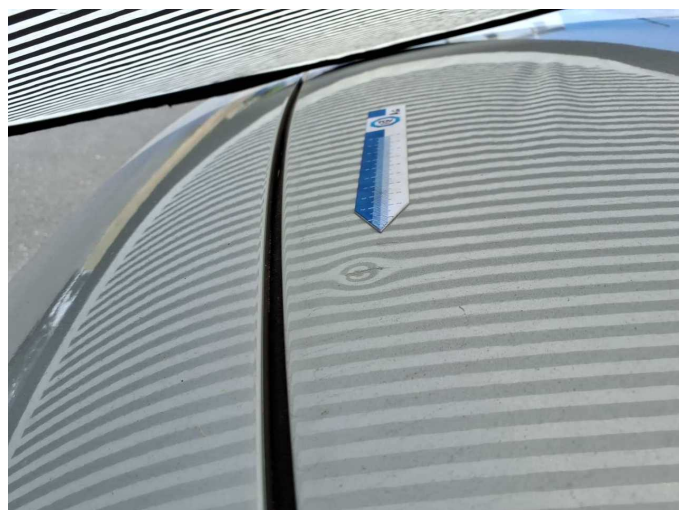
| No. | Component group | Description |
|---|---|---|
| 4 | Bonnet | Bonnet - Dent / paintcoat damage - Repair and paint |

**Damage 4:** Bonnet: Bonnet - Dent / paintcoat damage - Repair and paint

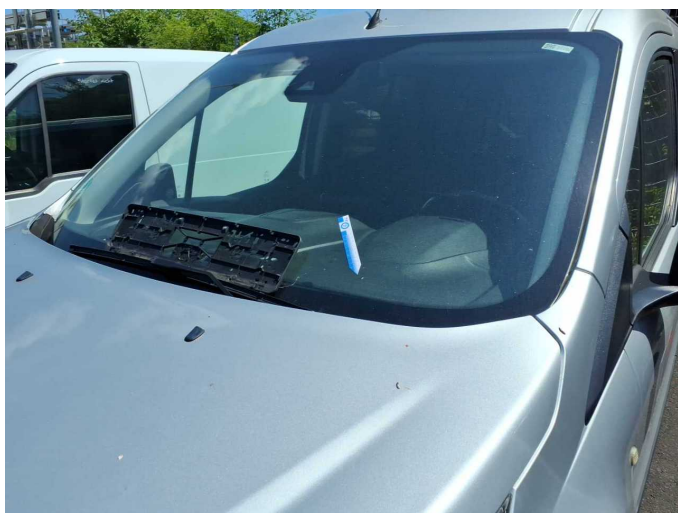
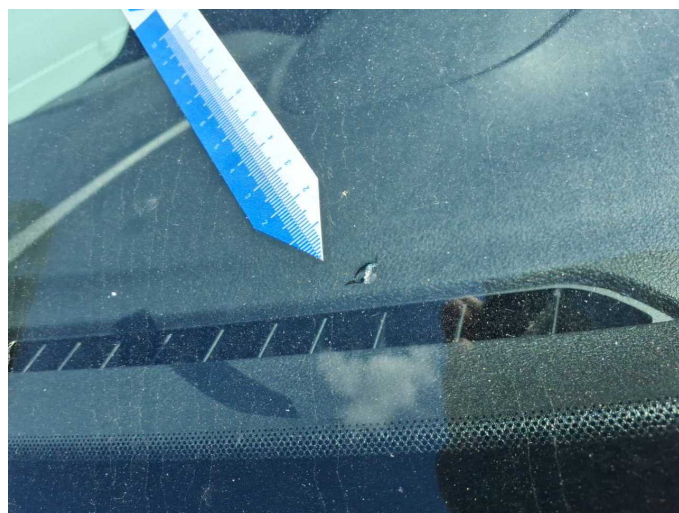
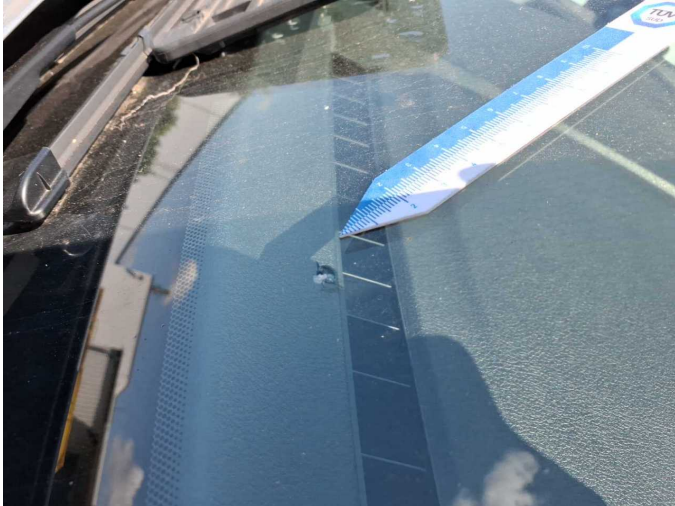
| No. | Component group | Description |
|---|---|---|
| 5 | Vehicle glazing | Windscreen (Rissbildung) - Stone chips - Replace |

**Damage 5:** Vehicle glazing: Windscreen (Rissbildung) - Stone chips - Replace

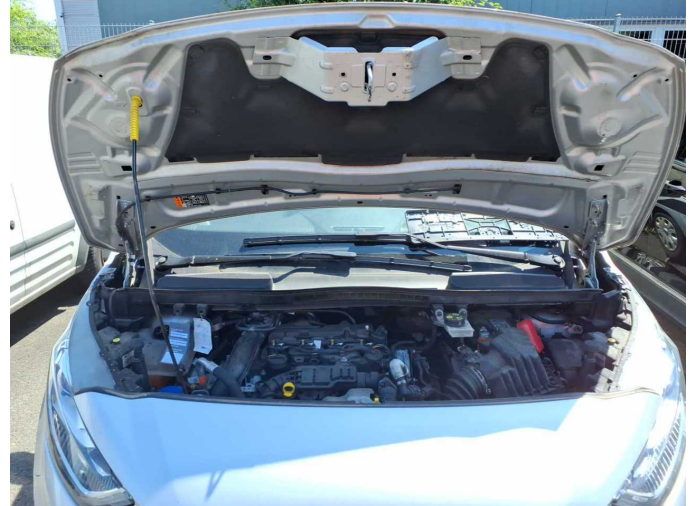
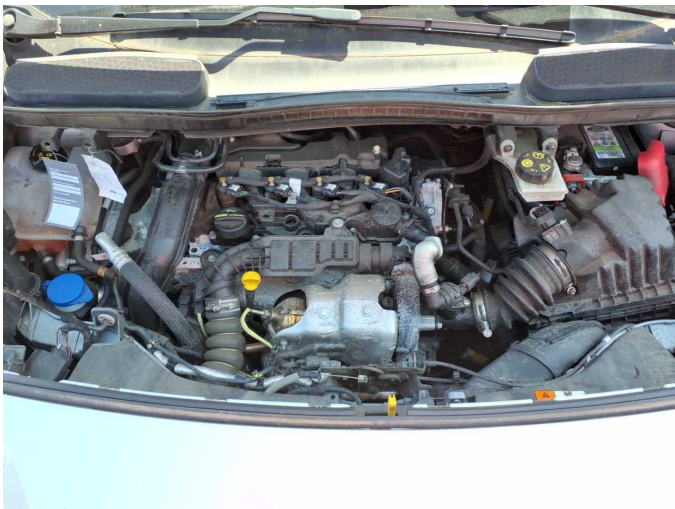
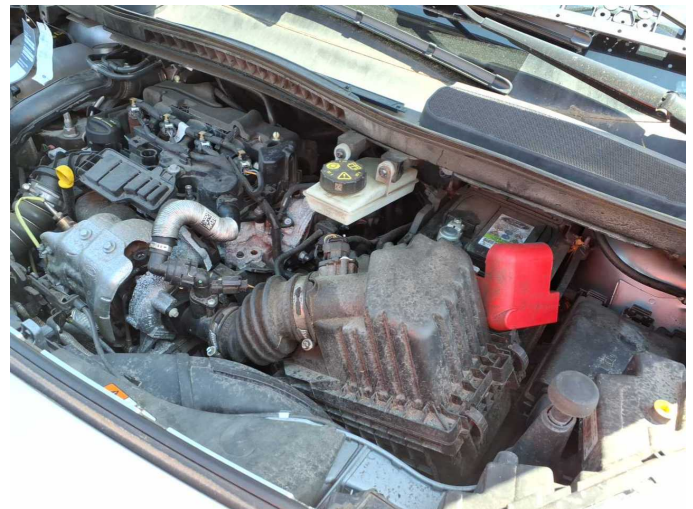
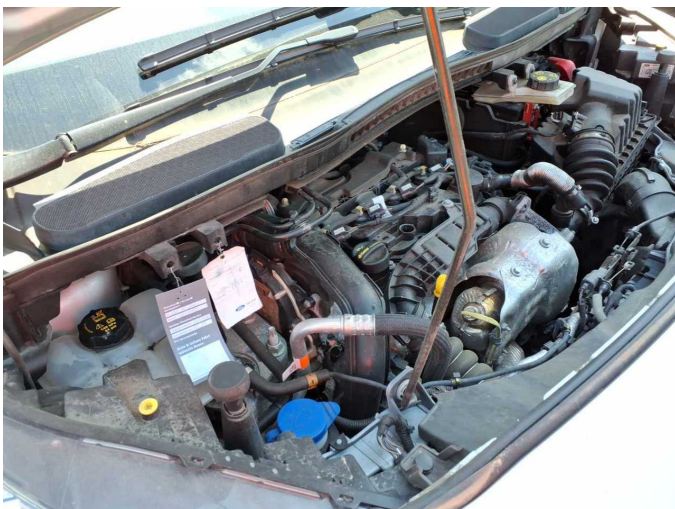
| Engine function test | An engine test run could not be performed.<br>This is due to the following reason.:<br>Motorschaden |

| No. | Component group | Description |
|---|---|---|
| 6 | Engine | Engine - Non-operational - repair according to calculation |

**Damage 6:** Engine: Engine - Non-operational - repair according to calculation

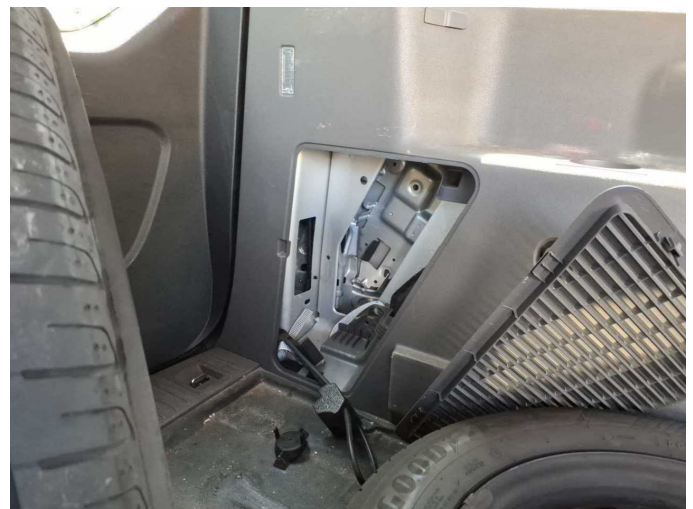
Equipment - Tirefit complete

**Missing part 1:** Equipment: Tirefit complete - Missing - Replace

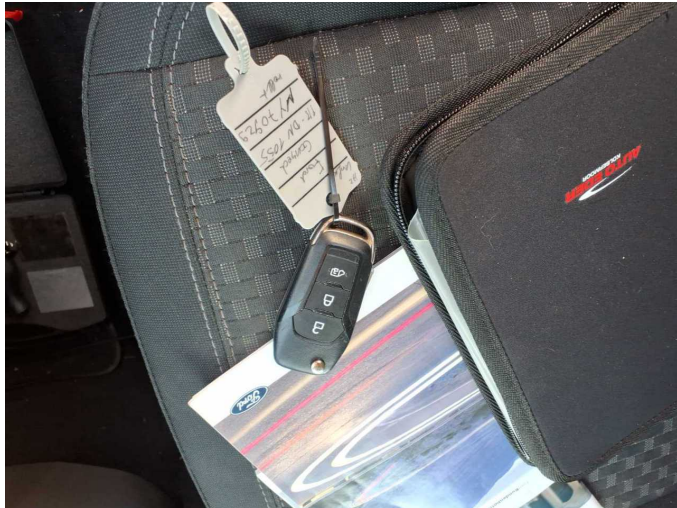
Equipment - Vehicle key with remote control

**Missing part 2:** Equipment: Vehicle key with remote control - Missing -  
Replace
