Expertise

Protocol number: 45880424
Order No. / Reference: 26390281
Inspection date: 5 Jun 2026

Model: GLC 300 de 4Matic 9G-TRONIC AMG Line

VIN: W1N2539111V284469

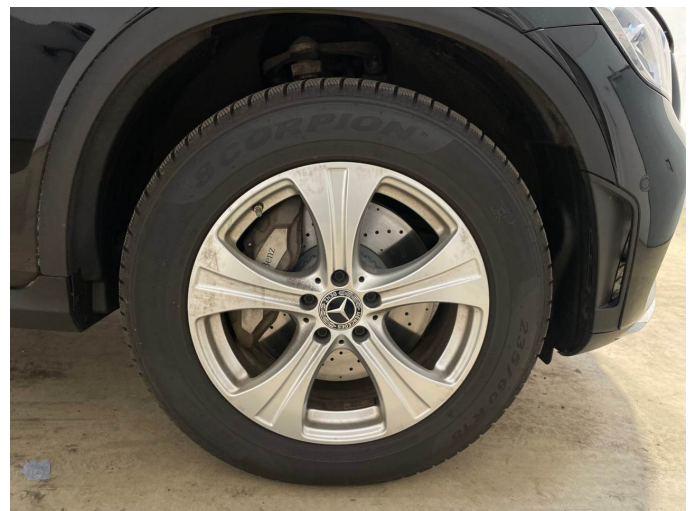
Mounted tyres				
#	Tyre size	Type of tyre	Manufacturer	Tread depth
1)	235/60 R18 103H	Winter tyres on Light alloy	Pirelli	6mm / 6mm
2)	235/60 R18 103H	Winter tyres on Light alloy	Pirelli	6mm / 6mm

Figure 12: Mounted tyres

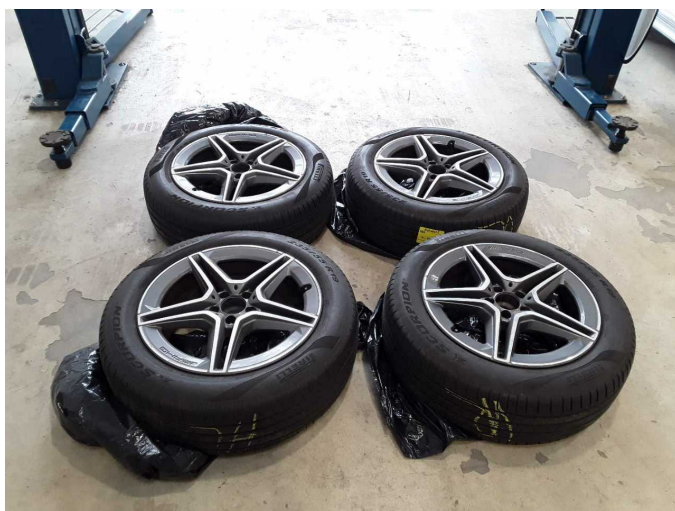
Additional tyres				
#	Tyre size	Type of tyre	Manufacturer	Tread depth
1)	235/55 R19 105W	Summer tyres on Light alloy	Pirelli	7mm / 7mm
2)	235/55 R19 105W	Summer tyres on Light alloy	Pirelli	7mm / 7mm

Figure 17: Additional tyres

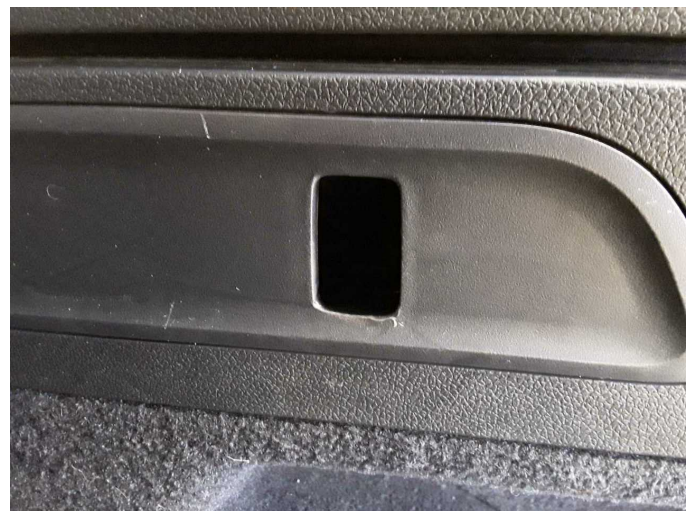
Damage 1: Trim / covers: Cargo area - lining - right side (Taster Sitzentriegelung reingedrückt) - Differs from the original configuration - Un- / install

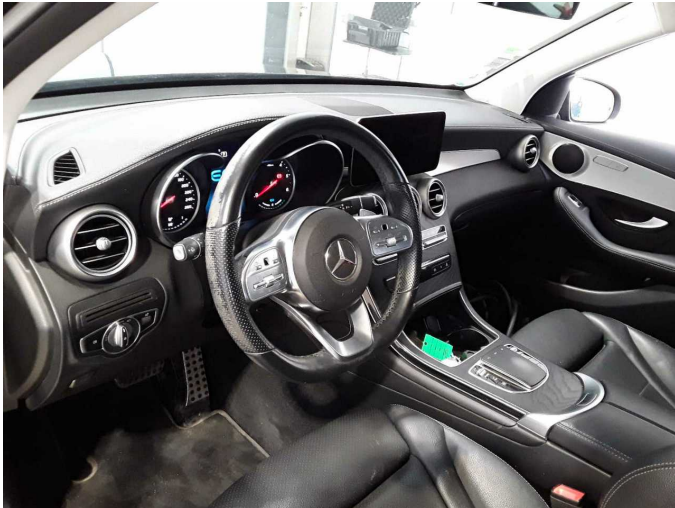
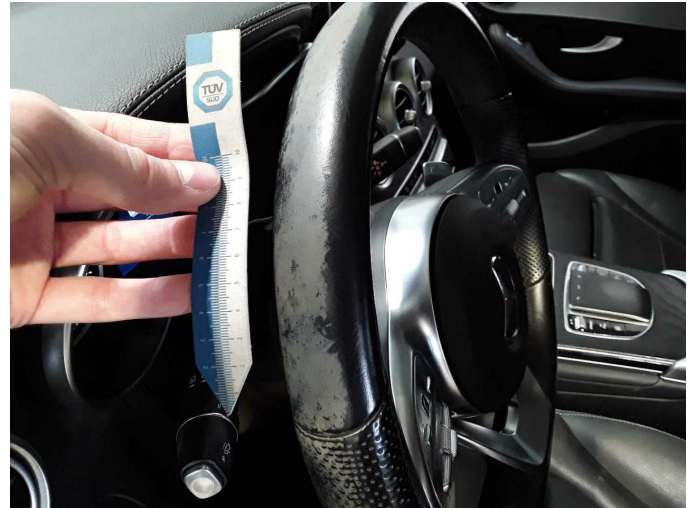
Damage 2: Steering system: Steering wheel - Worn - Smart repair

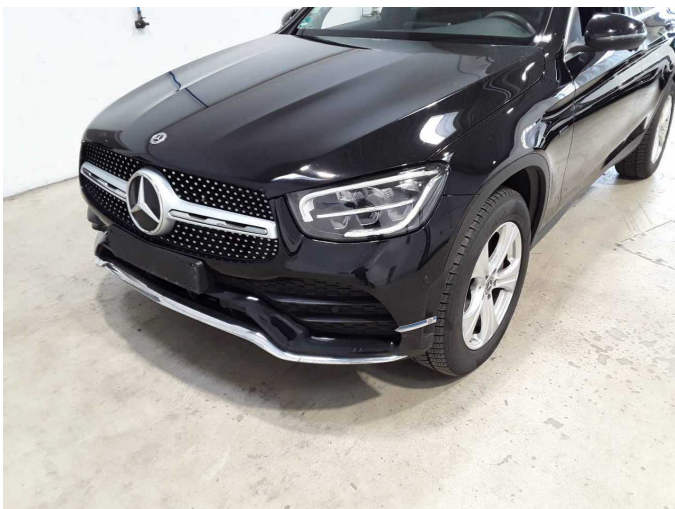
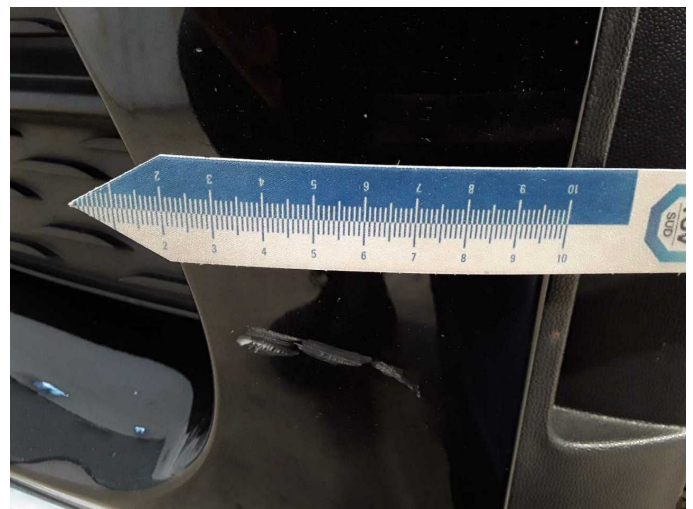
Damage 4: Front bumper: Front bumper - Scratch(es) - Paint

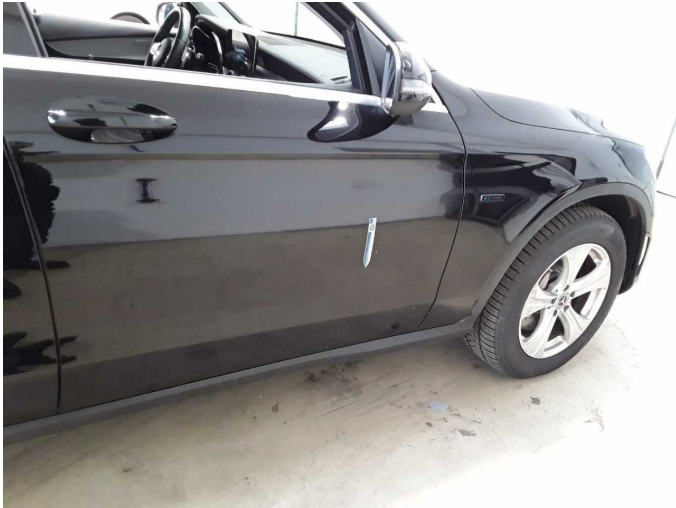
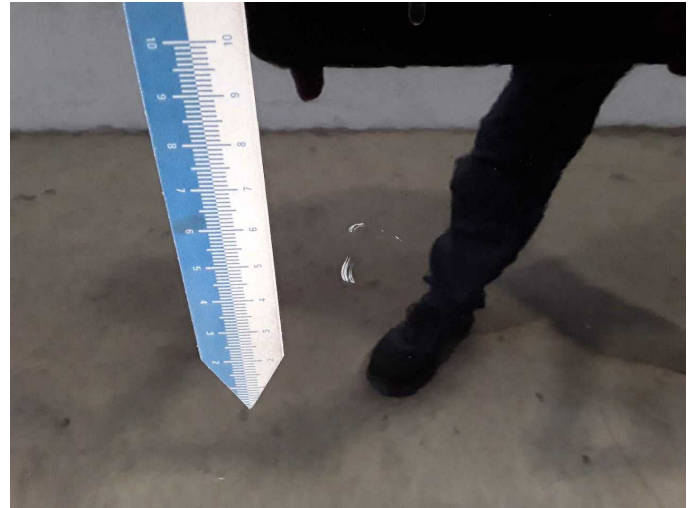
Damage 5: Door - front right side: Door - Scratch(es) - Paint

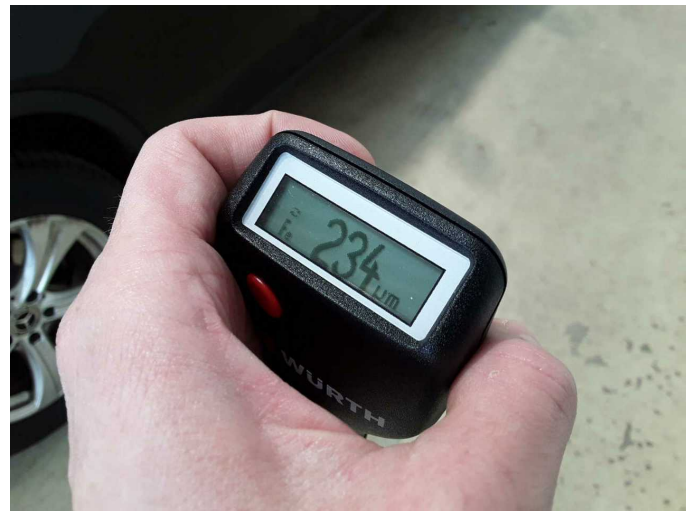
No.	Repainting
1	Door - rear right side, Professionally carried out, Invoice of repair done

Door - rear right side	234 µm
------------------------	--------

Repainting 1: Door - rear right side
