Expertise

Protocol number: 46294915  
Order No. / Reference: 26630377  
Inspection date: 2 Jul 2026

Manufacturer: Volkswagen

Model: Tiguan 2.0 TDI SCR DSG Life

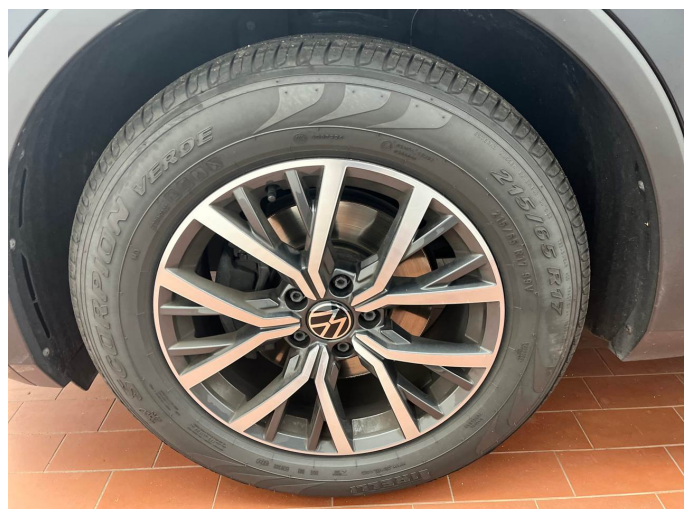
Figure 12: Mounted tyres

| Mounted tyres | | | | |
|---|---|---|---|---|
| 1) | 215/65 R17 99V | Summer tyres on Light alloy | Pirelli | 6mm / 6mm |
| 2) | 215/65 R17 99V | Summer tyres on Light alloy | Pirelli | 4mm / 4mm |

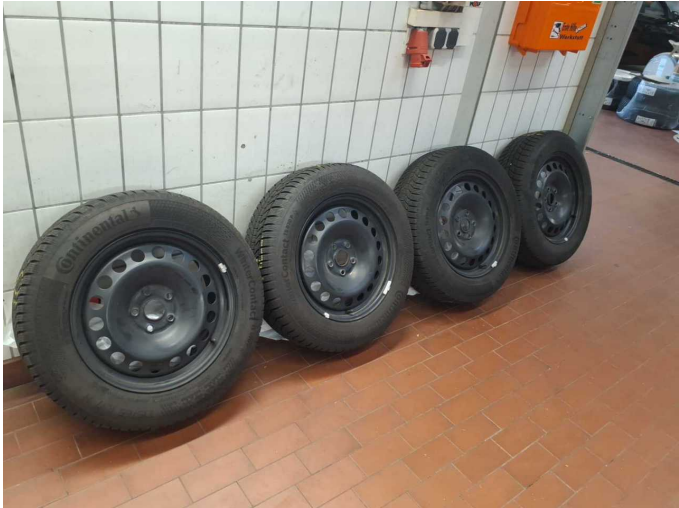
Figure 16: Additional tyres

| Mounted tyres | | | | |
|---|---|---|---|---|
| 1) | 215/65 R17 99H | Winter tyres on Steel | Continental | 5mm / 5mm |
| 2) | 215/65 R17 99H | Winter tyres on Steel | Continental | 7mm / 7mm |

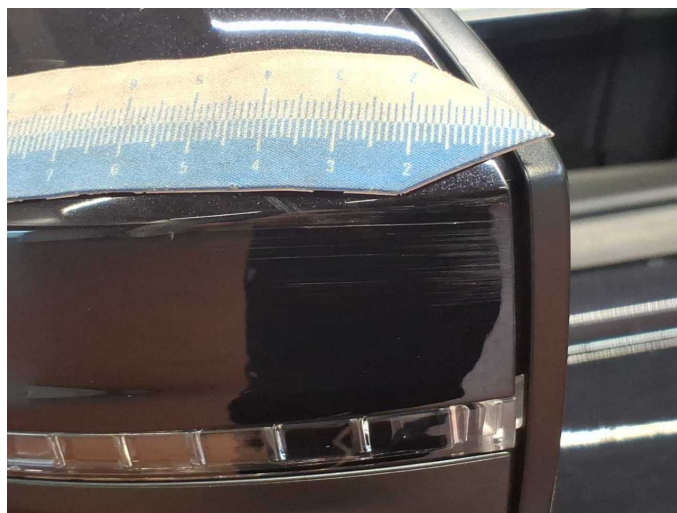
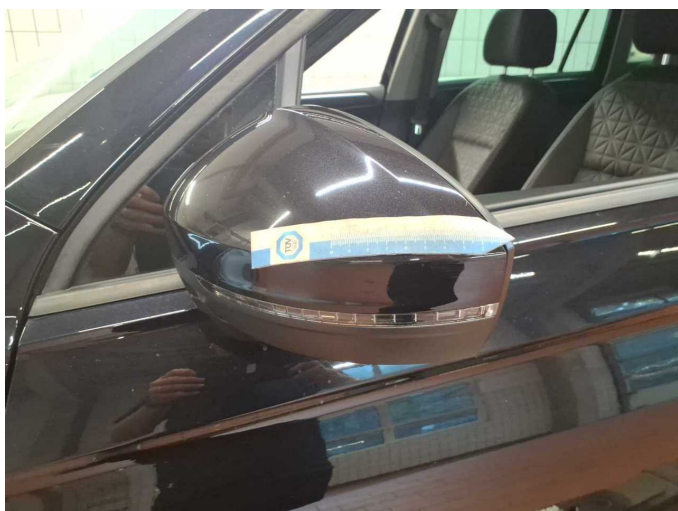
**Damage 1:** Wing mirror - left side: Cap - Scratch(es) - Smart repair

| No. | Component group | Description |
|---|---|---|
| 1 | Wing mirror - left side | Cap - Scratch(es) - Smart repair |

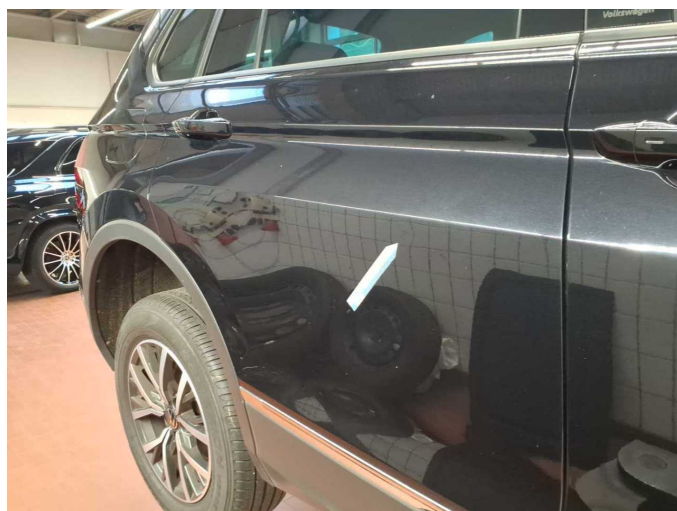
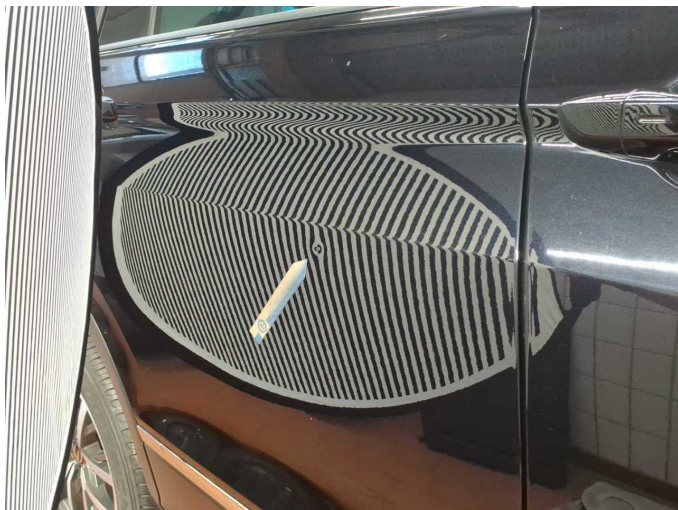
**Damage 2:** Door - rear right side: Door - dent(s) - Smooth repair work

| No. | Component group | Description |
|---|---|---|
| 2 | Door - rear right side | Door - dent(s) - Smooth repair work |

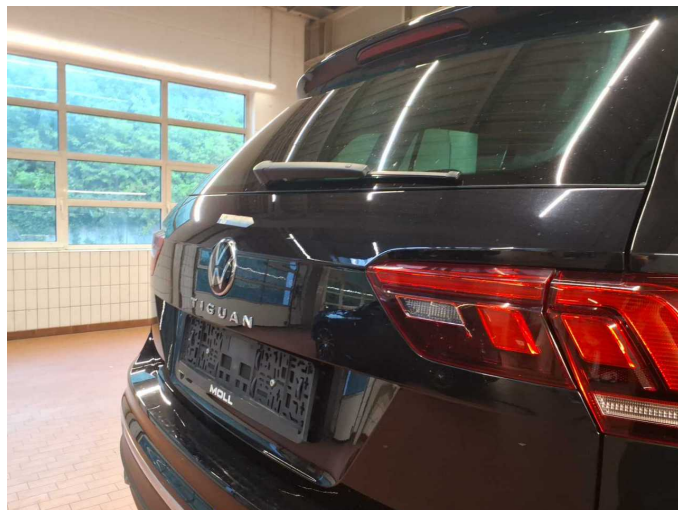
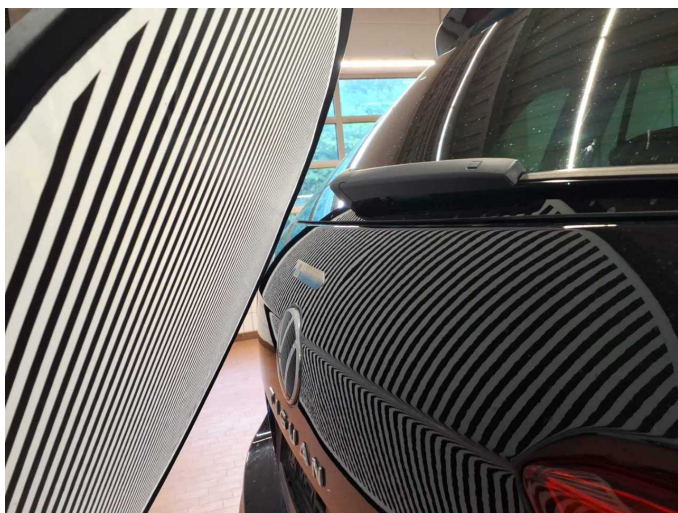
**Damage 3:** Boot lid / rear door: Boot lid - dent(s) - Smooth repair work

| No. | Component group | Description |
|---|---|---|
| 3 | Boot lid / rear door | Boot lid - dent(s) - Smooth repair work |

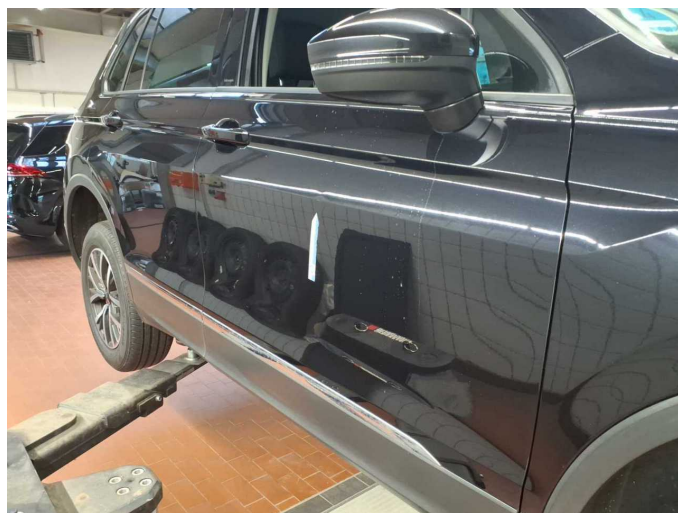
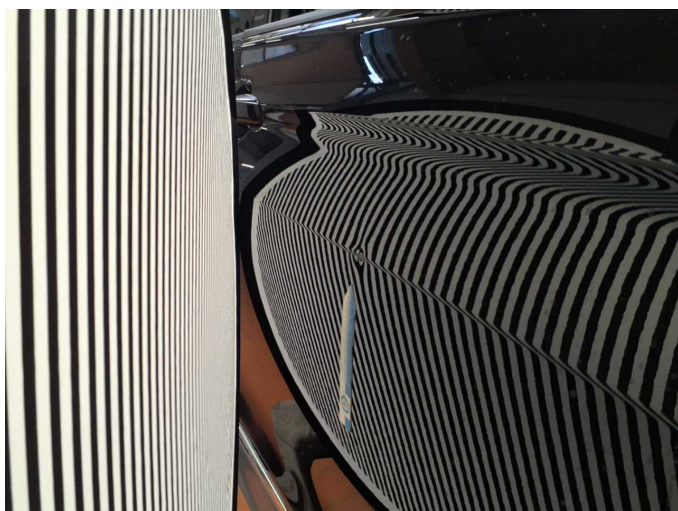
**Damage 4:** Door - front right side: Door - dent(s) - Smooth repair work

| No. | Component group | Description |
|---|---|---|
| 4 | Door - front right side | Door - dent(s) - Smooth repair work |

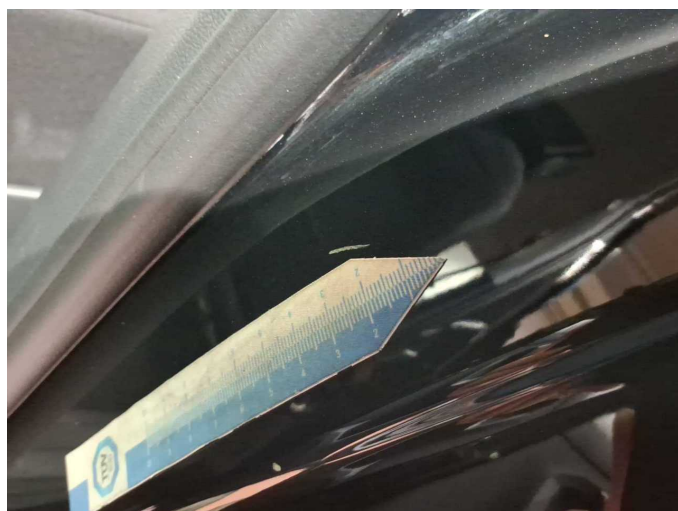
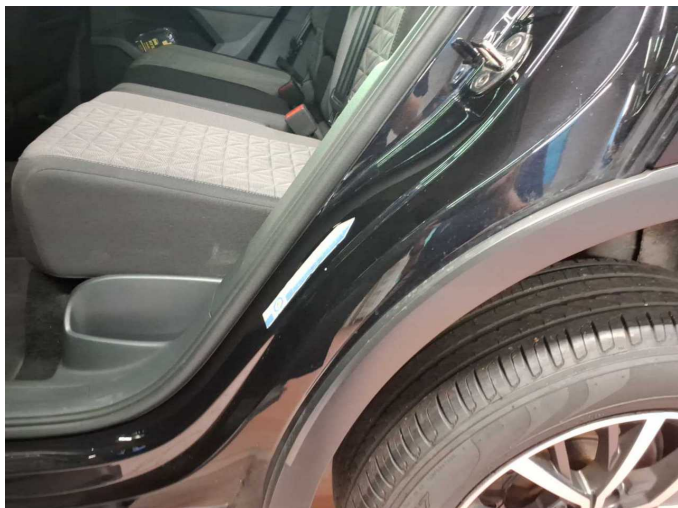
**Damage 5:** Side panel - rear left side: Sill - Scratch(es) - Smart repair

| No. | Component group | Description |
|---|---|---|
| 5 | Side panel - rear left side | Sill - Scratch(es) - Smart repair |

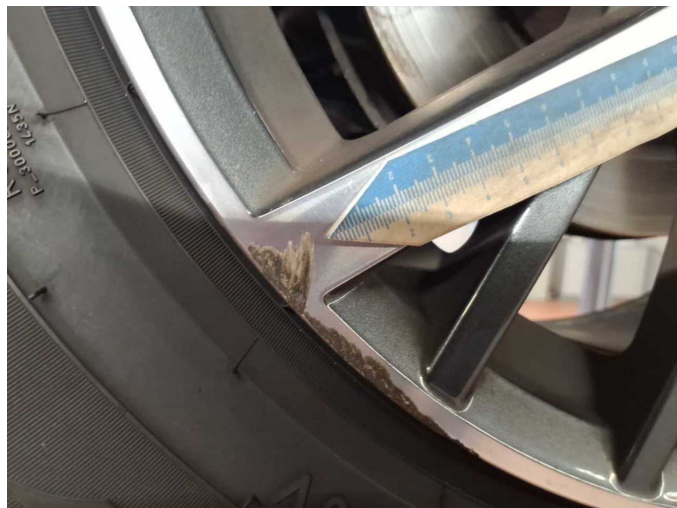
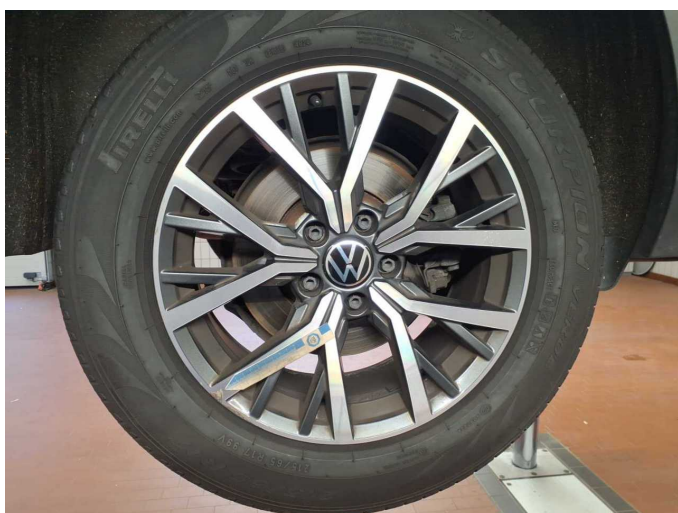
**Damage 6:** Wheel / tyres: Alloy rim - rear right side - Scratch(es) - Loss in value

| No. | Component group | Description |
|---|---|---|
| 6 | Wheel / tyres | Alloy rim - rear right side - Scratch(es) - Loss in value |

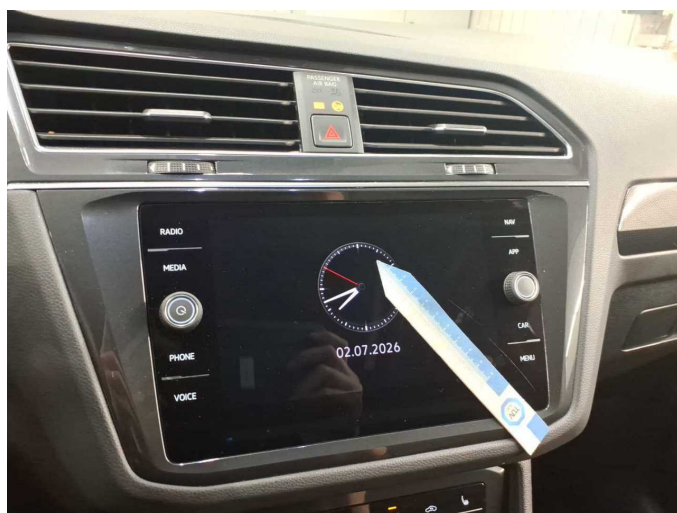
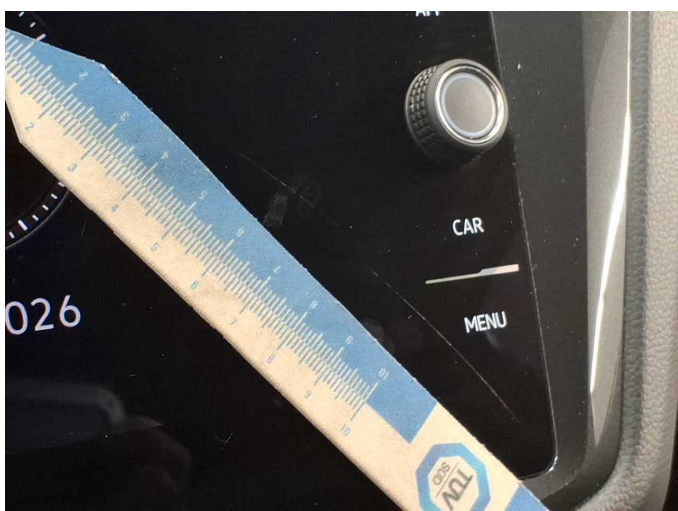
**Damage 7:** Multimedia system: Screen - Scratch(es) - Loss in value

| No. | Component group | Description |
|---|---|---|
| 7 | Multimedia system | Screen - Scratch(es) - Loss in value |

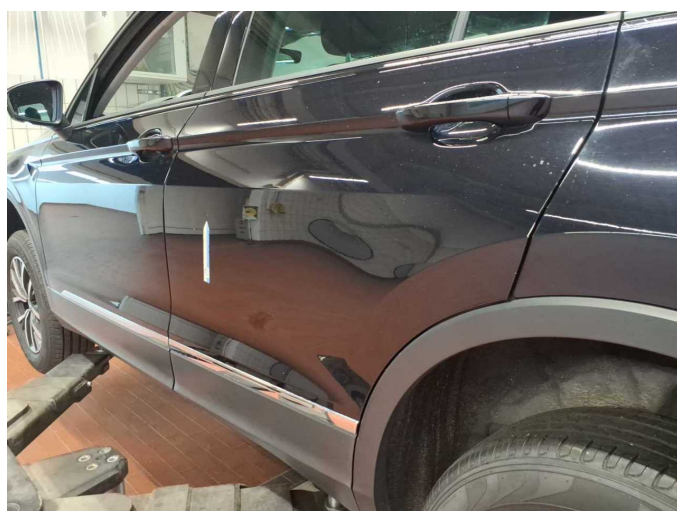
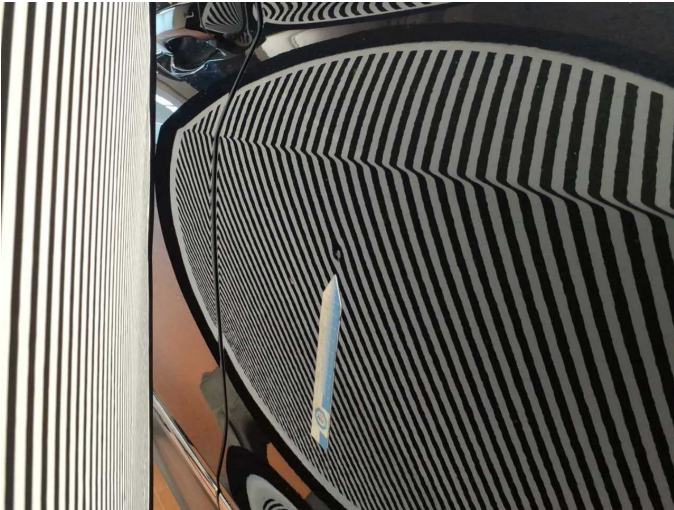
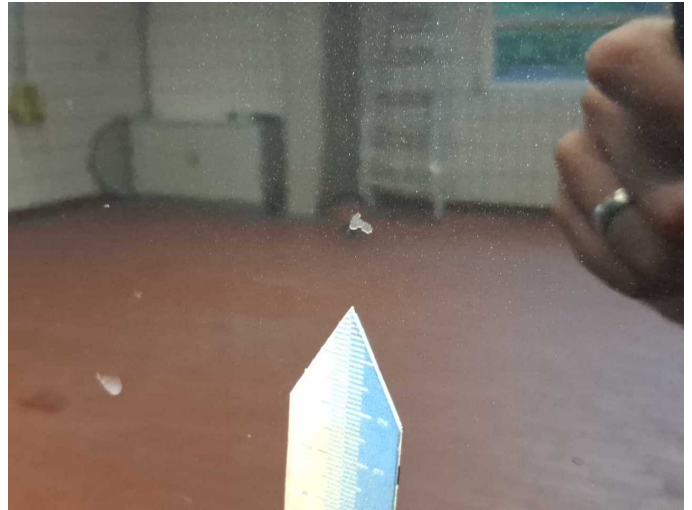
**Damage 8:** Door - rear left side: Door - Dent / paintcoat damage - Repair and paint

| No. | Component group | Description |
|---|---|---|
| 8 | Door - rear left side | Door - Dent / paintcoat damage - Repair and paint |

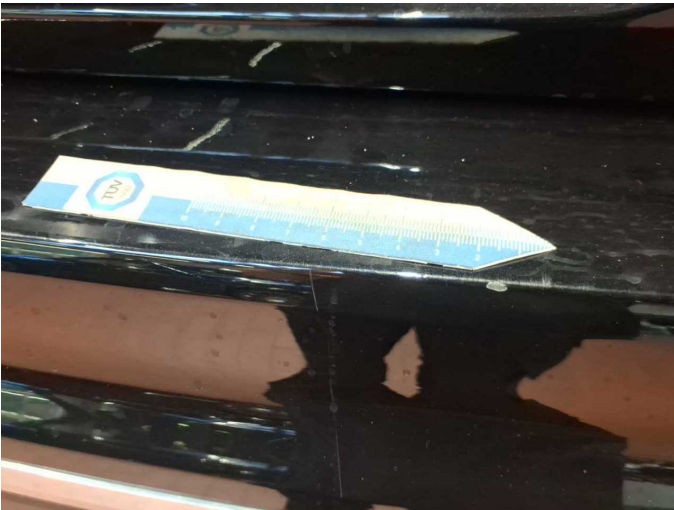
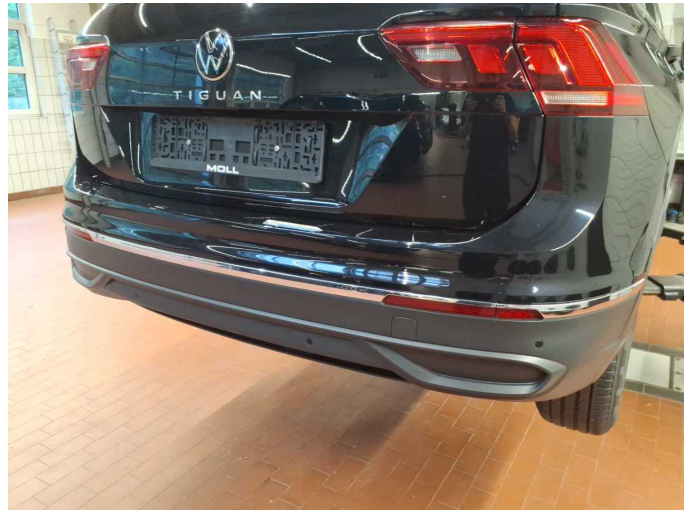
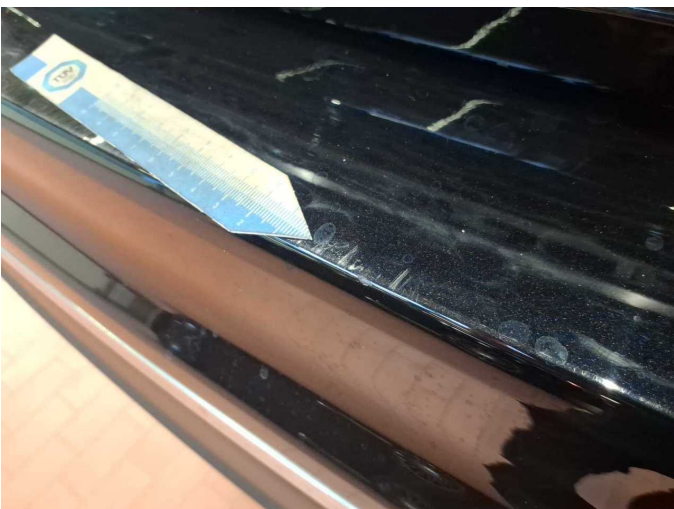
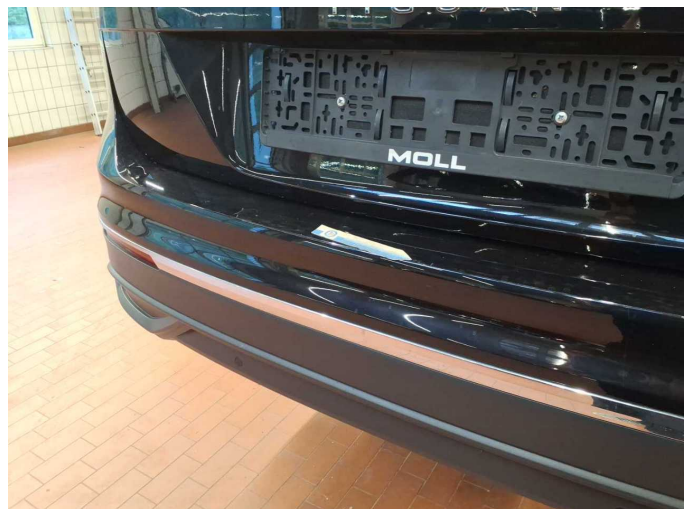
**Damage 9:** Rear bumper: Rear bumper - Scratch(es) - Paint

| No. | Component group | Description |
|---|---|---|
| 9 | Rear bumper | Rear bumper - Scratch(es) - Paint |

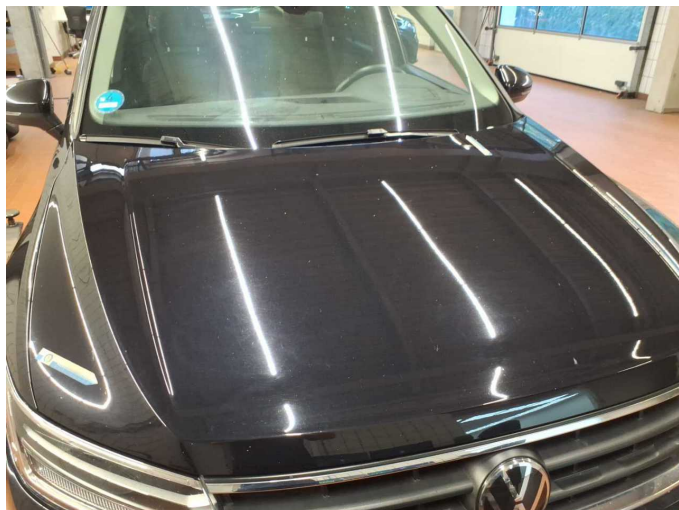
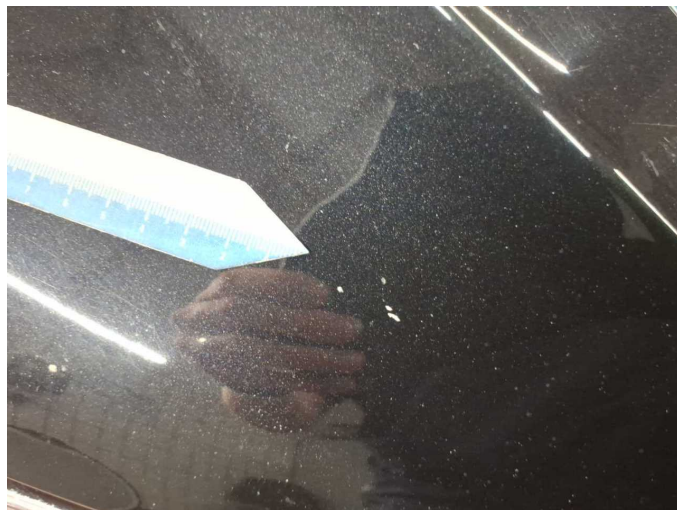
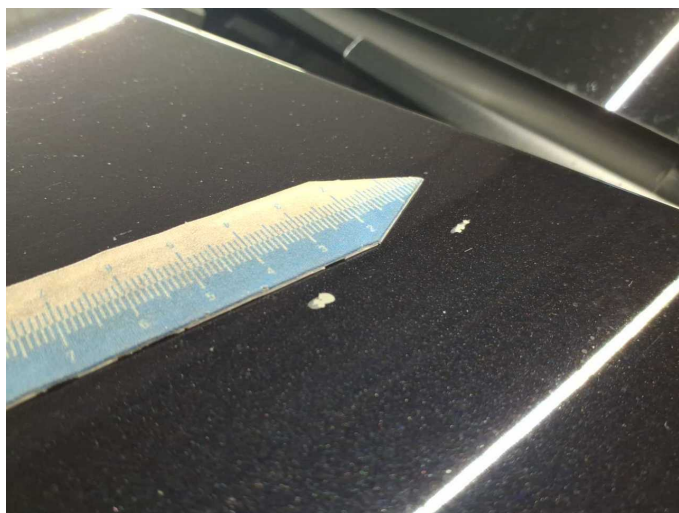
**Damage 10:** Bonnet: Bonnet - Stone chips - Paint

| No. | Component group | Description |
|---|---|---|
| 10 | Bonnet | Bonnet - Stone chips - Paint |

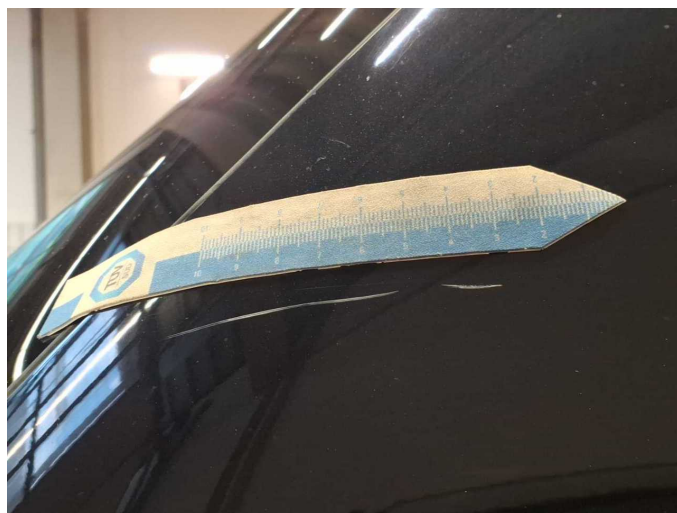
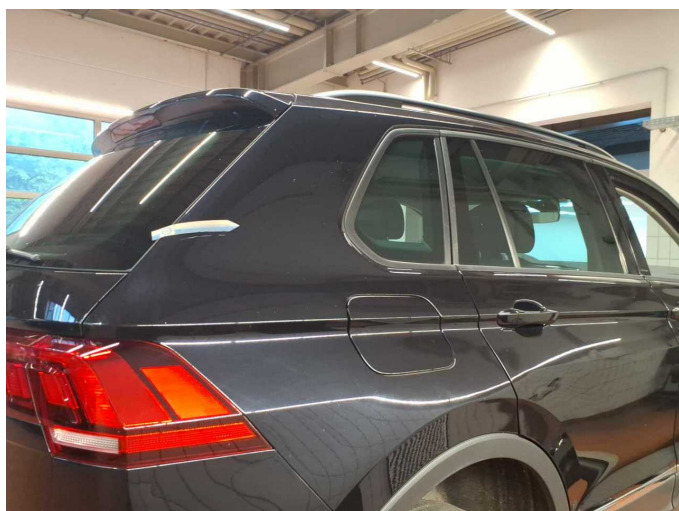
**Damage 11:** Side panel - rear right side: Side panel - Scratch(es) - Paint

| No. | Component group | Description |
|---|---|---|
| 11 | Side panel - rear right side | Side panel - Scratch(es) - Paint |

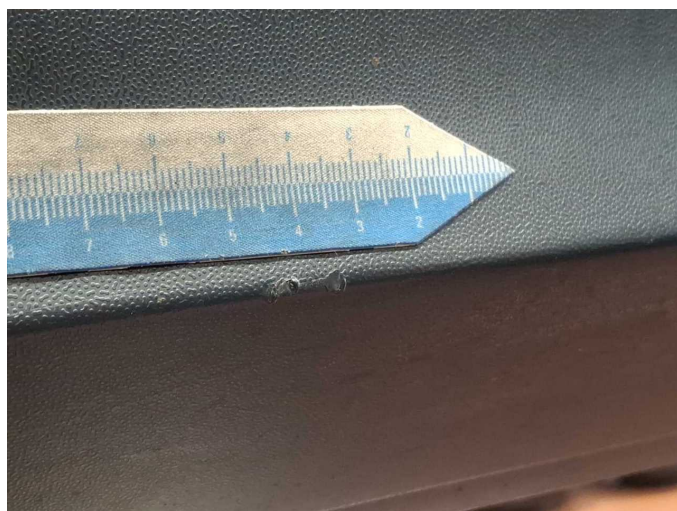
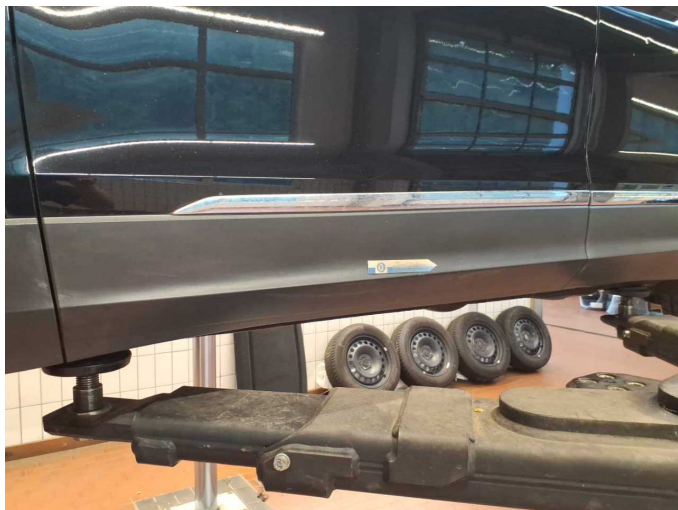
**Wear and tear 1:** Door - front left side: Brightware - lower - Scratch(es) - No deduction

| No. | Component group | Description |
|---|---|---|
| 1 | Door - front left side | Brightware - lower - Scratch(es) - No deduction |

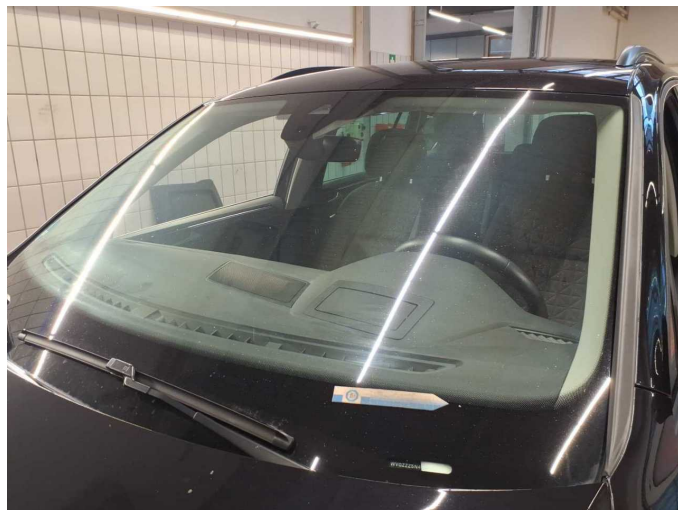
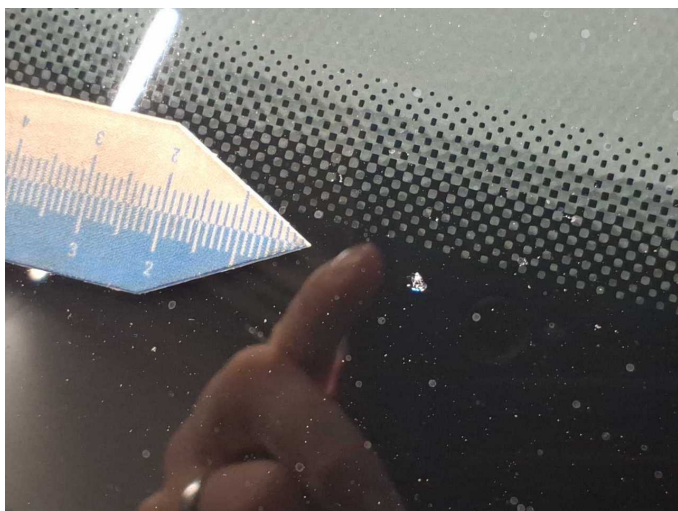
**Wear and tear 3:** Vehicle glazing: Windscreen - Stone chips - No deduction

| No. | Component group | Description |
|---|---|---|
| 3 | Vehicle glazing | Windscreen - Stone chips - No deduction |

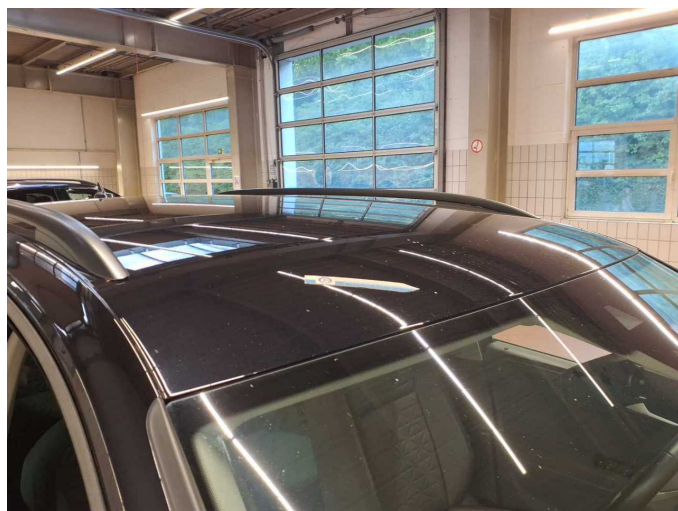
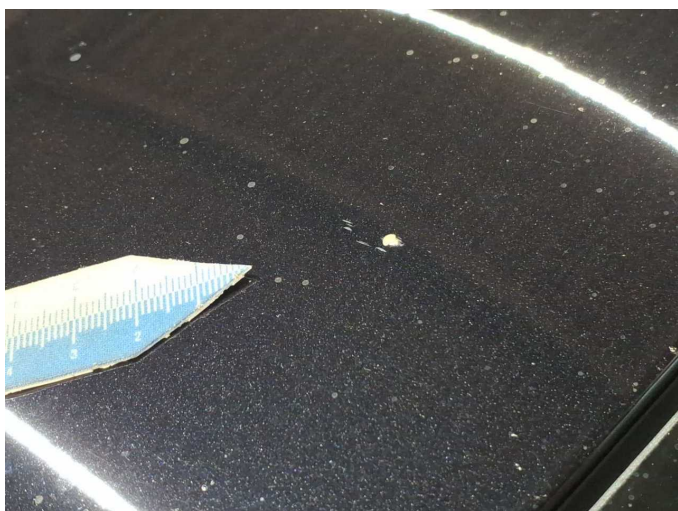
**Wear and tear 4:** Roof: Roof - Stone chips - No deduction

| No. | Component group | Description |
|---|---|---|
| 4 | Roof | Roof - Stone chips - No deduction |
