Expertise

Protocol number: 46593963  
Order No. / Reference: 26740946  
Inspection date: 17 Jul 2026

Manufacturer: Ford

Model: Galaxy 2.5 Duratec FHEV TITANIUM

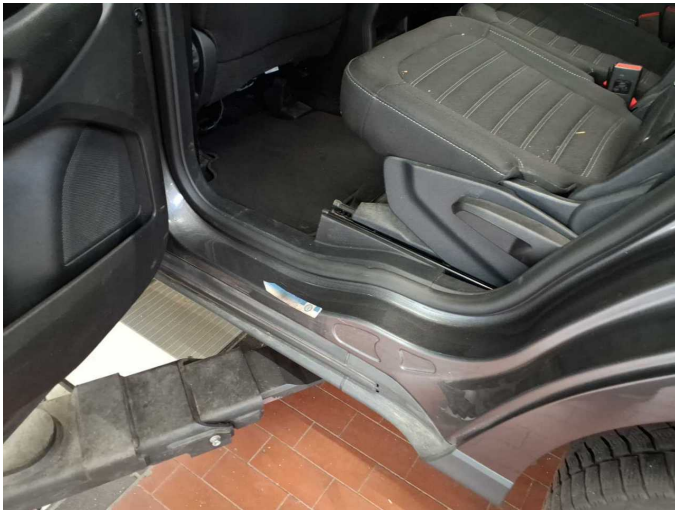
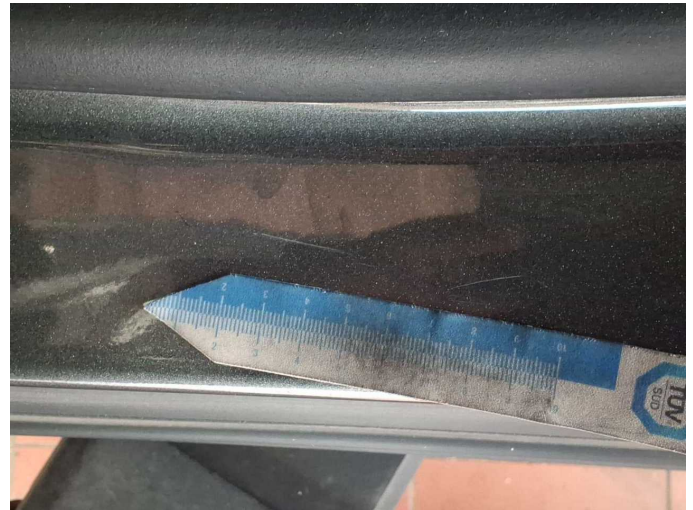
| No. | Component group | Description |
|---|---|---|
| 1 | Side panel - rear left side | Sill - Scratch(es) - Smart repair |

**Damage 1:** Side panel - rear left side: Sill - Scratch(es) - Smart repair

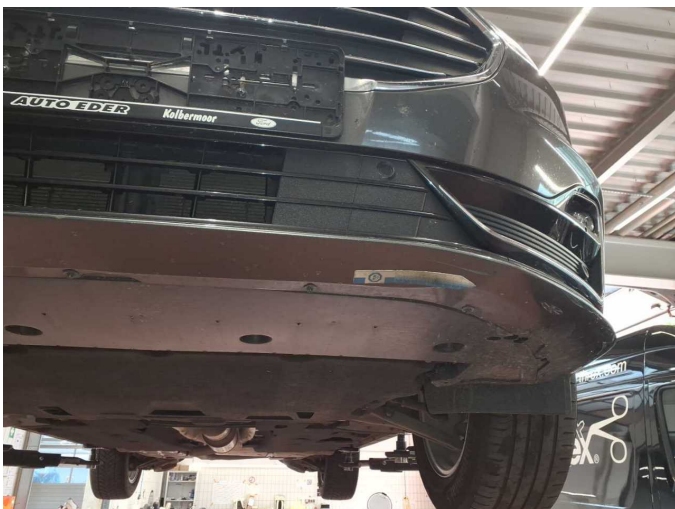
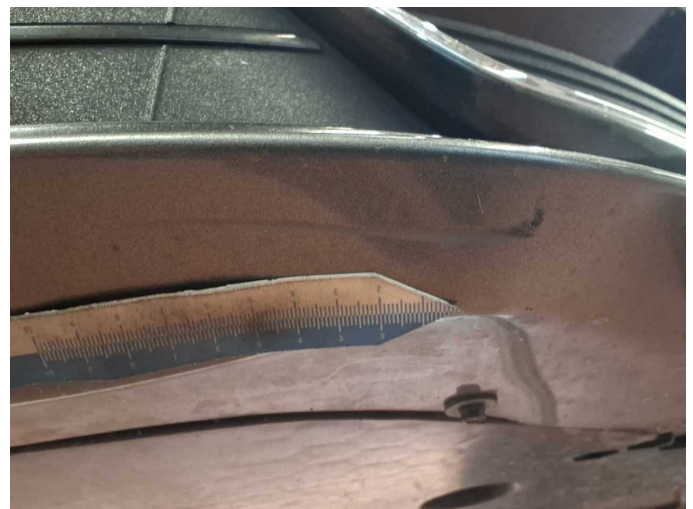
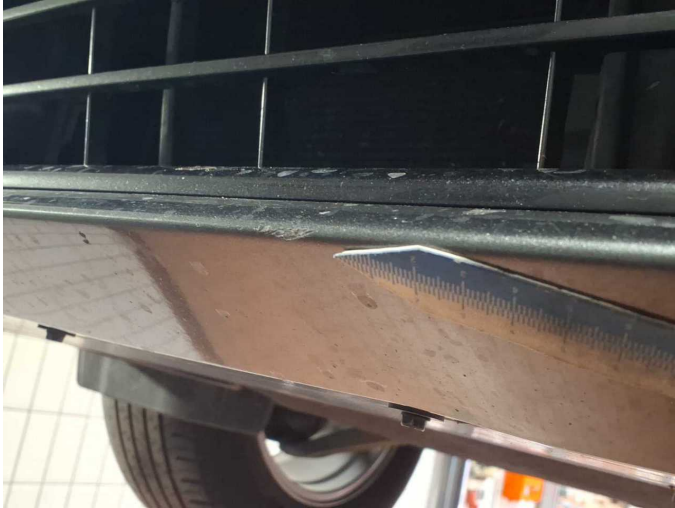
| No. | Component group | Description |
|---|---|---|
| 2 | Front bumper | Spoiler (Unterhalb) - Scratch(es) - Smart repair |

**Damage 2:** Front bumper: Spoiler (Unterhalb) - Scratch(es) - Smart repair

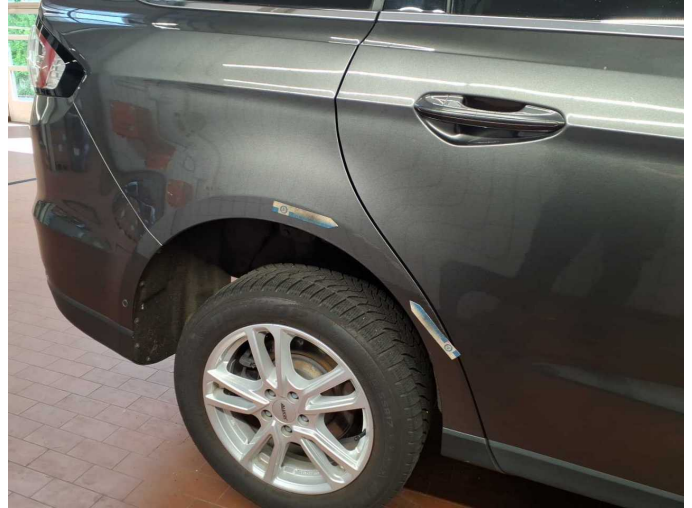
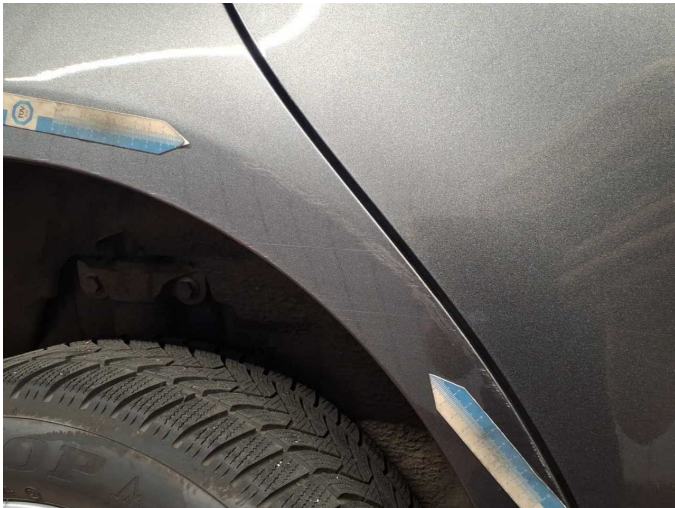
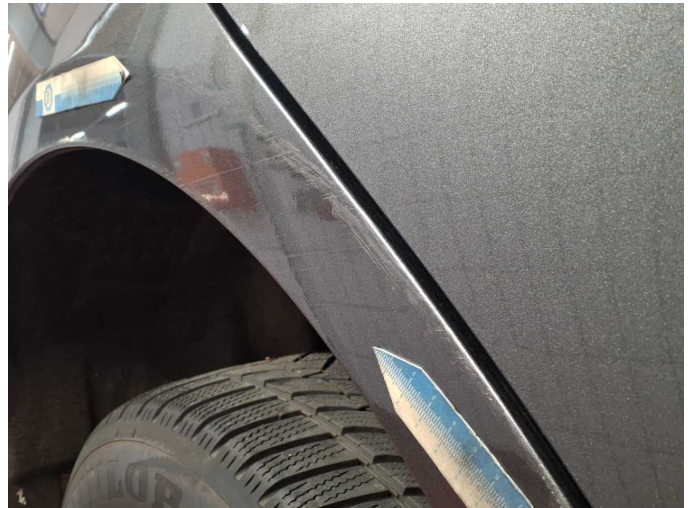
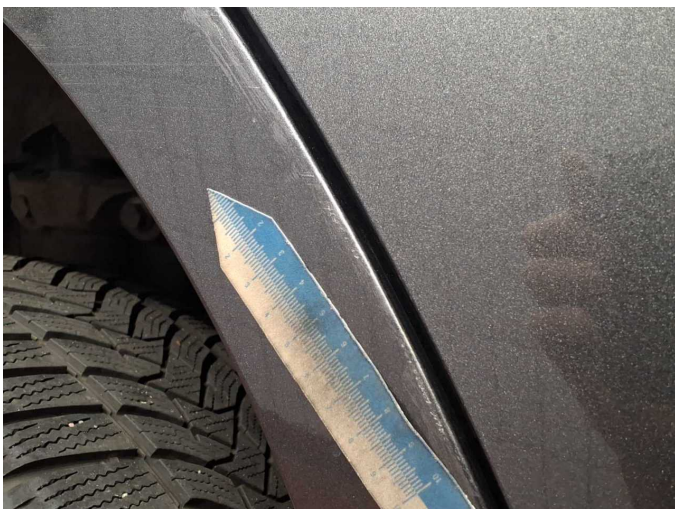
| No. | Component group | Description |
|---|---|---|
| 3 | Side panel - rear right side | Side panel - Scratched - Paint |

**Damage 3:** Side panel - rear right side: Side panel - Scratched - Paint

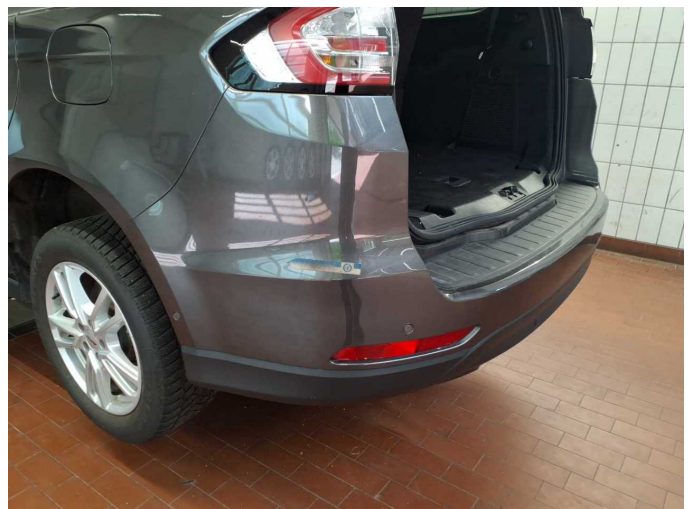
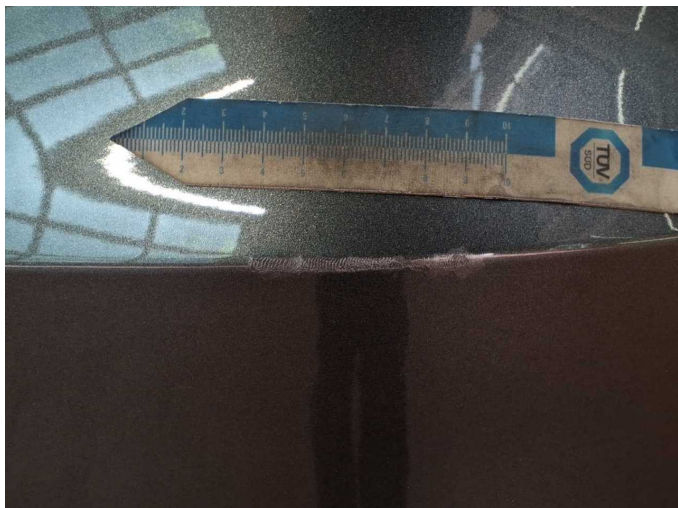
| No. | Component group | Description |
|---|---|---|
| 4 | Rear bumper | Rear bumper - Scratched - Paint |

**Damage 4:** Rear bumper: Rear bumper - Scratched - Paint

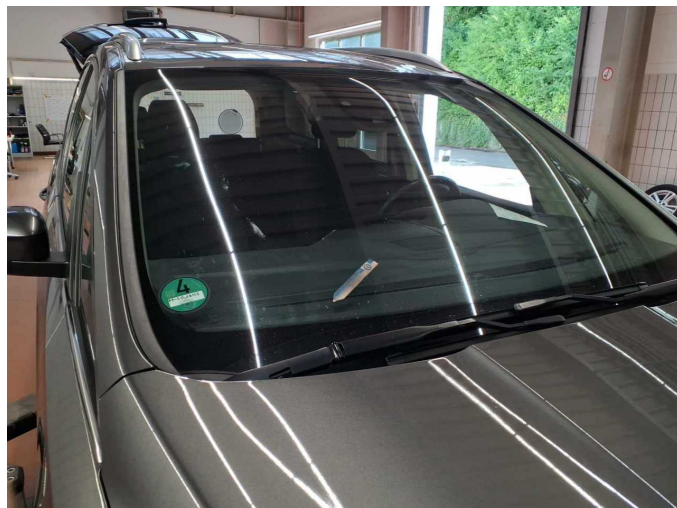
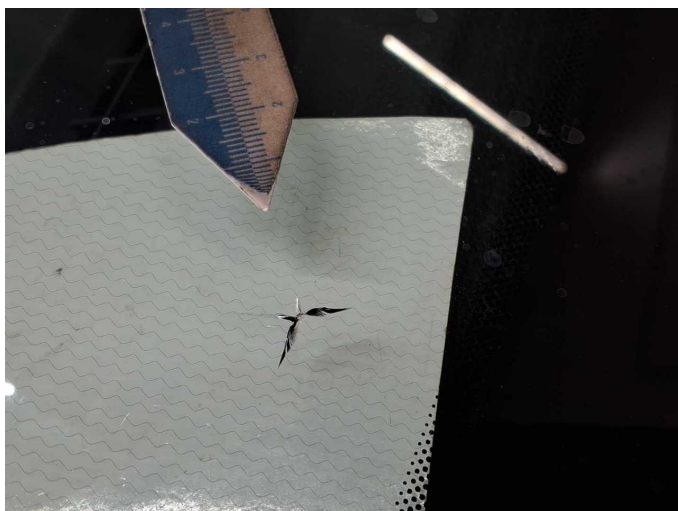
| No. | Component group | Description |
|---|---|---|
| 5 | Vehicle glazing | Windscreen (mit Heizung) - Stone chips - Replace |

**Damage 5:** Vehicle glazing: Windscreen (mit Heizung) - Stone chips - Replace
