Expertise

Protocol number: 46540665  
Order No. / Reference: 26701100  
Inspection date: 16 Jul 2026

Manufacturer: Ford

Model: S-Max 2.0 EcoBlue Aut. TITANIUM

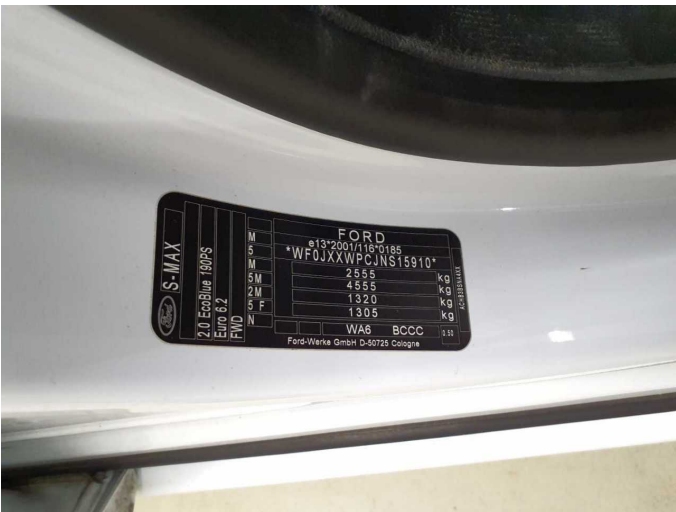
Figure 11: VIN

| VIN comparison | The vehicle identification number (VIN) was read from the vehicle and its conformity with the submitted documents was confirmed by the undersigned during the inspection. |

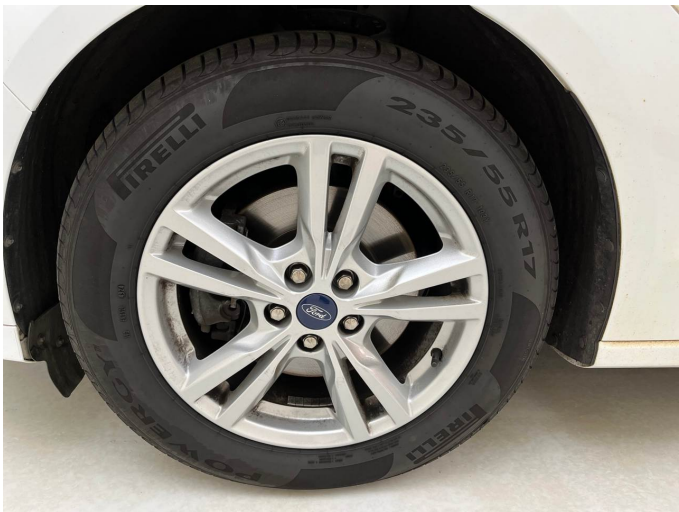
Figure 12: Mounted tyres

| # | Tyre size | Type of tyre | Manufacturer | Tread depth |
|---|---|---|---|---|
| 1) | 235/55 R17 103Y | Summer tyres on Light alloy | Pirelli | 4mm / 4mm |
| 2) | 235/55 R17 103V | Summer tyres on Light alloy | Continental | 4mm / 4mm |

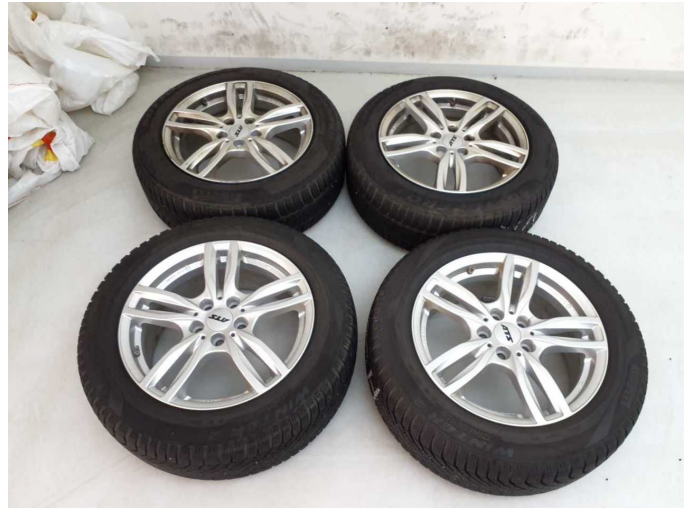
Figure 14: Additional tyres

| # | Tyre size | Type of tyre | Manufacturer | Tread depth |
|---|---|---|---|---|
| 1) | 235/55 R17 103V | Winter tyres on Light alloy | Pirelli | 6mm / 6mm |
| 2) | 235/55 R17 103V | Winter tyres on Light alloy | Pirelli | 6mm / 6mm |

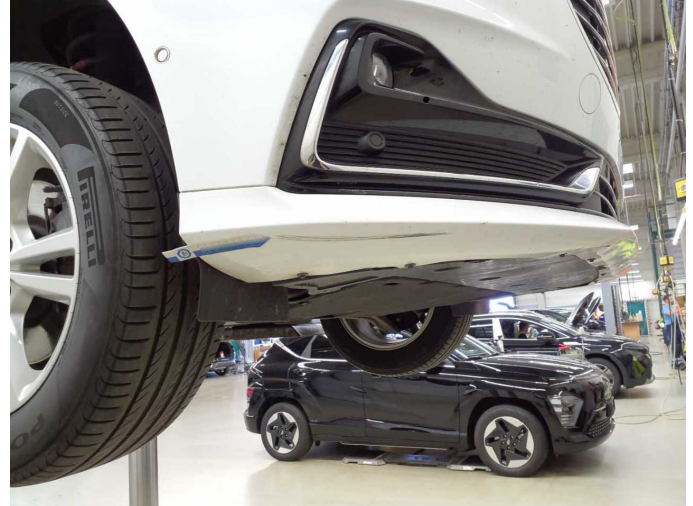
| No. | Component group | Description |
|---|---|---|
| 2 | Front bumper | Bumper with Parktronic - Scratched - Smart repair |

**Damage 2:** Front bumper: Bumper with Parktronic - Scratched - Smart repair

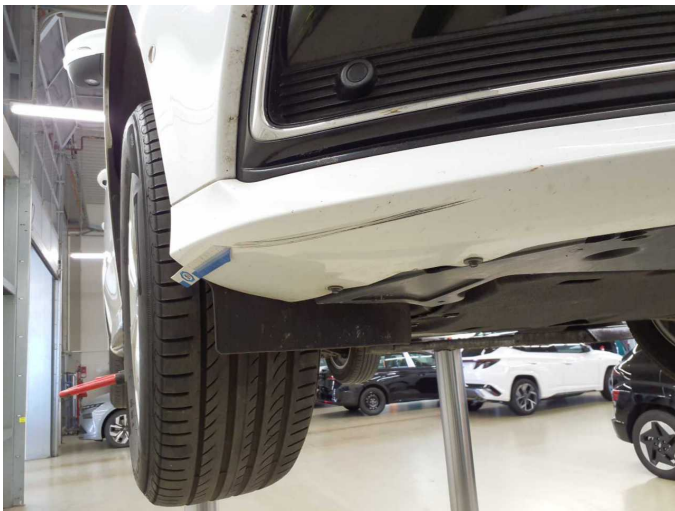
**Damage 2:** Front bumper: Bumper with Parktronic - Scratched - Smart repair

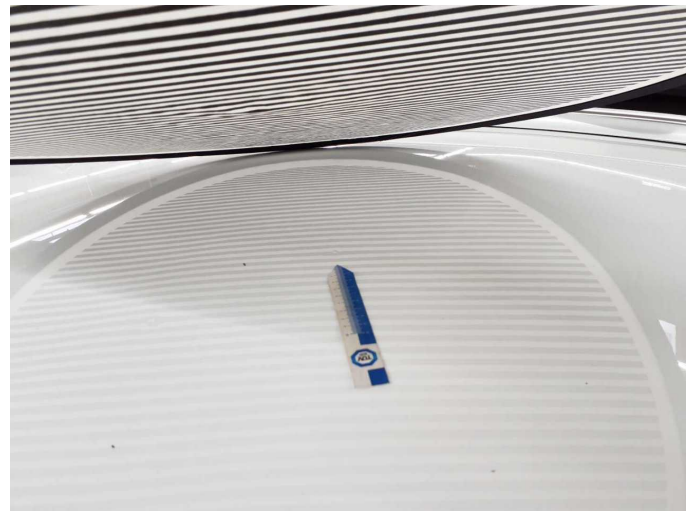
| No. | Component group | Description |
|---|---|---|
| 3 | Roof | Roof - dent(s) - Smart repair |

**Damage 3:** Roof: Roof - dent(s) - Smart repair

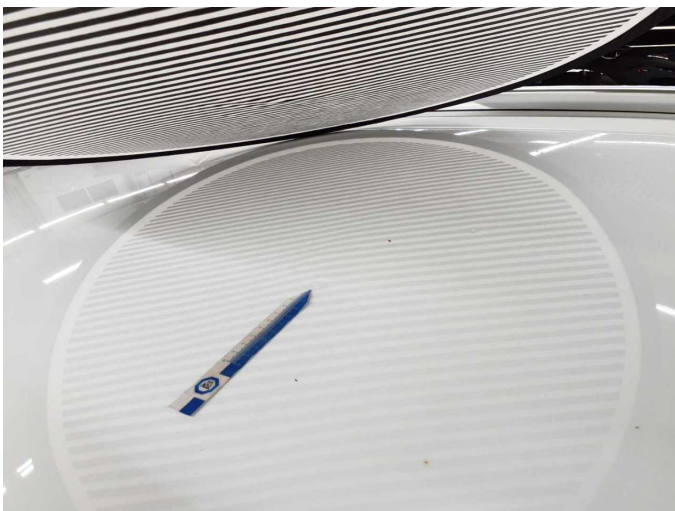
**Damage 3:** Roof: Roof - dent(s) - Smart repair

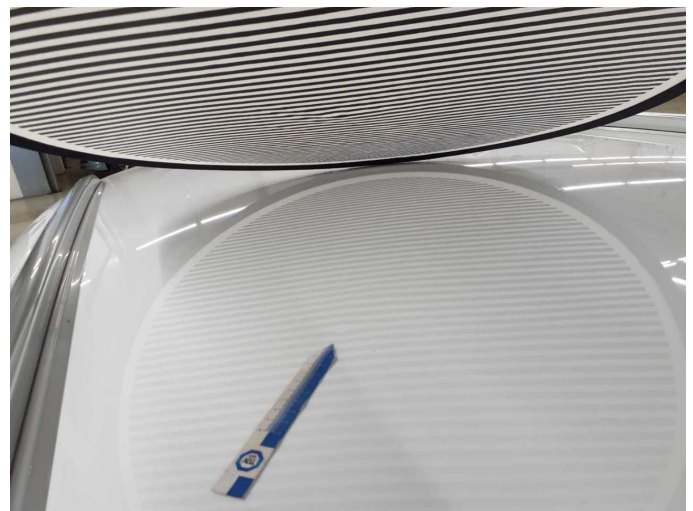
**Damage 3:** Roof: Roof - dent(s) - Smart repair

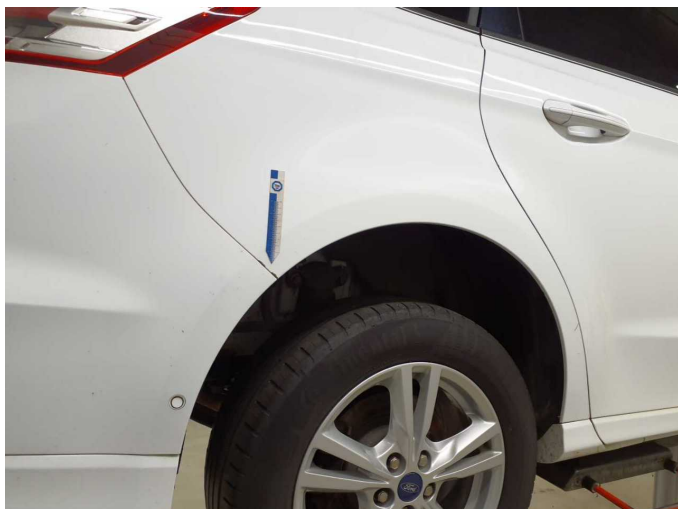
| No. | Component group | Description |
|---|---|---|
| 4 | Side panel - rear right side | Side panel - Paint defect - Paint |

**Damage 4:** Side panel - rear right side: Side panel - Paint defect - Paint

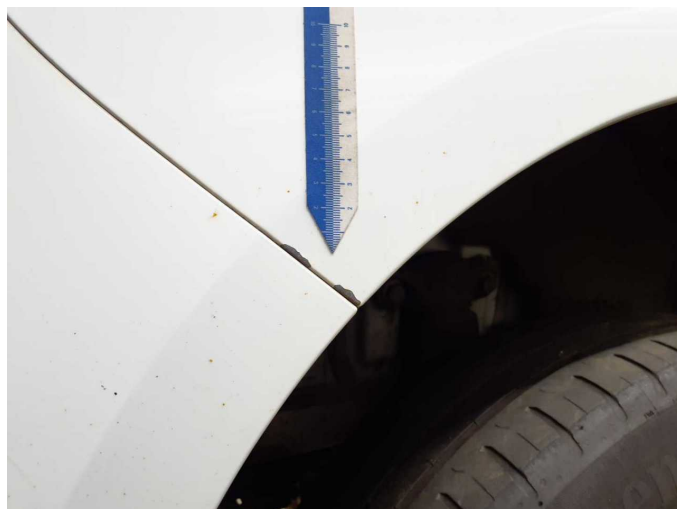
**Damage 4:** Side panel - rear right side: Side panel - Paint defect - Paint

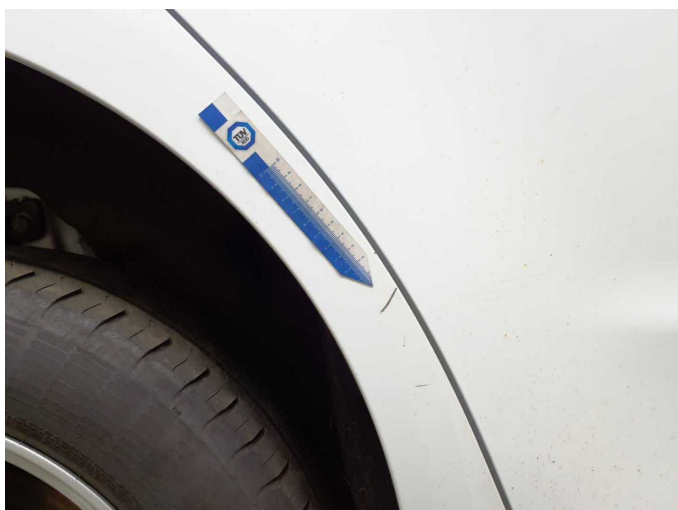
**Damage 4:** Side panel - rear right side: Side panel - Paint defect - Paint

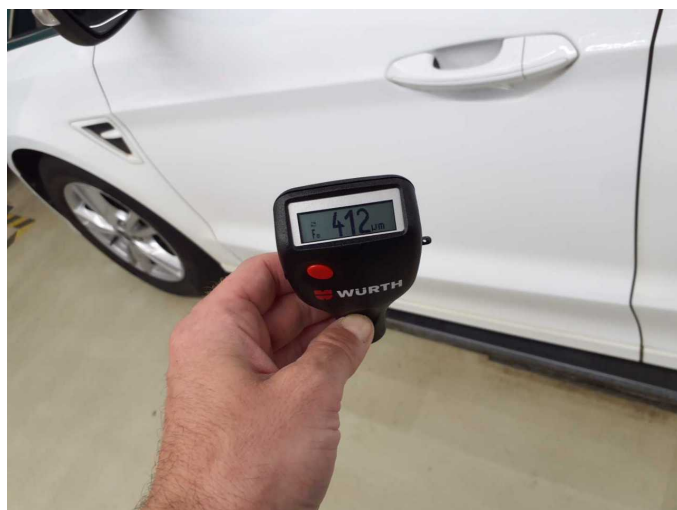
| No. | Repainting |
|---|---|
| 1 | Door - front left side |

| Door - front left side | 412 µm |

**Door - front left side:** 412 µm
