Expertise

Protocol number: 46614360  
Order No. / Reference: 26740838  
Inspection date: 14 Jul 2026

Manufacturer: Audi

Model: A4 Avant 35 TDI S tronic

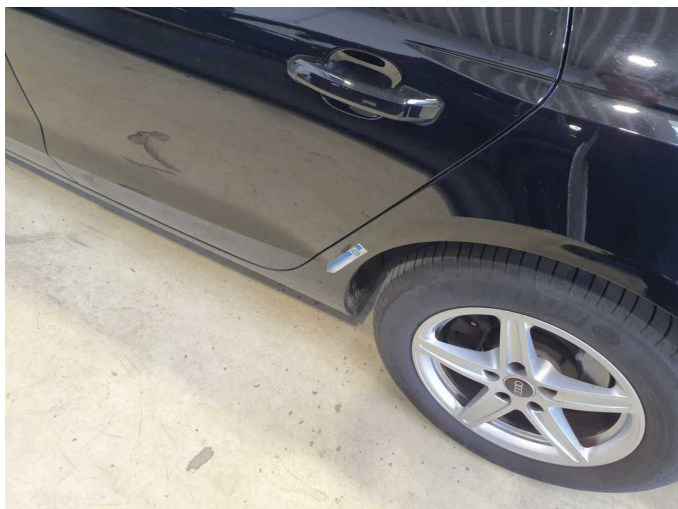
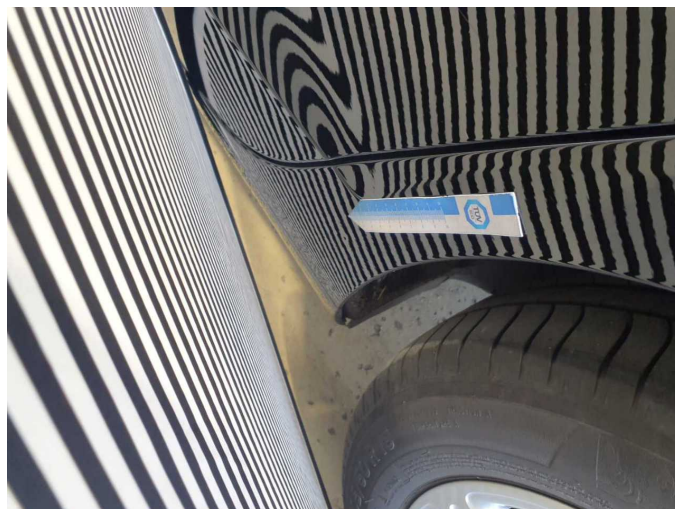
| No. | Component group | Description |
|---|---|---|
| 1 | Side panel - rear left side | Side panel - dent(s) - Smooth repair work |

**Damage 1:** Side panel - rear left side: Side panel - dent(s) - Smooth repair work

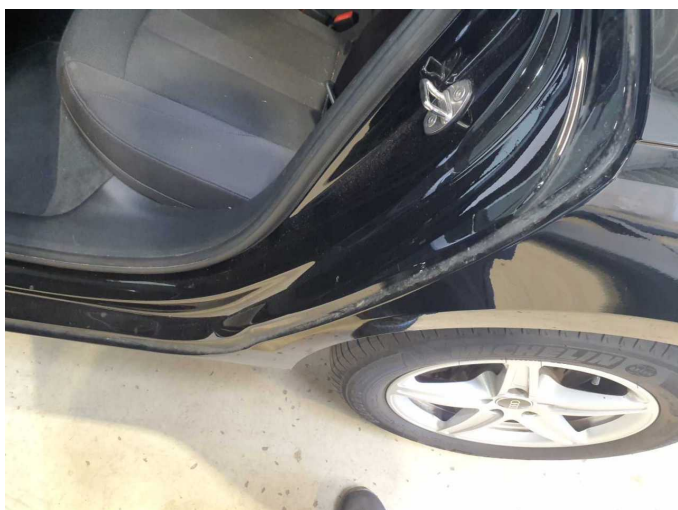
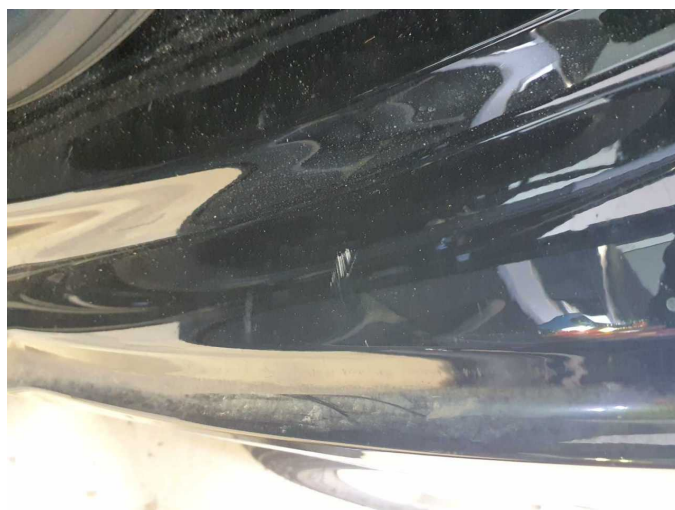
| No. | Component group | Description |
|---|---|---|
| 2 | Side panel - rear left side | Sill - Scratch(es) - Smart repair |

**Damage 2:** Side panel - rear left side: Sill - Scratch(es) - Smart repair

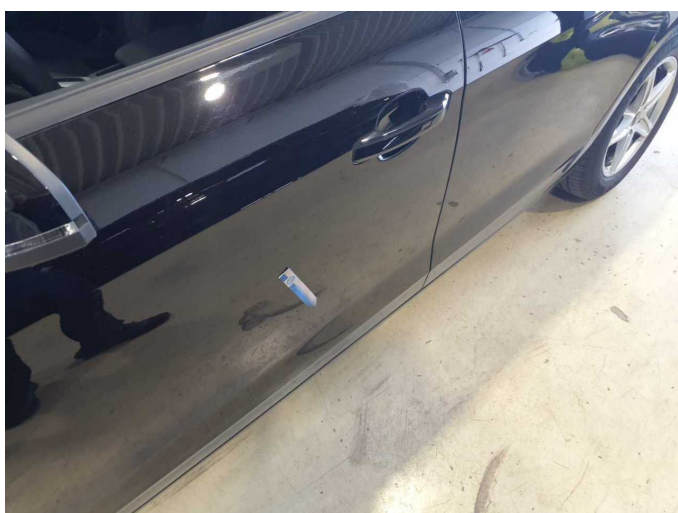
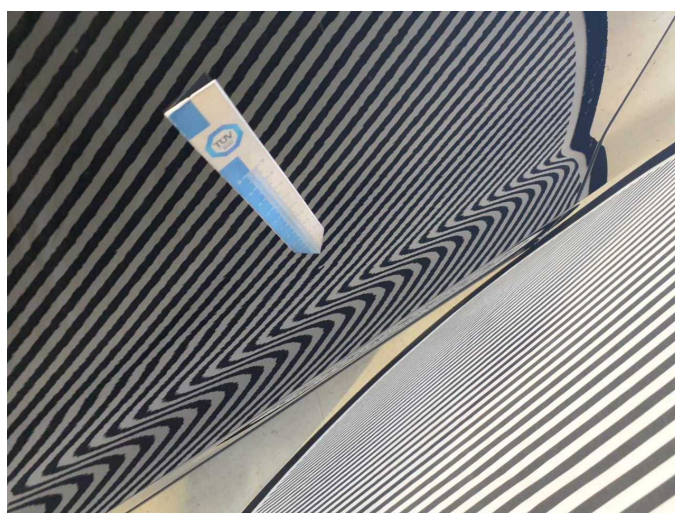
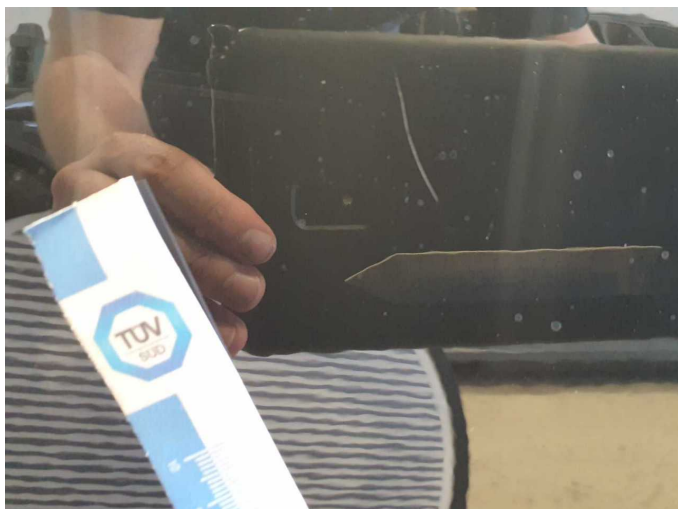
| No. | Component group | Description |
|---|---|---|
| 3 | Door - front left side | Door - Dent / paintcoat damage - Smart repair |

**Damage 3:** Door - front left side: Door - Dent / paintcoat damage - Smart repair

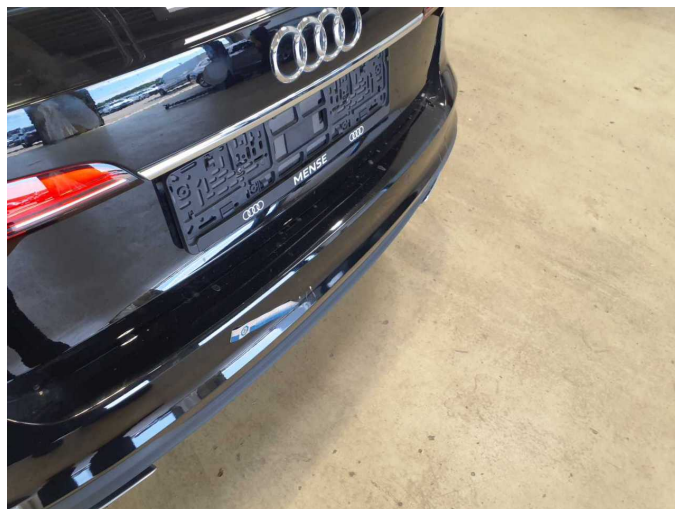
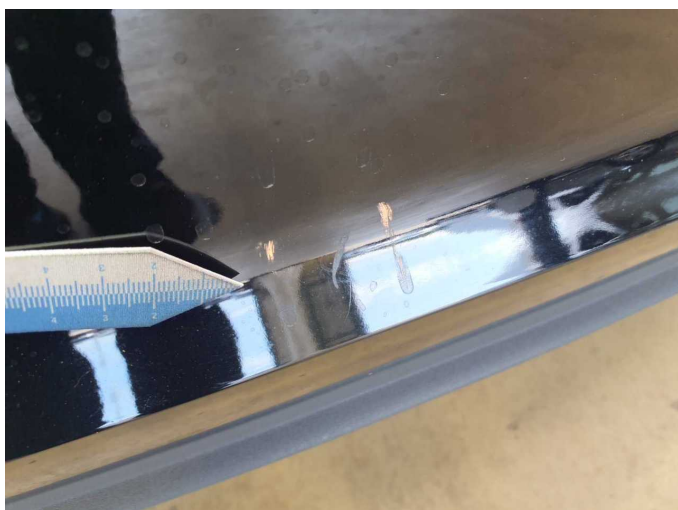
| No. | Component group | Description |
|---|---|---|
| 4 | Rear bumper | Rear bumper - Scratch(es) - Smart repair |

**Damage 4:** Rear bumper: Rear bumper - Scratch(es) - Smart repair

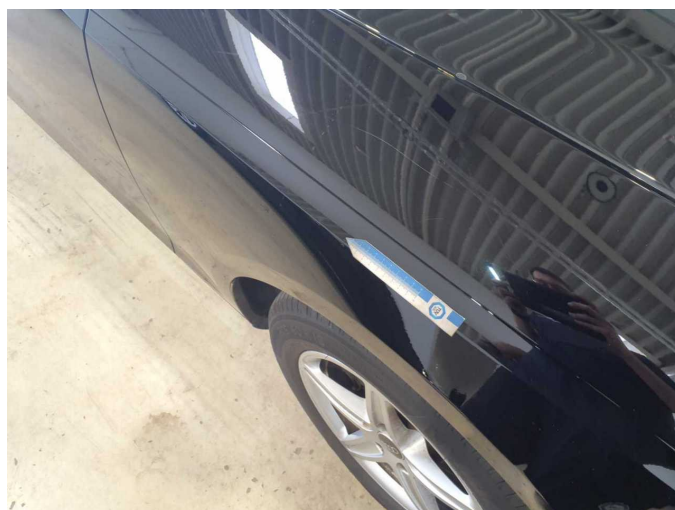
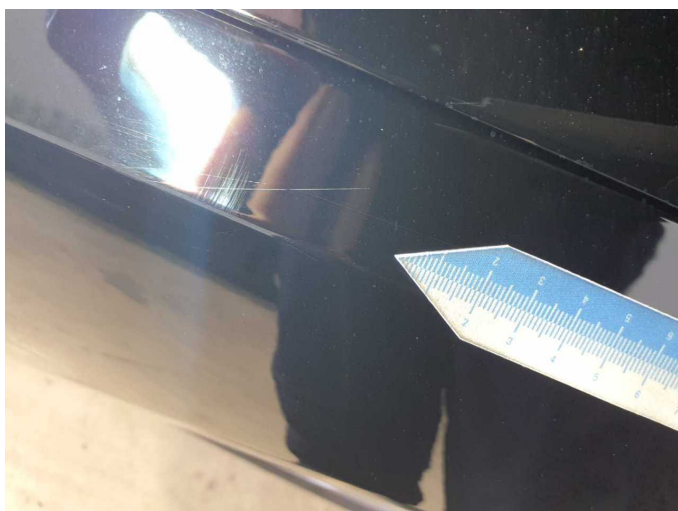
| No. | Component group | Description |
|---|---|---|
| 5 | Mudguard - right side | Mudguard - right side - Scratch(es) - Smart repair |

**Damage 5:** Mudguard - right side: Mudguard - right side - Scratch(es) - Smart repair

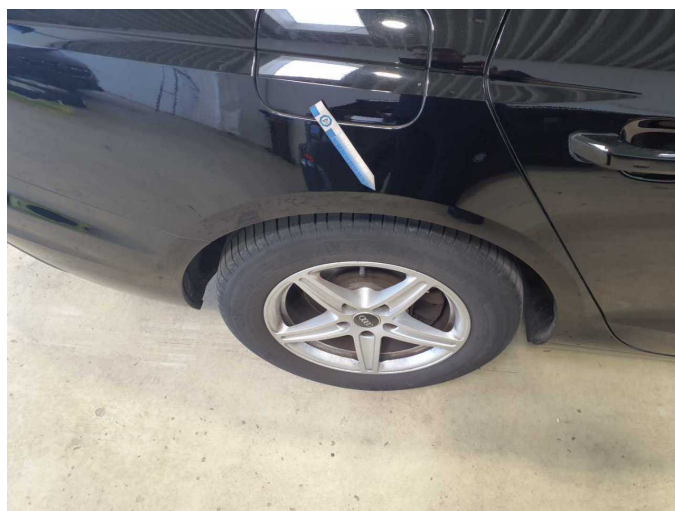
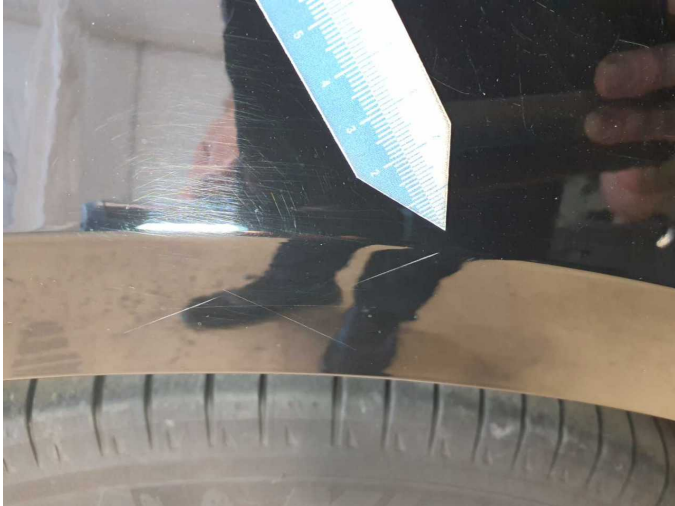
| No. | Component group | Description |
|---|---|---|
| 6 | Side panel - rear right side | Side panel - Scratch(es) - Smart repair |

**Damage 6:** Side panel - rear right side: Side panel - Scratch(es) - Smart repair

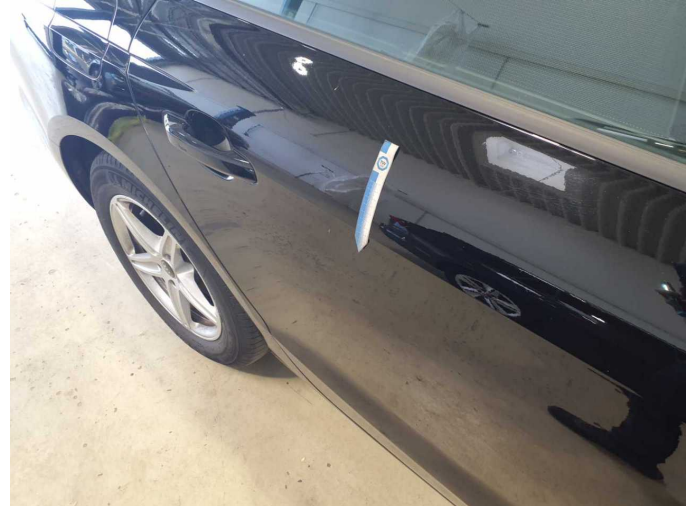
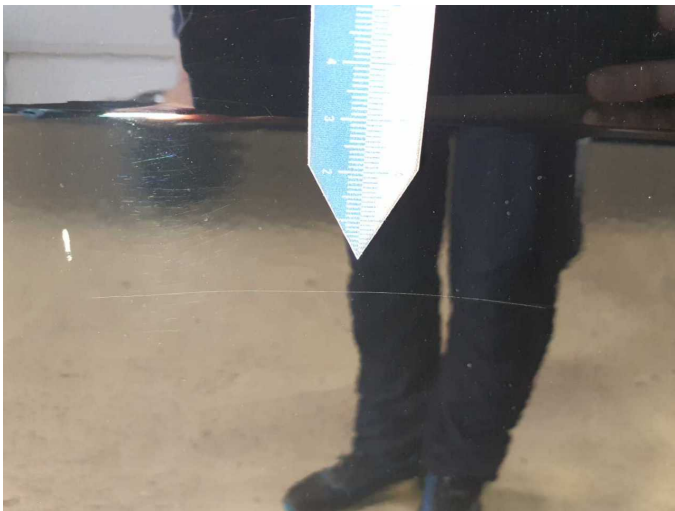
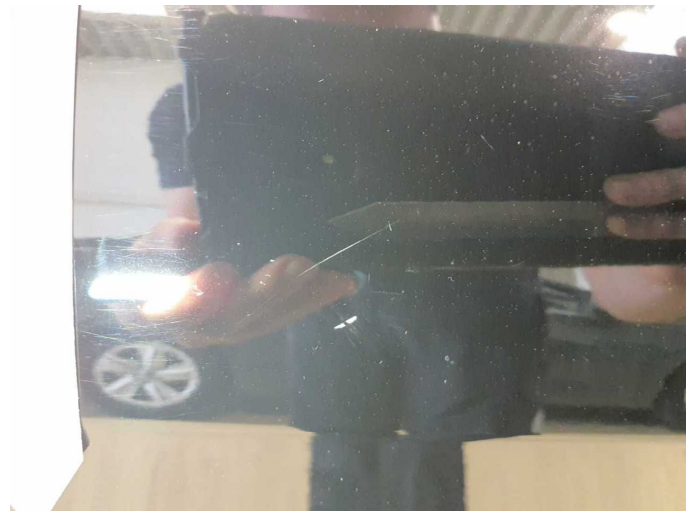
| No. | Component group | Description |
|---|---|---|
| 7 | Door - rear right side | Door - Scratch(es) - Paint |

**Damage 7:** Door - rear right side: Door - Scratch(es) - Paint

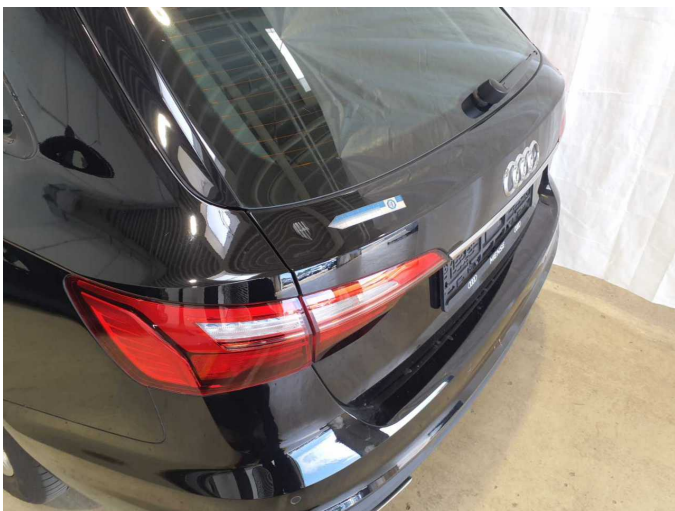
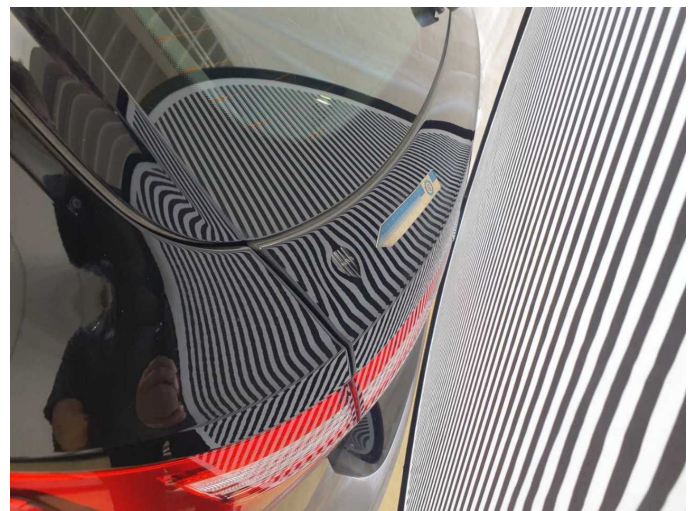
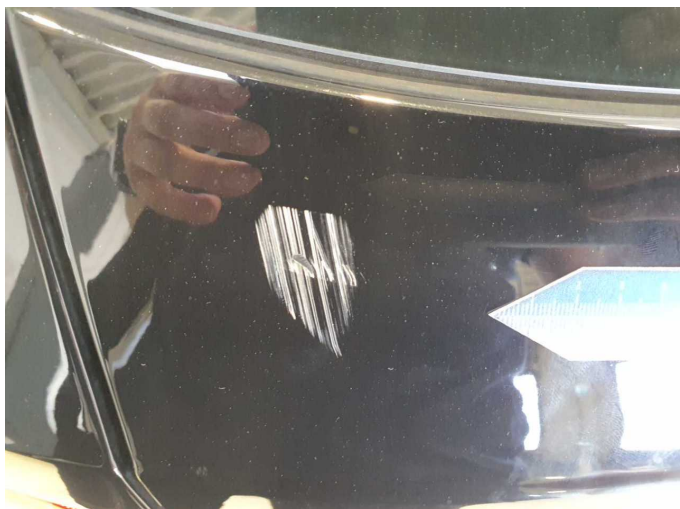
| No. | Component group | Description |
|---|---|---|
| 8 | Boot lid / rear door | Boot lid - Dent / paintcoat damage - Repair and paint |

**Damage 8:** Boot lid / rear door: Boot lid - Dent / paintcoat damage - Repair and paint

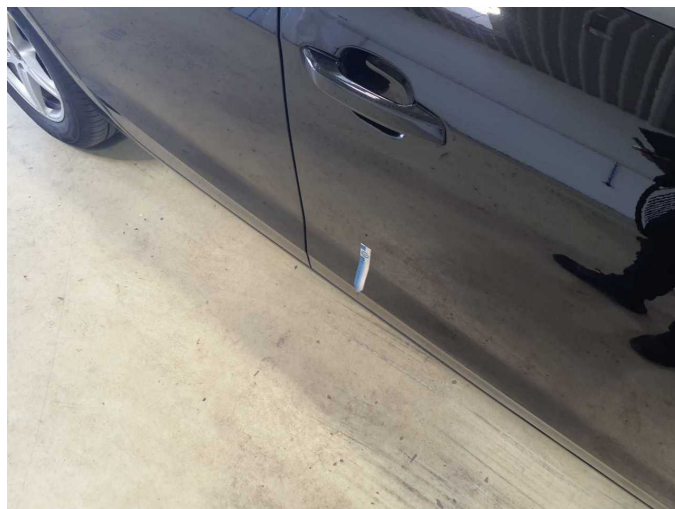
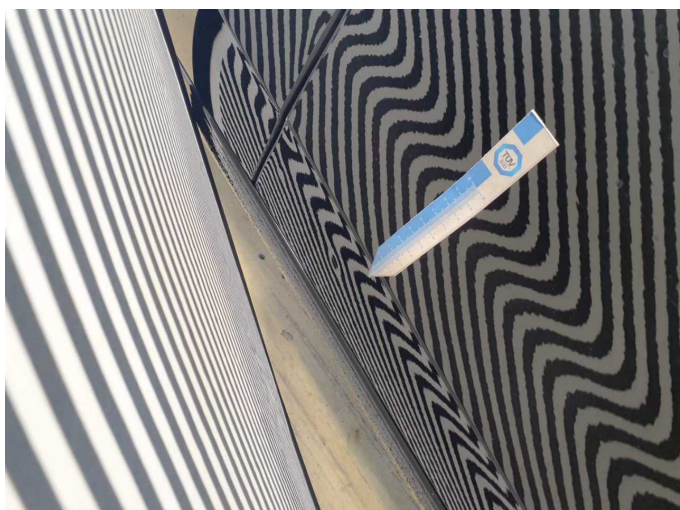
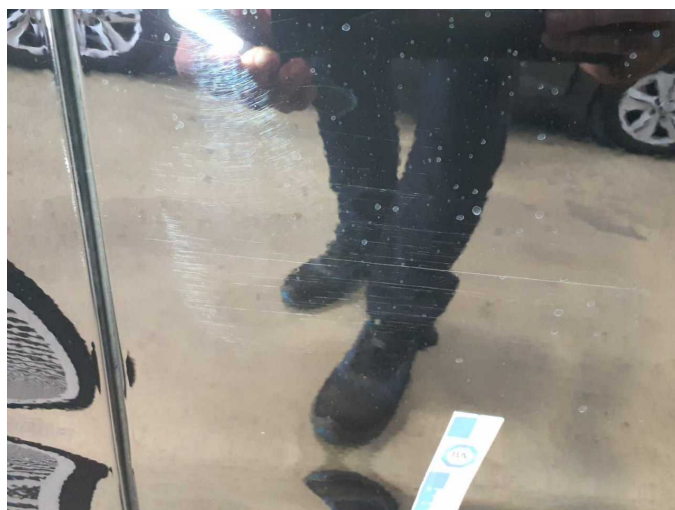
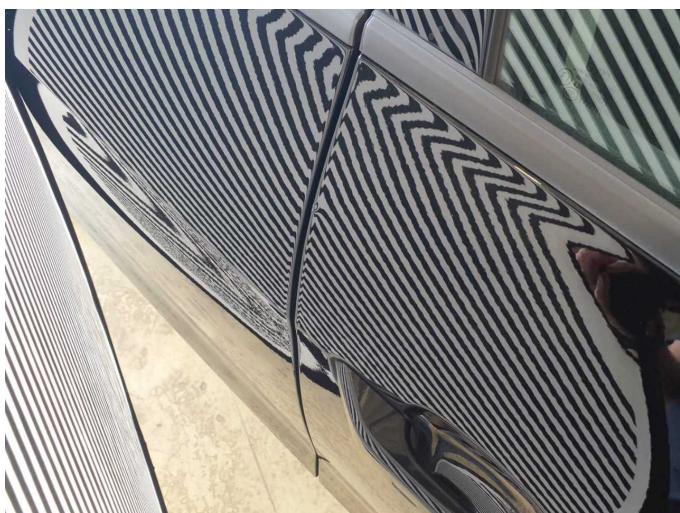
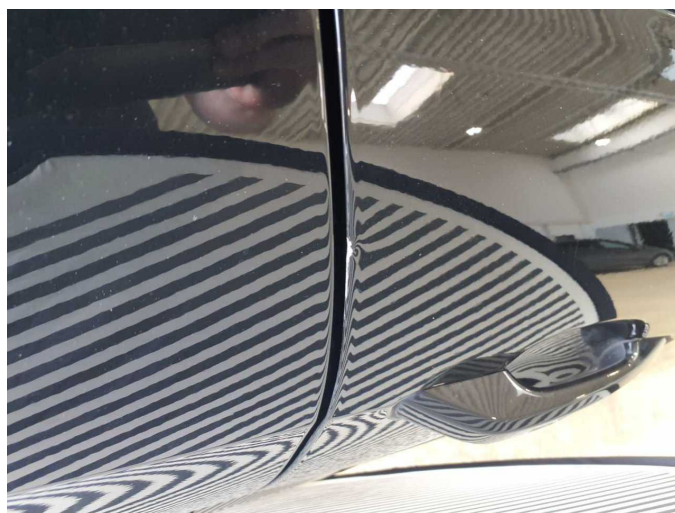
| No. | Component group | Description |
|---|---|---|
| 9 | Door - front right side | Door - Dent / paintcoat damage - Repair and paint |

**Damage 9:** Door - front right side: Door - Dent / paintcoat damage - Repair and paint

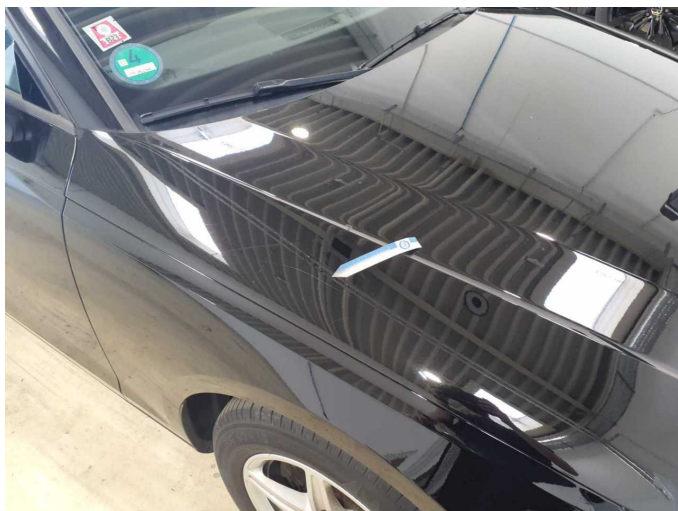
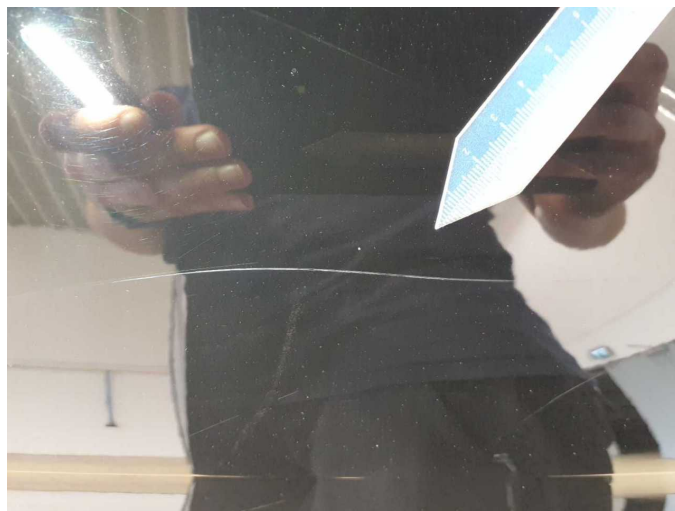
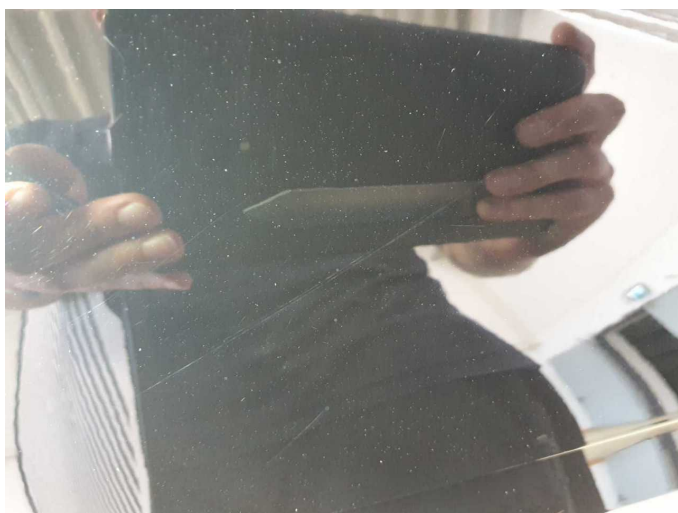
| No. | Component group | Description |
|---|---|---|
| 10 | Bonnet | Bonnet - Scratch(es) - Paint |

**Damage 10:** Bonnet: Bonnet - Scratch(es) - Paint

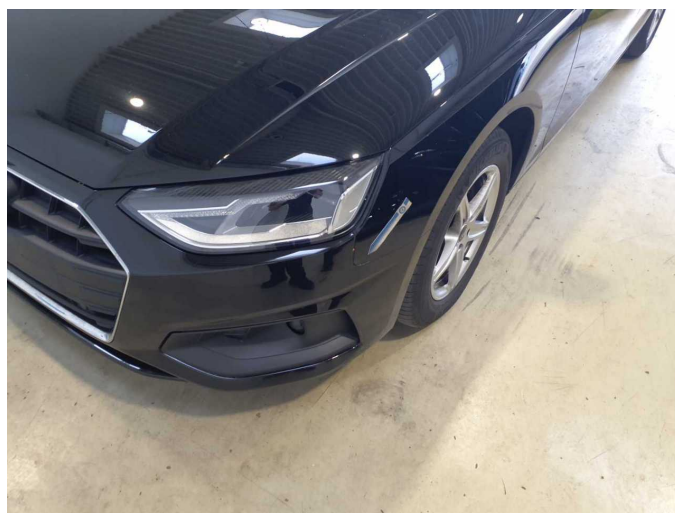
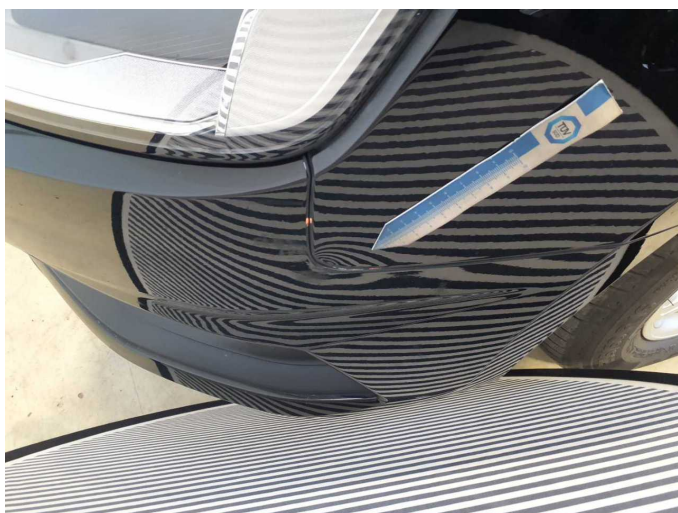
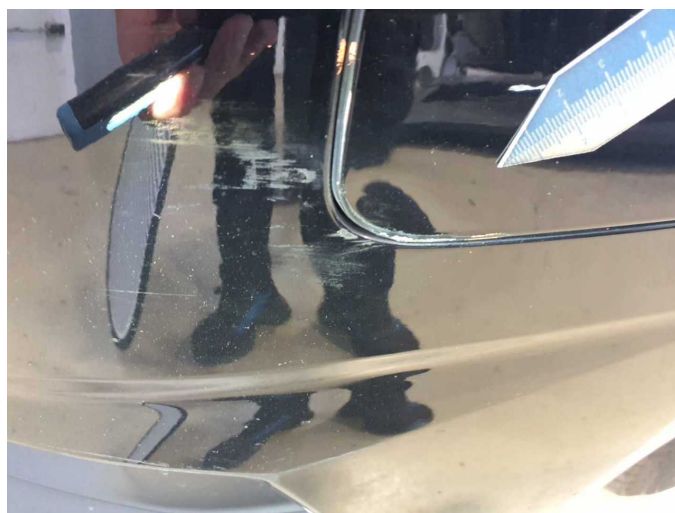
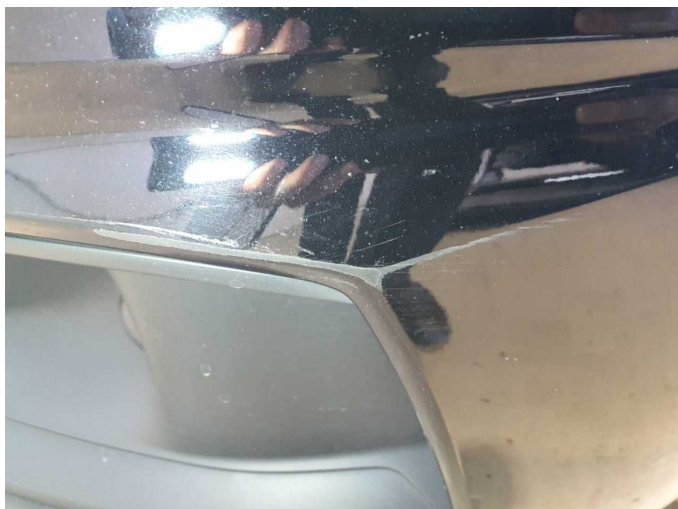
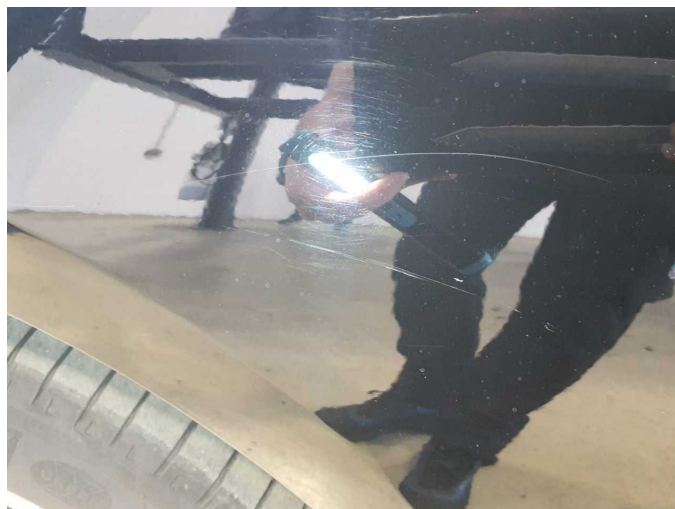
- 1 Front, Side - left

Non-repaired previous damages were found at the vehicle. The necessary repair costs are listed in the expert report or if necessary, are listed in detail in a separately enclosed repair cost calculation.

**Accident 1:** Front, Side - left

- Die beigefügte Reparaturkostenkalkulation wurde nach bestem Wissen und Gewissen unter eingeschränkter Besichtigungsbedingung im demontagefreien Zustand erstellt. Es können aufgrund verdeckter Beschädigung erhebliche Mehrkosten und somit Abweichung der für den Unfall ausgewiesenen Reparaturkosten nicht ausgeschlossen werden
