Expertise

Protocol number: 46023148
Order No. / Reference: 26446077
Inspection date: 18 Jun 2026

Model: Superb Combi 2.0 TDI DSG Ambition

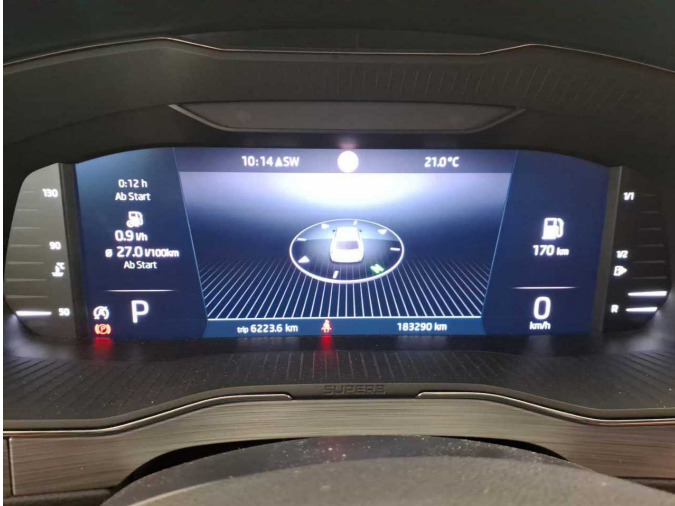
Figure 7: Instrument cluster

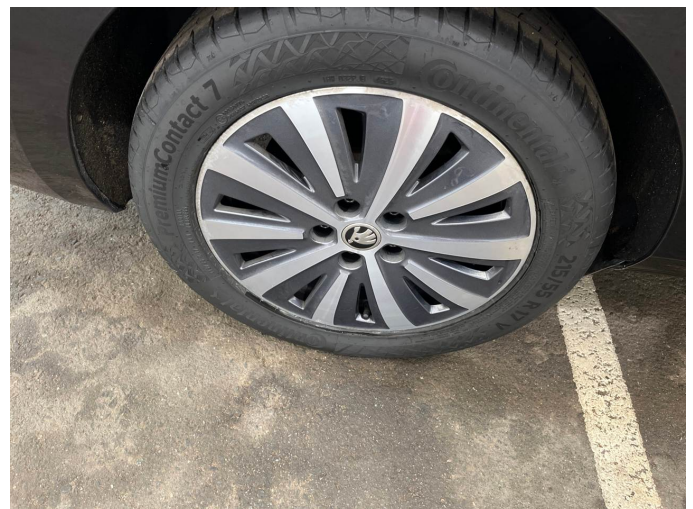
#	Tyre size	Type of tyre	Manufacturer	Tread depth
1)	215/55 R17 94V	Summer tyres on Light alloy	Continental	7mm / 7mm
2)	215/55 R17 94V	Summer tyres on Light alloy	Continental	7mm / 7mm

Figure 12: Mounted tyres

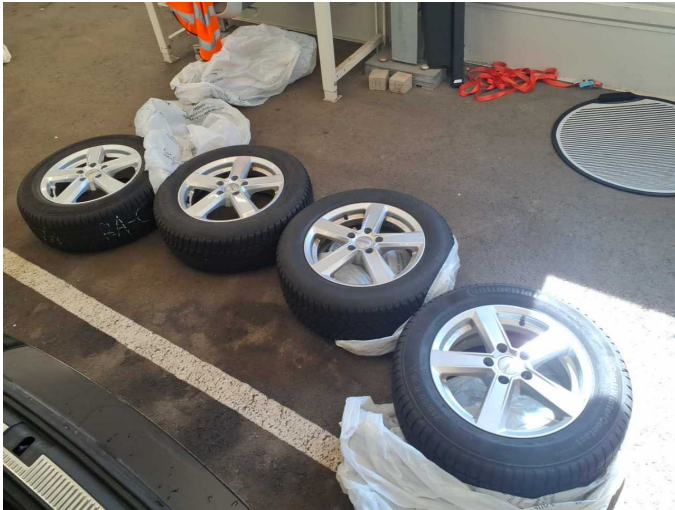
#	Tyre size	Type of tyre	Manufacturer	Tread depth
1)	215/60 R16 95H	Winter tyres on Light alloy	Dunlop	7mm / 7mm
2)	215/60 R16 99H	Winter tyres on Light alloy	Continental	7mm / 7mm

Figure 19: Additional tyres

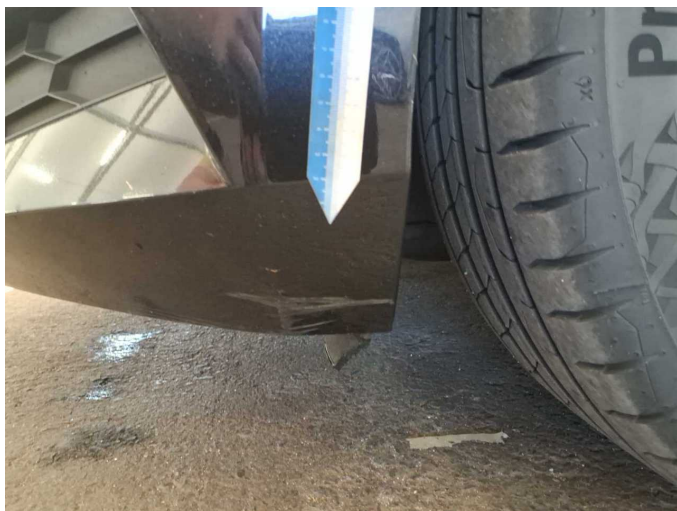
Damage 1: Front bumper: Front bumper - Scratched - Smart repair

No.	Component group	Description
1	Front bumper	Front bumper - Scratched - Smart repair

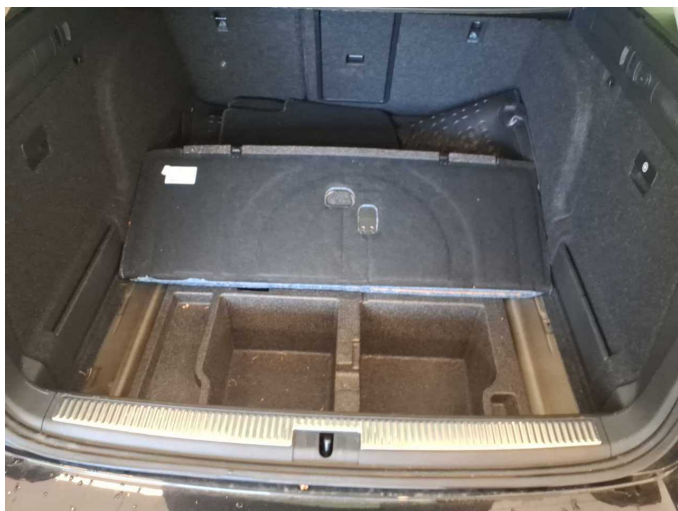
Missing part 2: Equipment: Tirefit complete - Missing - Replace

Documents - Service book (Digitaler Ausdruck)
Equipment - Tirefit complete
