Expertise

Protocol number: 46444785  
Order No. / Reference: 26587566  
Inspection date: 10 Jul 2026

| Manufacturer: Volvo | Model: XC60 B5 B AWD Ultra Dark |

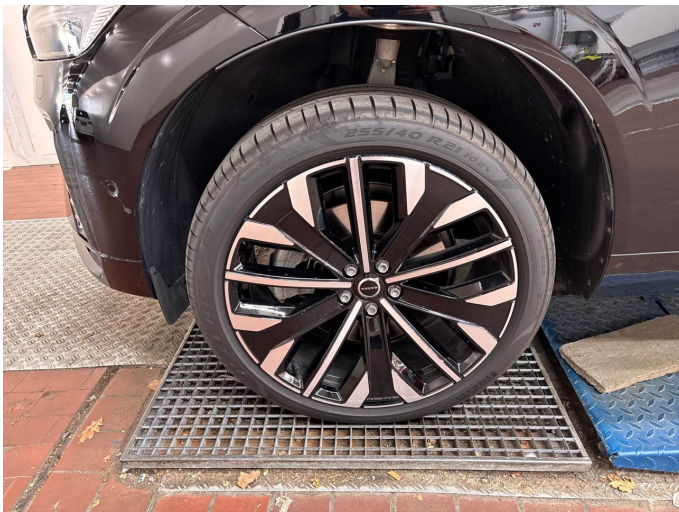
Figure 12: Mounted tyres

| # | Tyre size | Type of tyre | Manufacturer | Tread depth |
|---|---|---|---|---|
| 1) | 255/40 R21 102V | Summer tyres on Light alloy | Pirelli | 6mm / 6mm |
| 2) | 255/40 R21 102V | Summer tyres on Light alloy | Pirelli | 6mm / 6mm |

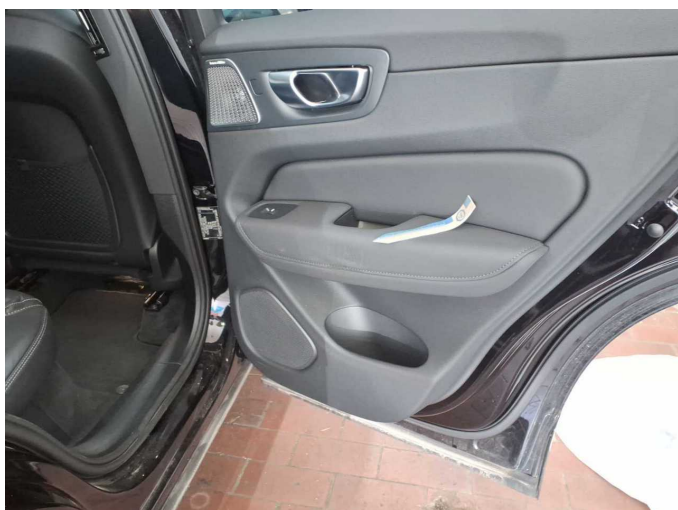
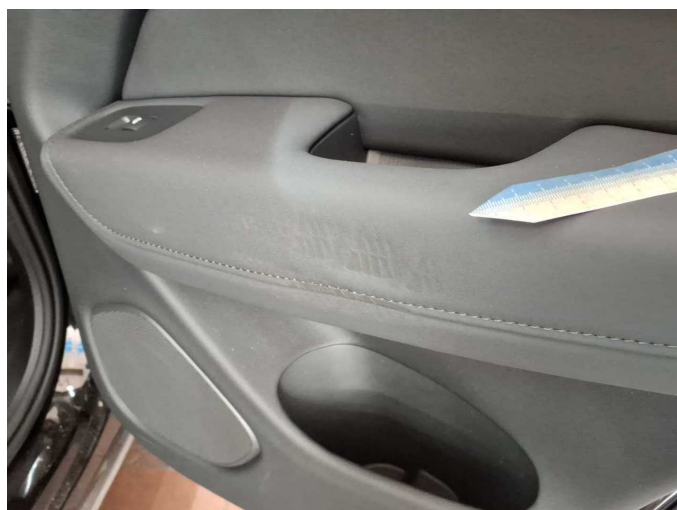
| No. | Component group | Description |
|---|---|---|
| 1 | Trim / covers | Door trim - rear left side - Deformed - Loss in value |

**Damage 1:** Trim / covers: Door trim - rear left side - Deformed - Loss in value

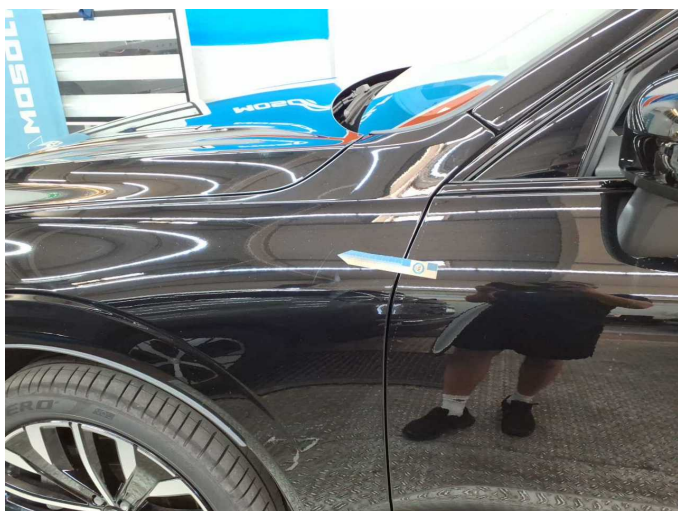
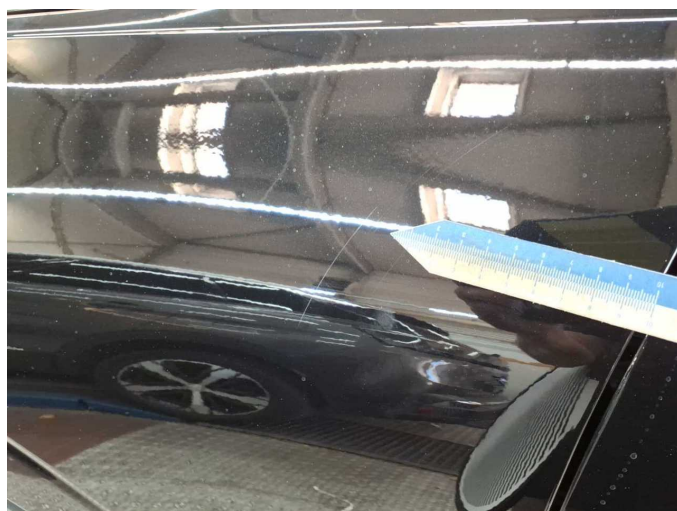
| No. | Component group | Description |
|---|---|---|
| 2 | Mudguard - left side | Mudguard - left side (Polieren) - Scratch(es) - Smart repair |

**Damage 2:** Mudguard - left side: Mudguard - left side (Polieren) - Scratch(es) - Smart repair

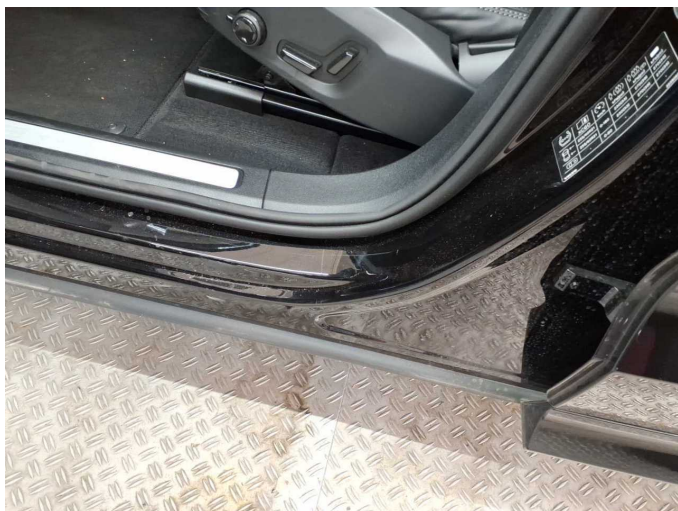
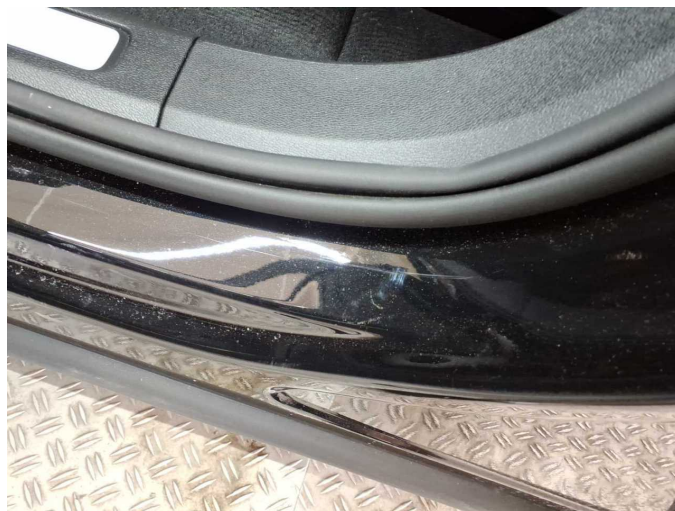
| No. | Component group | Description |
|---|---|---|
| 3 | Sill - left side | Sill - Scratch(es) - Smart repair |

**Damage 3:** Sill - left side: Sill - Scratch(es) - Smart repair

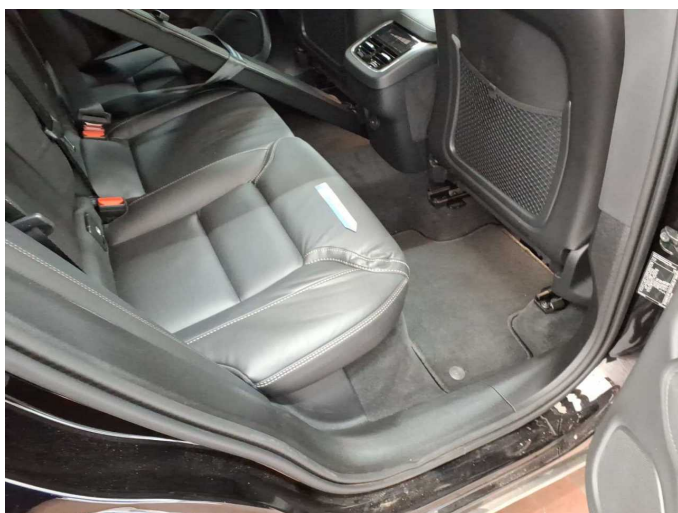
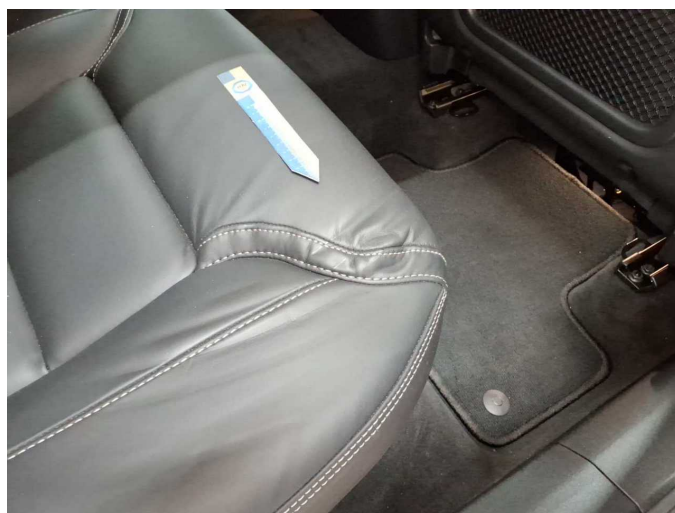
| No. | Component group | Description |
|---|---|---|
| 4 | Seat - rear | Back seat - Deformed - Loss in value |

**Damage 4:** Seat - rear: Back seat - Deformed - Loss in value

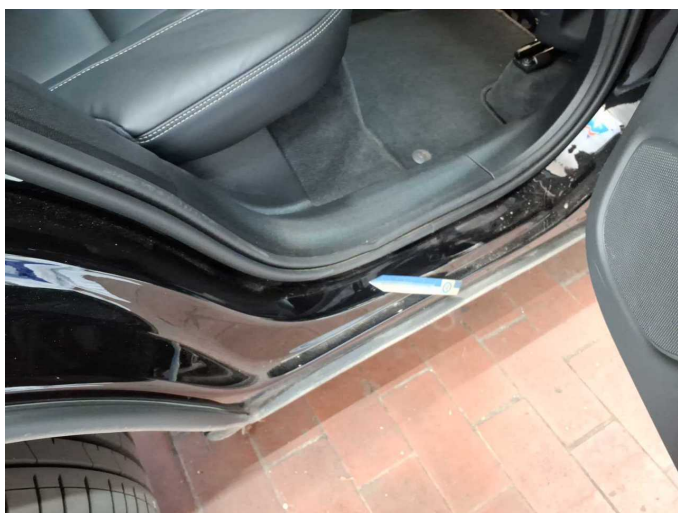
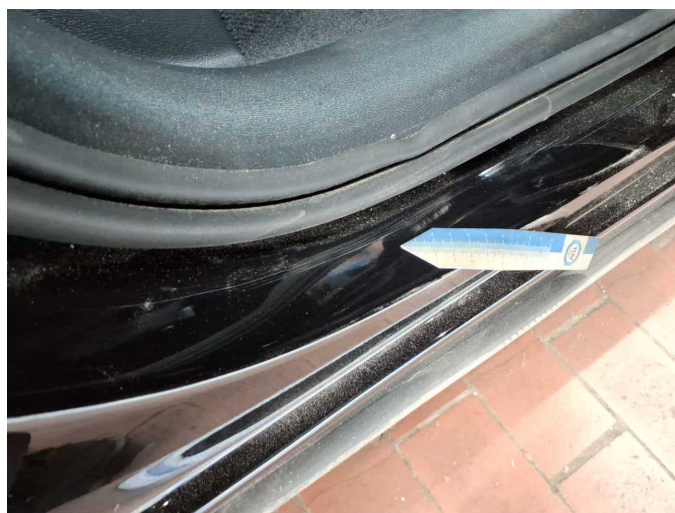
| No. | Component group | Description |
|---|---|---|
| 5 | Side panel - rear right side | Sill - Scratch(es) - Smart repair |

**Damage 5:** Side panel - rear right side: Sill - Scratch(es) - Smart repair

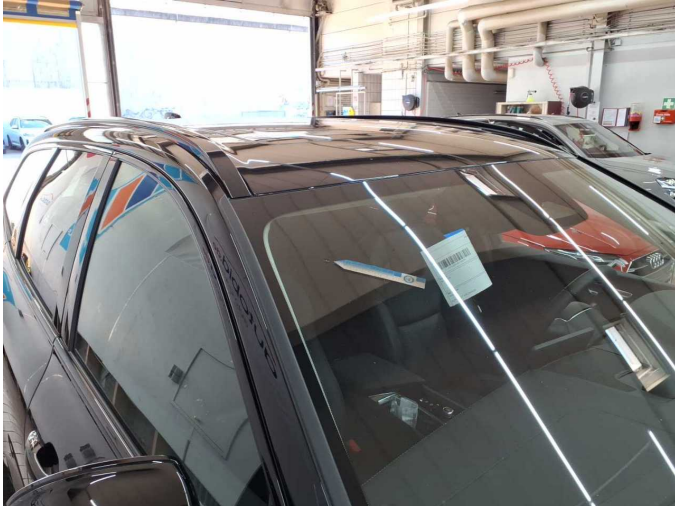
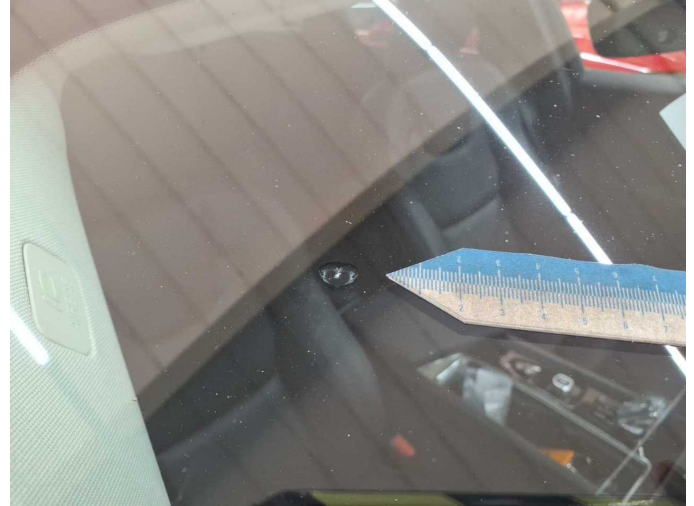
| No. | Component group | Description |
|---|---|---|
| 6 | Vehicle glazing | Windscreen (vorbehaltlich Folgekosten) - Stone chips - Smart repair |

**Damage 6:** Vehicle glazing: Windscreen (vorbehaltlich Folgekosten) - Stone chips - Smart repair

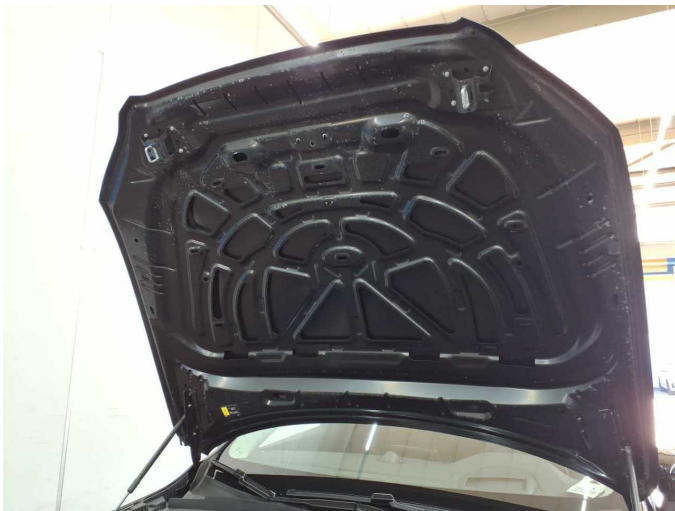
| No. | Component group | Description |
|---|---|---|
| 7 | Bonnet | Insulation lining - Missing - Replace |

**Damage 7:** Bonnet: Insulation lining - Missing - Replace
