## 2-FHA-988

2-FHA-988 · ST Line 1.0i EcoBoost 125pk M6 · 28 July 2026 · Zaventem (BE)

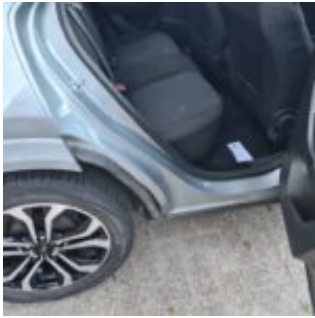
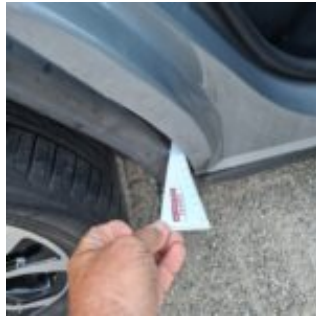
| Damage Part | Damage Type | Notes | Repair Type | Acceptable |
|---|---|---|---|---|
| Skirt - Right | Dislocated / Loose | Rubber | Repair | No |

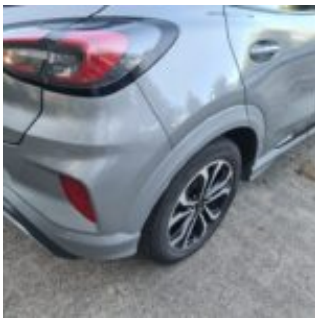
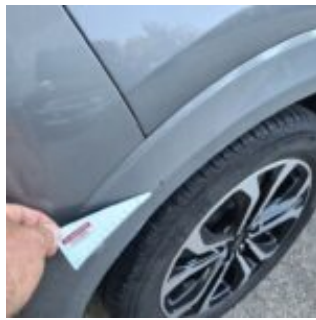
| Damage Part | Damage Type | Repair Type | Acceptable |
|---|---|---|---|
| Overfender | Small scratch(es) | Touch-up / Polish | No |

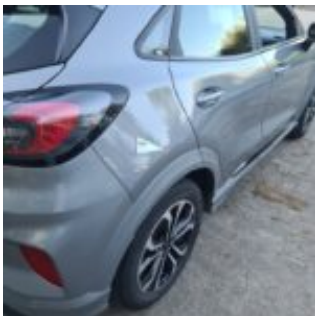
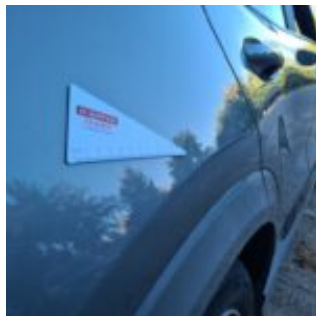
| Damage Part | Damage Type | Repair Type | Acceptable |
|---|---|---|---|
| Fender - Rear Right | Small dent(s) | Restyle | No |

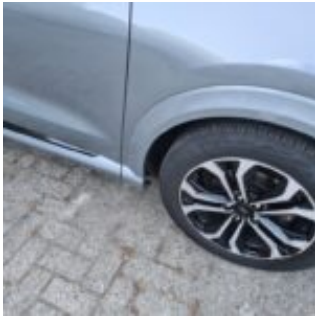
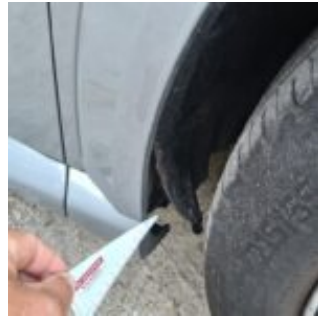
| Damage Part | Damage Type | Notes | Repair Type | Acceptable |
|---|---|---|---|---|
| Other | Dislocated / Loose | Wielkuipbescherming | Repair | No |

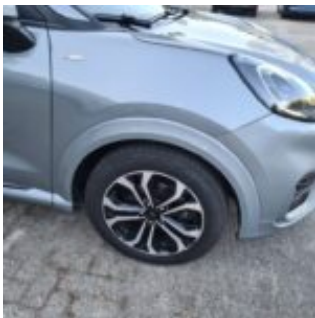
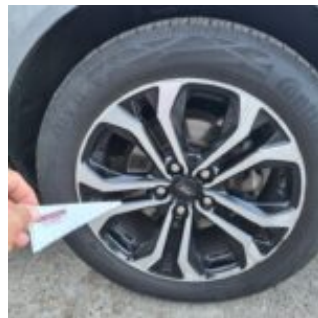
| Damage Part | Damage Type | Repair Type | Acceptable |
|---|---|---|---|
| Alloy – Right Front | Damaged | Rim repair | No |

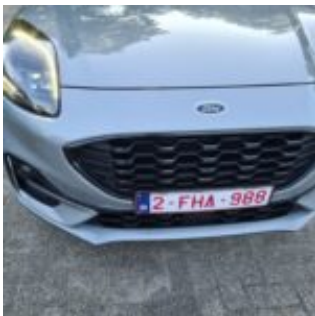
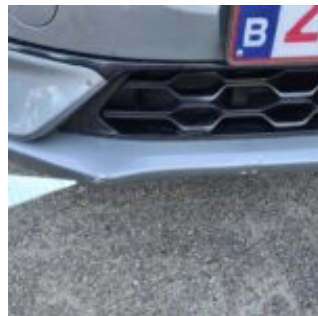
| Damage Part | Damage Type | Repair Type | Acceptable |
|---|---|---|---|
| spoiler FB | Scratch(es) | Spray | No |

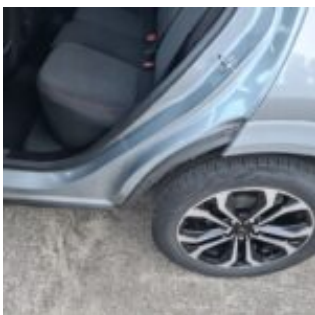
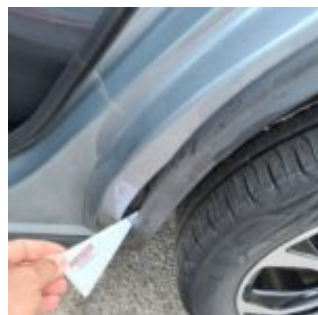
| Damage Part | Damage Type | Notes | Repair Type | Acceptable |
|---|---|---|---|---|
| Skirt - Left | Dislocated / Loose | Rubber | Repair | No |

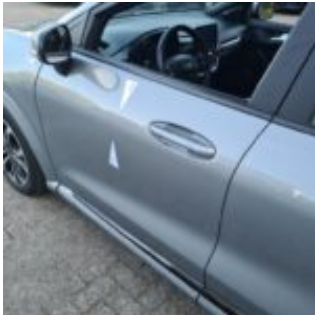
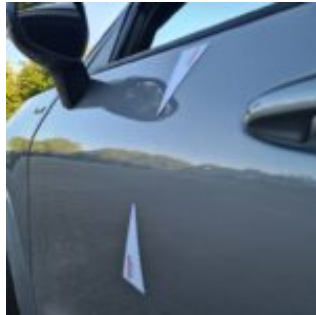
| Damage Part | Damage Type | Repair Type | Acceptable |
|---|---|---|---|
| Frontdoor - Left | Small dent(s) | Restyle | No |

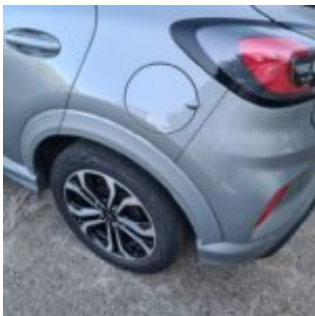
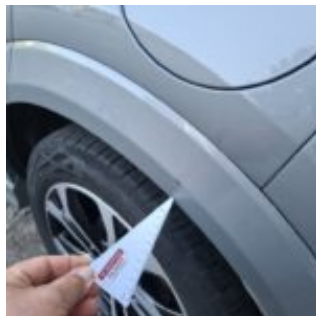
| Damage Part | Damage Type | Repair Type | Acceptable |
|---|---|---|---|
| Overfender | Small scratch(es) | Touch-up / Polish | No |

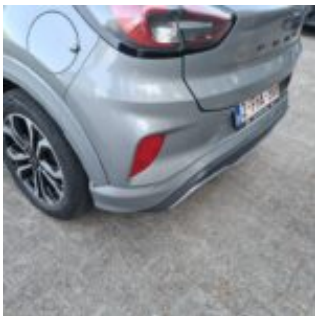
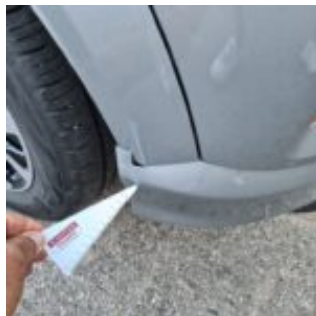
| Damage Part | Damage Type | Repair Type | Acceptable |
|---|---|---|---|
| Bumper - Rear | Dislocated / Loose | Repair | No |

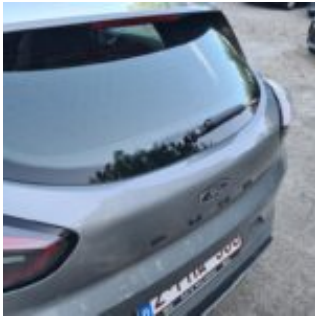
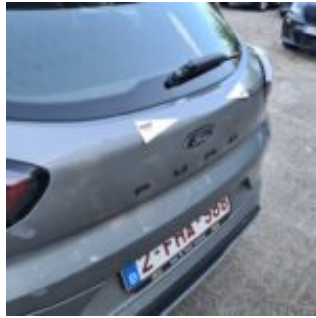
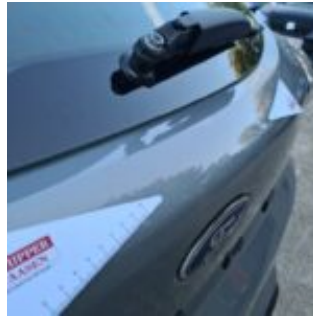
Tailgate

Small dent(s)

Restyle

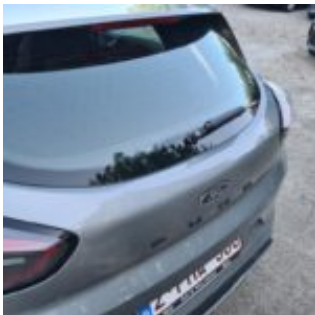
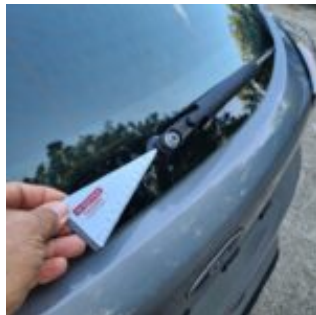
Tailgate

Missing

Ruitenwisserkapje

Replace

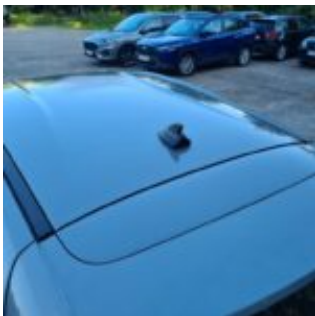
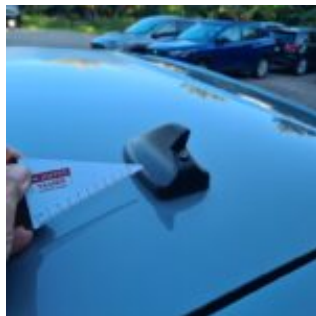
Roof

Missing

Antenne

Replace

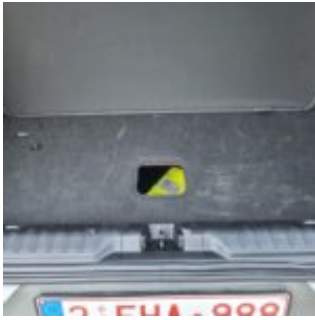
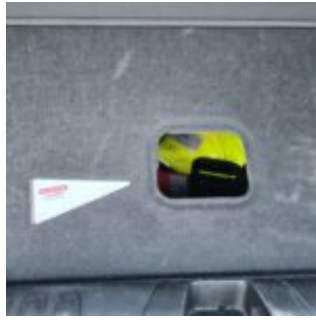
| Other | Missing | Handgriep | Replace | No |
