Expertise

Protocol number: 46661140  
Order No. / Reference: 26760916  
Inspection date: 22 Jul 2026

Manufacturer: Opel

Model: Corsa-e GS

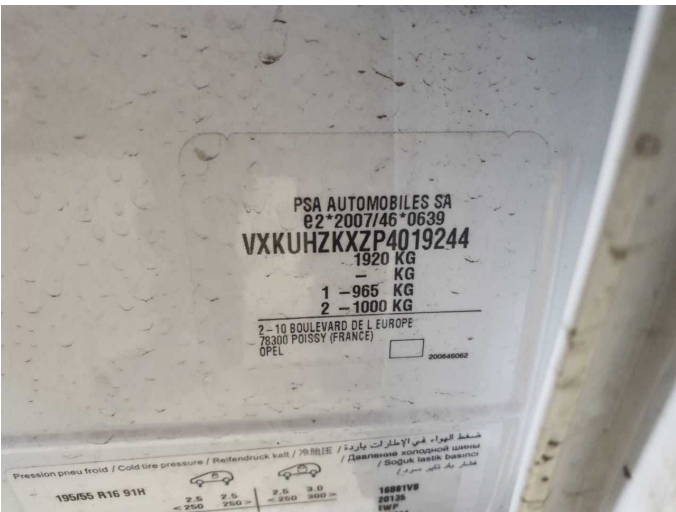
Figure 11: VIN

| VIN comparison | The vehicle identification number (VIN) was read from the vehicle and its conformity with the submitted documents was confirmed by the undersigned during the inspection. |

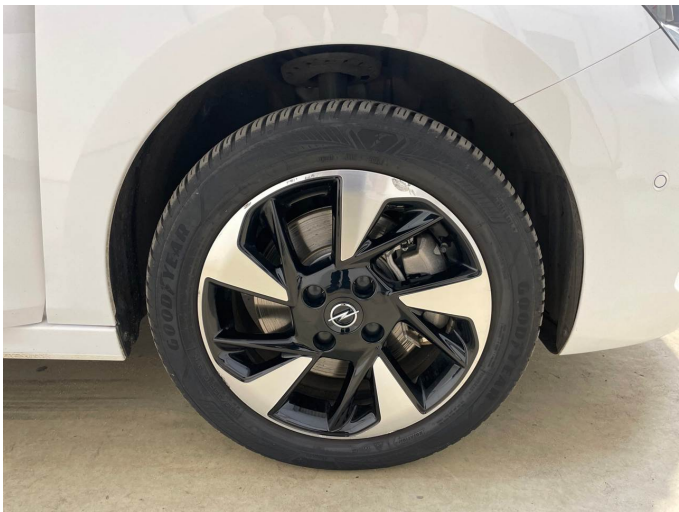
Figure 12: Mounted tyres

| # | Tyre size | Type of tyre | Manufacturer | Tread depth |
|---|---|---|---|---|
| 1) | 195/55 R16 91H | All-season tyres on Light alloy | Goodyear | 6mm / 6mm |
| 2) | 195/55 R16 91H | All-season tyres on Light alloy | Goodyear | 7mm / 7mm |

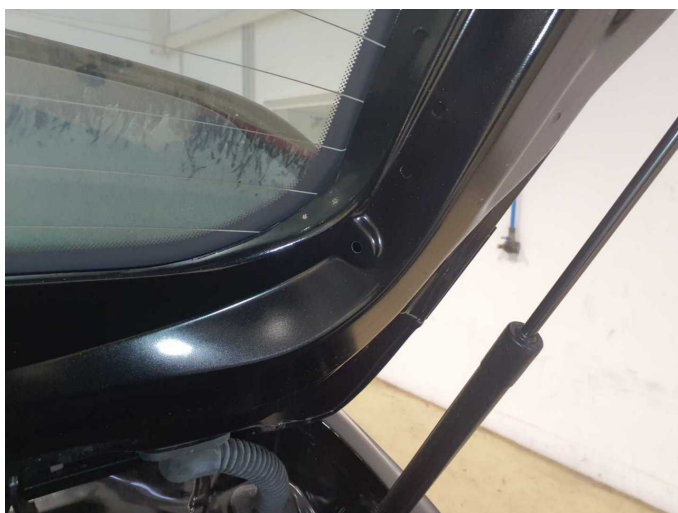
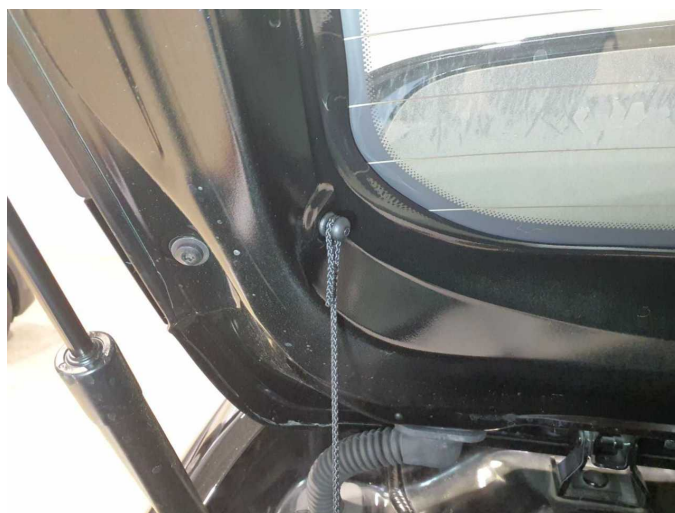
| No. | Component group | Description |
|---|---|---|
| 1 | Trim / covers | Trim / covers (Hutablagen Halterung) - Missing - Replace |

**Damage 1:** Trim / covers: Trim / covers (Hutablagen Halterung) - Missing - Replace

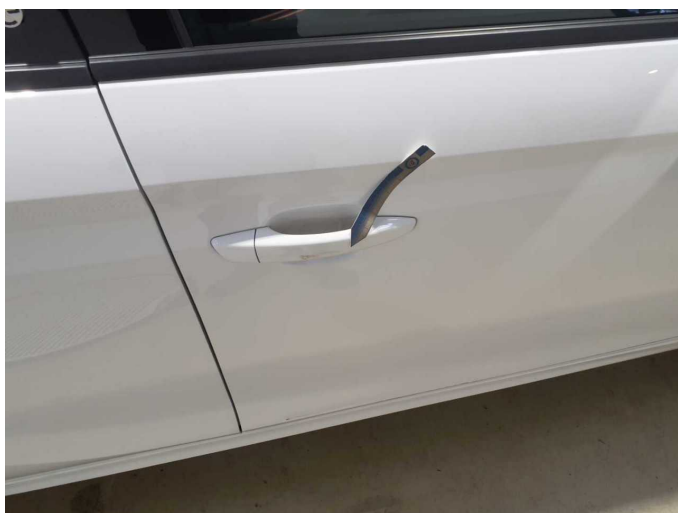
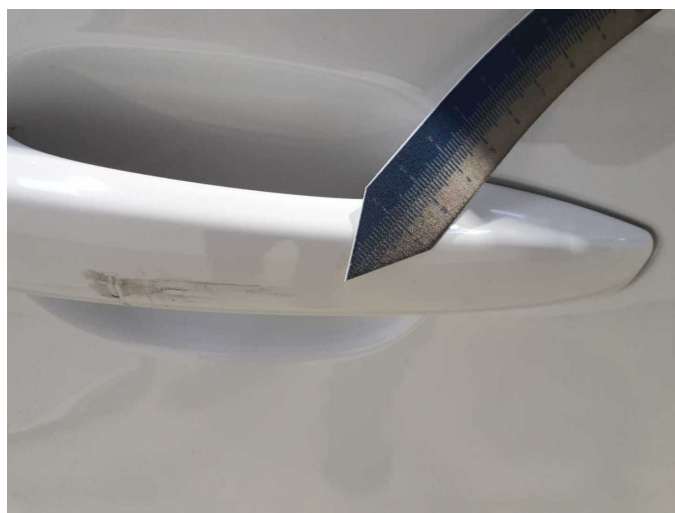
| No. | Component group | Description |
|---|---|---|
| 2 | Door - front right side | Door handle - outside - Scratch(es) - Smart repair |

**Damage 2:** Door - front right side: Door handle - outside - Scratch(es) - Smart repair

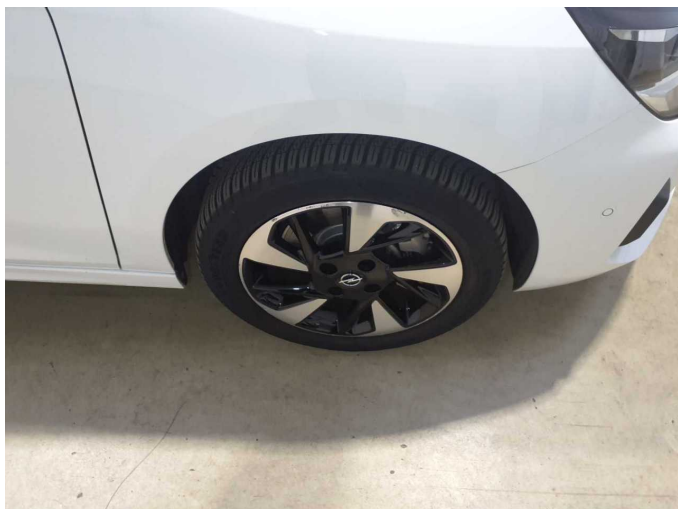
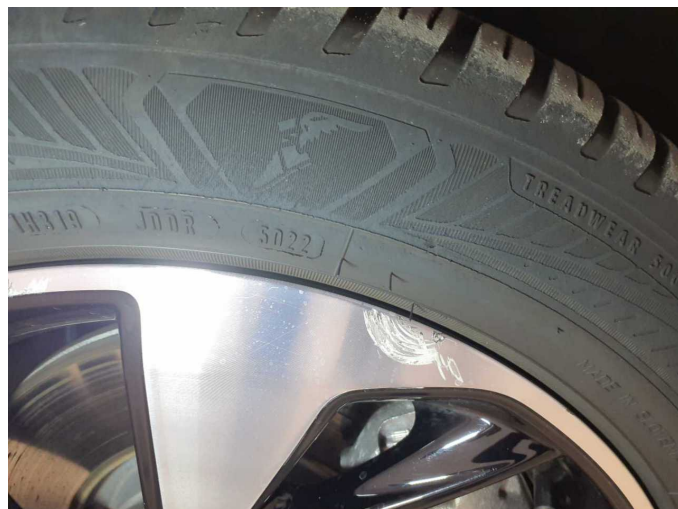
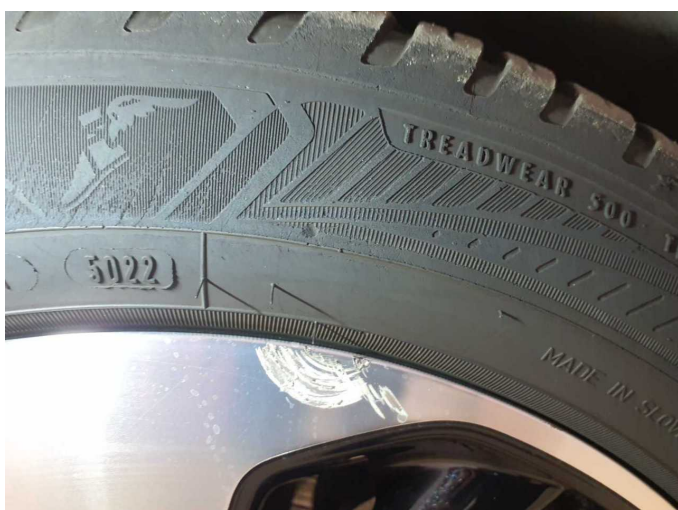
| No. | Component group | Description |
|---|---|---|
| 3 | Wheel / tyres | Tyre - front right side - Scratch(es) - Replace |

**Damage 3:** Wheel / tyres: Tyre - front right side - Scratch(es) - Replace

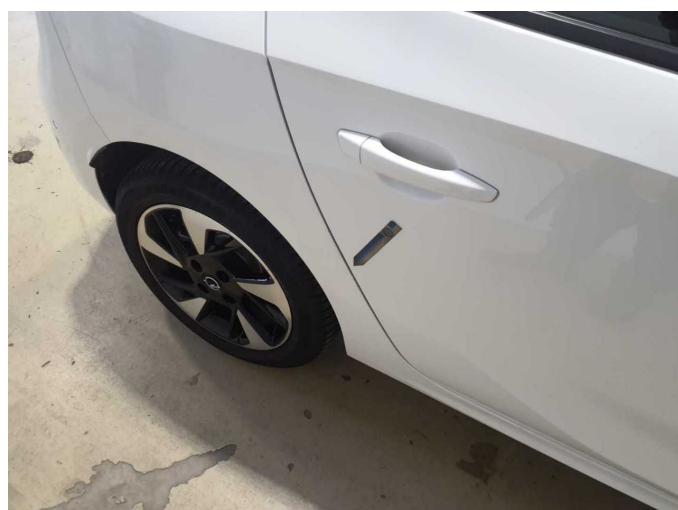
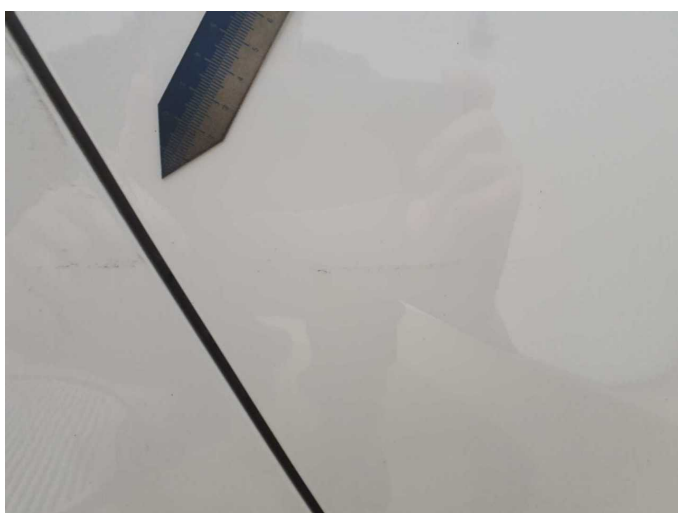
| No. | Component group | Description |
|---|---|---|
| 4 | Door - rear right side | Door - Scratch(es) - Smart repair |

**Damage 4:** Door - rear right side: Door - Scratch(es) - Smart repair

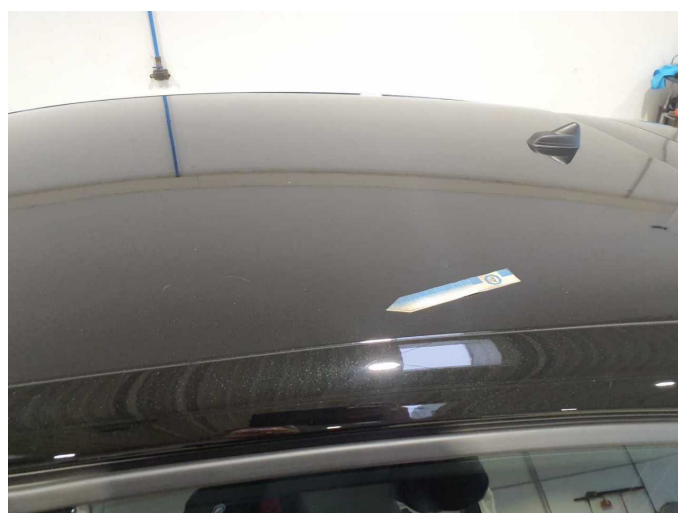
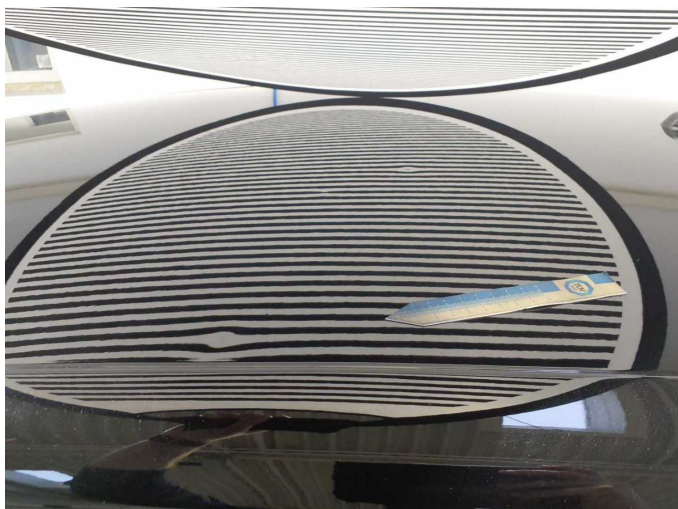
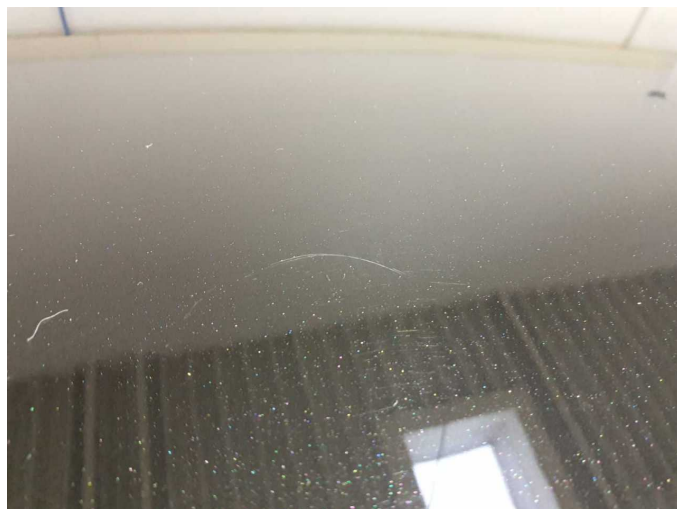
| No. | Component group | Description |
|---|---|---|
| 5 | Roof | Roof - Dent / paintcoat damage - Smart repair |

**Damage 5:** Roof: Roof - Dent / paintcoat damage - Smart repair

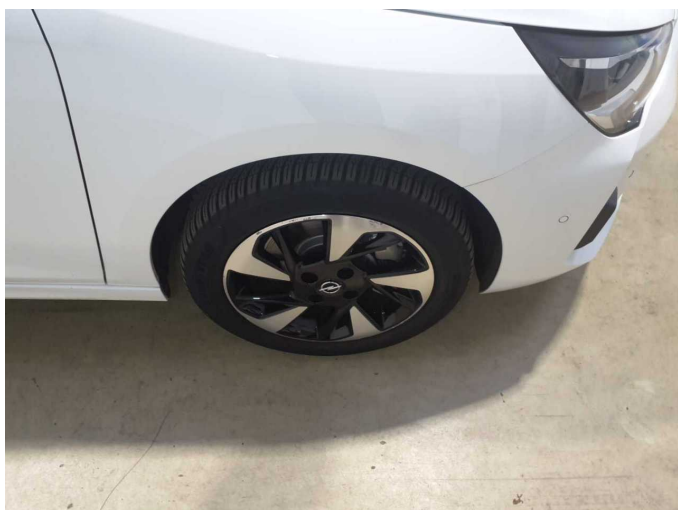
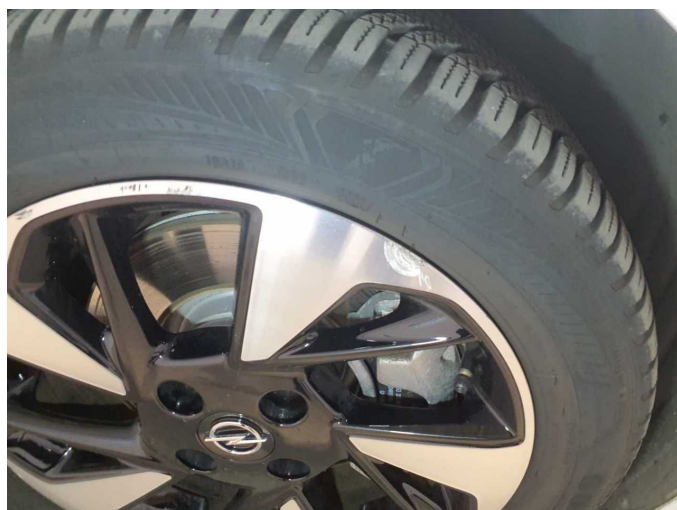
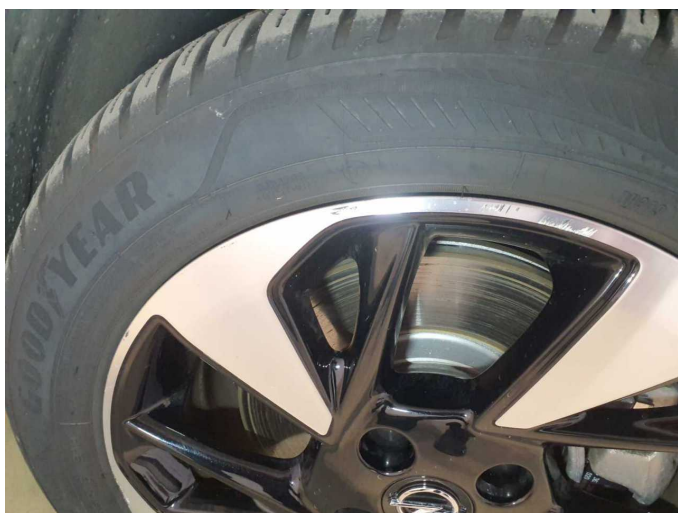
| No. | Component group | Description |
|---|---|---|
| 6 | Wheel / tyres | Alloy rim - front right side - Scratch(es) - Replace |

**Damage 6:** Wheel / tyres: Alloy rim - front right side - Scratch(es) - Replace

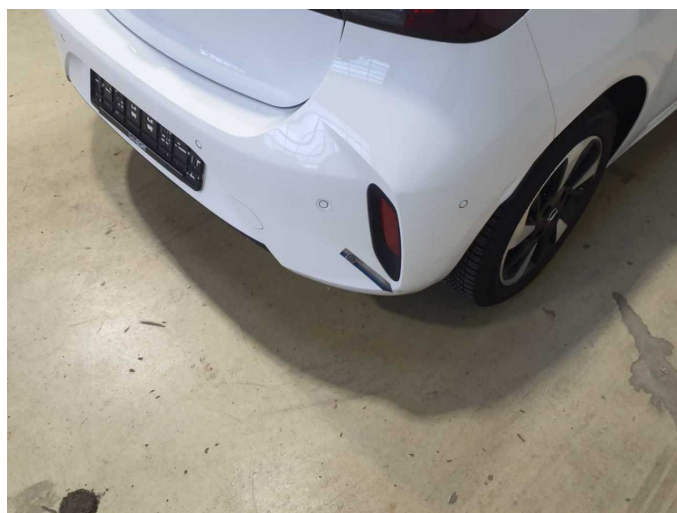
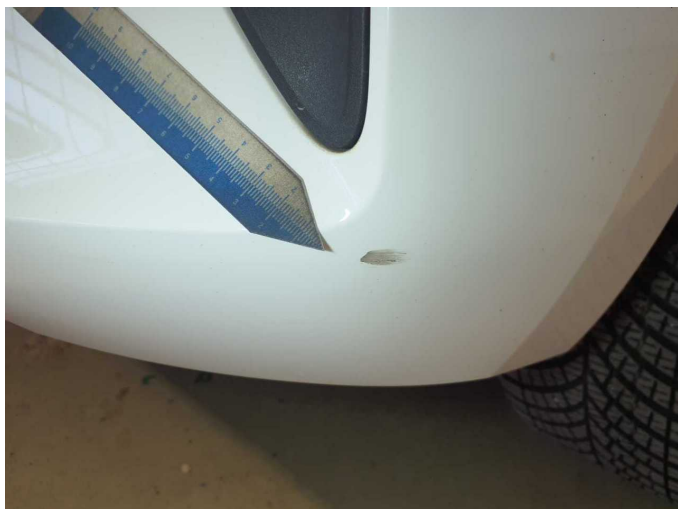
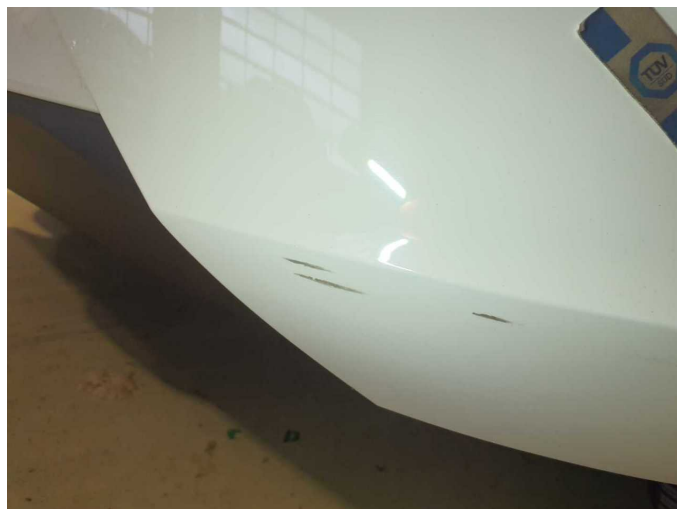
| No. | Component group | Description |
|---|---|---|
| 7 | Rear bumper | Rear bumper - Scratch(es) - Paint |

**Damage 7:** Rear bumper: Rear bumper - Scratch(es) - Paint

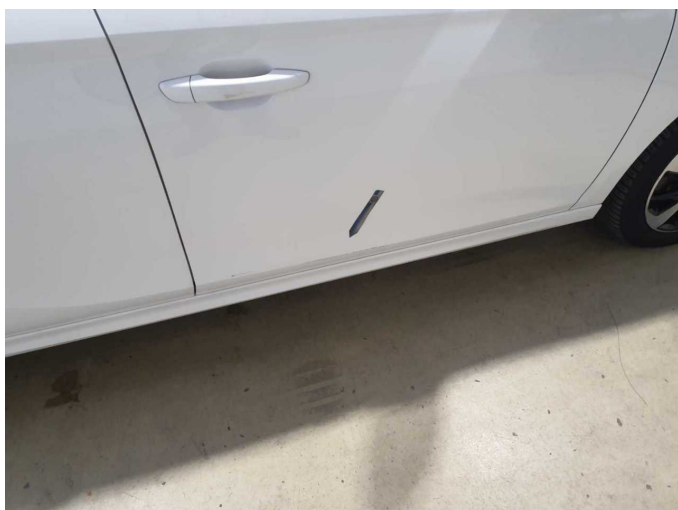
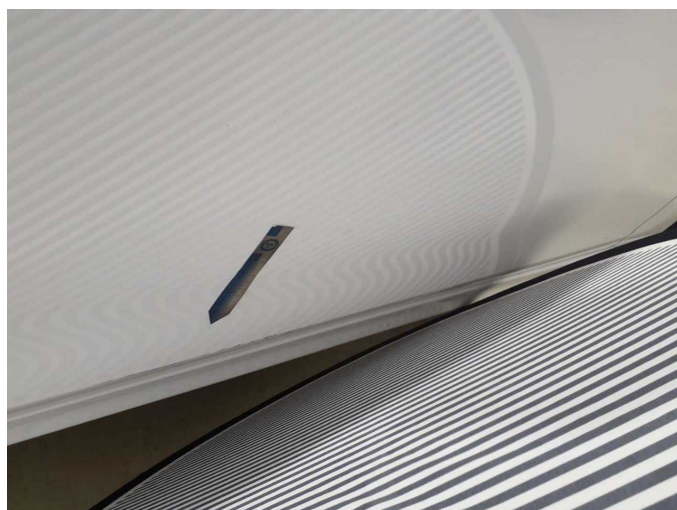
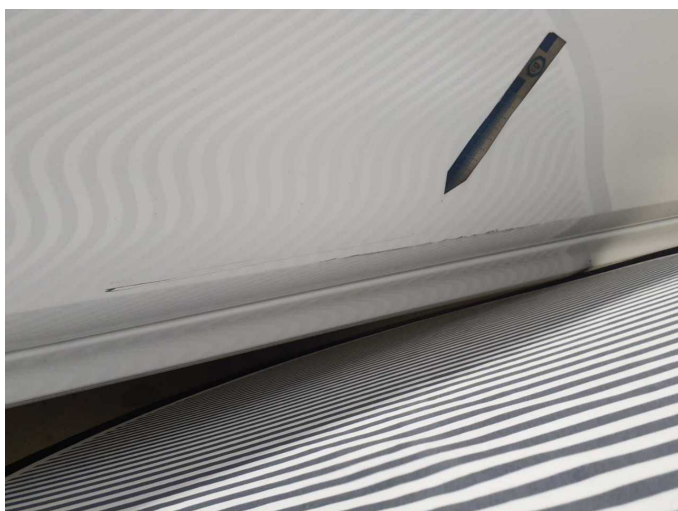
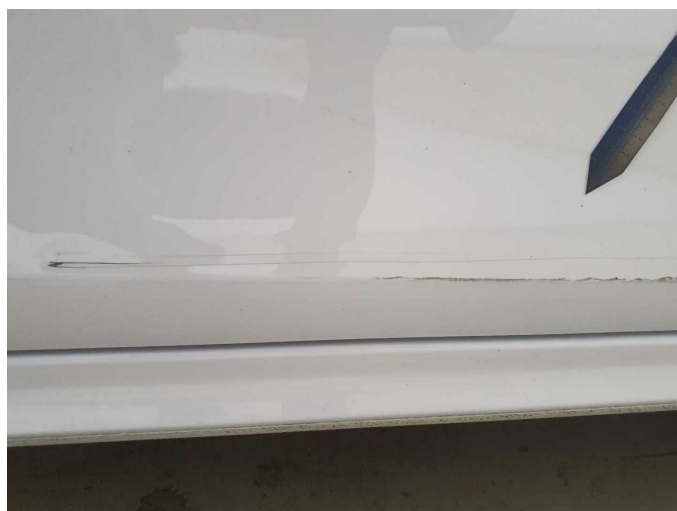
| No. | Component group | Description |
|---|---|---|
| 8 | Door - front right side | Door - Dent / paintcoat damage - Repair and paint |

**Damage 8:** Door - front right side: Door - Dent / paintcoat damage - Repair and paint

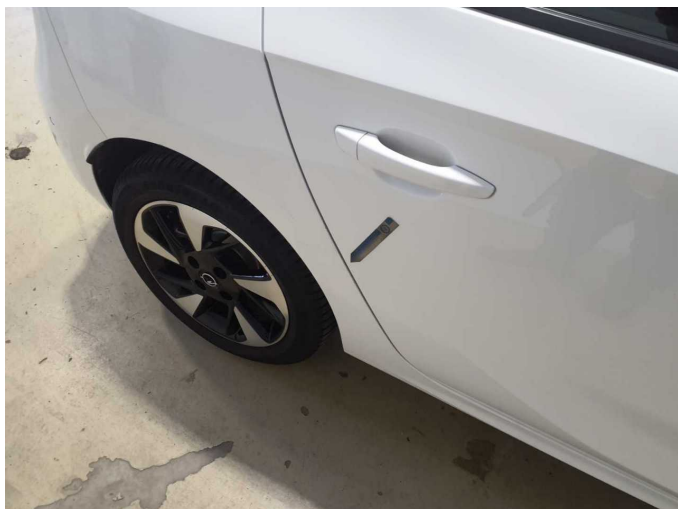
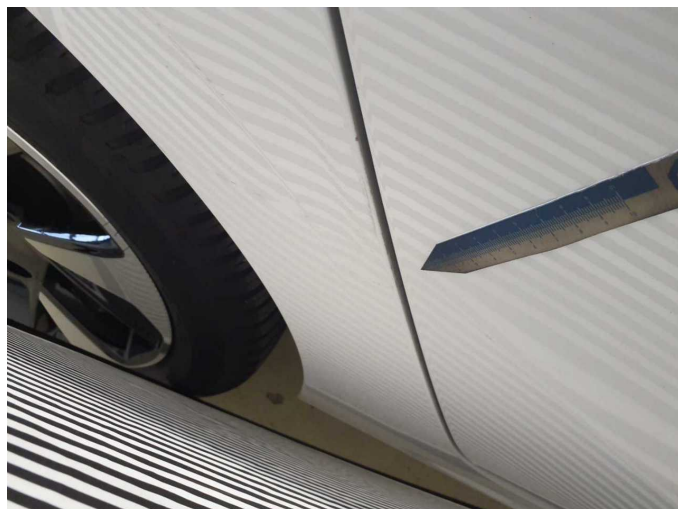
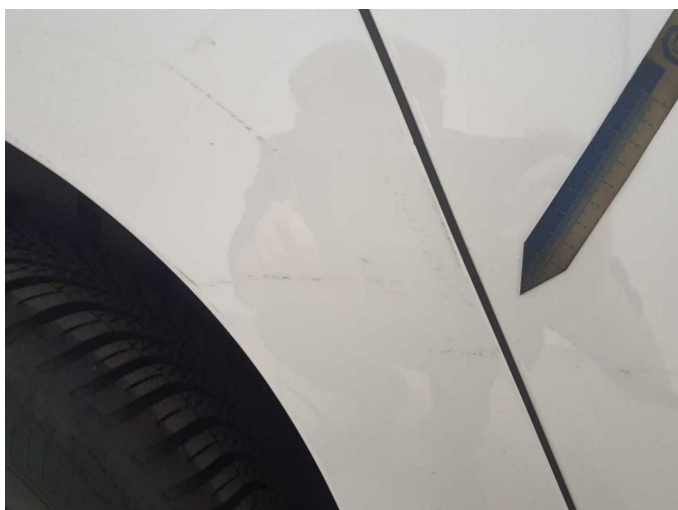
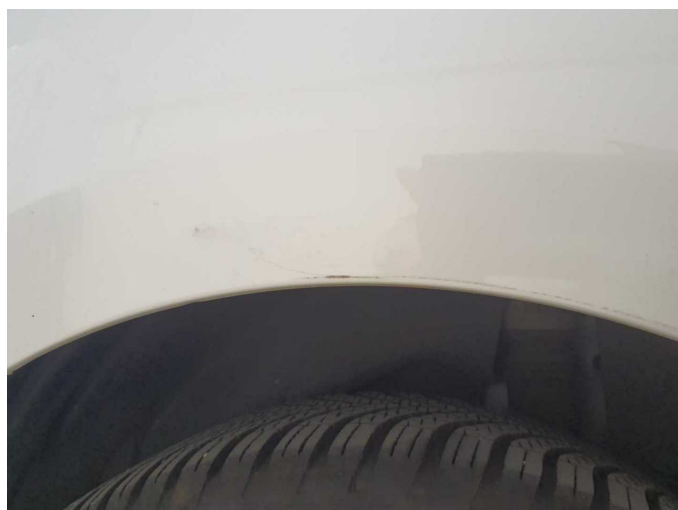
| No. | Component group | Description |
|---|---|---|
| 9 | Side panel - rear right side | Side panel - Dent / paintcoat damage - Repair and paint |

**Damage 9:** Side panel - rear right side: Side panel - Dent / paintcoat damage - Repair and paint
