Expertise

Protocol number: 46405932  
Order No. / Reference: 26559179  
Inspection date: 8 Jul 2026

Manufacturer: Mercedes-Benz  
VIN: W1NKM5BB2PF040427

Model: GLC 200 4Matic 9G-TRONIC AMG Line Advanced

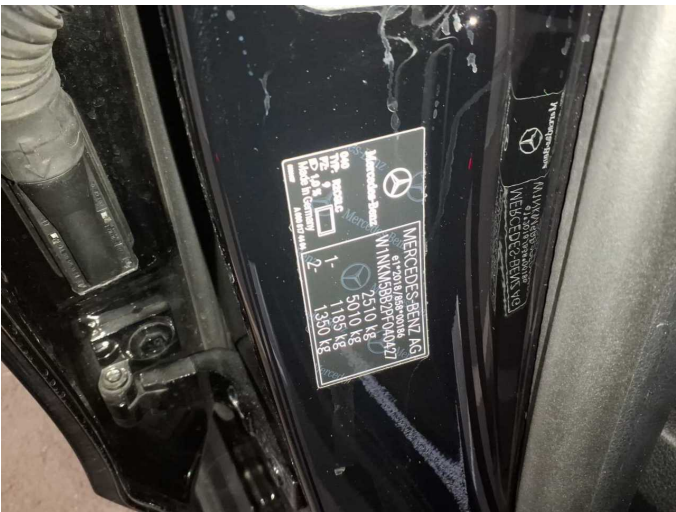
Figure 11: VIN

| VIN comparison | The vehicle identification number (VIN) was read from the vehicle and its conformity with the submitted documents was confirmed by the undersigned during the inspection. |

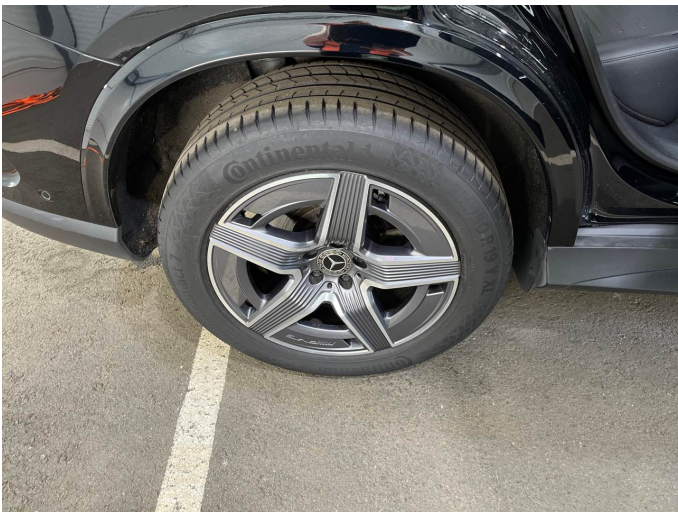
Figure 12: Mounted tyres

| # | Tyre size | Type of tyre | Manufacturer | Tread depth |
|---|---|---|---|---|
| 1) | 235/55 R19 105W | Summer tyres on Light alloy | Continental | 5mm / 5mm |
| 2) | 255/50 R19 107Y | Summer tyres on Light alloy | Continental | 7mm / 7mm |

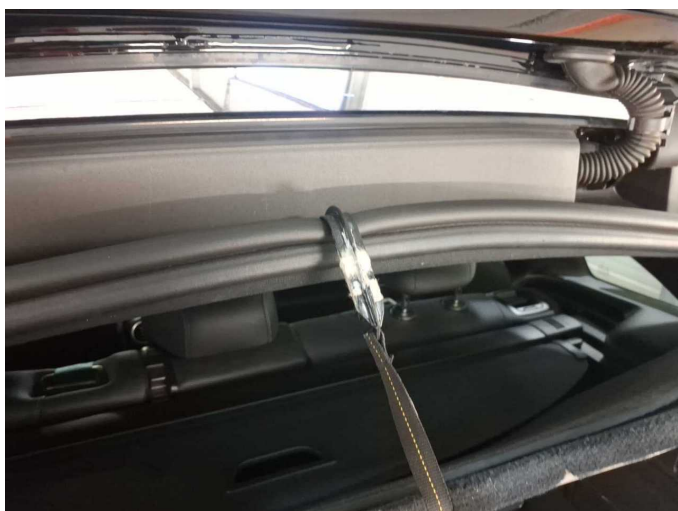
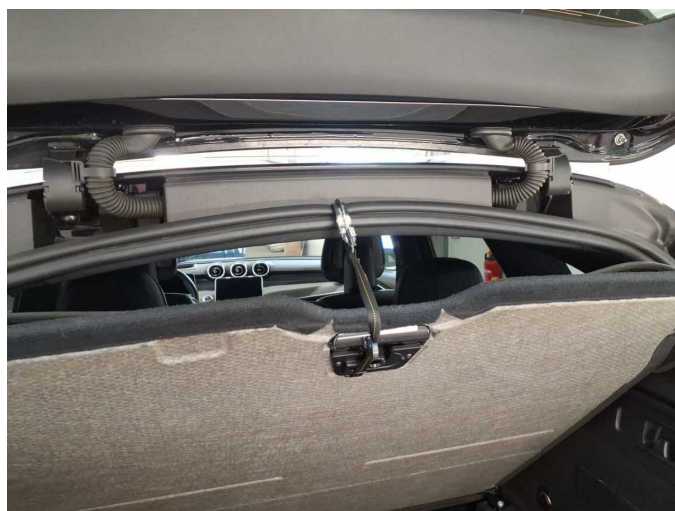
| No. | Component group | Description |
|---|---|---|
| 2 | Interior | Cargo area floor (Halter laderaumboden) - Broken / torn - Loss in value |

**Damage 2:** Interior: Cargo area floor (Halter laderaumboden) - Broken / torn - Loss in value

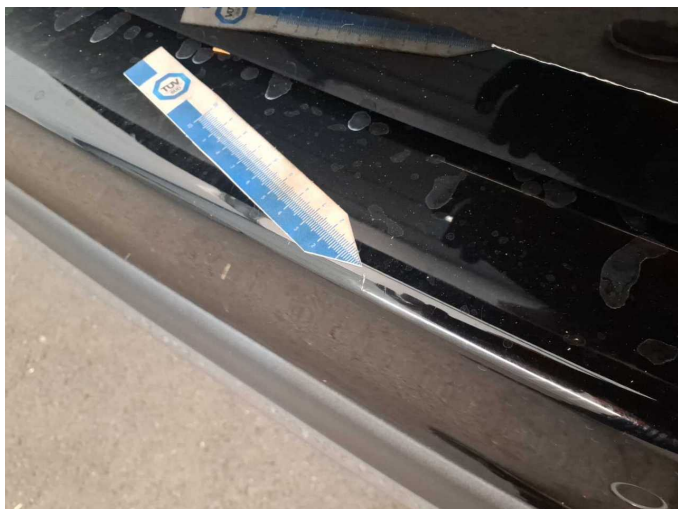
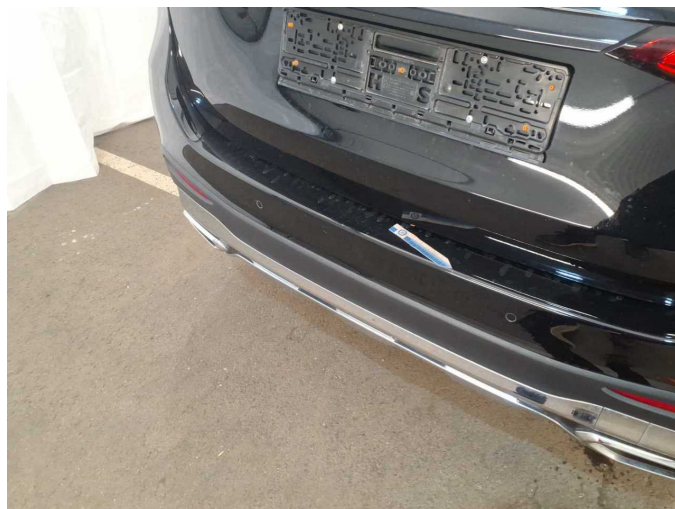
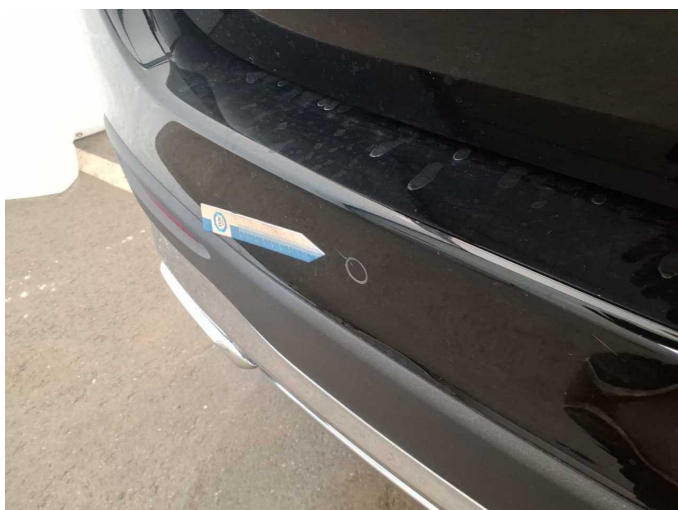
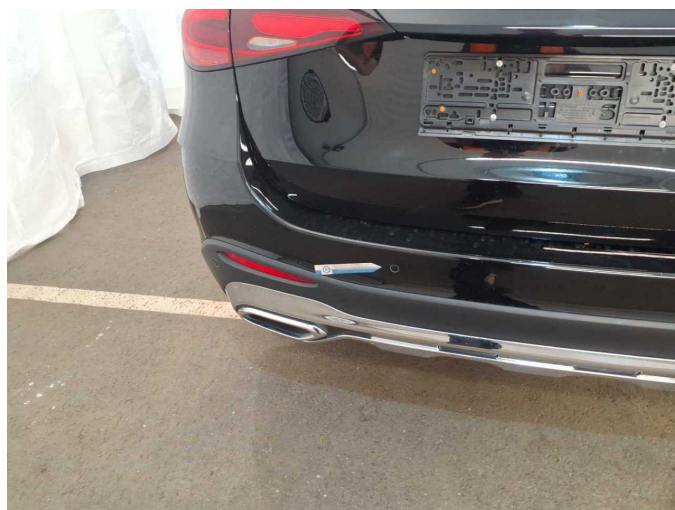
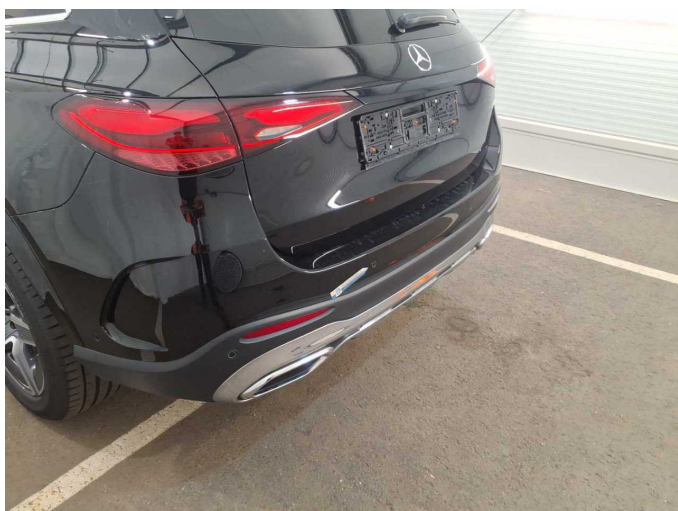
| No. | Component group | Description |
|---|---|---|
| 3 | Rear bumper | Rear bumper - Scratch(es) - Paint |

**Damage 3:** Rear bumper: Rear bumper - Scratch(es) - Paint

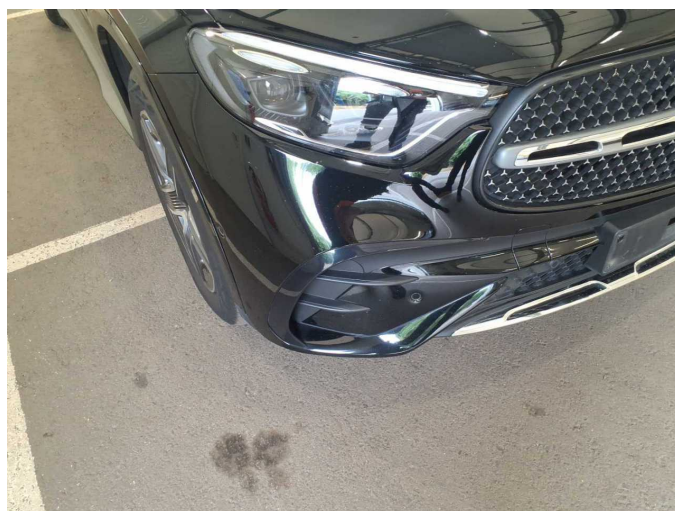
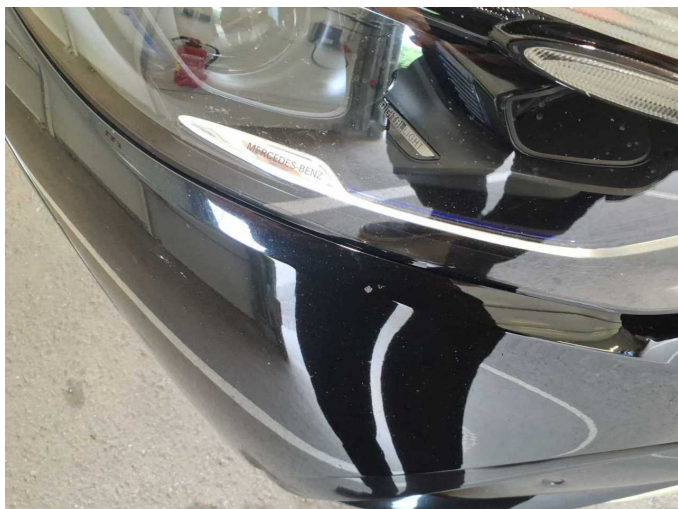
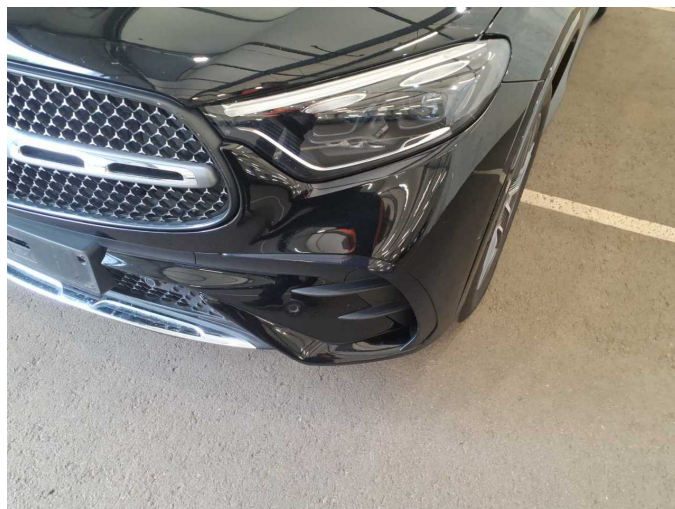
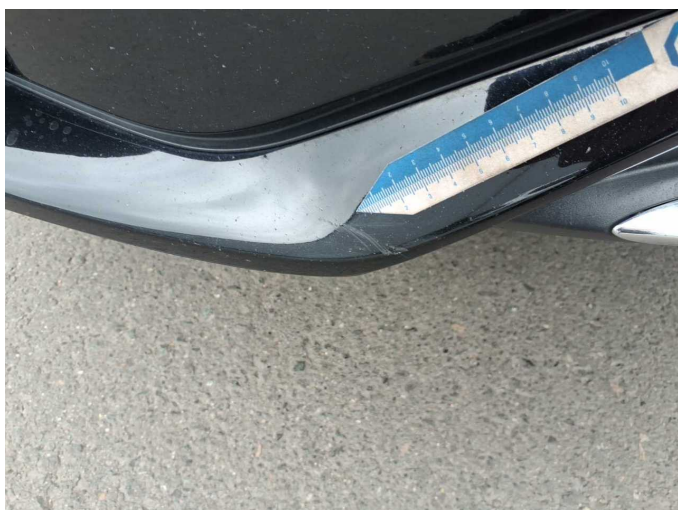
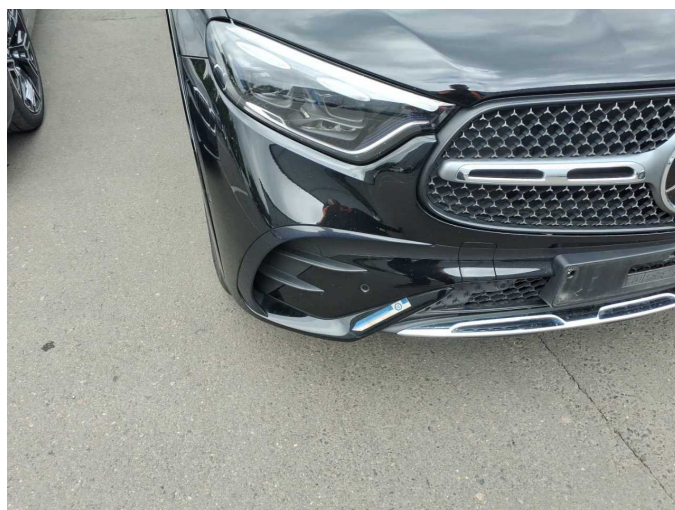
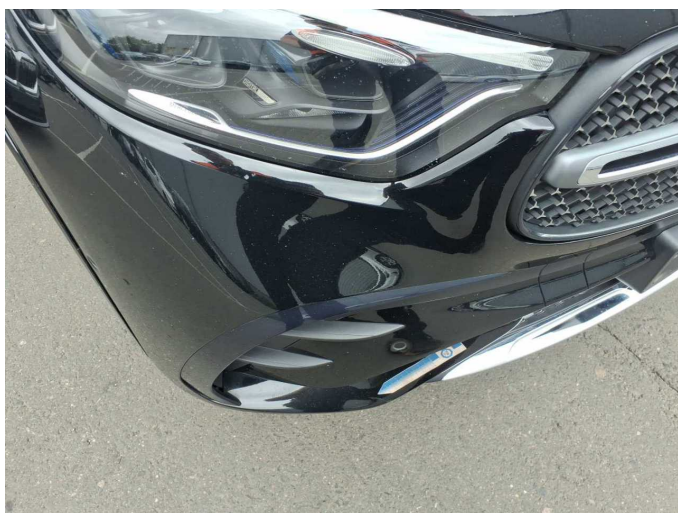
| No. | Component group | Description |
|---|---|---|
| 4 | Front bumper | Front bumper - Scratch(es) - Paint |

**Damage 4:** Front bumper: Front bumper - Scratch(es) - Paint

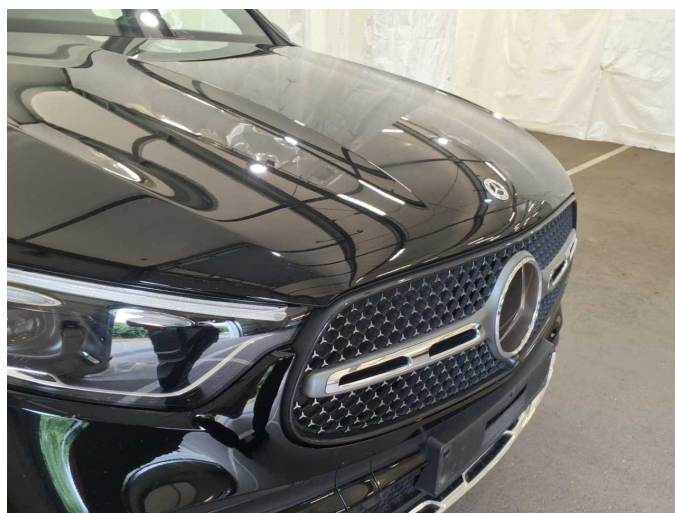
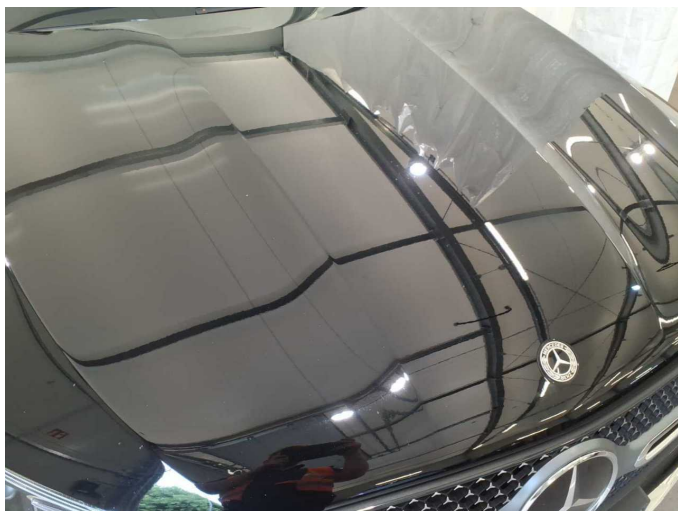
| No. | Component group | Description |
|---|---|---|
| 2 | Bonnet | Bonnet - Stone chips - No deduction |

**Wear and tear 2:** Bonnet: Bonnet - Stone chips - No deduction

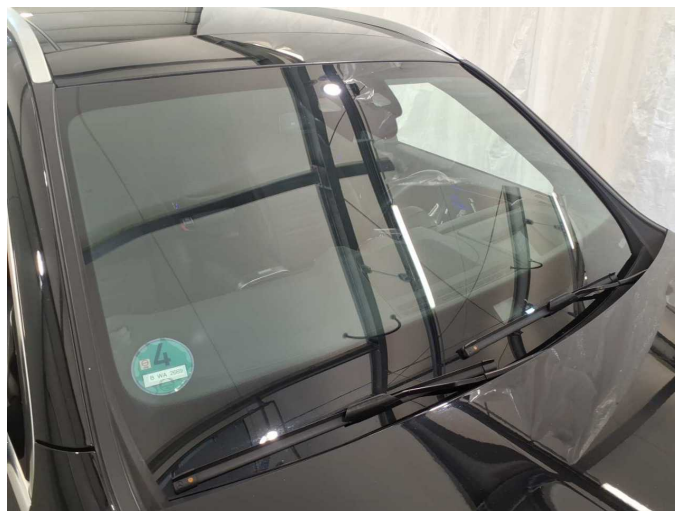
| No. | Component group | Description |
|---|---|---|
| 3 | Vehicle glazing | Windscreen - Stone chips - No deduction |

**Wear and tear 3:** Vehicle glazing: Windscreen - Stone chips - No deduction

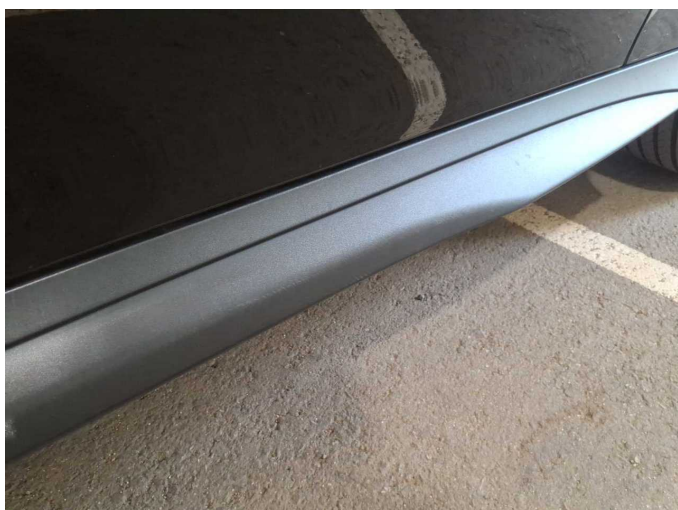
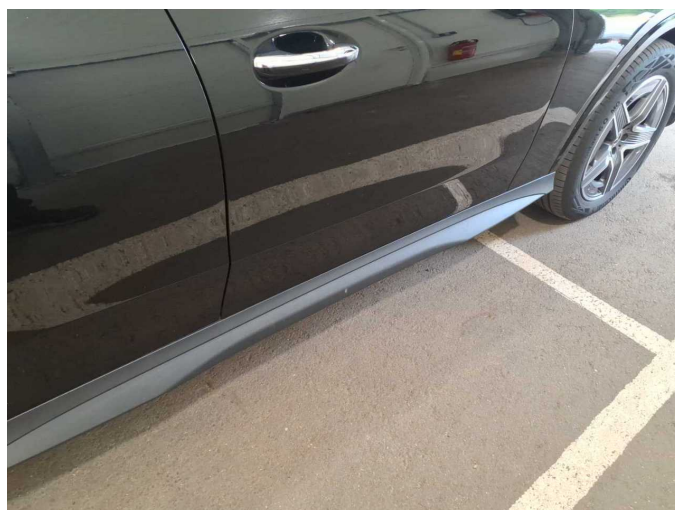
| No. | Component group | Description |
|---|---|---|
| 4 | Sill - right side | Sill - Scratch(es) - No deduction |

**Wear and tear 4:** Sill - right side: Sill - Scratch(es) - No deduction
