Expertise

Protocol number: 46410010  
Order No. / Reference: 26547483  
Inspection date: 8 Jul 2026

Manufacturer: Skoda  
VIN: TMBLN7NS2P8527776

Model: Kodiah 2.0 TDI 4x4 DSG Sportline

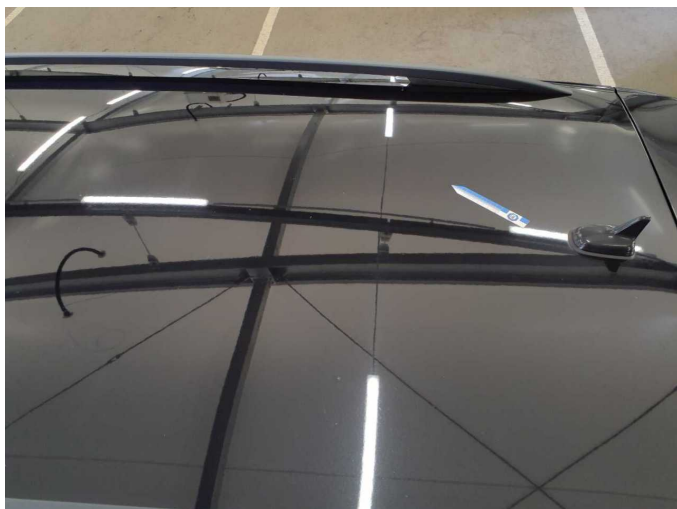
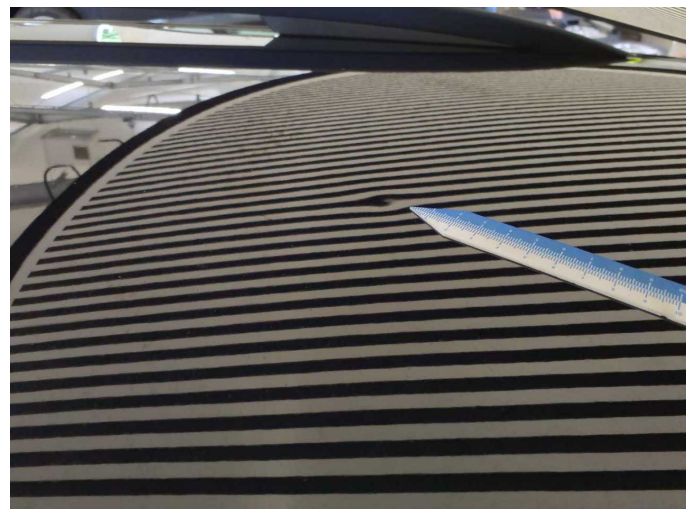
| No. | Component group | Description |
|---|---|---|
| 1 | Roof | Roof - dent(s) - Smooth repair work |

**Damage 1:** Roof: Roof - dent(s) - Smooth repair work

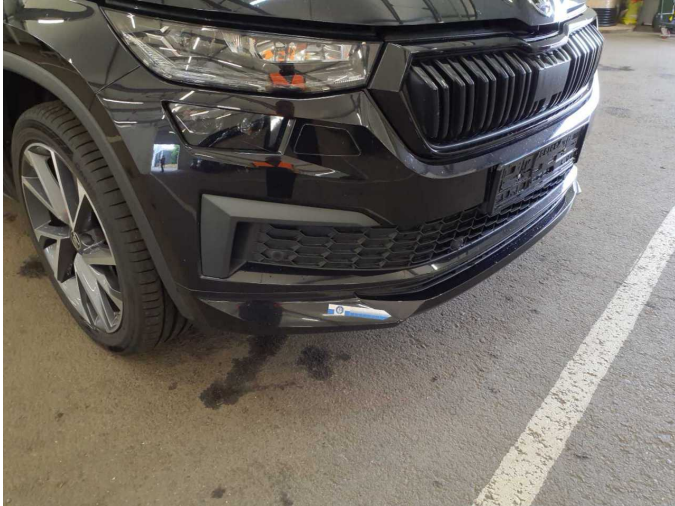
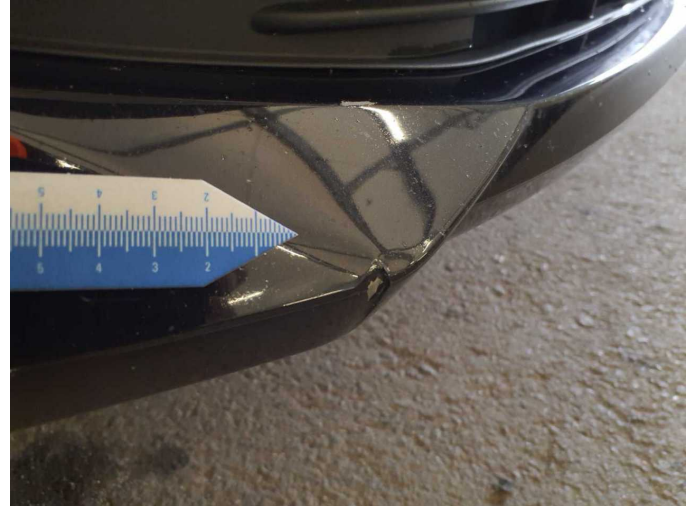
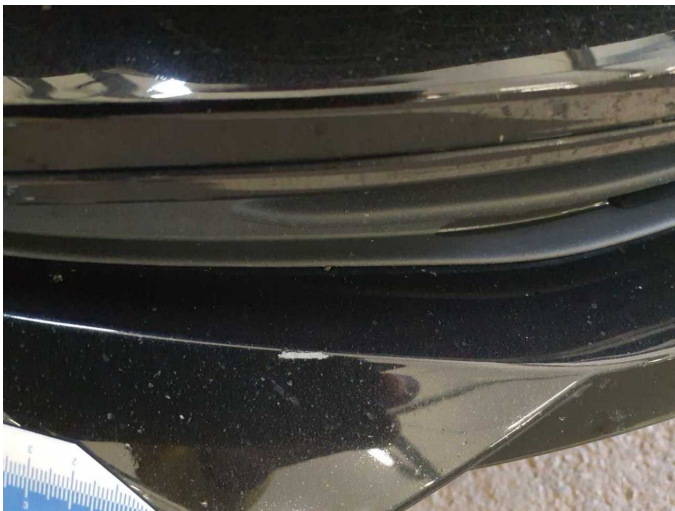
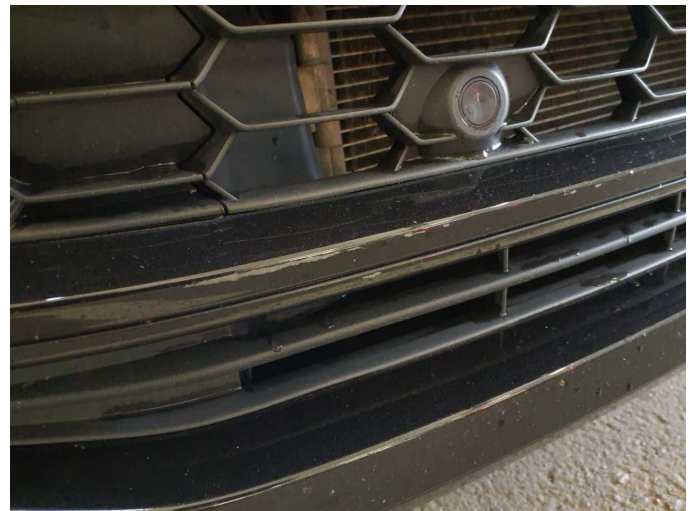
| No. | Component group | Description |
|---|---|---|
| 2 | Front bumper | Spoiler - Scratched - Replace |

**Damage 2:** Front bumper: Spoiler - Scratched - Replace

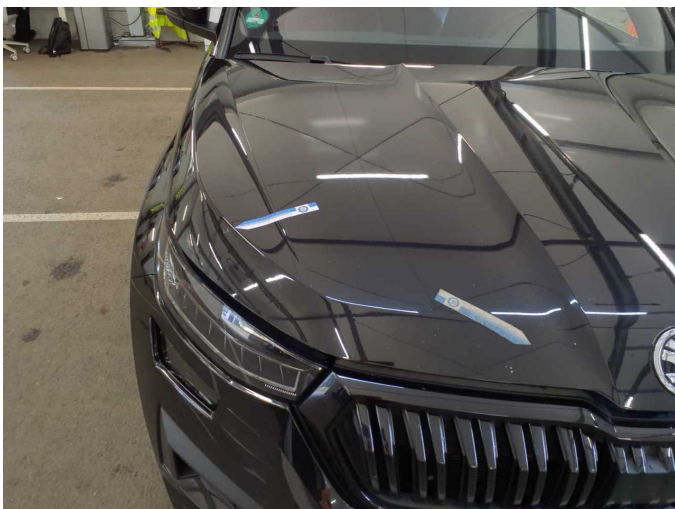
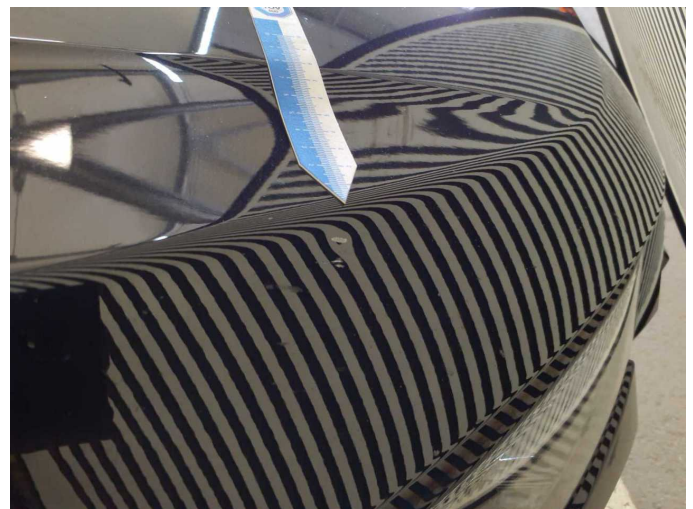
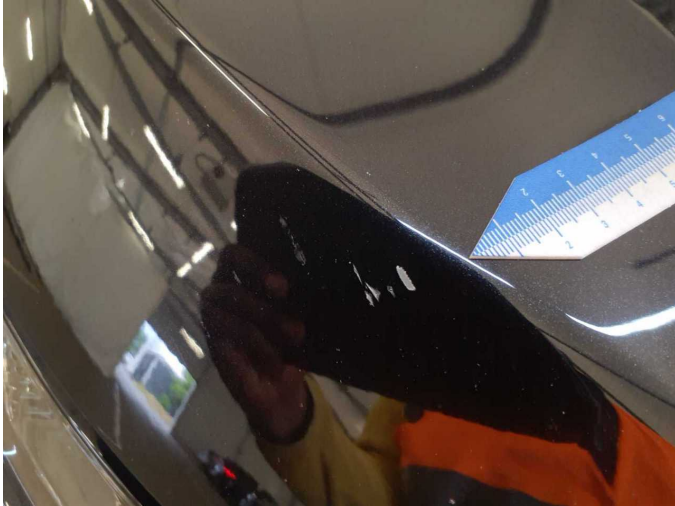
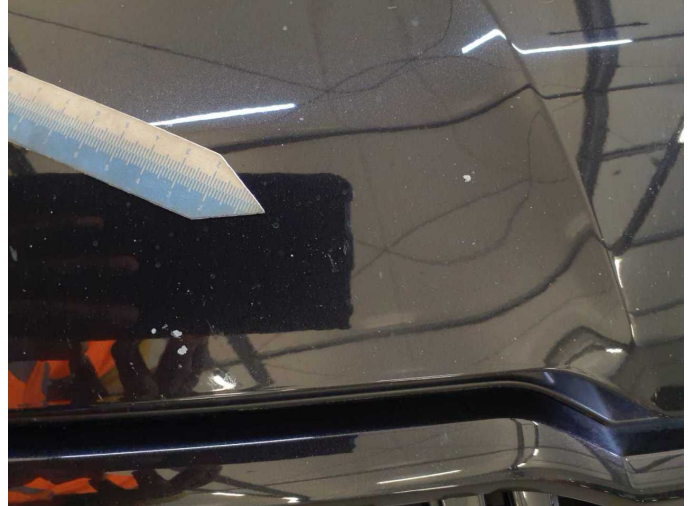
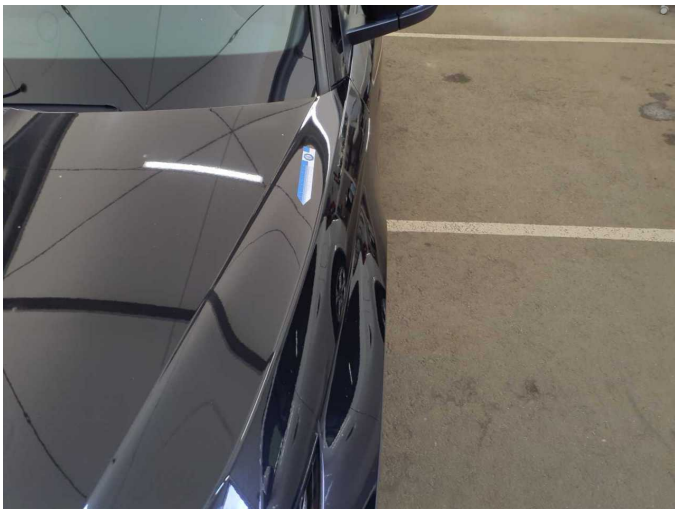
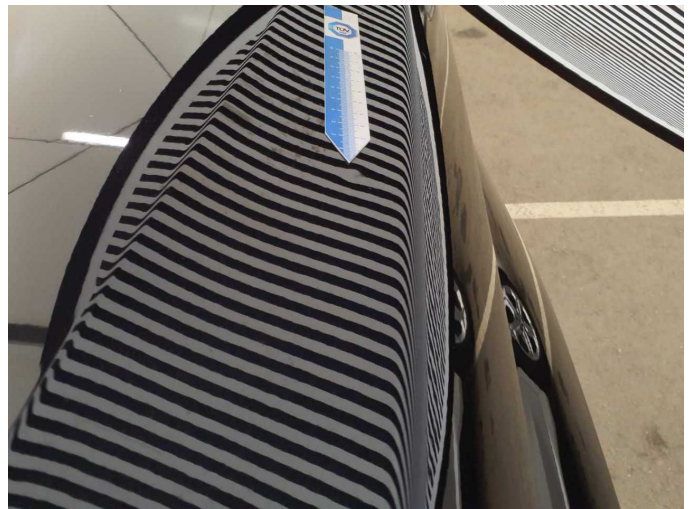
| No. | Component group | Description |
|---|---|---|
| 3 | Bonnet | Bonnet - Dent / paintcoat damage - Repair and paint |

**Damage 3:** Bonnet: Bonnet - Dent / paintcoat damage - Repair and paint

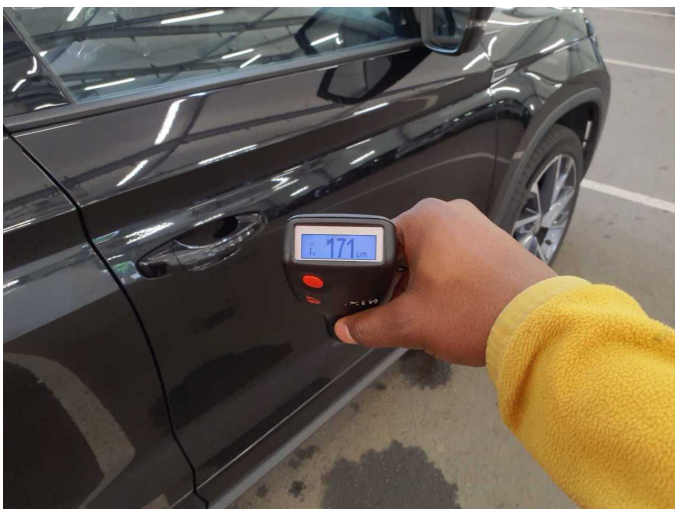
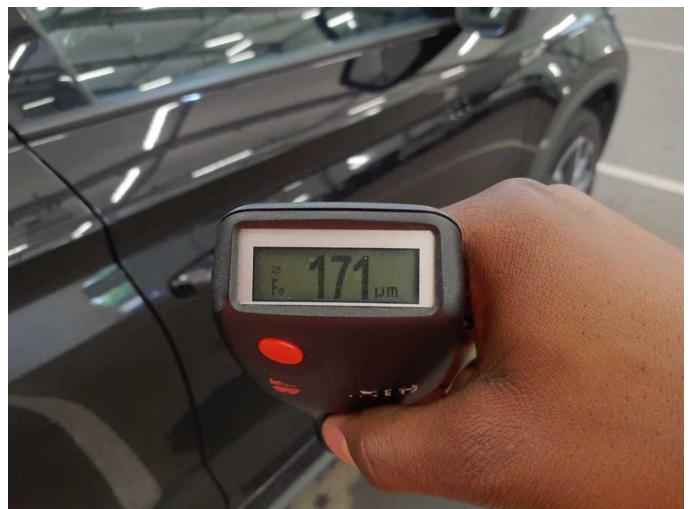
| No. | Repainting |
|---|---|
| 1 | Door - front right side, Professionally carried out, Invoice of repair done Non-existent |

| Door - front right side | 171 µm |

**Repainting 1:** Door - front right side
