Expertise

Protocol number: 46101424
Order No. / Reference: 26518220
Inspection date: 23 Jun 2026

Manufacturer: Volvo

Model: XC60 T6 AWD Recharge Core

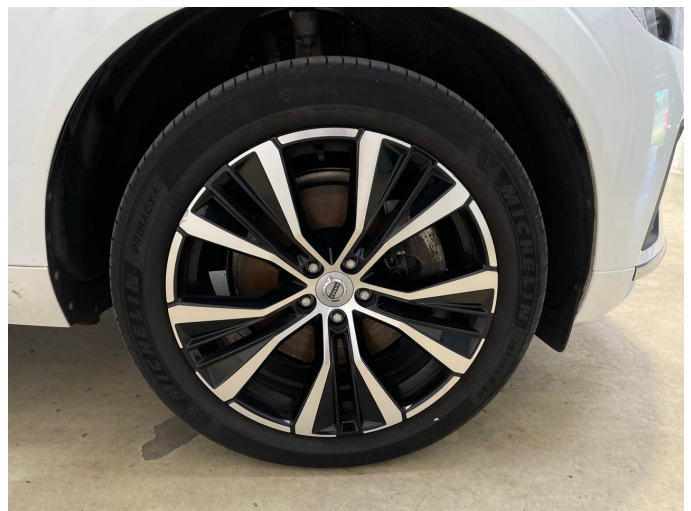
Figure 12: Mounted tyres

Mounted tyres				
#	Tyre size	Type of tyre	Manufacturer	Tread depth
1)	255/45 R20 105V	Summer tyres on Light alloy	Michelin	5mm / 5mm
2)	255/45 R20 105V	Summer tyres on Light alloy	Michelin	5mm / 5mm
Additional tyres				
#	Tyre size	Type of tyre	Manufacturer	Tread depth
1)	235/60 R18 107H	Winter tyres on Light alloy	Pirelli	6mm / 6mm
2)	235/60 R18 107H	Winter tyres on Light alloy	Pirelli	6mm / 6mm
Replacement				
Typ	Tyre size	Type of tyre	Manufacturer	Tread depth
	Tirefit	Expiration date 03/2027

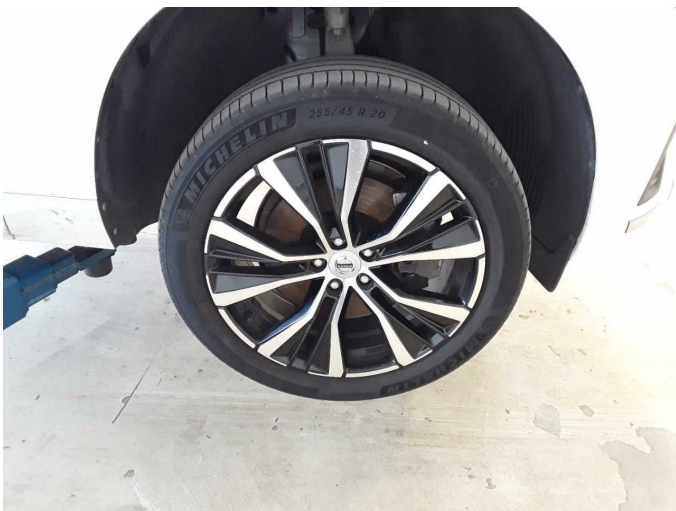
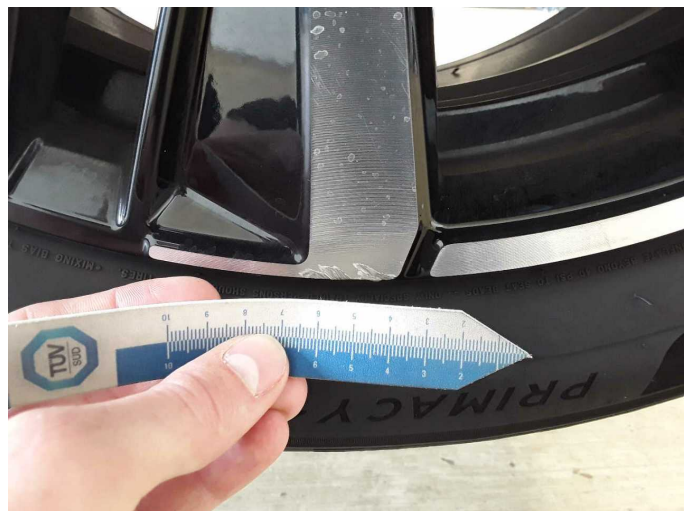
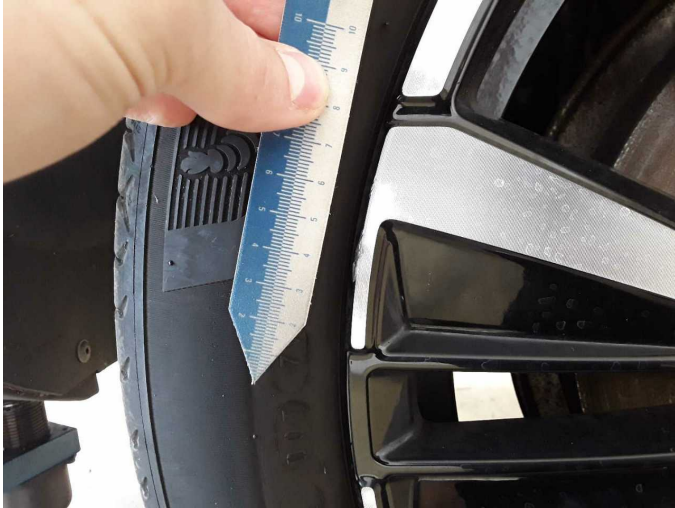
Damage 1: Wheel / tyres: Alloy rim - front right side - Scratch(es) - Loss in value

No.	Component group	Description
1	Wheel / tyres	Alloy rim - front right side - Scratch(es) - Loss in value
2	Engine	Engine cover - top / cover - Damage caused by marten / rodent - Replace
3	Vehicle glazing	Windscreen - Broken / torn - Replace

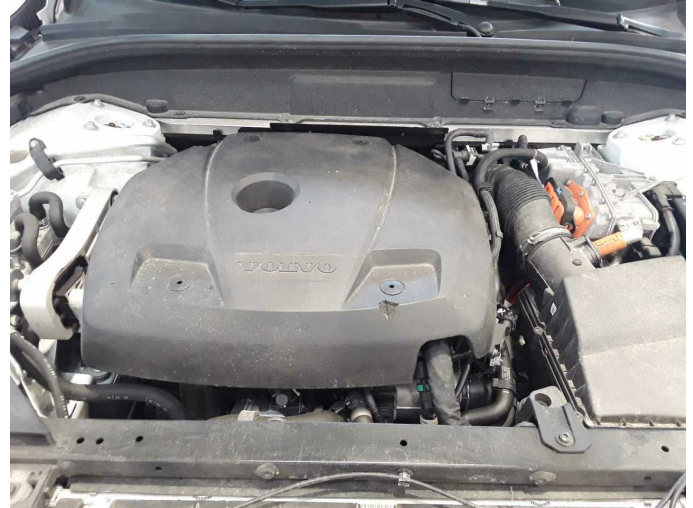
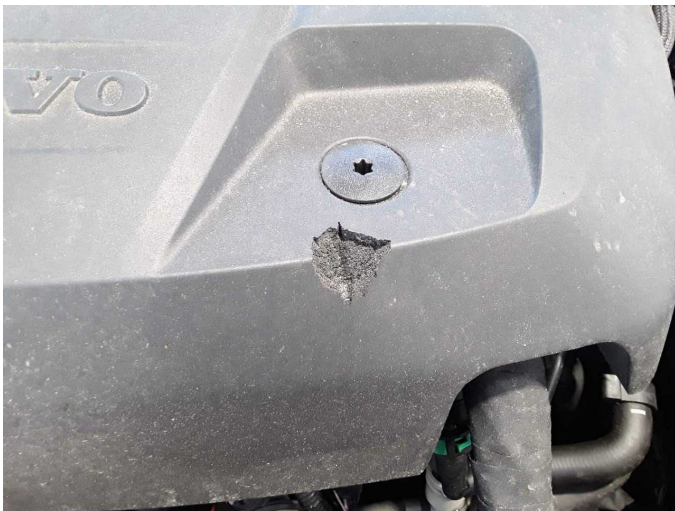
Damage 2: Engine: Engine cover - top / cover - Damage caused by marten / rodent - Replace

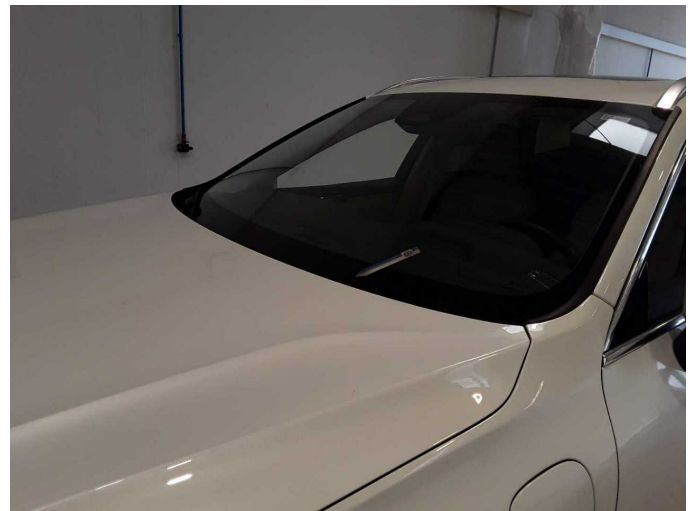
Damage 3: Vehicle glazing: Windscreen - Broken / torn - Replace
