Opel

VIN: W0VECYHZ2NN554778

Estimated repair cost

Statement details

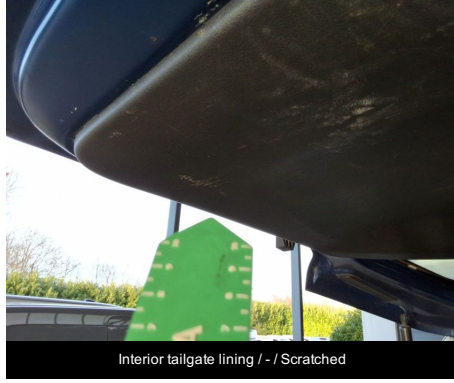
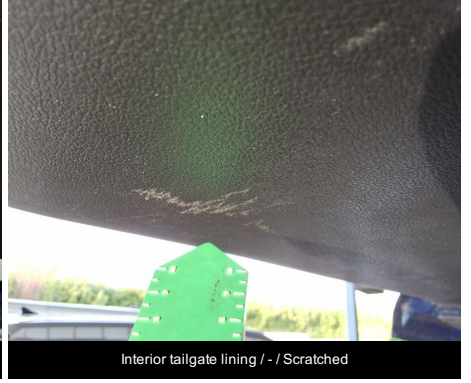
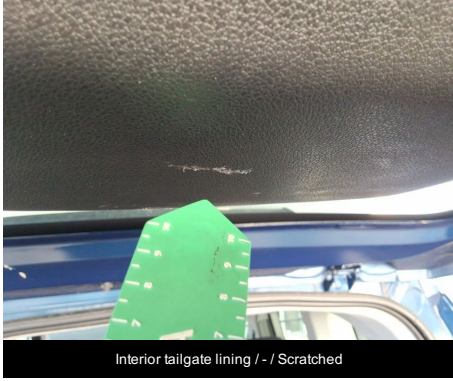
#	Element	Defect	Correction	net cost
001	Interior tailgate lining / -	Scratched	Smart repair	53.00 EUR

Interior tailgate lining / - / Scratched

Bodywork time	Paint time	Part Price	Lumpsum 53.00 EUR
	-	-	-	
	Bodywork cost	Paint cost	MaterialCost	
	-	-	-	
002	Tyre repair kit complete / -	Missing	Acceptable	-
	Bodywork time	Paint time	Part Price	Lumpsum -

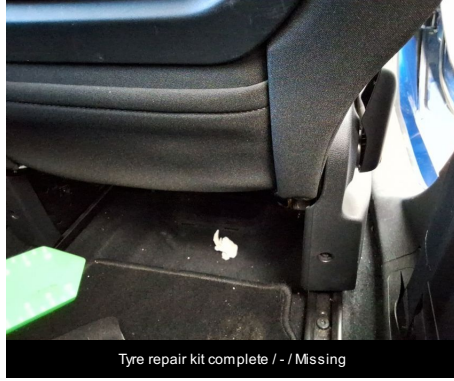
Tyre repair kit complete / - / Missing

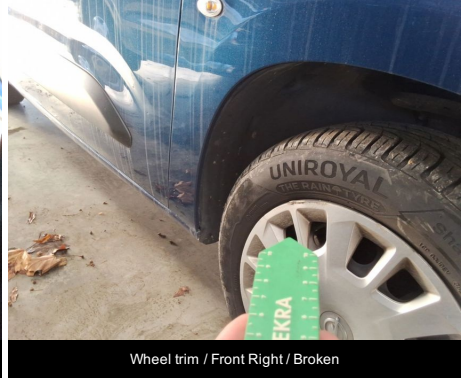
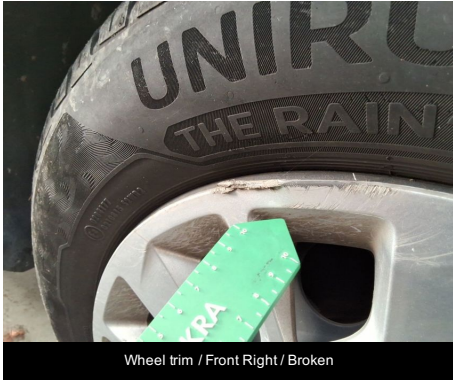
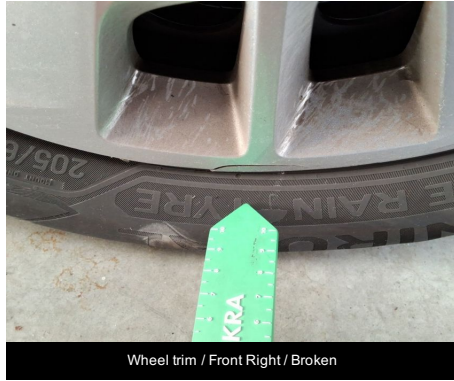
-	-	-	
	Bodywork cost	Paint cost	MaterialCost	
	-	-	-	
003	Wheel trim / Front Right Rim/Tyre diameter : 16 "	Broken	Replace	25.14 EUR
	Bodywork time	Paint time	Part Price	Lumpsum -

Wheel trim / Front Right / Broken

0.20 h	-	13.14 EUR	
	Bodywork cost	Paint cost	MaterialCost	
	12.00 EUR	-	-	
004	Wheel trim / Back Left Rim/Tyre diameter : 16 "	Scratched	Acceptable	-
	Bodywork time	Paint time	Part Price	Lumpsum -

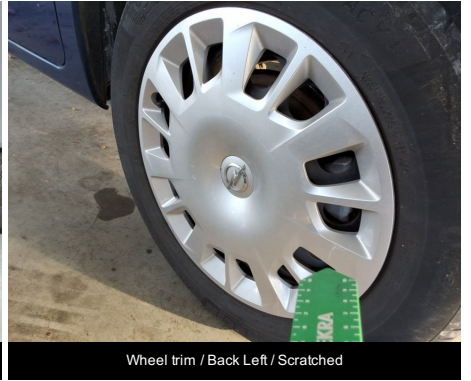
Wheel trim / Back Left / Scratched

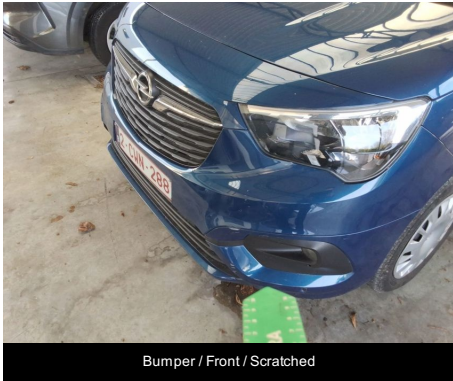
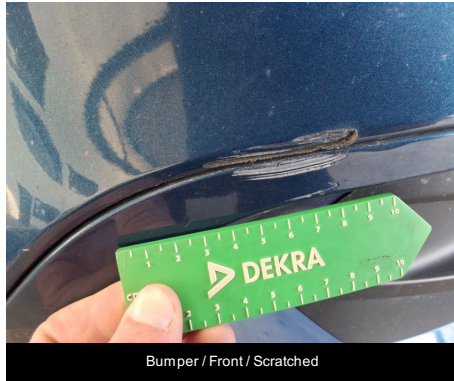
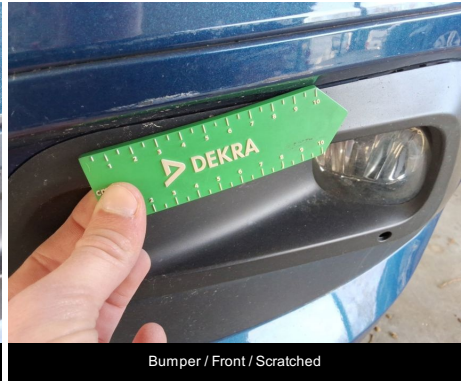
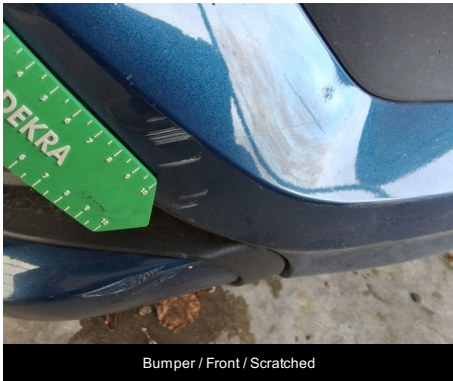
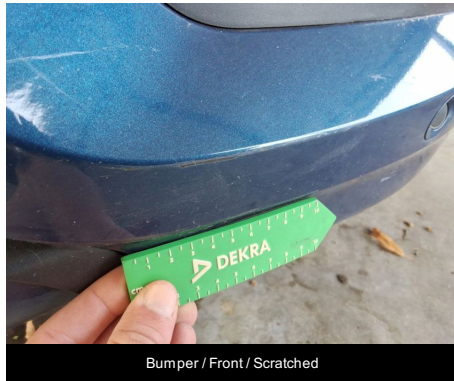
-	-	-	
	Bodywork cost	Paint cost	MaterialCost	
	-	-	-	
005	Bumper / Front Painted : Yes	Scratched	Repair	193.00 EUR
	Bodywork time	Paint time	Part Price	Lumpsum -

Bumper / Front / Scratched

-	-	-	
	Bodywork cost	Paint cost	MaterialCost	
	-	193.00 EUR	-	
006	Spoiler / Front Painted : Yes	Scratched	Repair	65.00 EUR
	Bodywork time	Paint time	Part Price	Lumpsum -

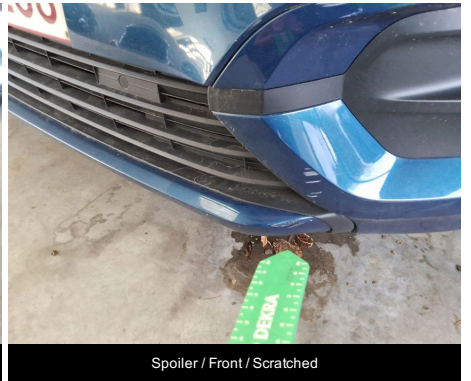
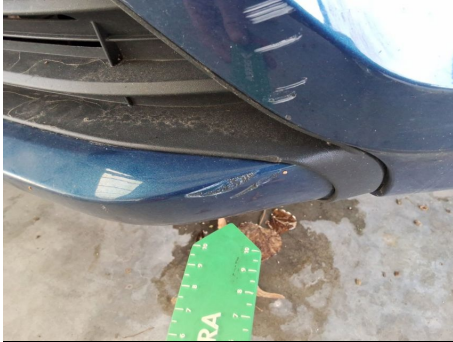
Spoiler / Front / Scratched

-	-	-	
	Bodywork cost	Paint cost	MaterialCost	
	-	65.00 EUR	-	
007	Seat cover / Front Left	Burn mark	Smart repair	53.00 EUR

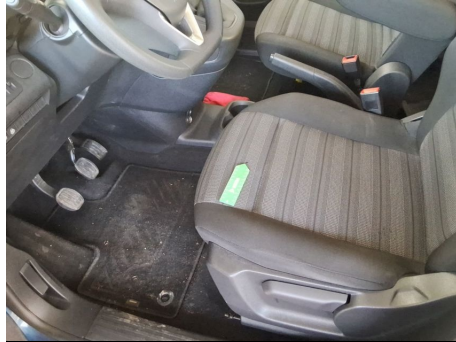
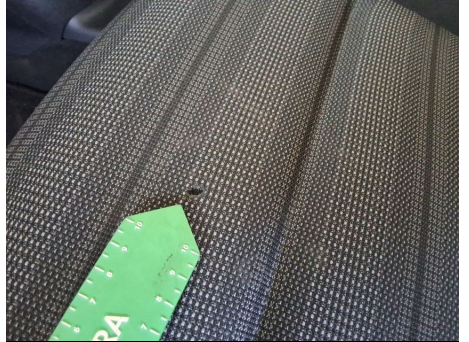
Seat cover / Front Left / Burn mark

Bodywork time	Paint time	Part Price	Lumpsum 53.00 EUR
	Bodywork cost	Paint cost	MaterialCost	
008	Door sill / Front Left ¹	Dent	Smart repair	40.00 EUR

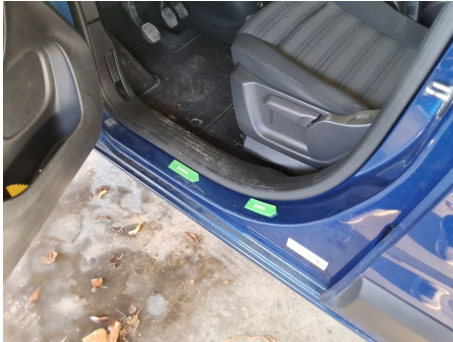
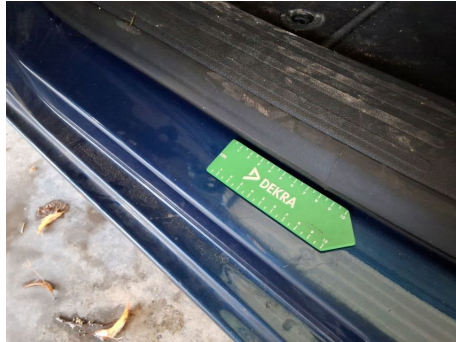
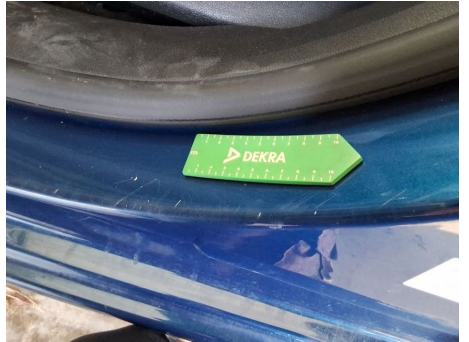
¹ 2x deuk +kras

Door sill / Front Left / Dent

Bodywork time	Paint time	Part Price	Lumpsum 40.00 EUR
	Bodywork cost	Paint cost	MaterialCost	
009	Carpet / Front Left	Burn mark	Smart repair	53.00 EUR

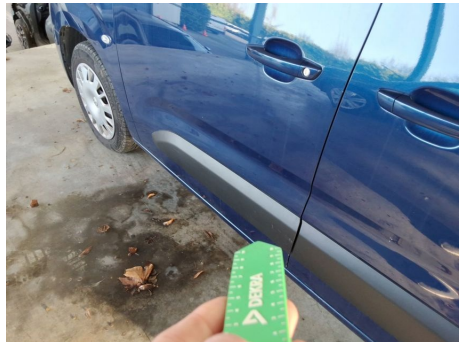
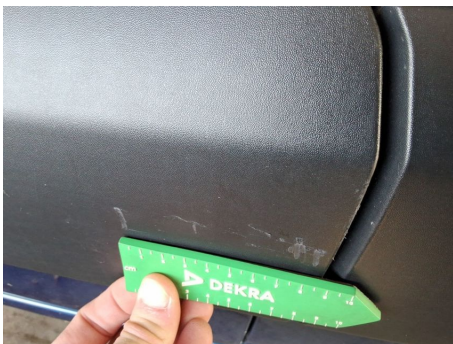
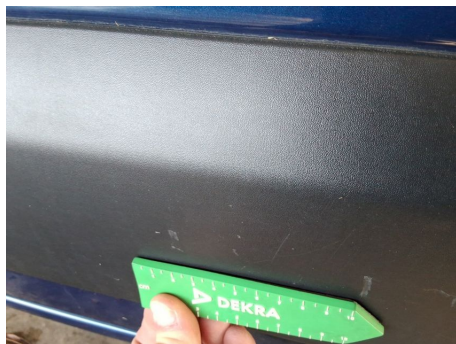
Bodywork time	Paint time	Part Price	Lumpsum 53.00 EUR
	Bodywork cost	Paint cost	MaterialCost	
010	Door moulding / Front Left Painted : No	Scratched	Acceptable	-

Door moulding / Front Left / Scratched

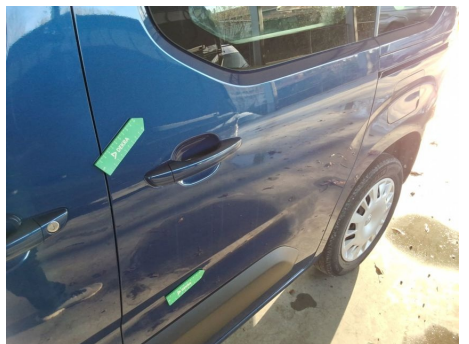
Bodywork time	Paint time	Part Price	Lumpsum -
	Bodywork cost	Paint cost	MaterialCost	
011	Door / Back Left Windowed : Yes	Scratched	Acceptable	-

Door / Back Left / Scratched

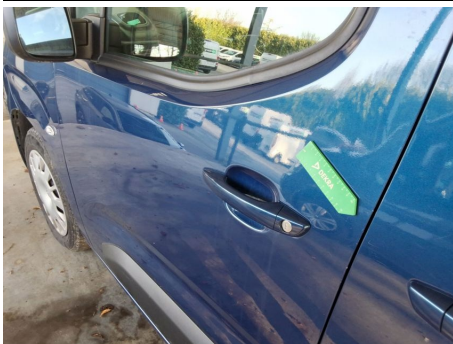
Bodywork time	Paint time	Part Price	Lumpsum -
	Bodywork cost	Paint cost	MaterialCost	
012	Door / Front Left	Scratched	Acceptable	-

Door / Front Left / Scratched

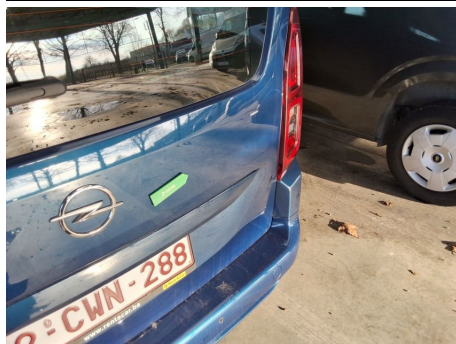
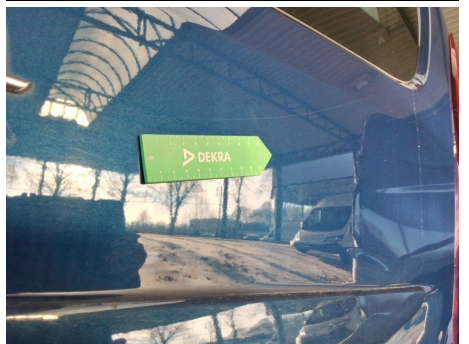
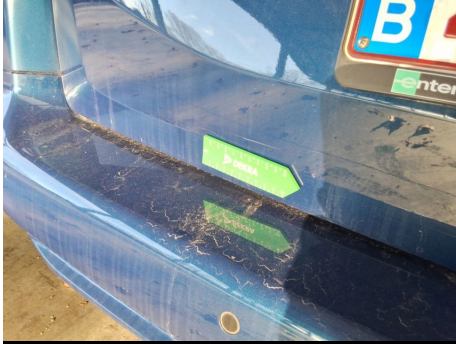
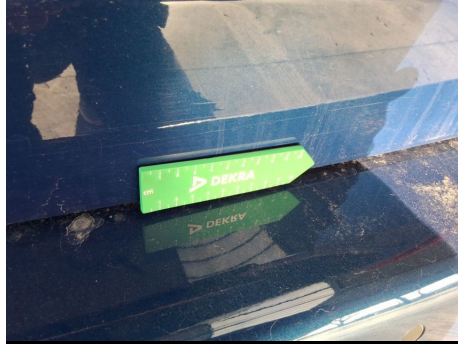
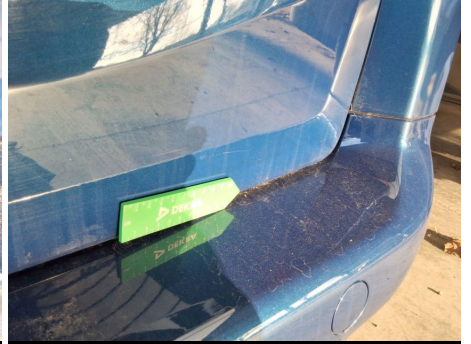
Bodywork time	Paint time	Part Price	Lumpsum -
	Bodywork cost	Paint cost	MaterialCost	
013	Tailgate / Boot door / -	Scratched	Polishing	29.00 EUR

Tailgate / Boot door / - / Scratched

Bodywork time	Paint time	Part Price	Lumpsum 29.00 EUR
	Bodywork cost	Paint cost	MaterialCost	
014	Wing / Back Right ²	Dent	Smart repair	40.00 EUR

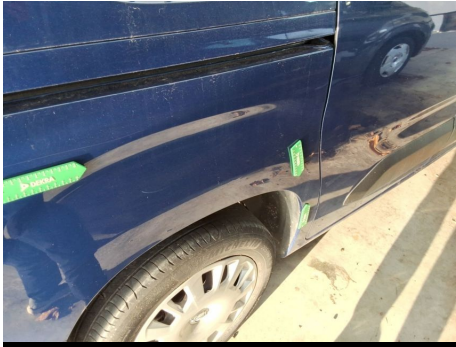
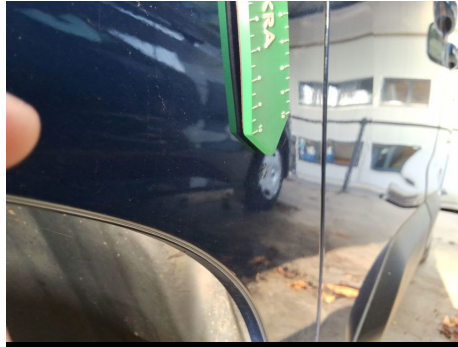
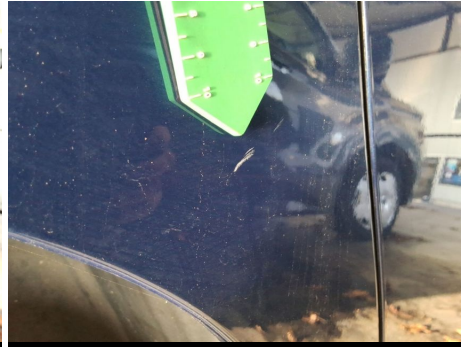
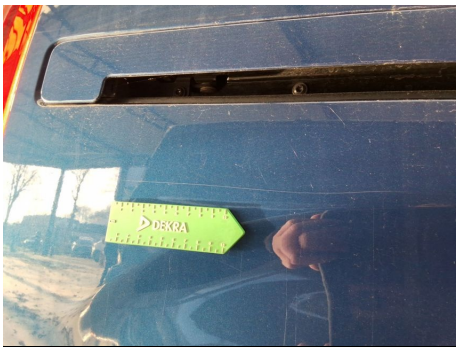
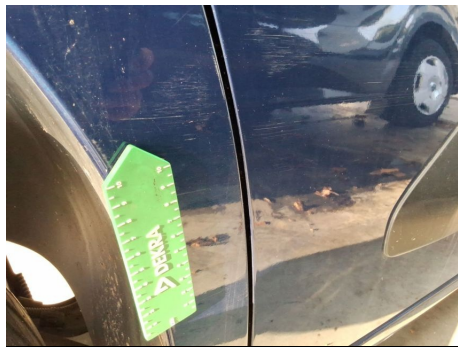
² +kras

Wing / Back Right / Dent

Bodywork time	Paint time	Part Price	Lumpsum 40.00 EUR
	Bodywork cost	Paint cost	MaterialCost	
015	Door / Back Right	Scratched	Polishing	29.00 EUR

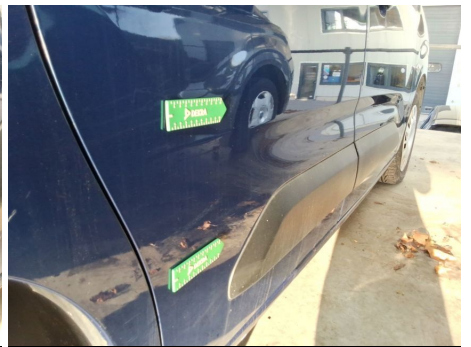
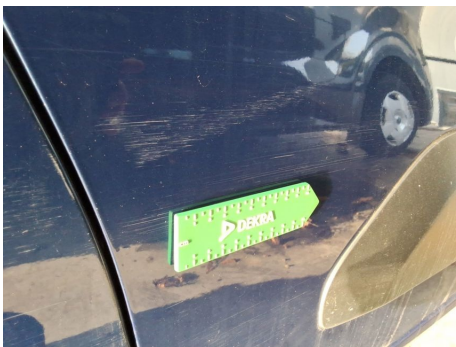
Door / Back Right / Scratched

Bodywork time	Paint time	Part Price	Lumpsum 29.00 EUR
	Bodywork cost	Paint cost	MaterialCost	
016	Door / Front Right ³	Scratched	Acceptable	-

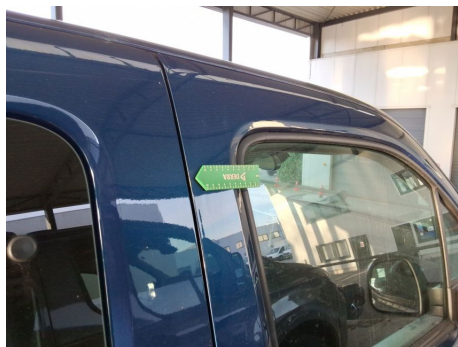
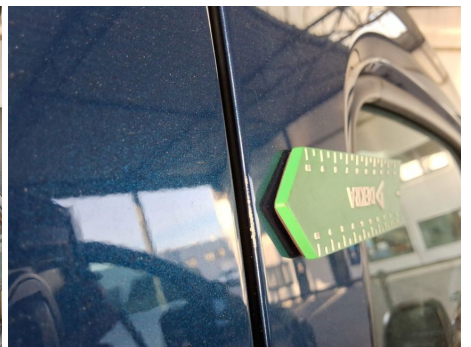
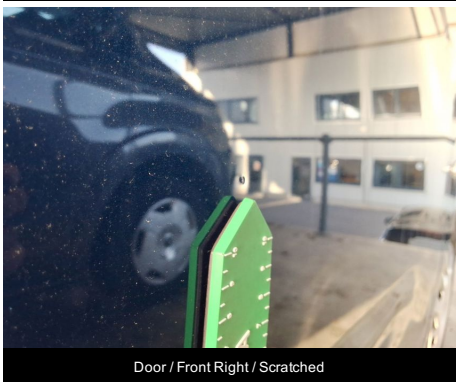
³ +reeds hersteld

Door / Front Right / Scratched
