Expertise

Protocol number: 46468925  
Order No. / Reference: 26555285  
Inspection date: 13 Jul 2026

Manufacturer: Mercedes-Benz  
VIN: W1KAH0DB6PF109603

Model: C 200 d T 9G-TRONIC Avantgarde

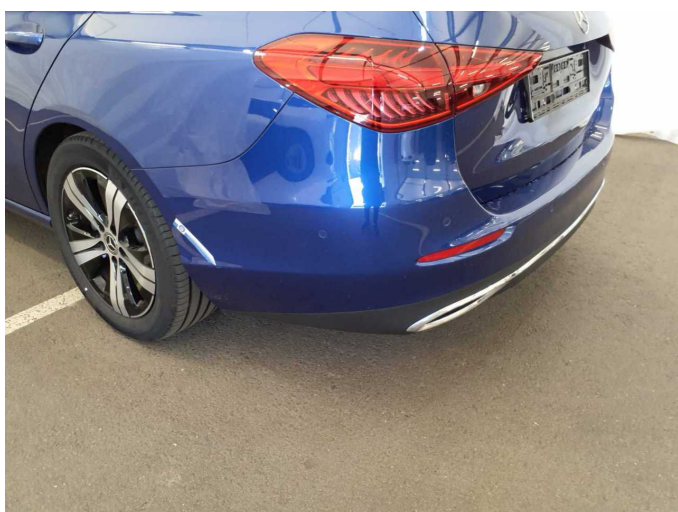
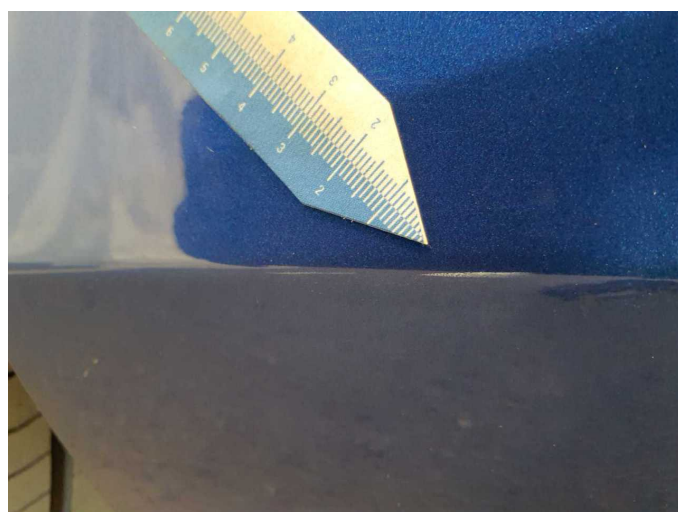
| No. | Component group | Description |
|---|---|---|
| 1 | Rear bumper | Rear bumper - Scratch(es) - Smart repair |

**Damage 1:** Rear bumper: Rear bumper - Scratch(es) - Smart repair

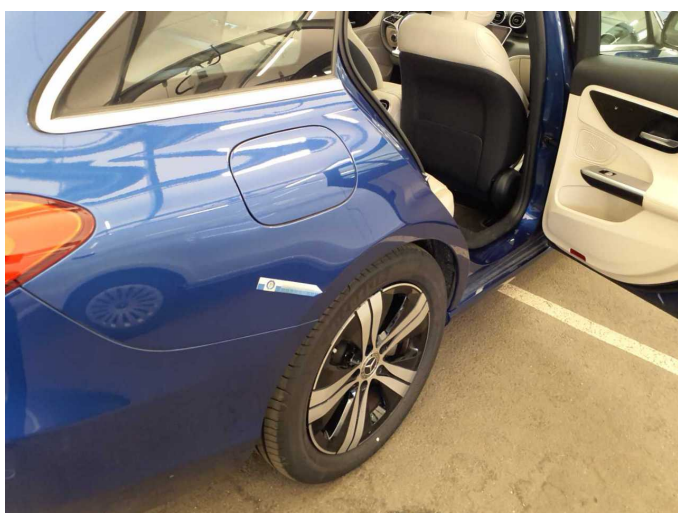
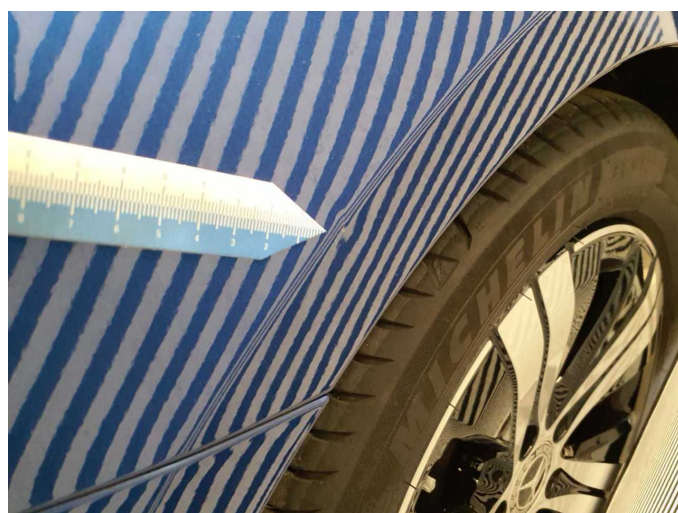
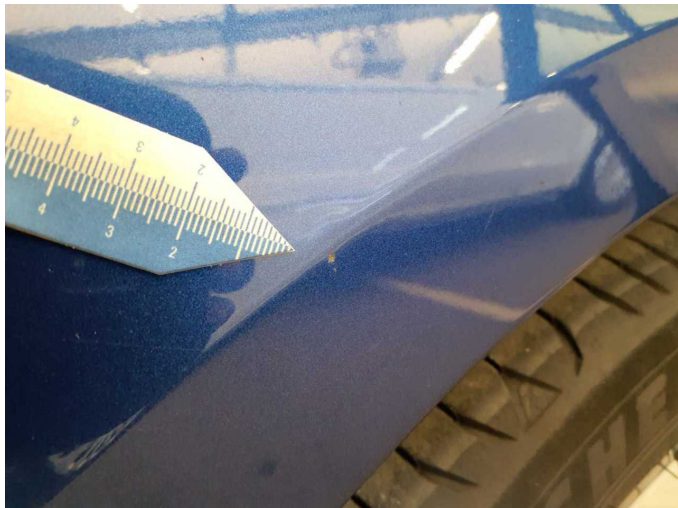
| No. | Component group | Description |
|---|---|---|
| 2 | Side panel - rear right side | Side panel - Dent / paintcoat damage - Smart repair |

**Damage 2:** Side panel - rear right side: Side panel - Dent / paintcoat damage - Smart repair

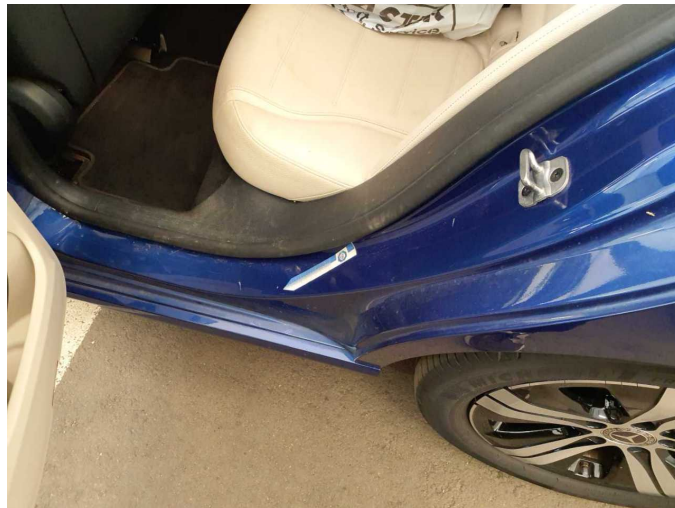
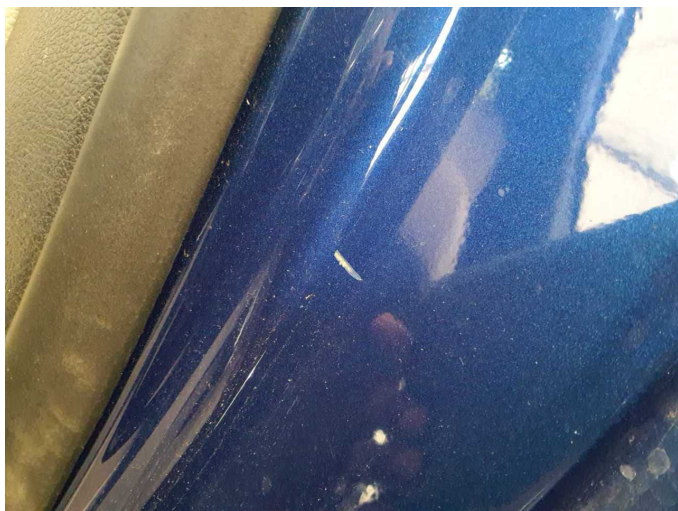
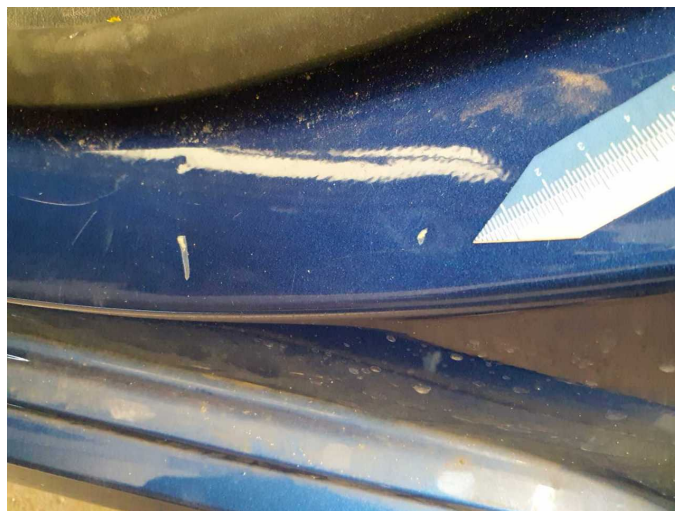
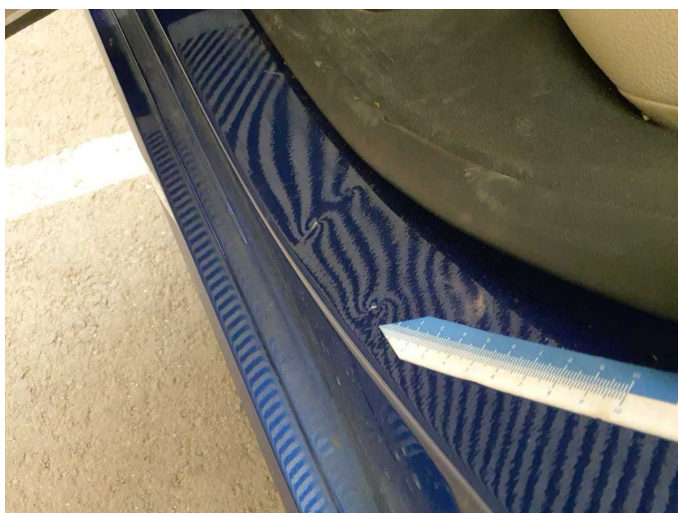
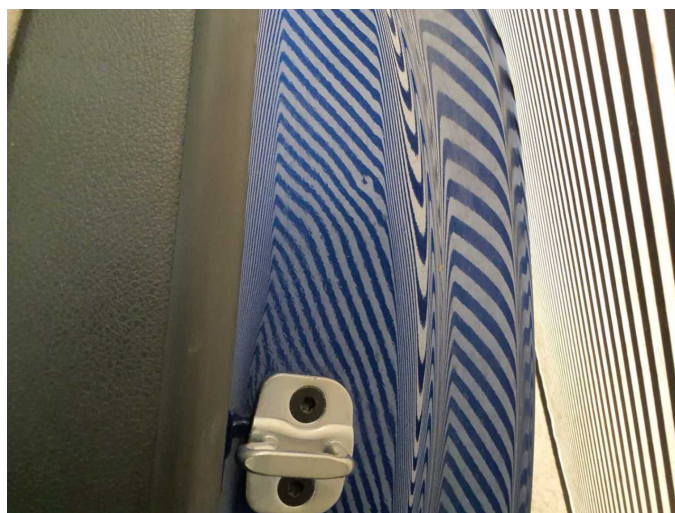
| No. | Component group | Description |
|---|---|---|
| 3 | Side panel - rear left side | Sill - Dent / paintcoat damage - Smart repair |

**Damage 3:** Side panel - rear left side: Sill - Dent / paintcoat damage - Smart repair

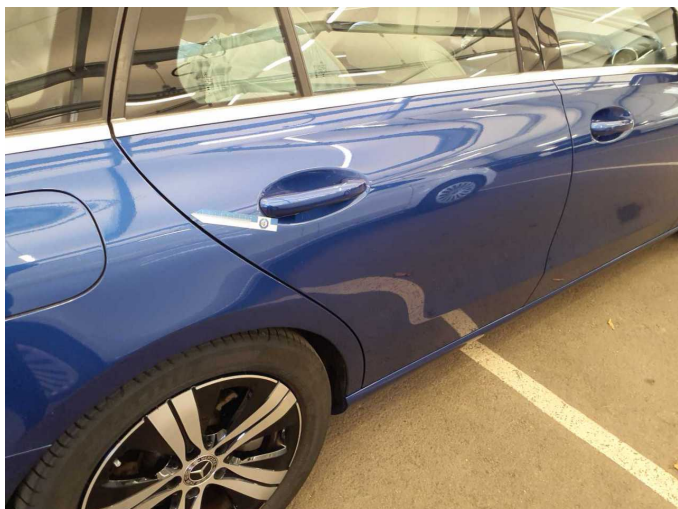
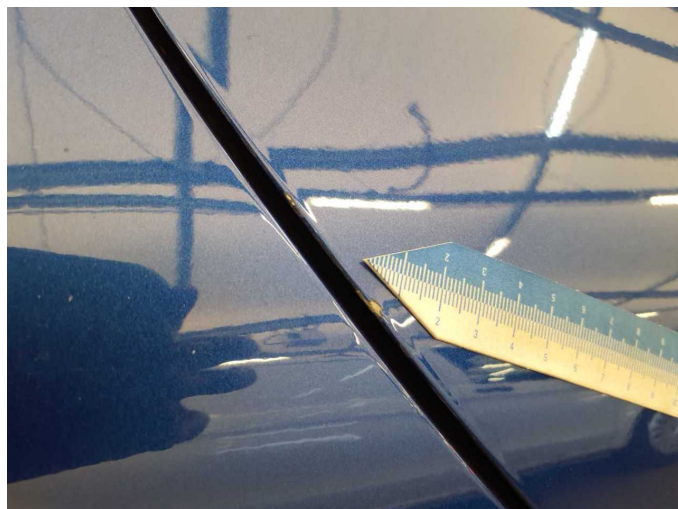
| No. | Component group | Description |
|---|---|---|
| 4 | Door - rear right side | Door edge - Scratch(es) - Smart repair |

**Damage 4:** Door - rear right side: Door edge - Scratch(es) - Smart repair

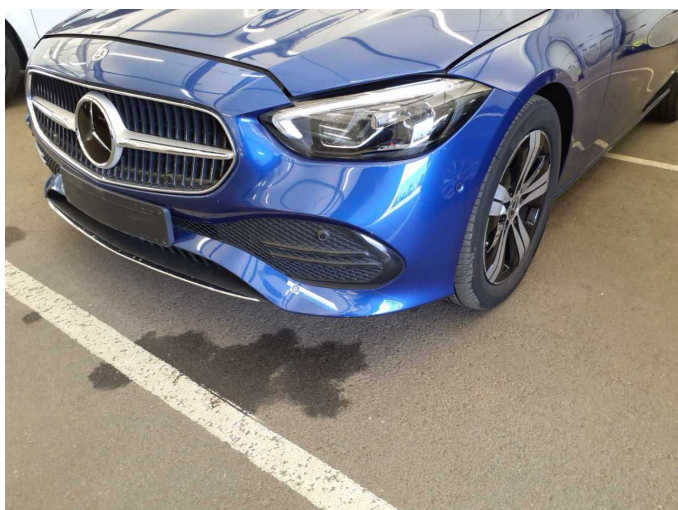
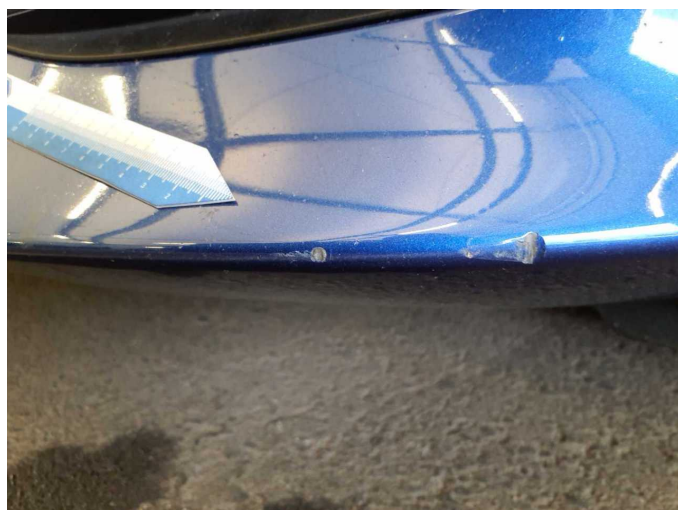
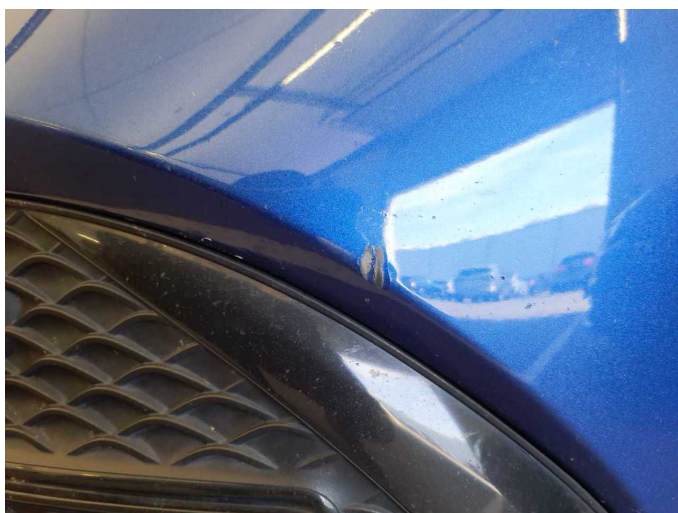
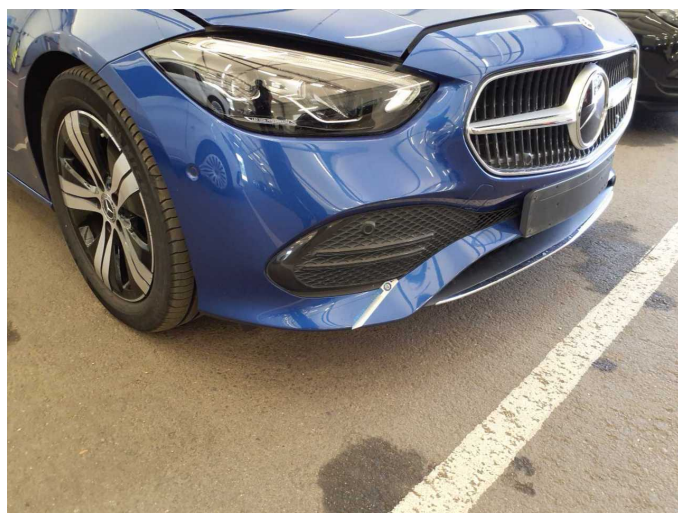
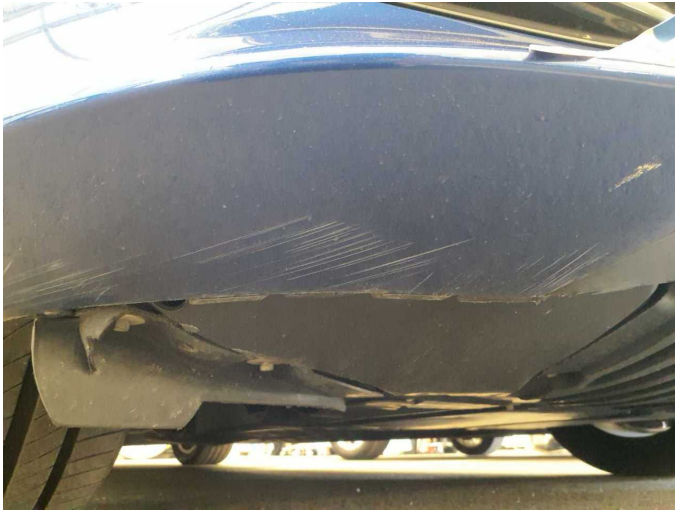
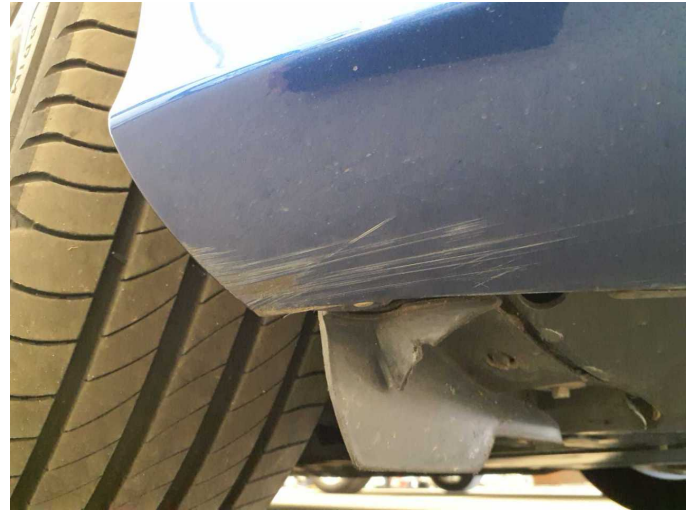
| No. | Component group | Description |
|---|---|---|
| 5 | Front bumper | Front bumper - Dent / paintcoat damage - Repair and paint |

**Damage 5:** Front bumper: Front bumper - Dent / paintcoat damage - Repair and paint
