Expertise

Protocol number: 46692426  
Order No. / Reference: 26661238  
Inspection date: 20 Jul 2026

Manufacturer: Mercedes-Benz

Model: GLA 220 d 4Matic 8G-DCT AMG Line

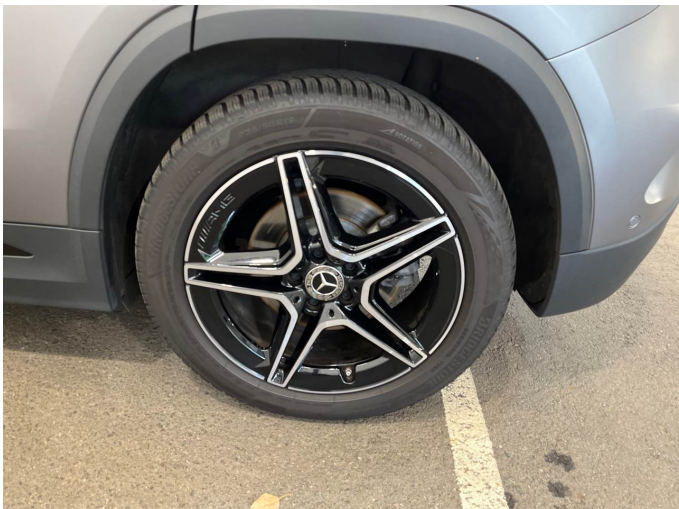
Figure 12: Mounted tyres

| # | Tyre size | Type of tyre | Manufacturer | Tread depth |
|---|---|---|---|---|
| 1) | 235/50 R19 103V | Winter tyres on Light alloy | Bridgestone | 6mm / 6mm |
| 2) | 235/50 R19 103V | Winter tyres on Light alloy | Bridgestone | 6mm / 6mm |

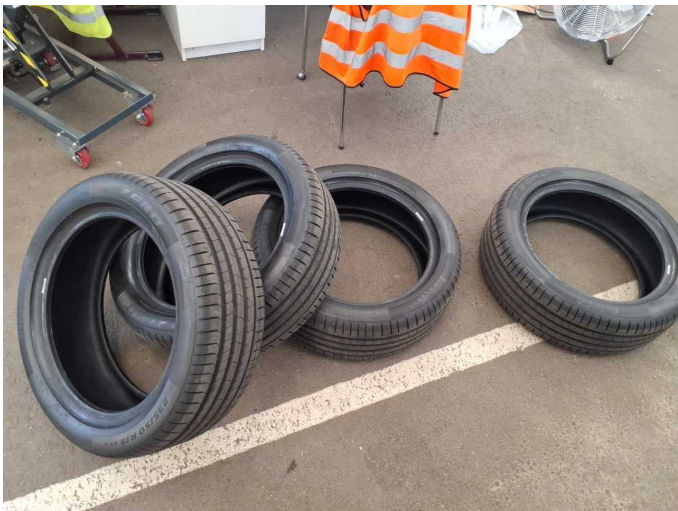
Figure 15: Additional tyres

| # | Tyre size | Type of tyre | Manufacturer | Tread depth |
|---|---|---|---|---|
| 1) | 235/50 R19 99W | Summer tyres (Without wheel rim) | Pirelli | 7mm / 7mm |
| 2) | 235/50 R19 99W | Summer tyres (Without wheel rim) | Pirelli | 7mm / 7mm |

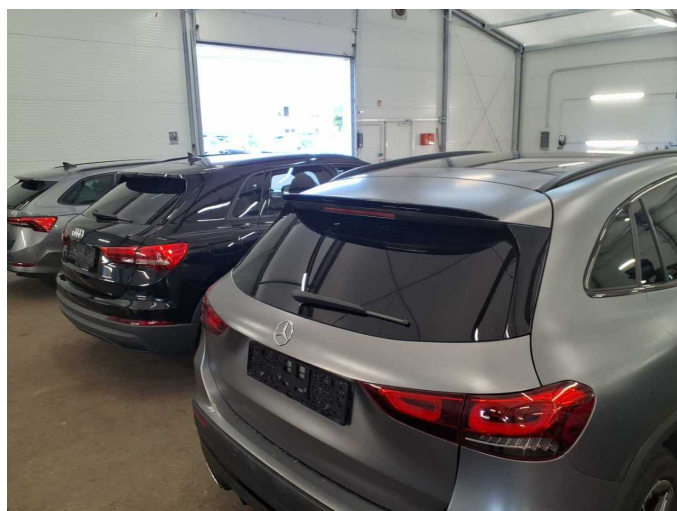
| No. | Component group | Description |
|---|---|---|
| 1 | Boot lid / rear door | Rear spoiler (Zusätzliche Spoilerlippe, nicht Bestandteil der Ausstattung) - Differs from the original configuration - Un- / install |

**Damage 1:** Boot lid / rear door: Rear spoiler (Zusätzliche Spoilerlippe, nicht Bestandteil der Ausstattung) - Differs from the original configuration - Un- / install

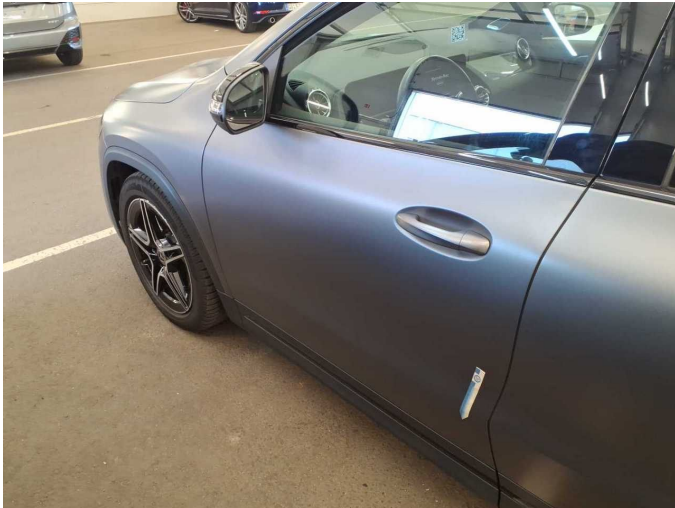
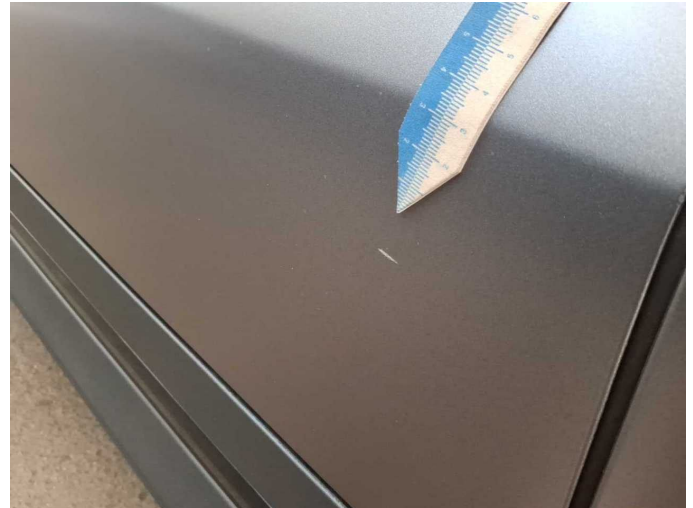
| No. | Component group | Description |
|---|---|---|
| 3 | Door - front left side | Door - Scratch(es) - Paint |

**Damage 3:** Door - front left side: Door - Scratch(es) - Paint

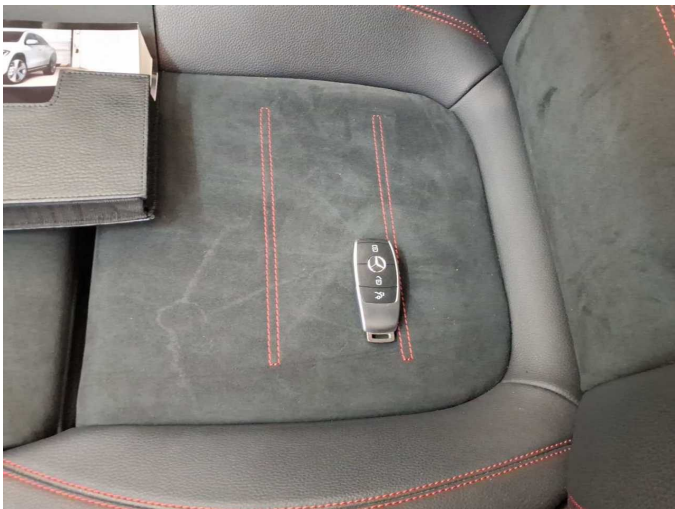
Equipment - Vehicle key

**Missing part 1:** Equipment: Vehicle key - Missing - Replace

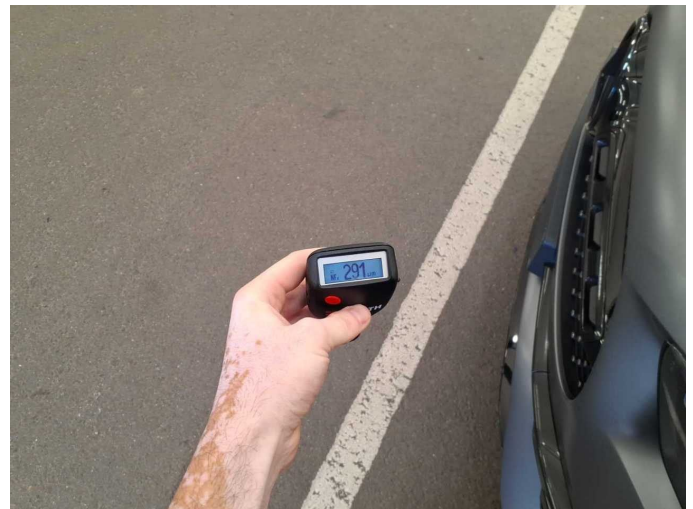
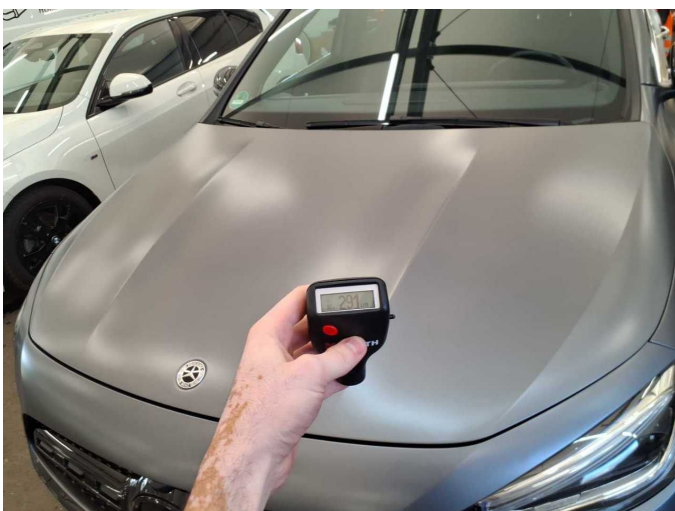
- 1 Bonnet, Professionally carried out, Invoice of repair done Non-existent
- 2 Side panel - rear right side, Professionally carried out, Invoice of repair done Non-existent
- 3 Door - front right side, Professionally carried out, Invoice of repair done Non-existent

| Bonnet | 291 µm | Side panel - rear right side | 218 µm |

**Repainting 1:** Bonnet

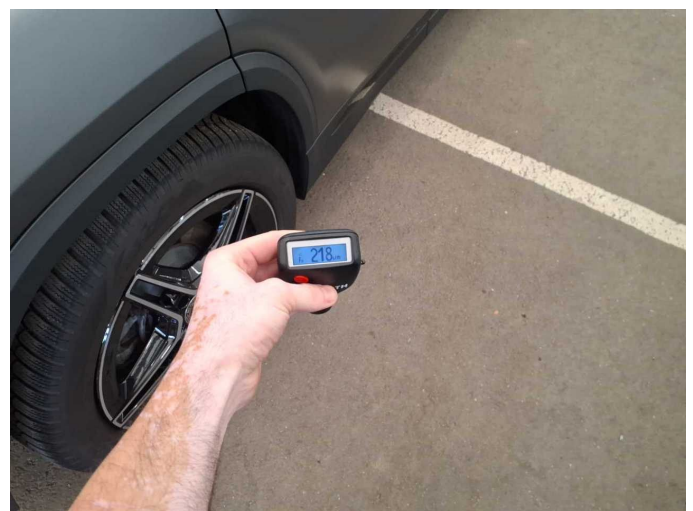
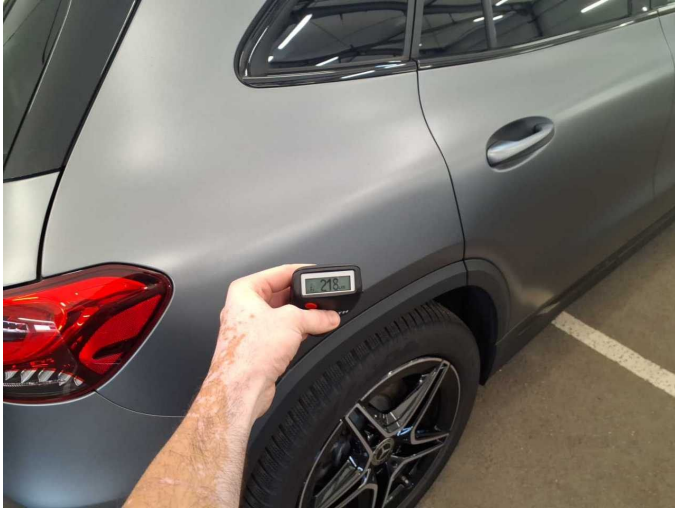
**Repainting 2:** Side panel - rear right side

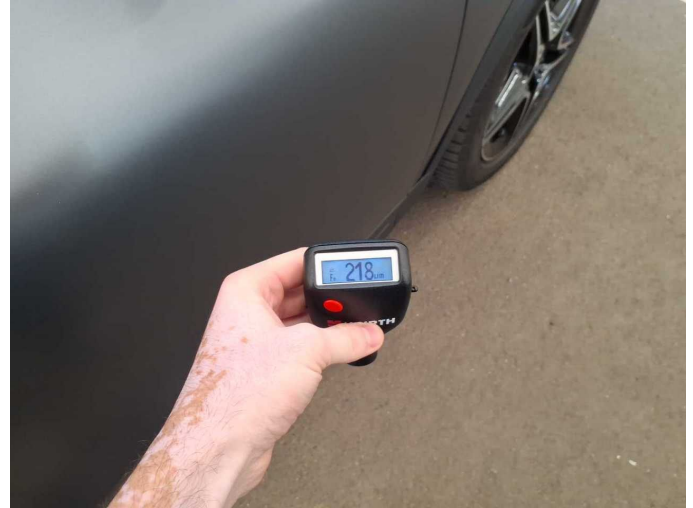
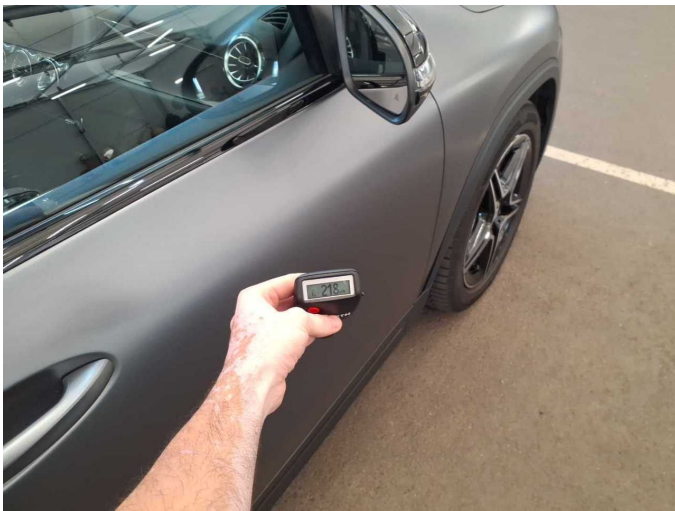
| Door - front right side | 218 µm | | |

**Repainting 3:** Door - front right side
