Expertise

Protocol number: 46179537  
Order No. / Reference: 26511819  
Inspection date: 26 Jun 2026

| Manufacturer: Volvo | Model: XC40 Recharge 69 kWh Single Motor Ultimate |

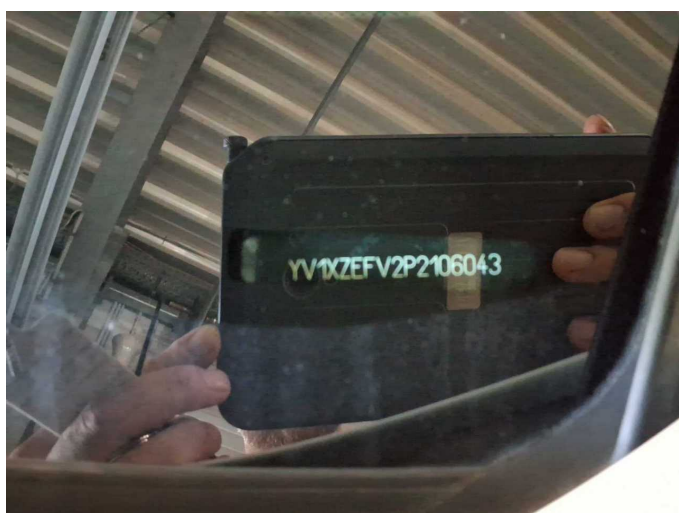
| VIN comparison | The vehicle identification number (VIN) was read from the vehicle and its conformity with the submitted documents was confirmed by the undersigned during the inspection. |

Figure 11: VIN

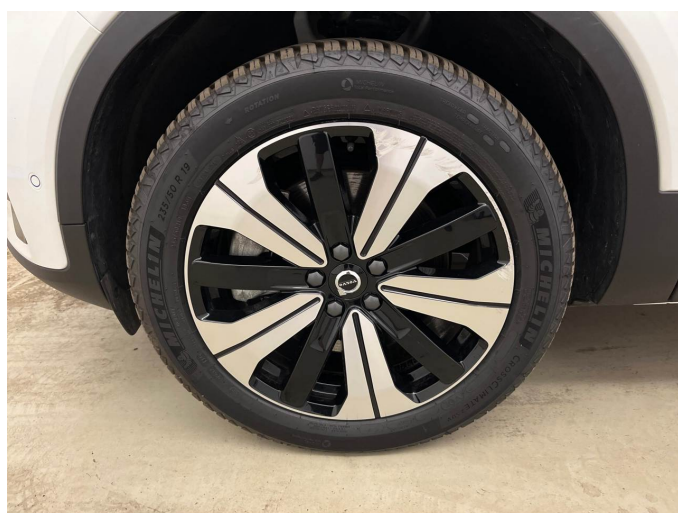
| # | Tyre size | Type of tyre | Manufacturer | Tread depth |
|---|---|---|---|---|
| 1) | 255/45 R19 104H | All-season tyres on Light alloy | Michelin | 5mm / 5mm |
| 2) | 255/45 R19 104H | All-season tyres on Light alloy | Michelin | 5mm / 5mm |

Figure 12: Mounted tyres

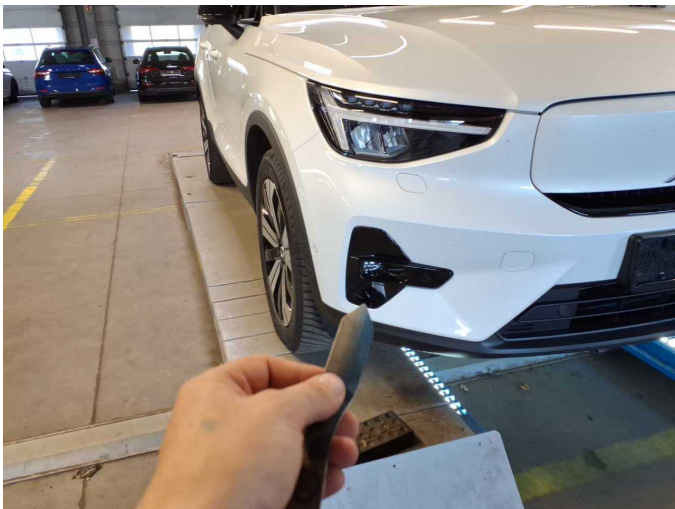
| No. | Component group | Description |
|---|---|---|
| 1 | Fog lamp | Fog lamp - front right side (Rahmen) - Scratch(es) - Replace |

**Damage 1:** Fog lamp: Fog lamp - front right side (Rahmen) - Scratch(es)  
- Replace

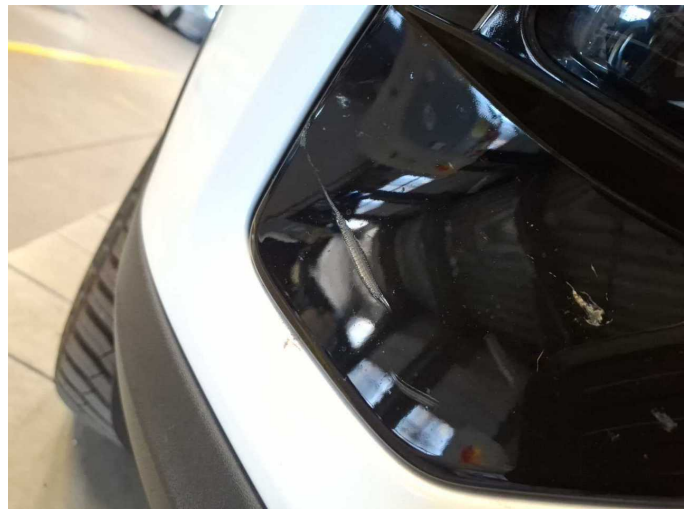
**Damage 1:** Fog lamp: Fog lamp - front right side (Rahmen) - Scratch(es)  
- Replace

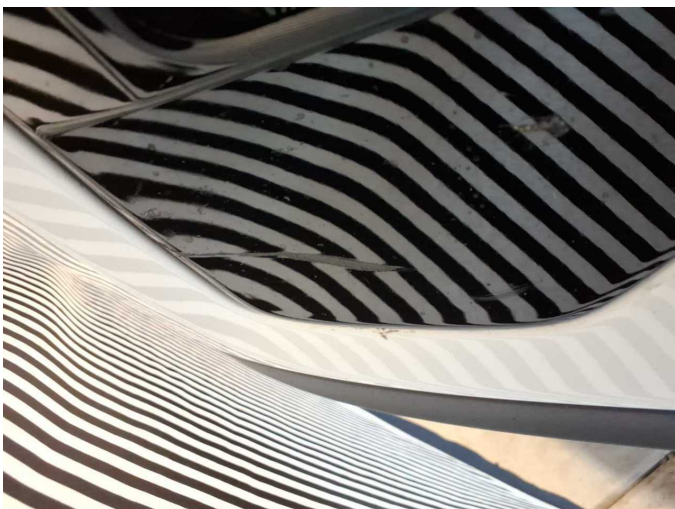
**Damage 1:** Fog lamp: Fog lamp - front right side (Rahmen) - Scratch(es)  
- Replace

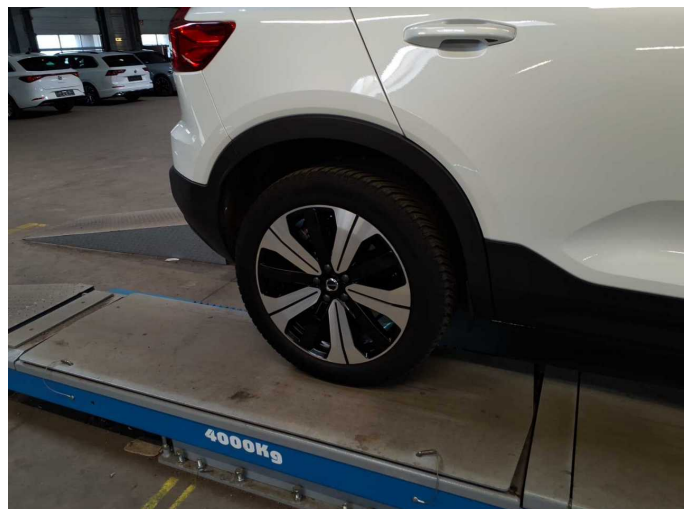
| No. | Component group | Description |
|---|---|---|
| 2 | Wheel / tyres | Tyre - rear right side (Flanke) - Damaged - Replace |

**Damage 2:** Wheel / tyres: Tyre - rear right side (Flanke) - Damaged -  
Replace

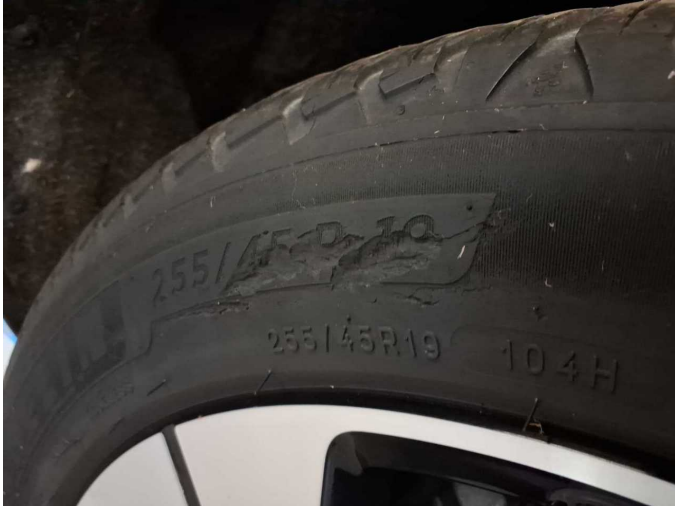
**Damage 2:** Wheel / tyres: Tyre - rear right side (Flanke) - Damaged - Replace

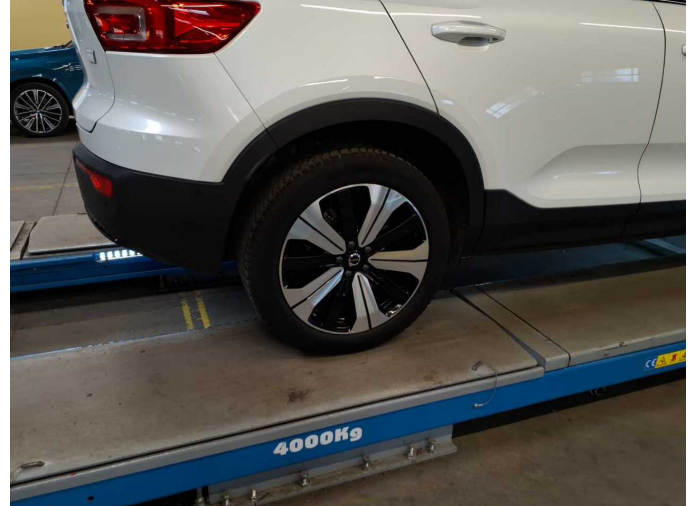
| No. | Component group | Description |
|---|---|---|
| 3 | Wheel / tyres | Alloy rim - rear right side - Scratch(es) - Loss in value |

**Damage 3:** Wheel / tyres: Alloy rim - rear right side - Scratch(es) - Loss in value

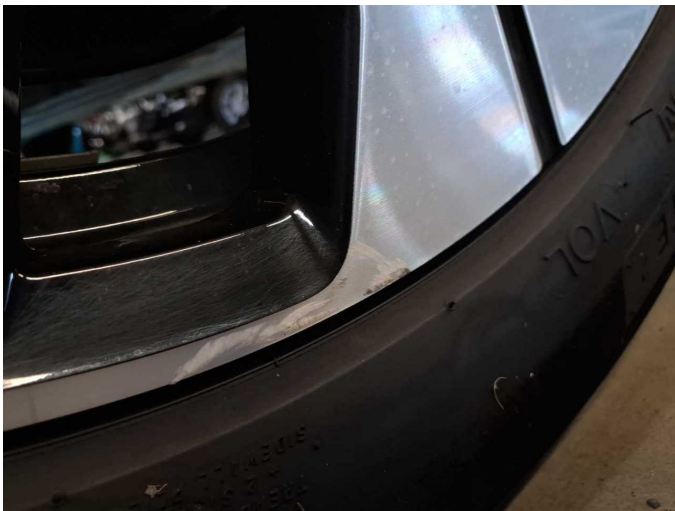
**Damage 3:** Wheel / tyres: Alloy rim - rear right side - Scratch(es) - Loss in value

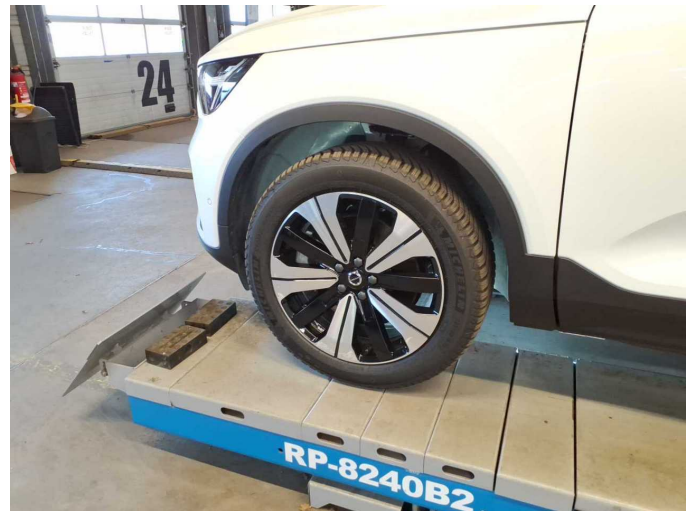
| No. | Component group | Description |
|---|---|---|
| 4 | Wheel / tyres | Alloy rim - front left side (Materialabtrag) - Scratched - Replace |

**Damage 4:** Wheel / tyres: Alloy rim - front left side (Materialabtrag) - Scratched - Replace

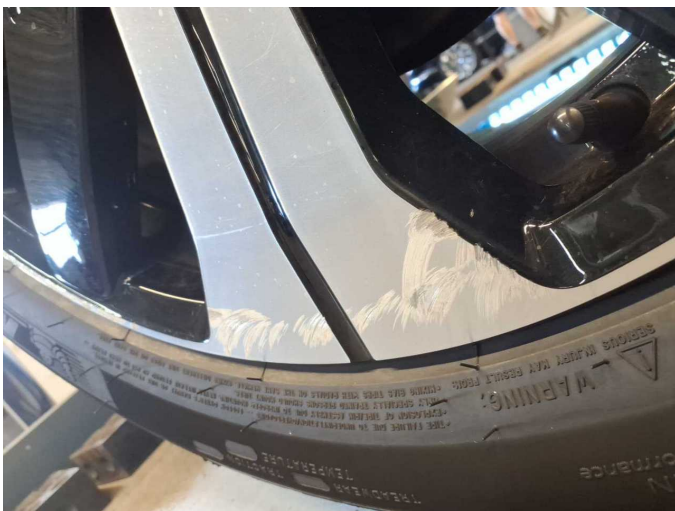
**Damage 4:** Wheel / tyres: Alloy rim - front left side (Materialabtrag) - Scratched - Replace

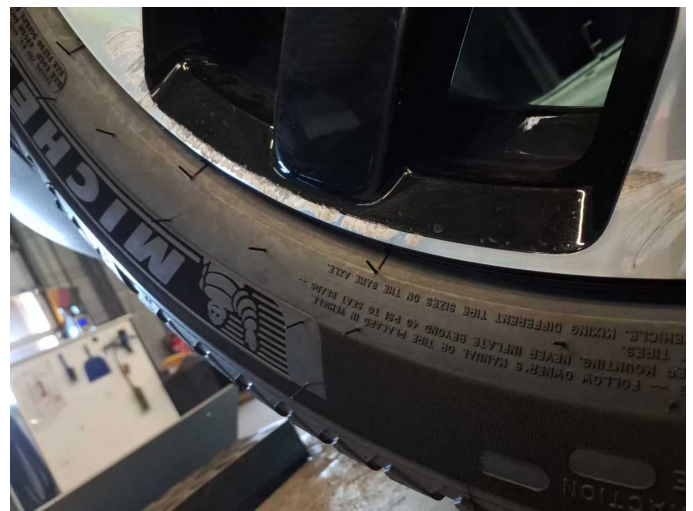
**Damage 4:** Wheel / tyres: Alloy rim - front left side (Materialabtrag) - Scratched - Replace

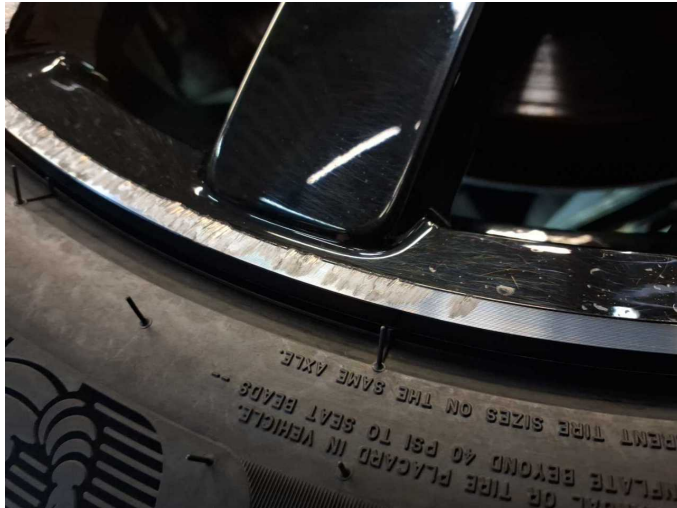
**Damage 4:** Wheel / tyres: Alloy rim - front left side (Materialabtrag) - Scratched - Replace

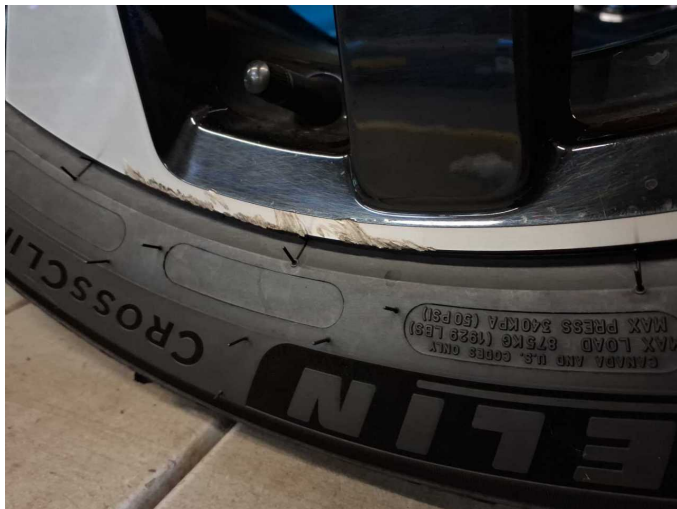
**Damage 5:** Wheel / tyres: Alloy rim - front right side (Materialabtrag) - Scratched - Replace

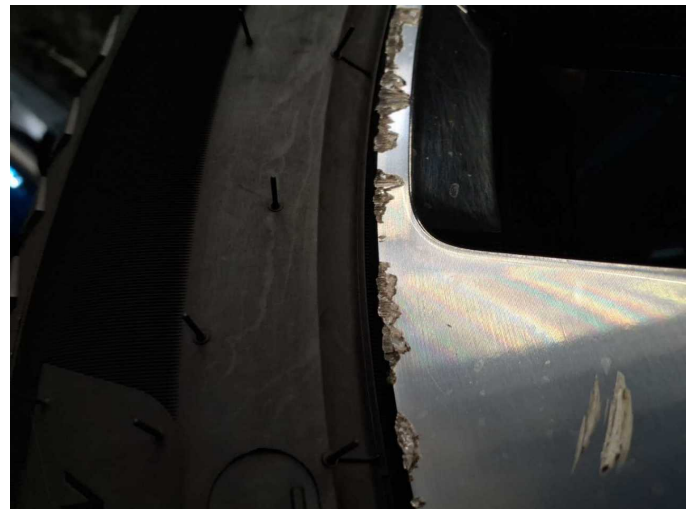
**Damage 5:** Wheel / tyres: Alloy rim - front right side (Materialabtrag) - Scratched - Replace

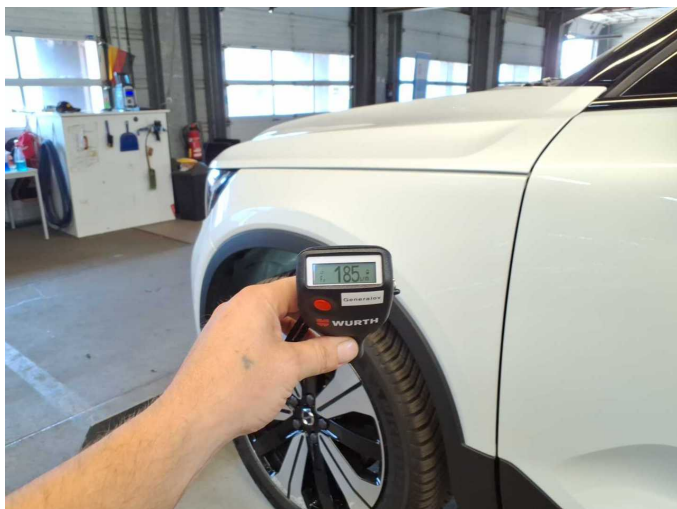
| No. | Repainting |
|---|---|
| 1 | Mudguard - left side, Professionally carried out, Invoice of repair done Non-existent |

| Mudguard - left side | 185 µm | Mudguard - right side | 147 µm |

**Repainting 1:** Mudguard - left side

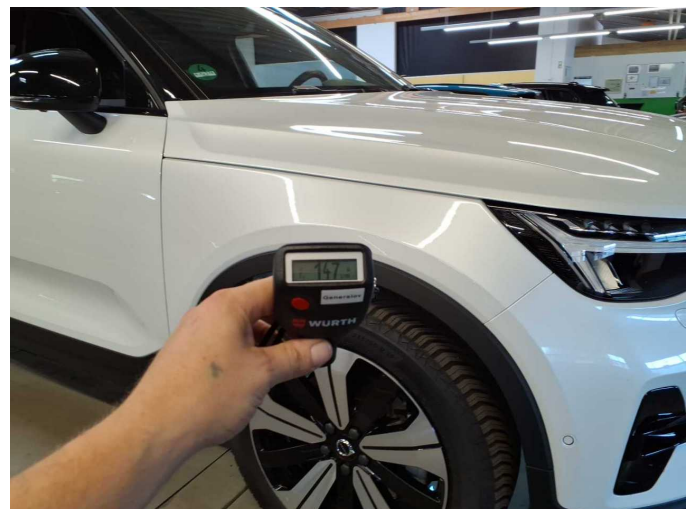
| No. | Repainting |
|---|---|
| 2 | Mudguard - right side, Professionally carried out, Invoice of repair done Non-existent |

**Repainting 2:** Mudguard - right side

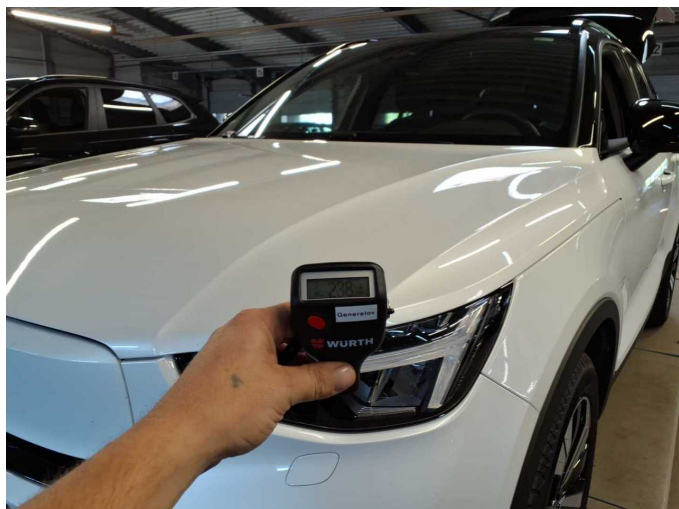
| No. | Repainting |
|---|---|
| 3 | Bonnet, Professionally carried out, Invoice of repair done Non-existent |

| Bonnet | 238 µm | Door - front right side | 196 µm |

**Repainting 3:** Bonnet

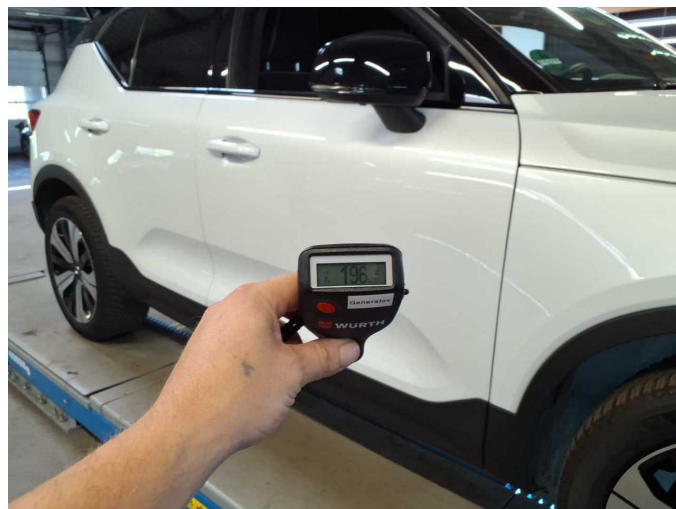
| No. | Repainting |
|---|---|
| 4 | Door - front right side, Professionally carried out, Invoice of repair done Non-existent |

**Repainting 4:** Door - front right side
