Expertise

Protocol number: 46837895  
Order No. / Reference: 26824467  
Inspection date: 31 Jul 2026

Manufacturer: Opel

Model: Grandland X 1.5 D Start/Stop Automatik Ultimate

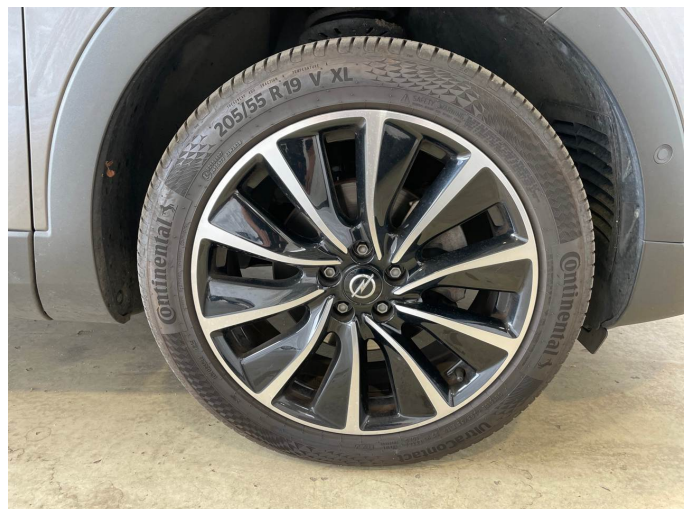
Figure 12: Mounted tyres

| # | Tyre size | Type of tyre | Manufacturer | Tread depth |
|---|---|---|---|---|
| 1) | 205/55 R19 97V | Summer tyres on Light alloy | Continental | 6mm / 6mm |
| 2) | 205/55 R19 97V | Summer tyres on Light alloy | Continental | 6mm / 6mm |

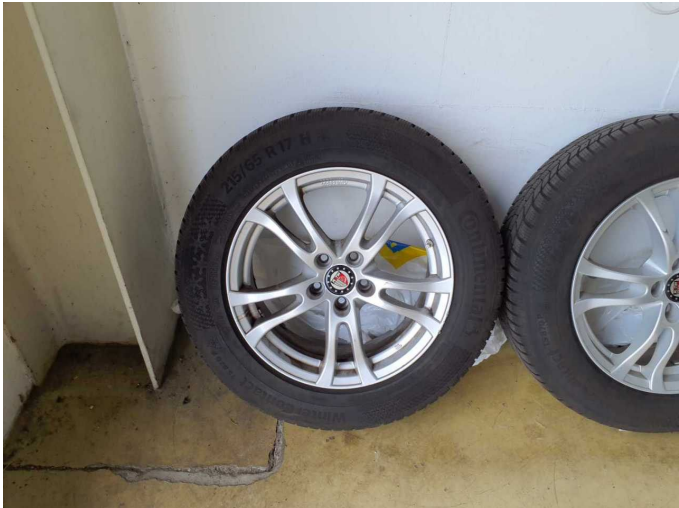
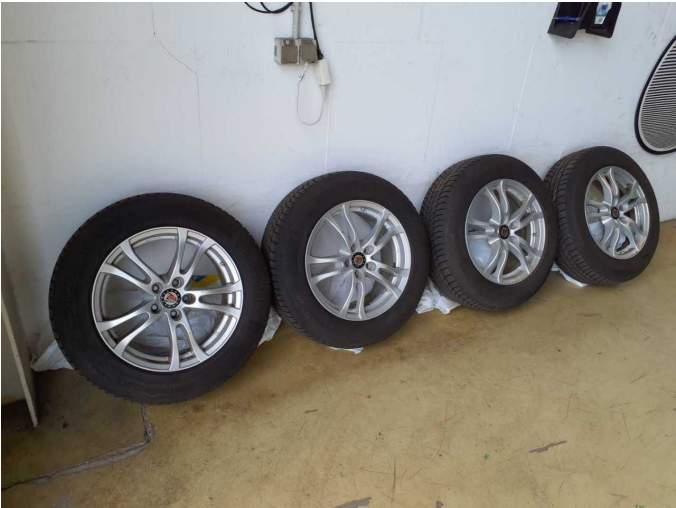
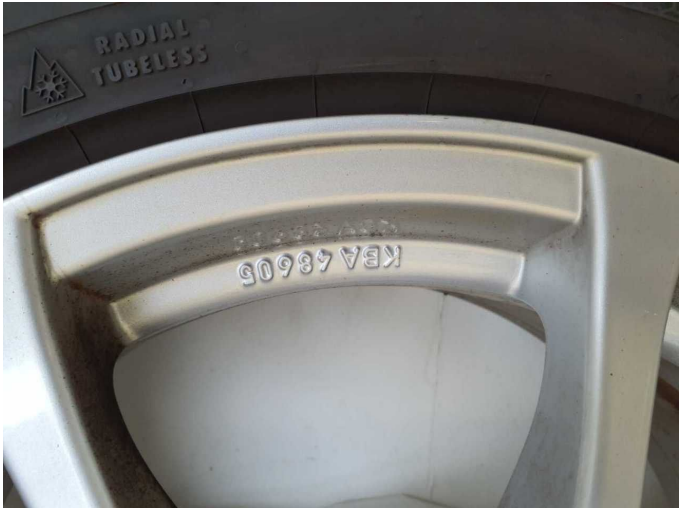
Figure 14: Additional tyres

| # | Tyre size | Type of tyre | Manufacturer | Tread depth |
|---|---|---|---|---|
| 1) | 215/65 R17 99H | Winter tyres on Light alloy | Continental | 6mm / 6mm |
| 2) | 215/65 R17 99H | Winter tyres on Light alloy | Continental | 7mm / 7mm |

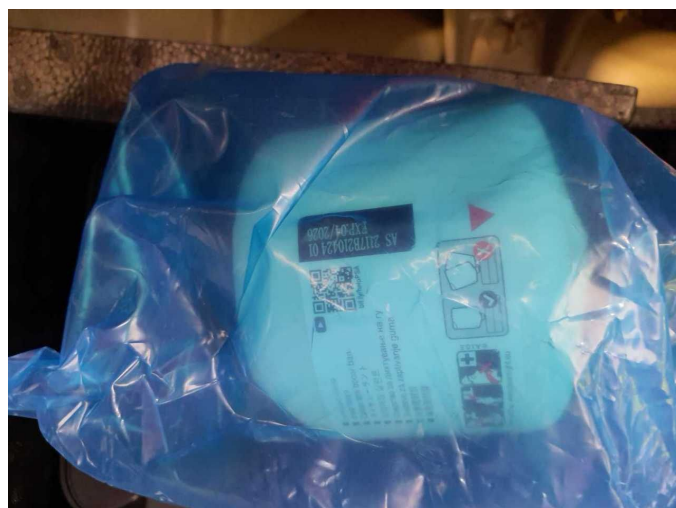
**Damage 1:** Equipment: Tirefit filler - Expired - Replace

| No. | Component group | Description |
|---|---|---|
| 1 | Equipment | Tirefit filler - Expired - Replace |

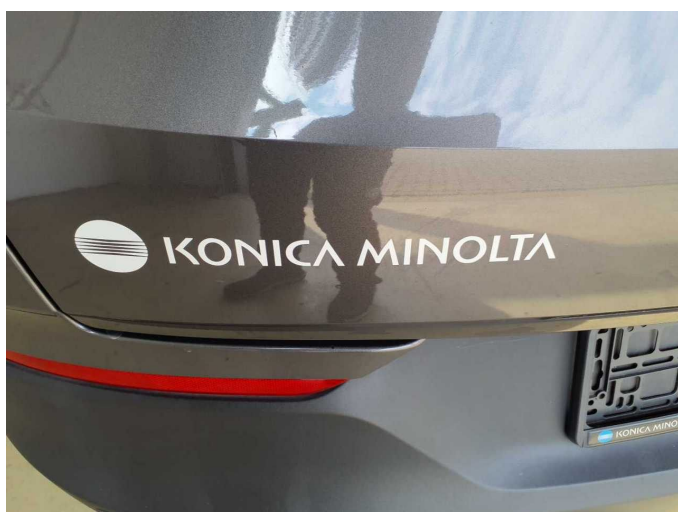
**Damage 2:** Body: Body - Glued / labelled - De-glue / neutralise

| No. | Component group | Description |
|---|---|---|
| 2 | Body | Body - Glued / labelled - De-glue / neutralise |

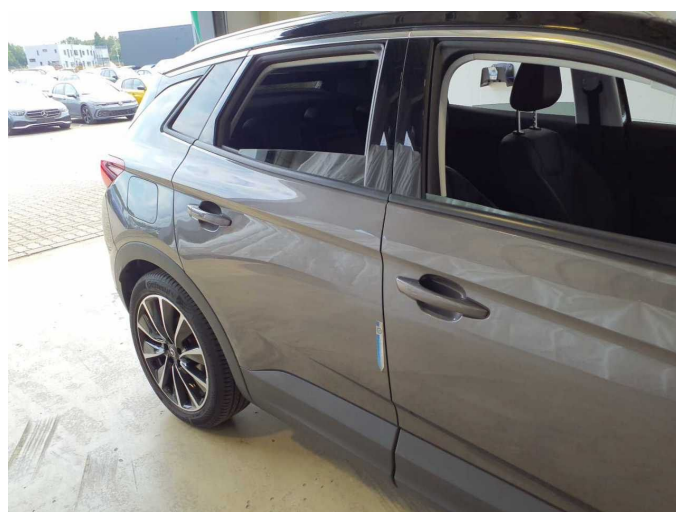
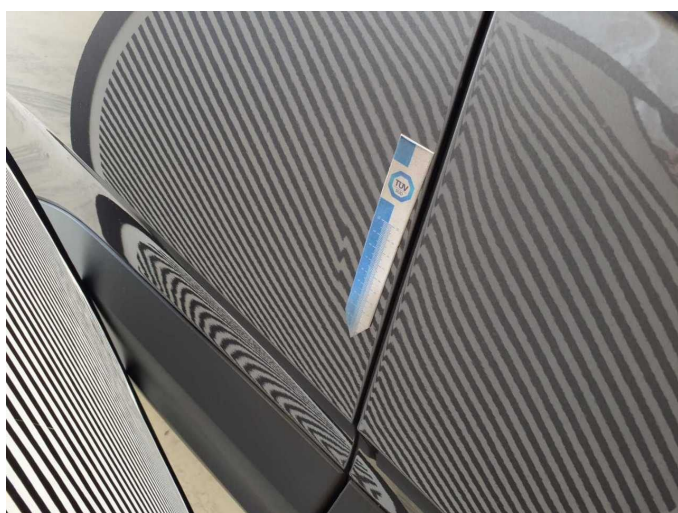
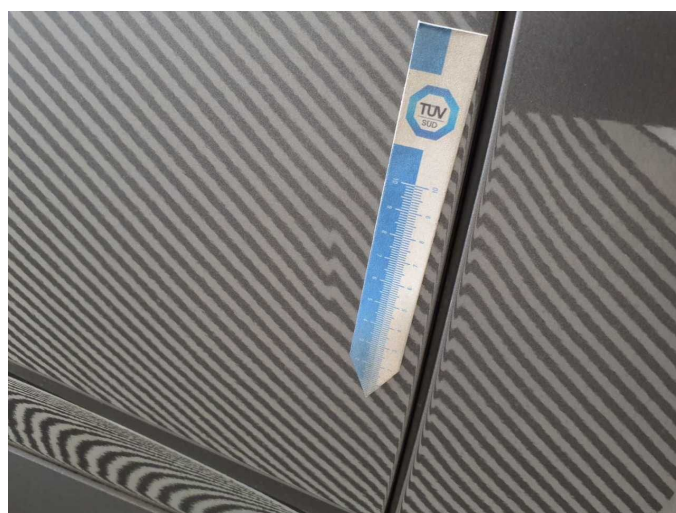
**Damage 3:** Door - rear right side: Door - dent(s) - Smart repair

| No. | Component group | Description |
|---|---|---|
| 3 | Door - rear right side | Door - dent(s) - Smart repair |

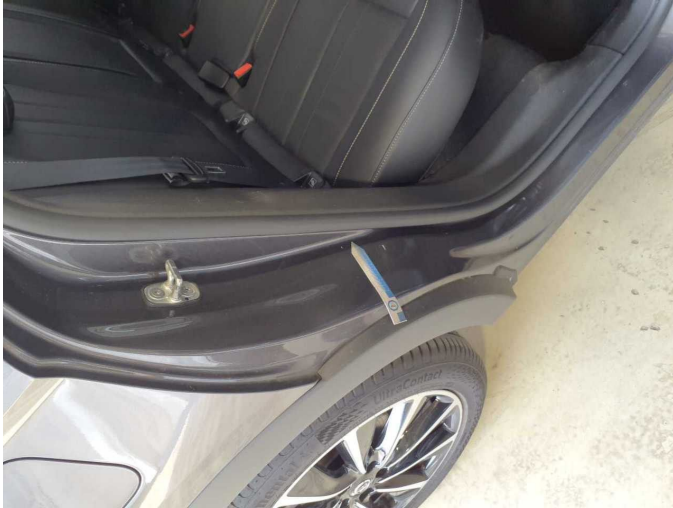
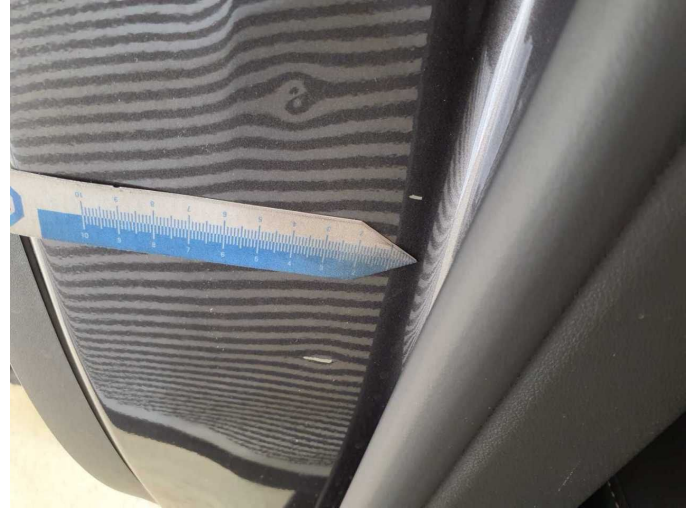
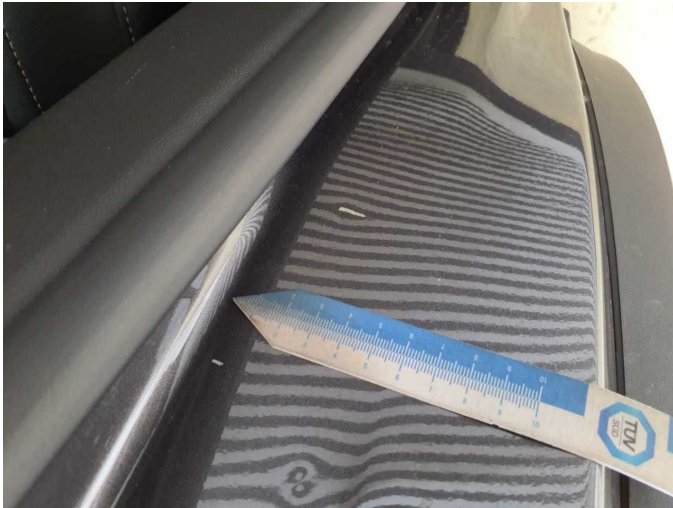
**Damage 4:** Side panel - rear right side: Sill - Dent / paintcoat damage - Smart repair

| No. | Component group | Description |
|---|---|---|
| 4 | Side panel - rear right side | Sill - Dent / paintcoat damage - Smart repair |

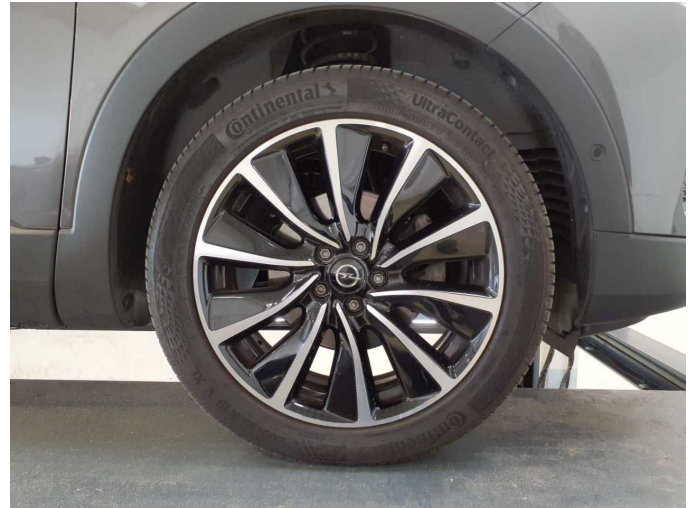
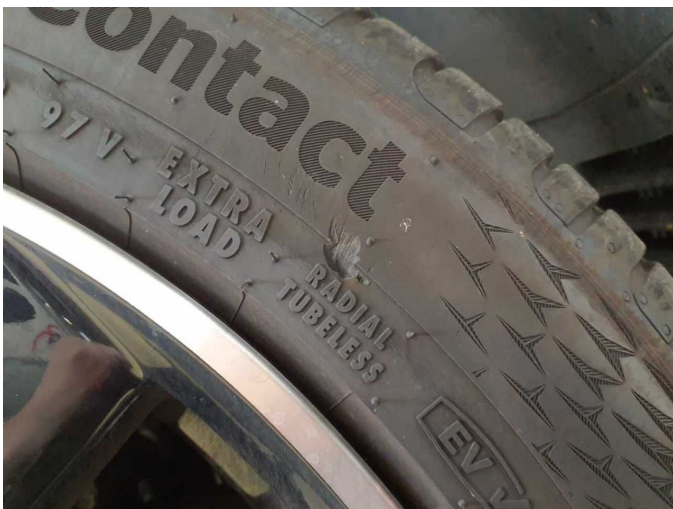
**Damage 5:** Wheel / tyres: Tyre - front right side - Porous / cracked - Replace

| No. | Component group | Description |
|---|---|---|
| 5 | Wheel / tyres | Tyre - front right side - Porous / cracked - Replace |

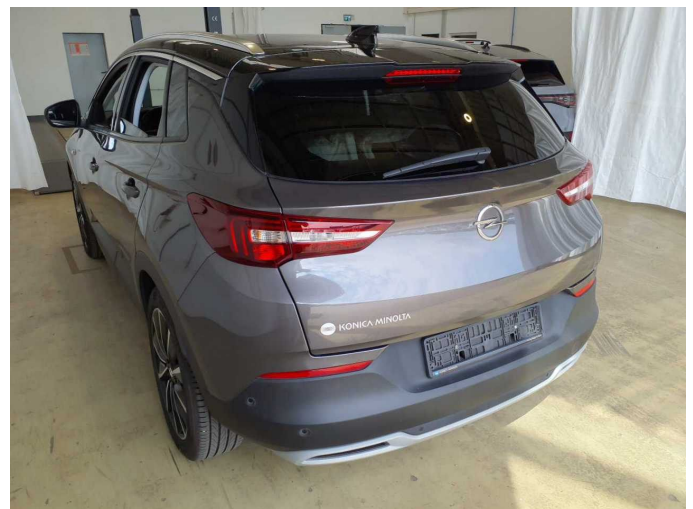
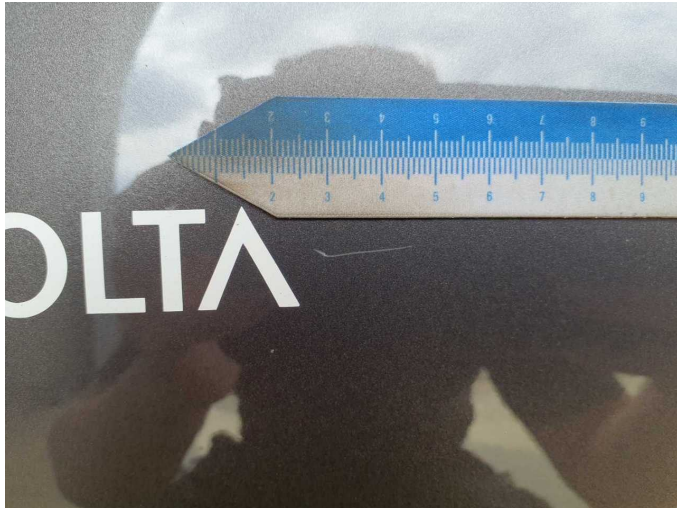
**Damage 6:** Boot lid / rear door: Boot lid - Scratch(es) - Smart repair

| No. | Component group | Description |
|---|---|---|
| 6 | Boot lid / rear door | Boot lid - Scratch(es) - Smart repair |

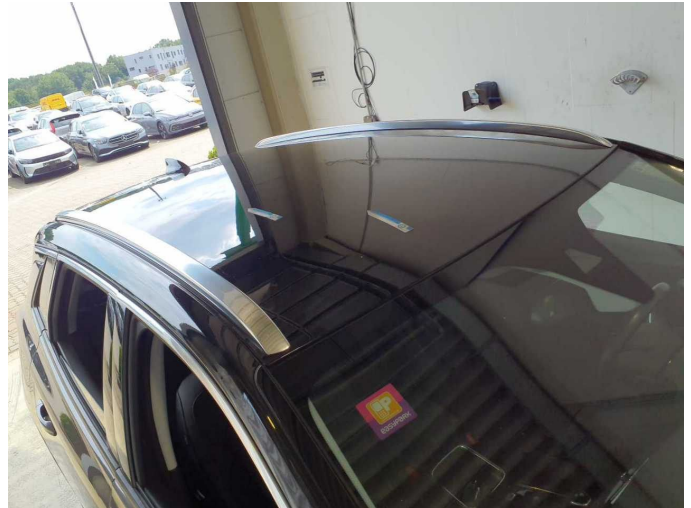
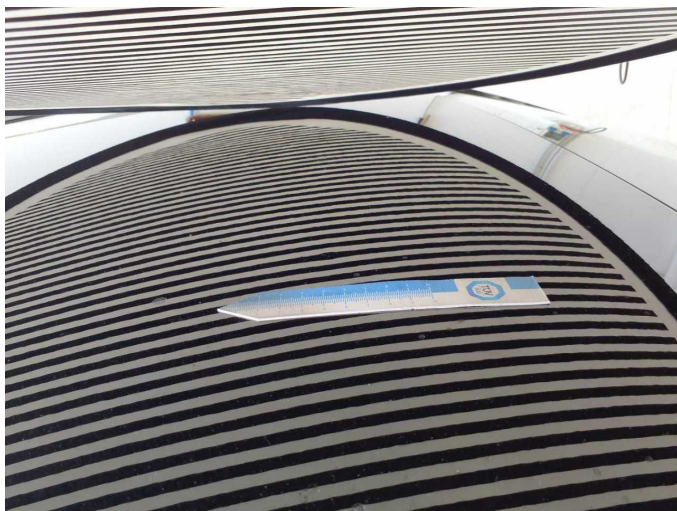
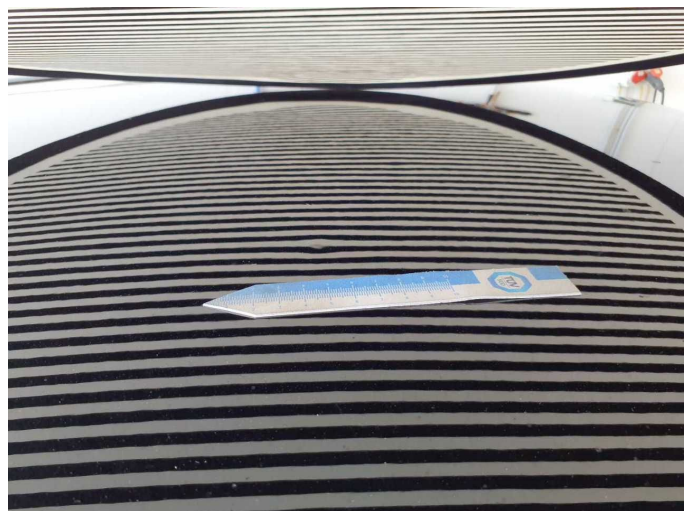
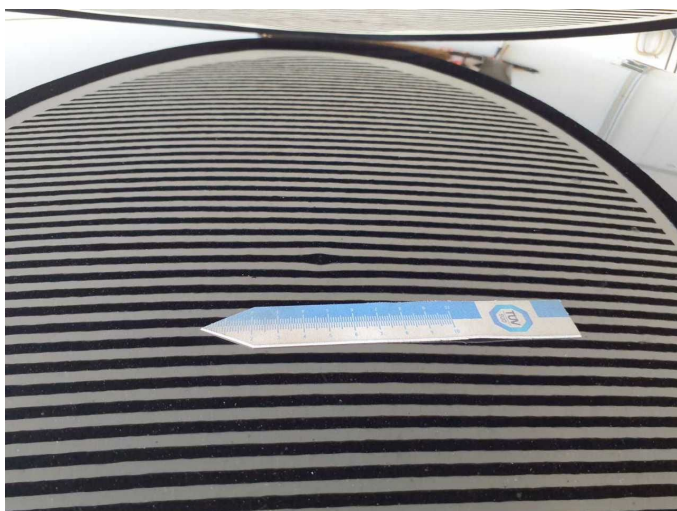
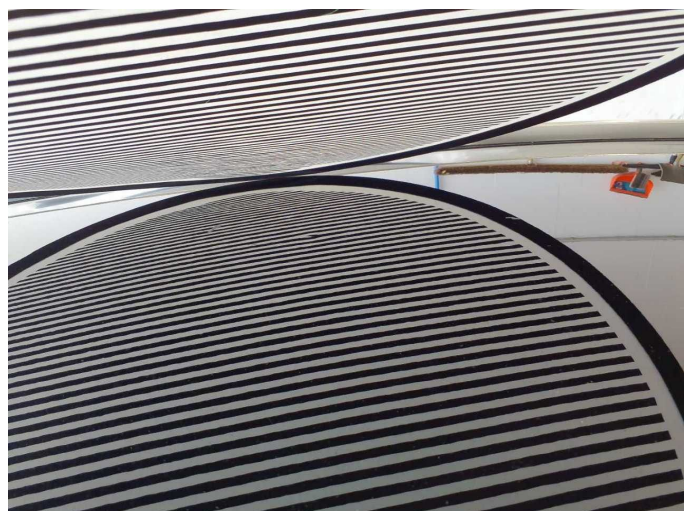
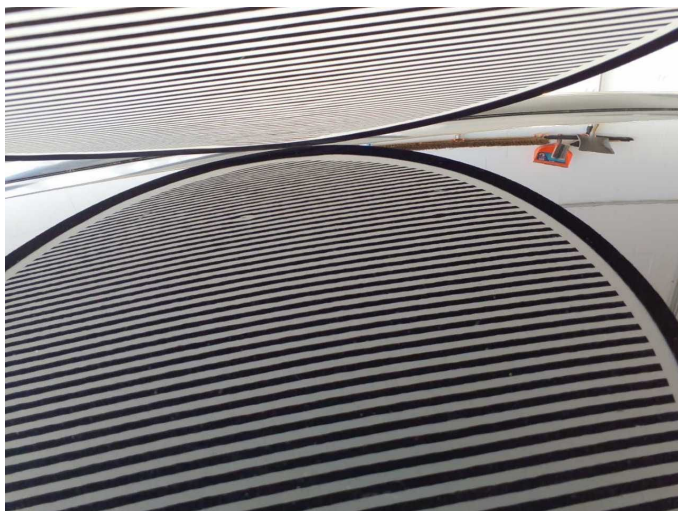
**Damage 7:** Roof: Roof - dent(s) - Smooth repair work

| No. | Component group | Description |
|---|---|---|
| 7 | Roof | Roof - dent(s) - Smooth repair work |

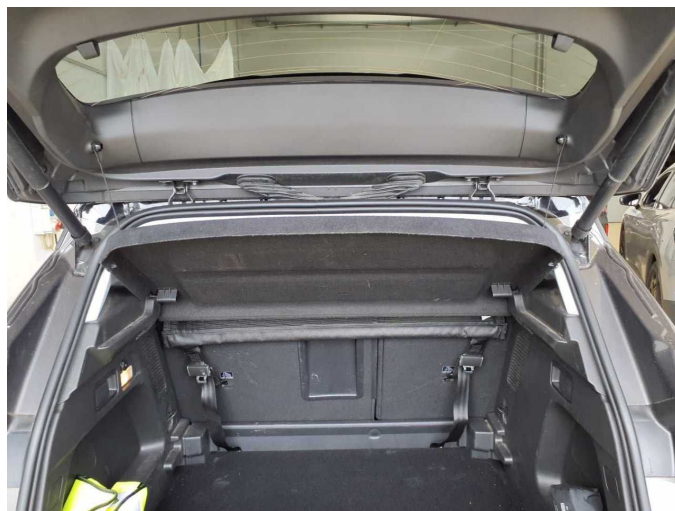
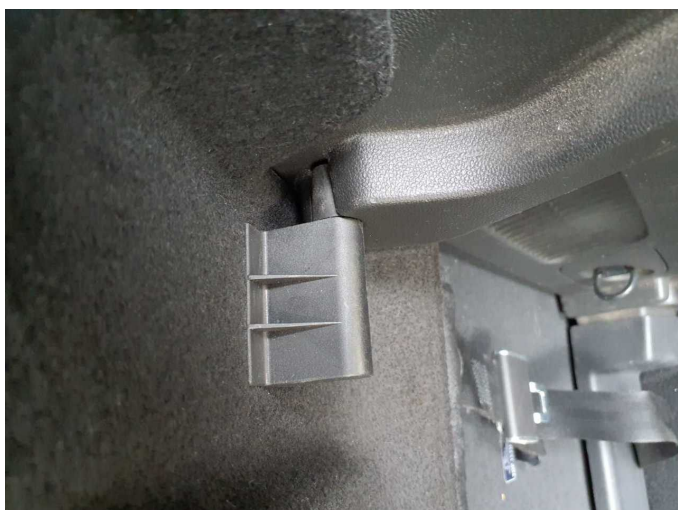
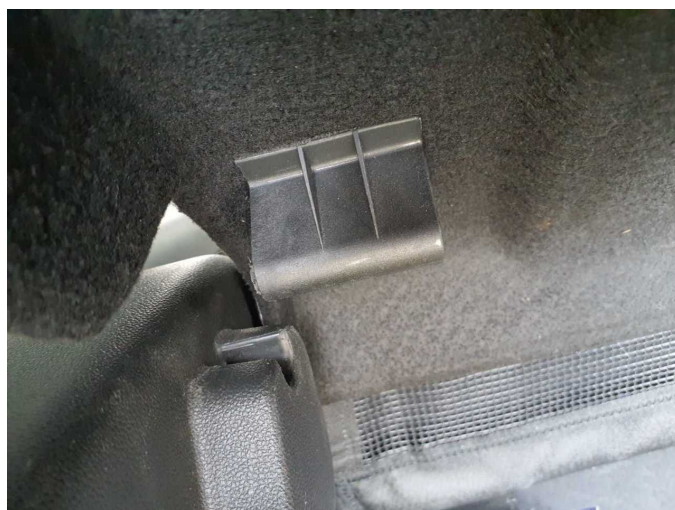
**Damage 8:** Interior: Boot cover / roller cover - Broken / torn - Replace

| No. | Component group | Description |
|---|---|---|
| 8 | Interior | Boot cover / roller cover - Broken / torn - Replace |

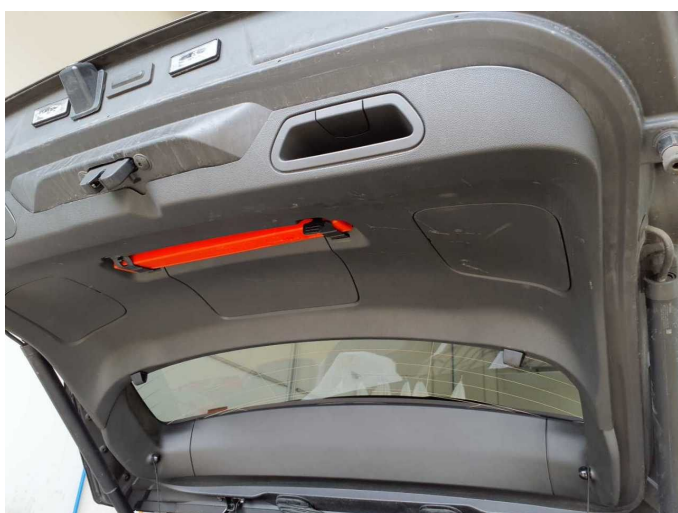
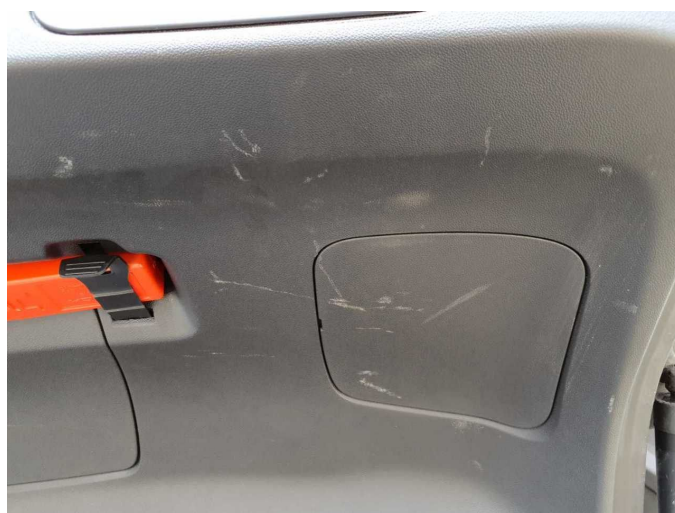
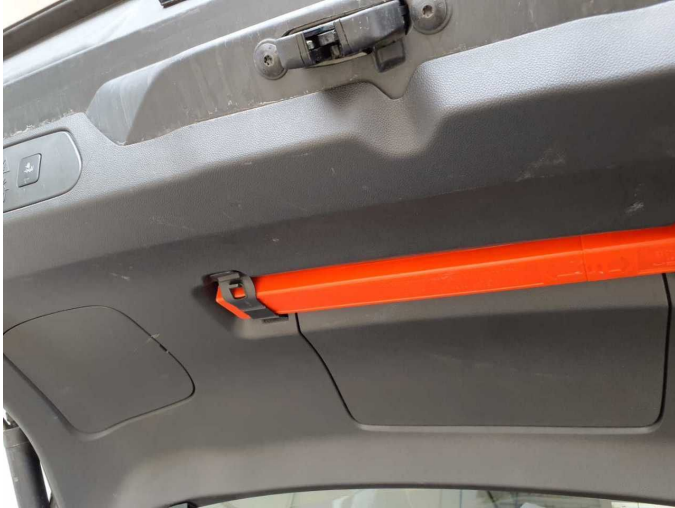
**Damage 9:** Trim / covers: Boot lid - interior trim - Scratch(es) - Replace

| No. | Component group | Description |
|---|---|---|
| 9 | Trim / covers | Boot lid - interior trim - Scratch(es) - Replace |
