Expertise

Protocol number: 46557915  
Order No. / Reference: 26575023  
Inspection date: 16 Jul 2026

| Manufacturer: Ford | Model: Focus Turnier 1.0 EcoBoost Start-Stopp-System Aut. ACTIVE X |

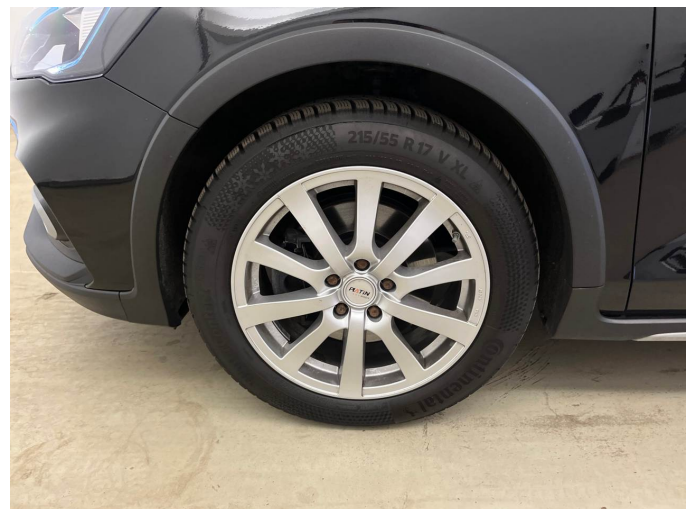
Figure 12: Mounted tyres

| Tyres | | | | |
|---|---|---|---|---|
| 1) | 215/55 R17 98V | Winter tyres on Light alloy | Continental | 6mm / 6mm |
| 2) | 215/55 R17 98V | Winter tyres on Light alloy | Continental | 6mm / 6mm |

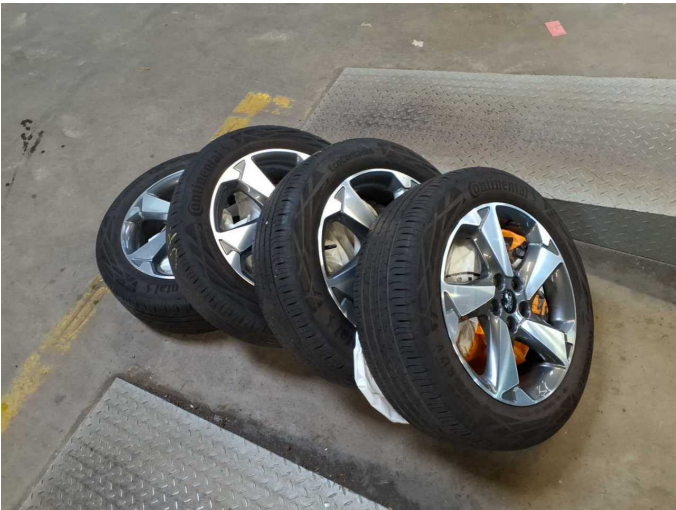
Figure 17: Additional tyres

| Tyres | | | | |
|---|---|---|---|---|
| 1) | 215/55 R17 94V | Summer tyres on Light alloy | Continental | 4mm / 4mm |
| 2) | 215/55 R17 94V | Summer tyres on Light alloy | Continental | 4mm / 4mm |

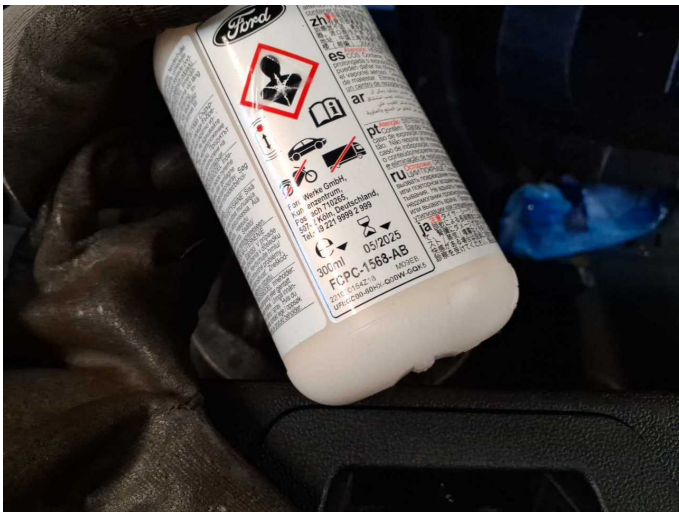
Damage 1: Equipment: Tirefit filler - Expired - Replace

| No. | Component group | Description |
|---|---|---|
| 1 | Equipment | Tirefit filler - Expired - Replace |

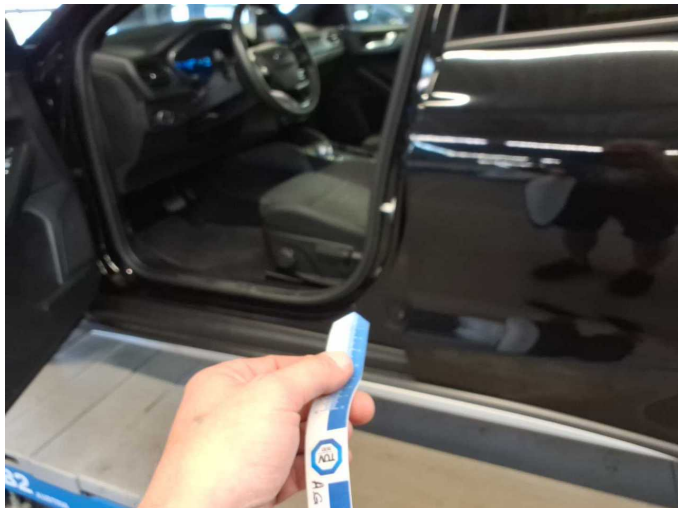
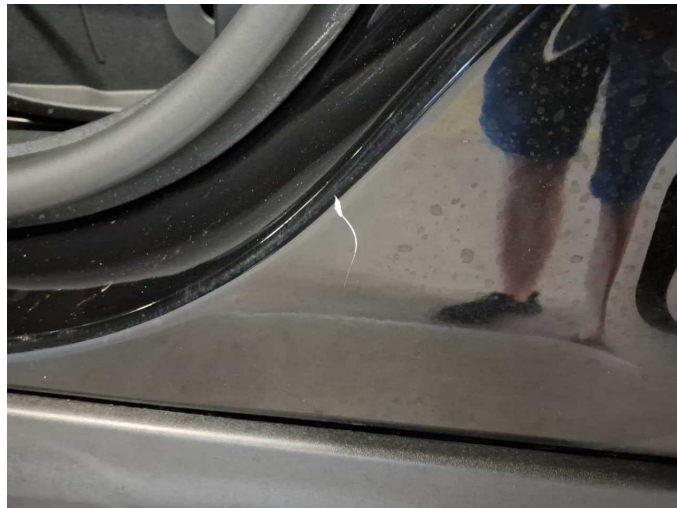
**Damage 2:** Sill - left side: Sill - Scratch(es) - Smart repair

| No. | Component group | Description |
|---|---|---|
| 2 | Sill - left side | Sill - Scratch(es) - Smart repair |

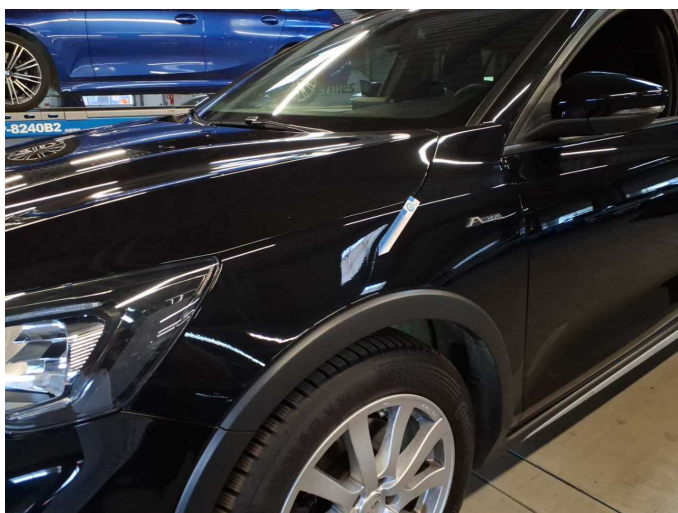
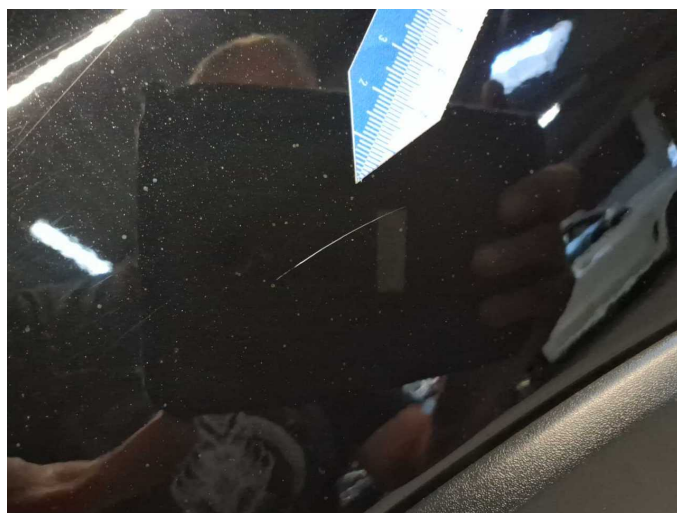
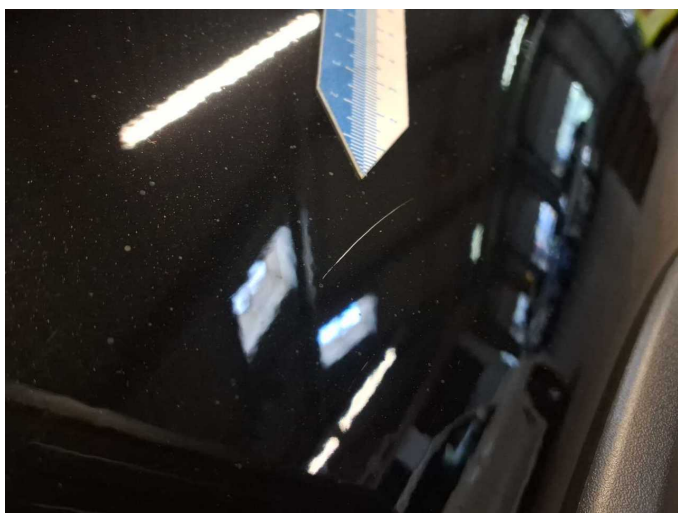
**Damage 3:** Mudguard - left side: Mudguard - left side - Scratch(es) - Smart repair

| No. | Component group | Description |
|---|---|---|
| 3 | Mudguard - left side | Mudguard - left side - Scratch(es) - Smart repair |

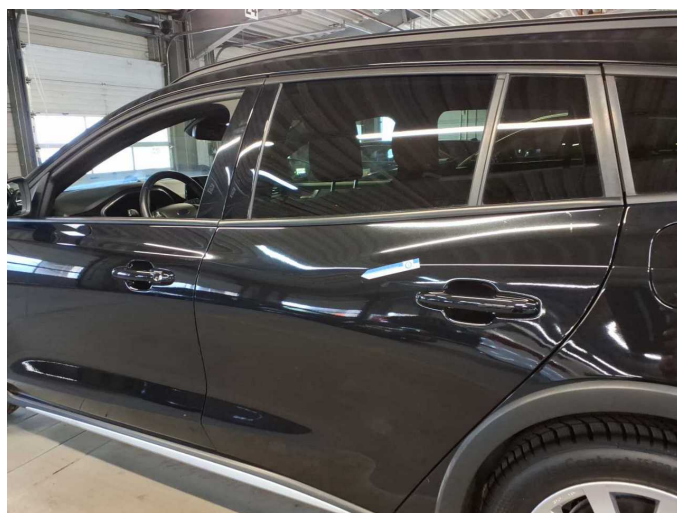
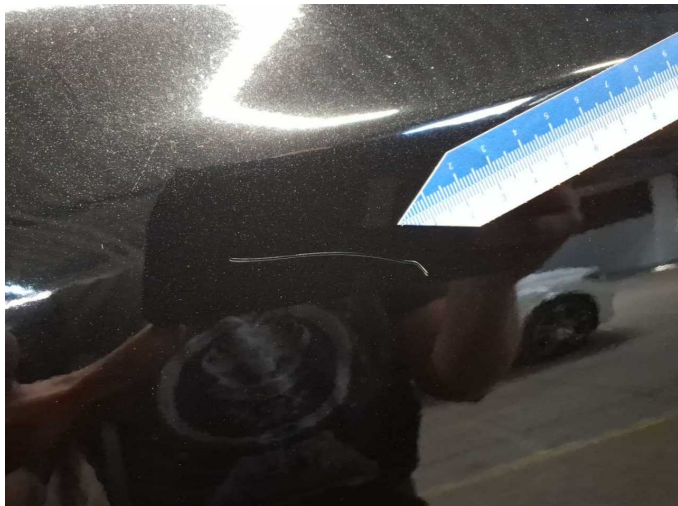
**Damage 4:** Door - rear left side: Door - Scratch(es) - Smart repair

| No. | Component group | Description |
|---|---|---|
| 4 | Door - rear left side | Door - Scratch(es) - Smart repair |

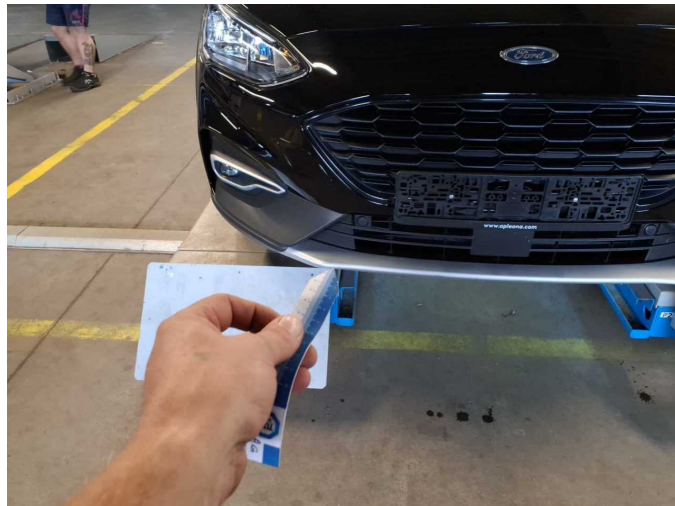
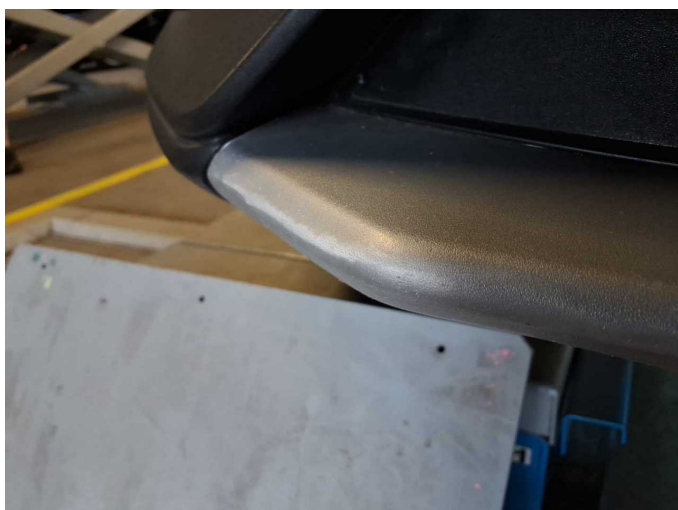
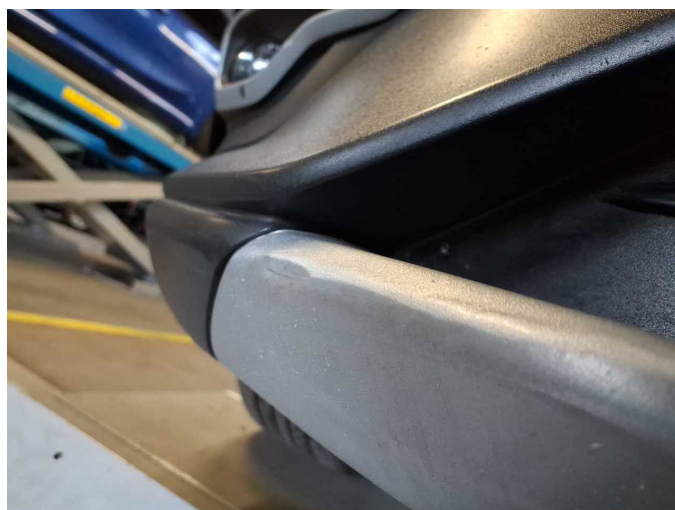
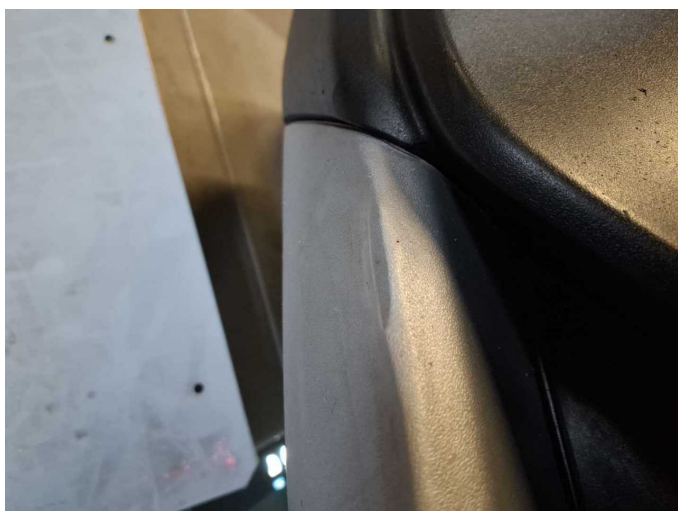
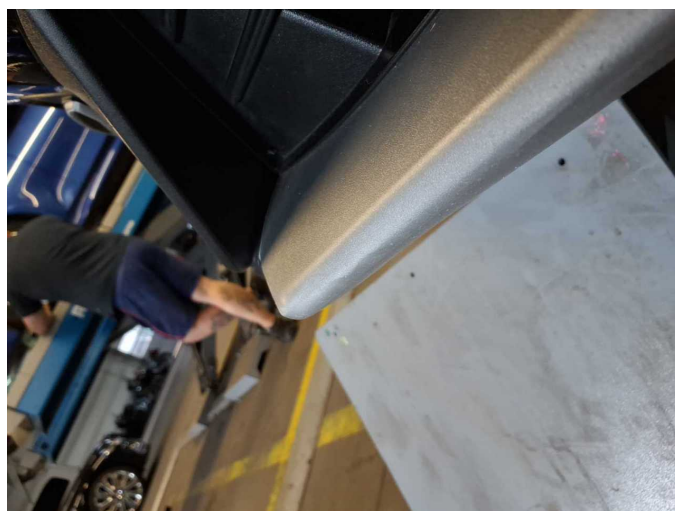
**Damage 5:** Front bumper: Spoiler - Deformed - Replace

| No. | Component group | Description |
|---|---|---|
| 5 | Front bumper | Spoiler - Deformed - Replace |

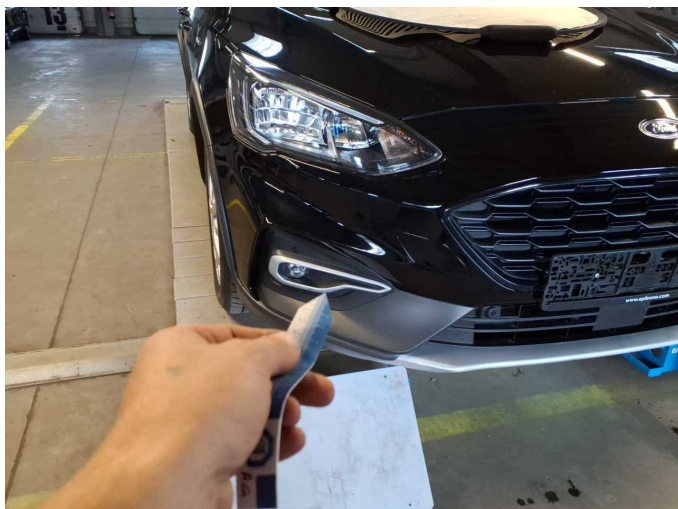
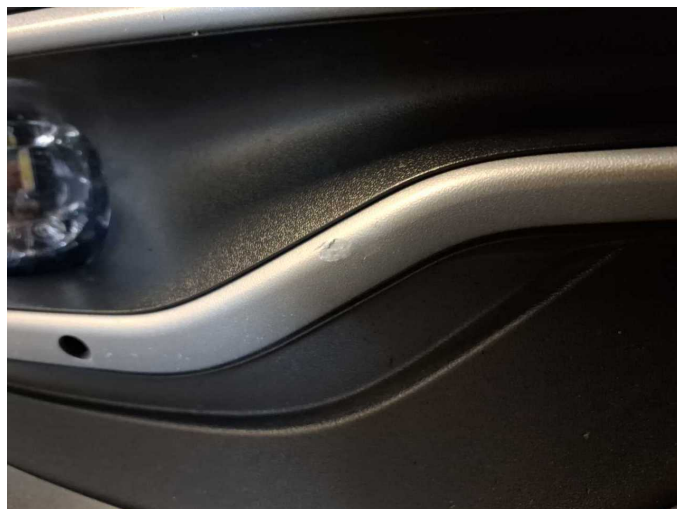
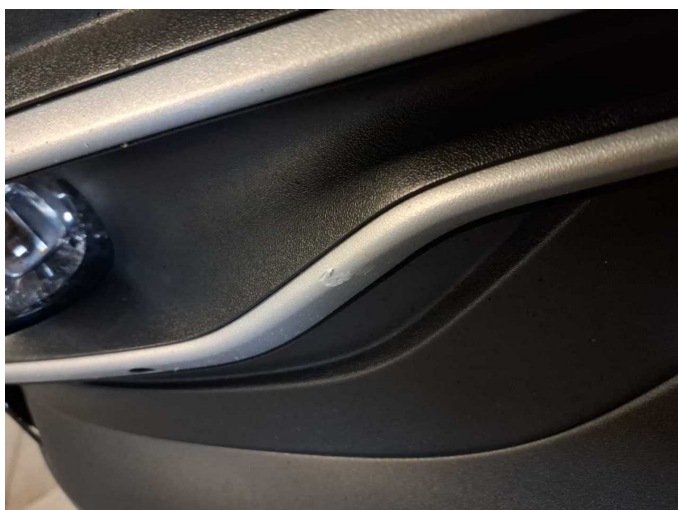
**Damage 6:** Fog lamp: Fog lamp - front right side (Rahmen) - Scratched - Replace

| No. | Component group | Description |
|---|---|---|
| 6 | Fog lamp | Fog lamp - front right side (Rahmen) - Scratched - Replace |

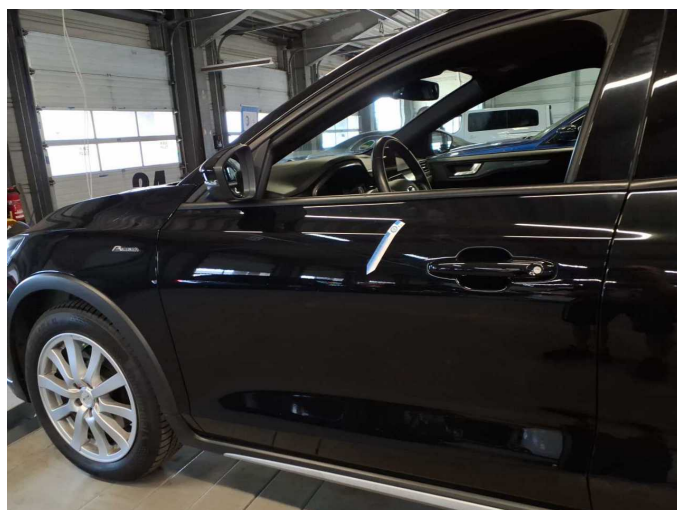
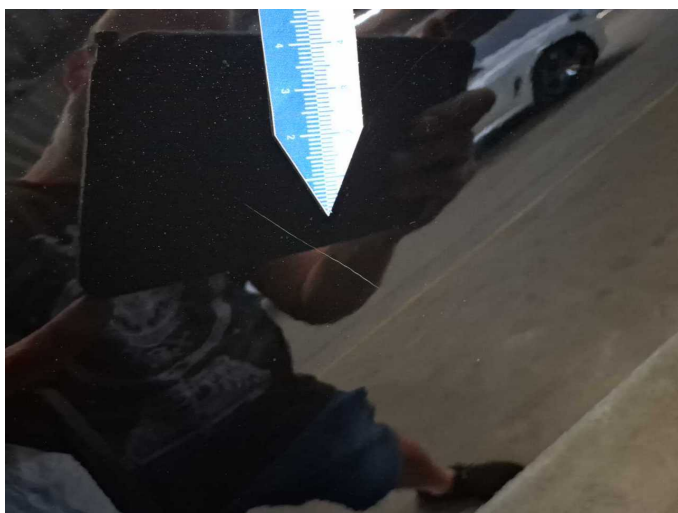
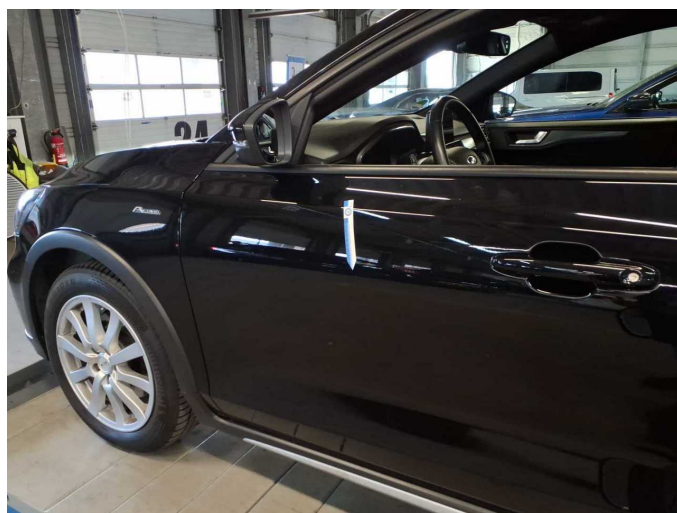
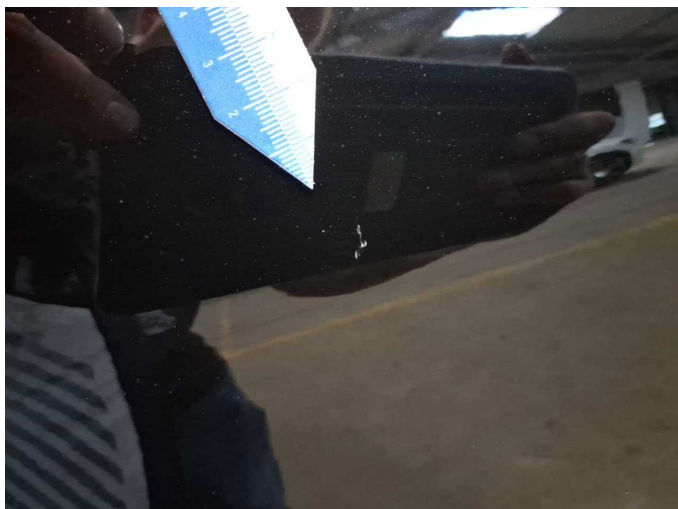
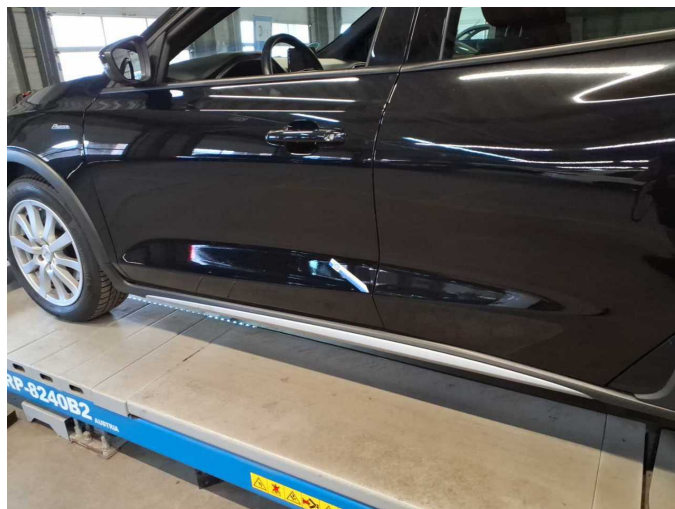
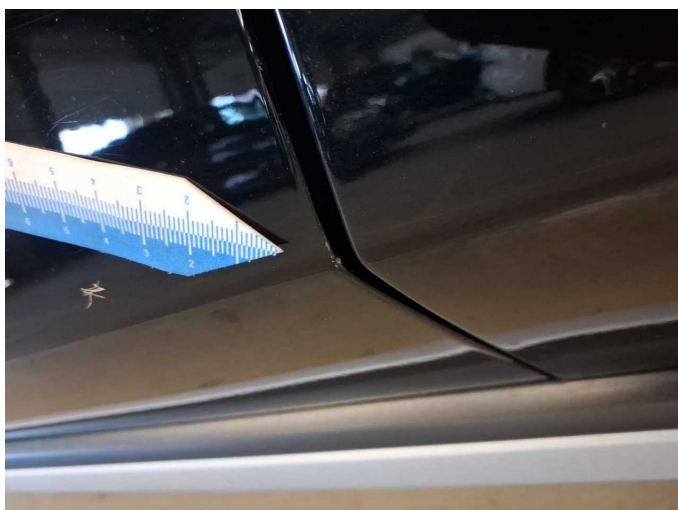
**Damage 7:** Door - front left side: Door - Scratch(es) - Paint

| No. | Component group | Description |
|---|---|---|
| 7 | Door - front left side | Door - Scratch(es) - Paint |

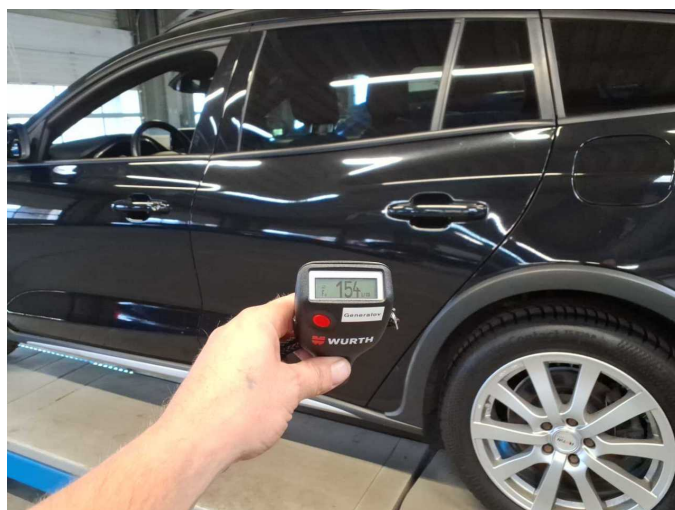
| No. | Repainting |
|---|---|
| 1 | Door - rear left side, Professionally carried out, Invoice of repair done Non-existent |

| Door - rear left side | 154 µm | Door - front left side | 148 µm |

**Repainting 1:** Door - rear left side

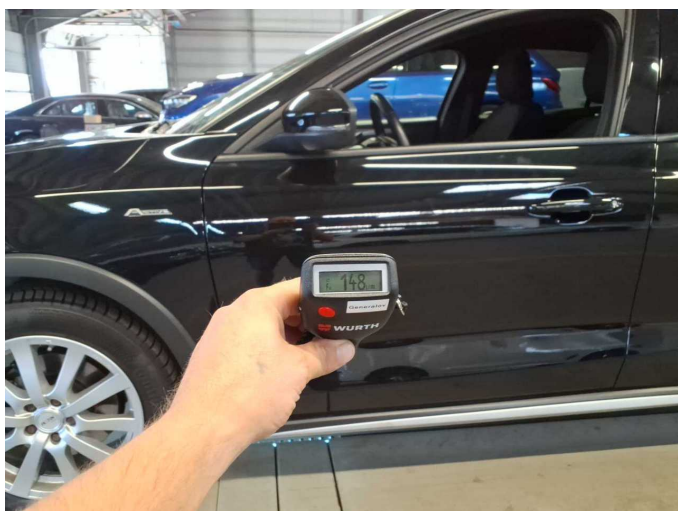
| No. | Repainting |
|---|---|
| 2 | Door - front left side, Professionally carried out, Invoice of repair done Non-existent |

**Repainting 2:** Door - front left side

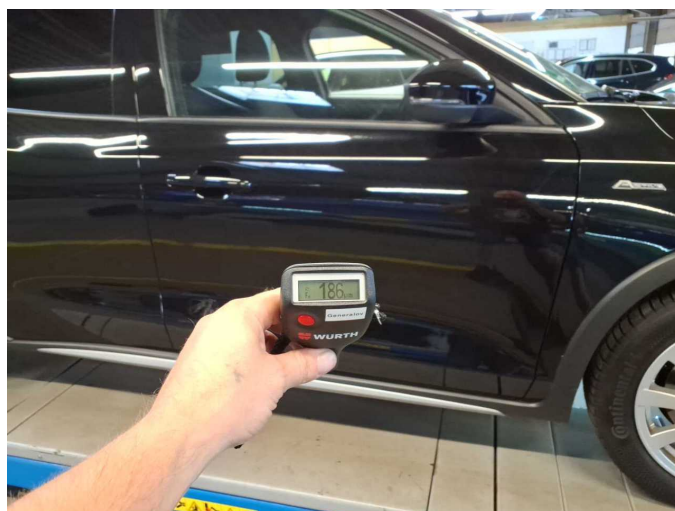
| No. | Repainting |
|---|---|
| 3 | Door - front right side, Professionally carried out, Invoice of repair done Non-existent |

| Door - front right side | 186 µm | | |

**Repainting 3:** Door - front right side
