Expertise

Protocol number: 45988863  
Order No. / Reference: 26512991  
Inspection date: 17 Jun 2026

Manufacturer: Volkswagen

Model: Tiguan 2.0 TDI SCR DSG Life

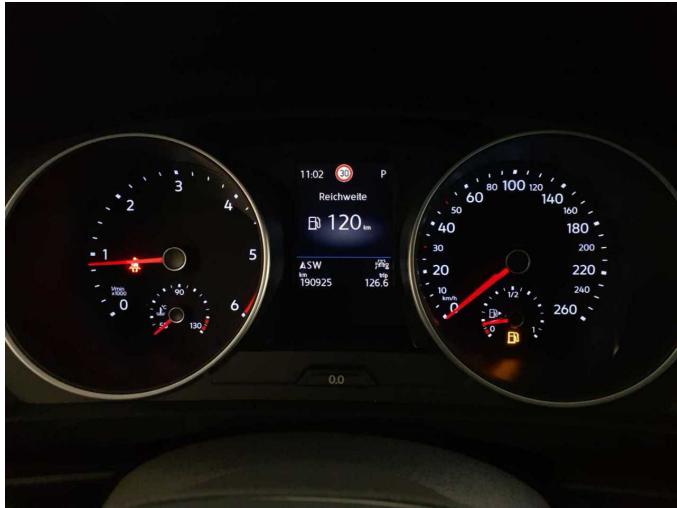
| Vehicle details | |
|---|---|
| Mileage (Read) | 190,925 km |

Figure 7: Instrument cluster

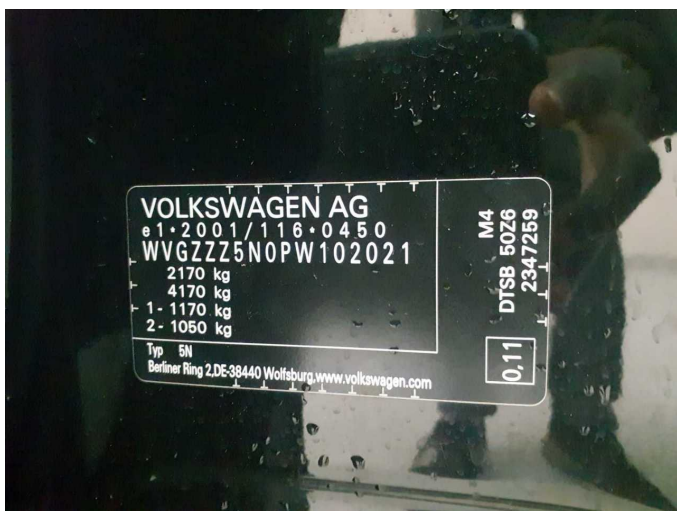
| VIN comparison | The vehicle identification number (VIN) was read from the vehicle and its conformity with the submitted documents was confirmed by the undersigned during the inspection. |

Figure 11: VIN

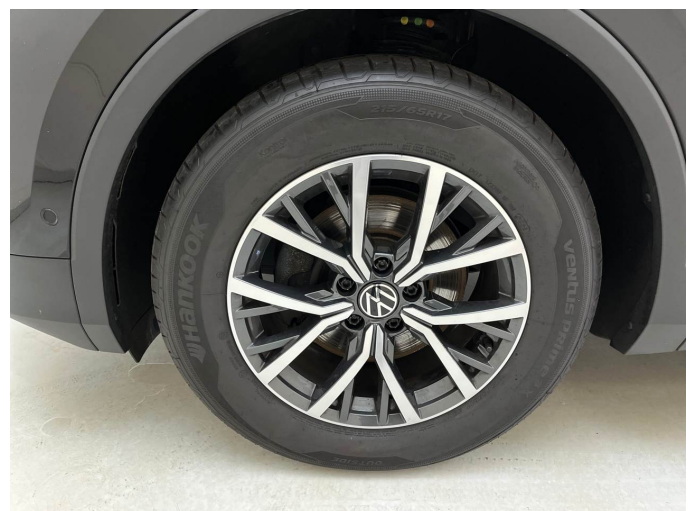
| # | Tyre size | Type of tyre | Manufacturer | Tread depth |
|---|---|---|---|---|
| 1) | 215/65 R17 99V | Summer tyres on Light alloy | Hankook | 6mm / 6mm |
| 2) | 215/65 R17 99V | Summer tyres on Light alloy | Hankook | 6mm / 6mm |

Figure 12: Mounted tyres

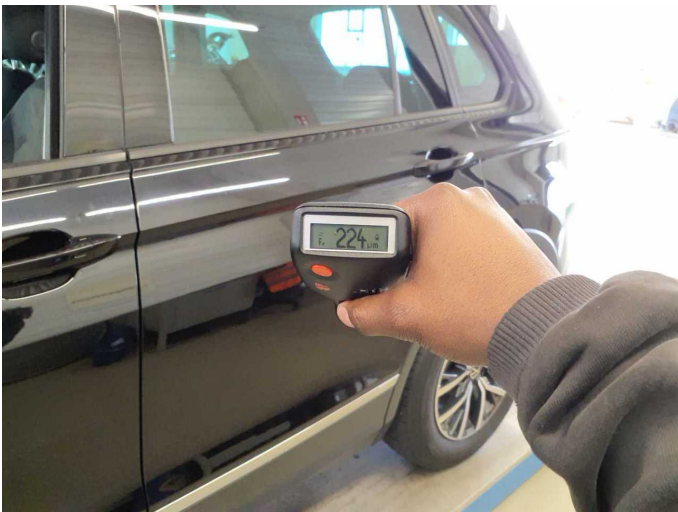
| 1 | Door - rear left side, Professionally carried out, Invoice of repair done Non-existent |

Repainting 1: Door - rear left side

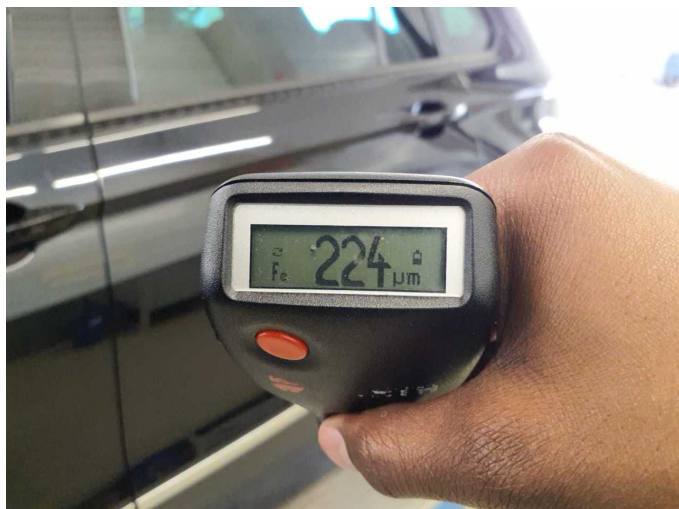
| Door - rear left side | 224 µm |

**Repainting 1:** Door - rear left side
