Expertise

Protocol number: 46628906  
Order No. / Reference: 26687057  
Inspection date: 20 Jul 2026

| Manufacturer: Audi | Model: A4 Avant 35 TDI S tronic S line |

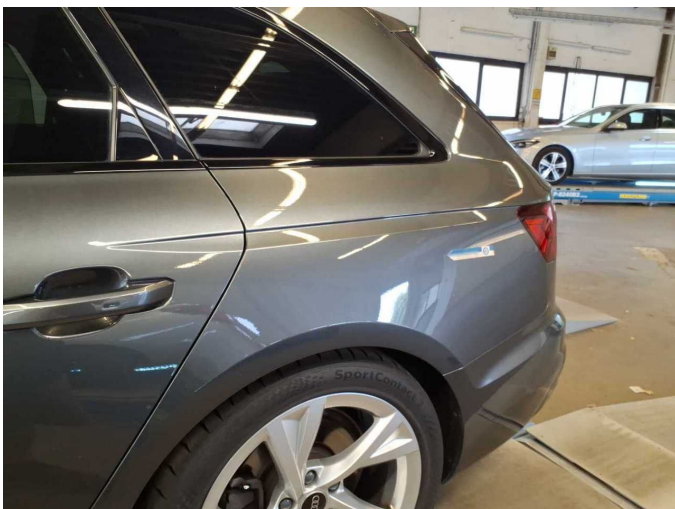
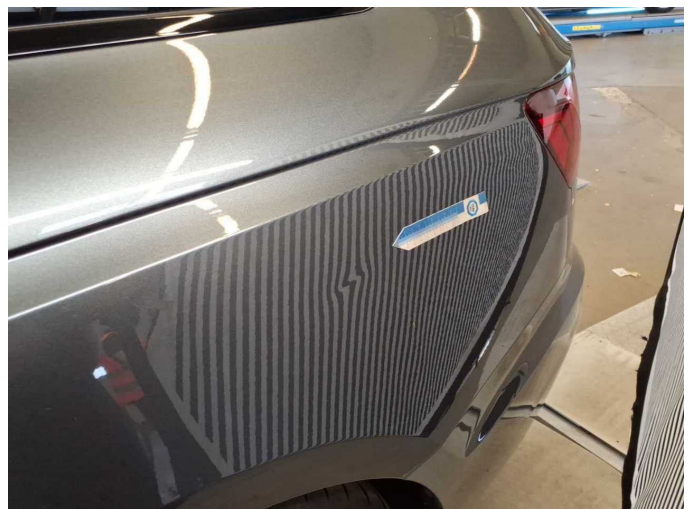
| No. | Component group | Description |
|---|---|---|
| 1 | Side panel - rear left side | Side panel - dent(s) - Smooth repair work |

**Damage 1:** Side panel - rear left side: Side panel - dent(s) - Smooth repair work

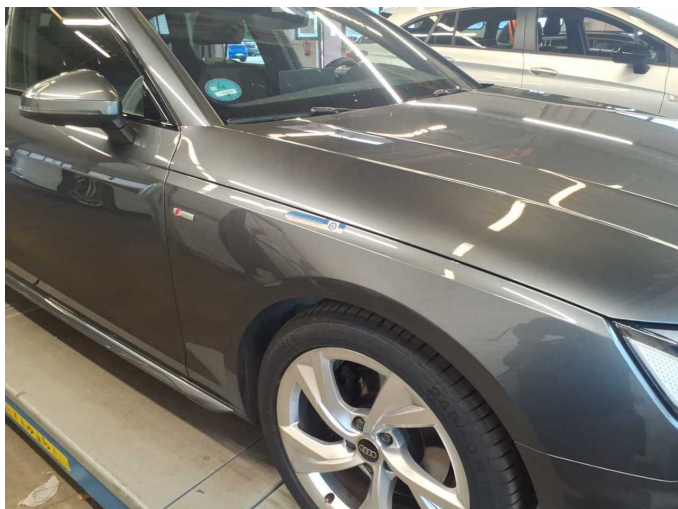
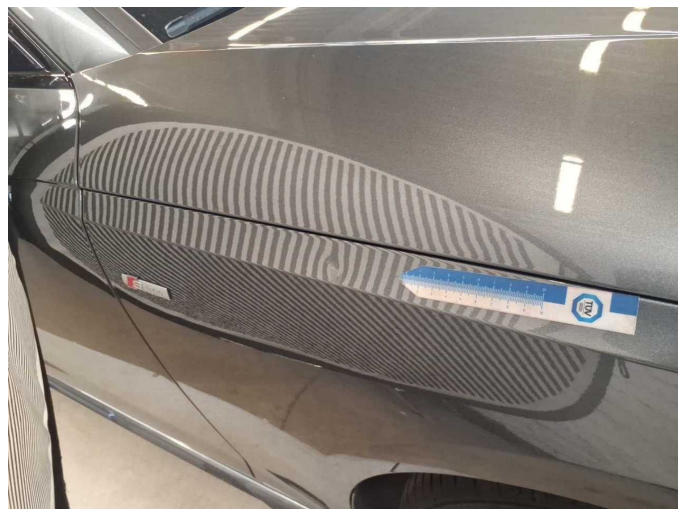
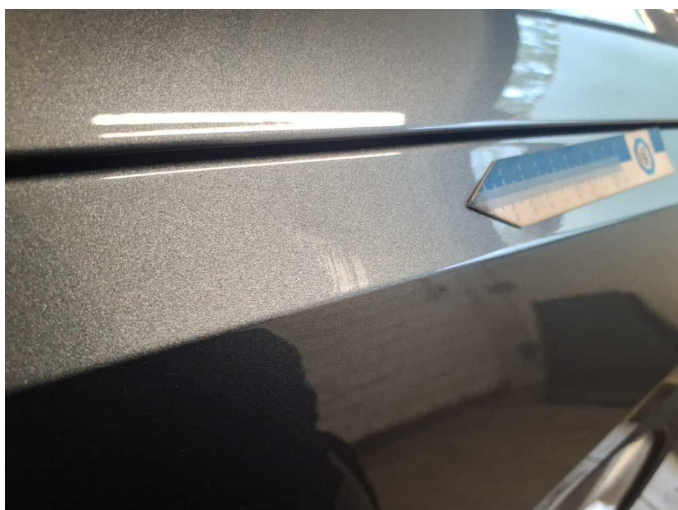
| No. | Component group | Description |
|---|---|---|
| 2 | Mudguard - right side | Mudguard - right side - dent(s) - Smooth repair work |

**Damage 2:** Mudguard - right side: Mudguard - right side - dent(s) - Smooth repair work

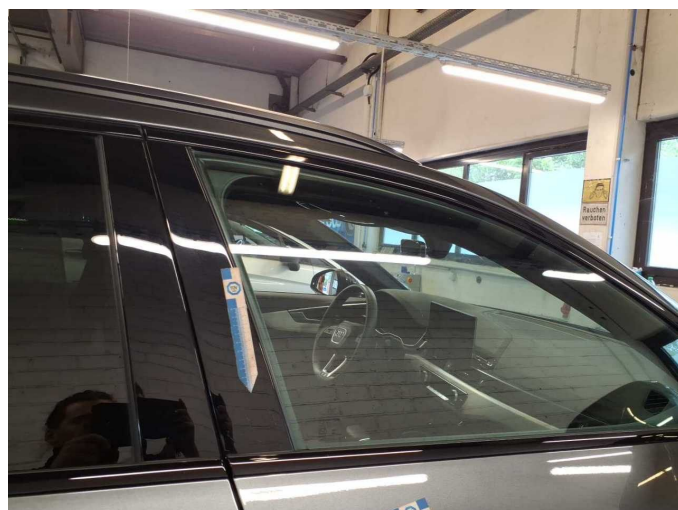
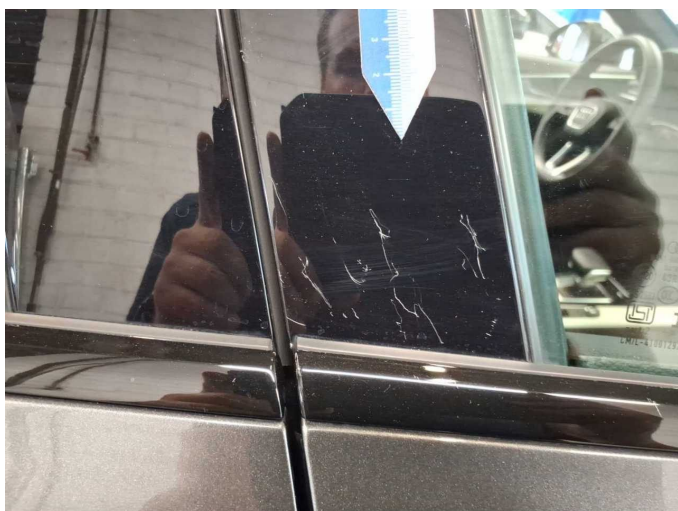
| No. | Component group | Description |
|---|---|---|
| 3 | Door - front right side | Brightware - upper - Scratched - Smart repair |

**Damage 3:** Door - front right side: Brightware - upper - Scratched - Smart repair

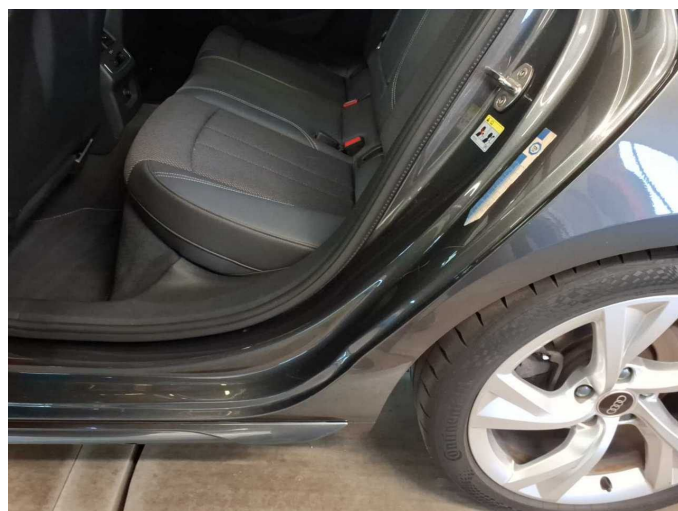
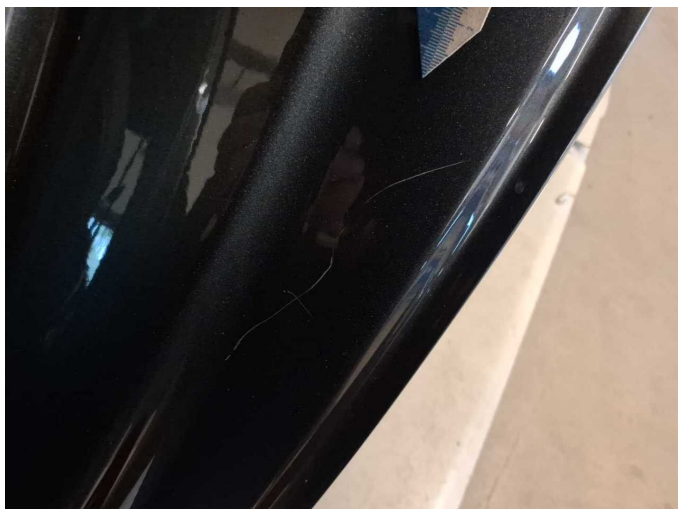
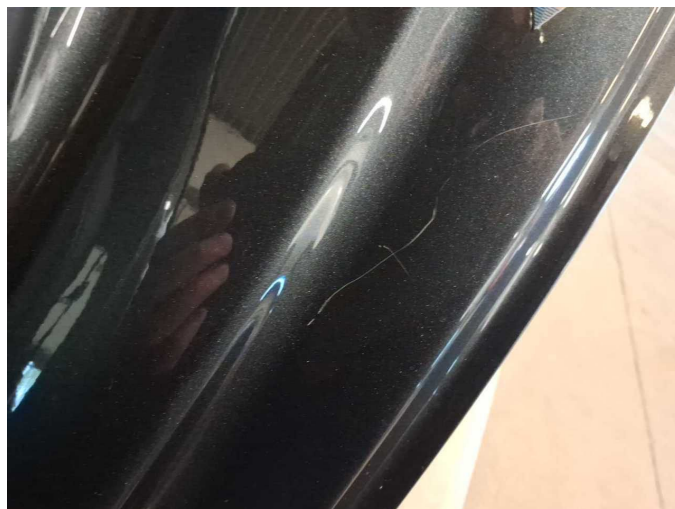
| No. | Component group | Description |
|---|---|---|
| 4 | Side panel - rear left side | Sill - Scratched - Smart repair |

**Damage 4:** Side panel - rear left side: Sill - Scratched - Smart repair

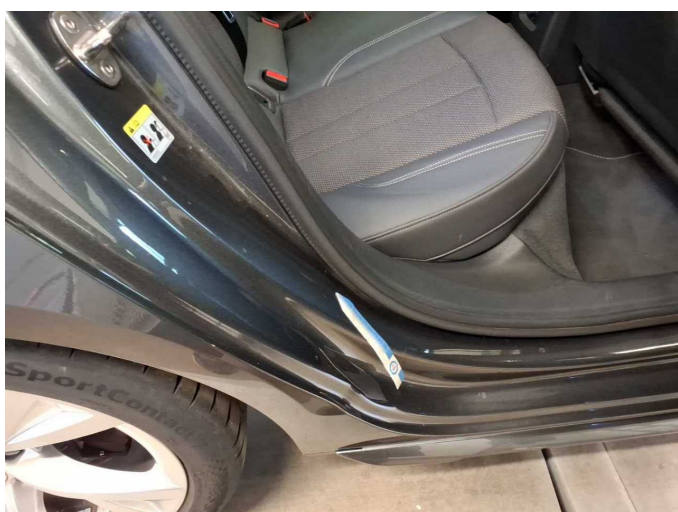
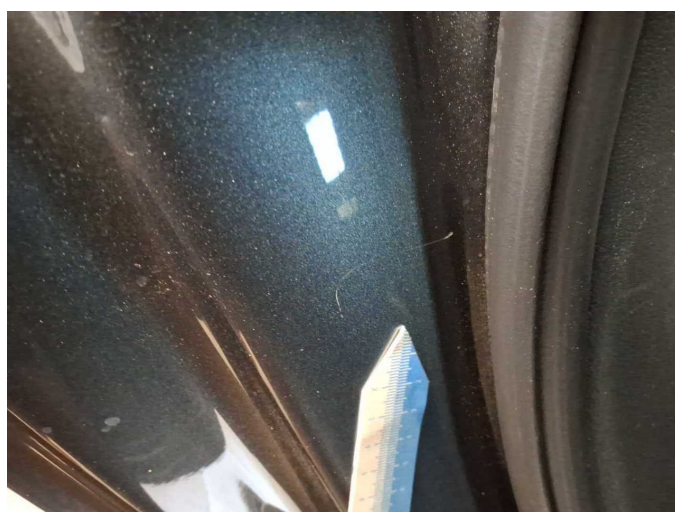
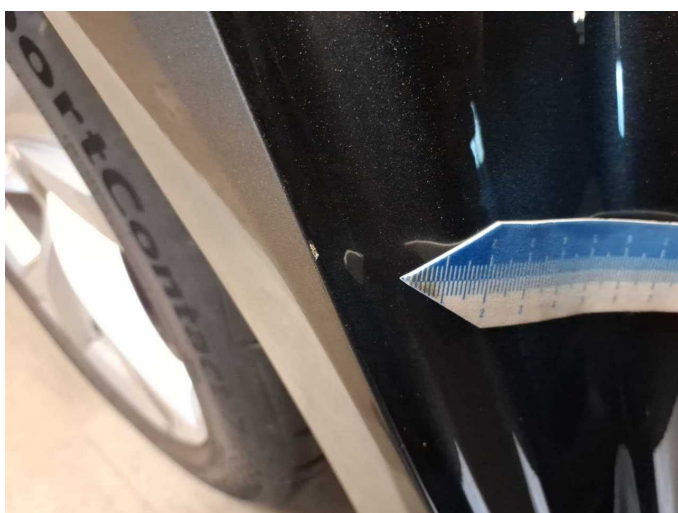
| No. | Component group | Description |
|---|---|---|
| 5 | Side panel - rear right side | Sill - Scratched - Smart repair |

**Damage 5:** Side panel - rear right side: Sill - Scratched - Smart repair

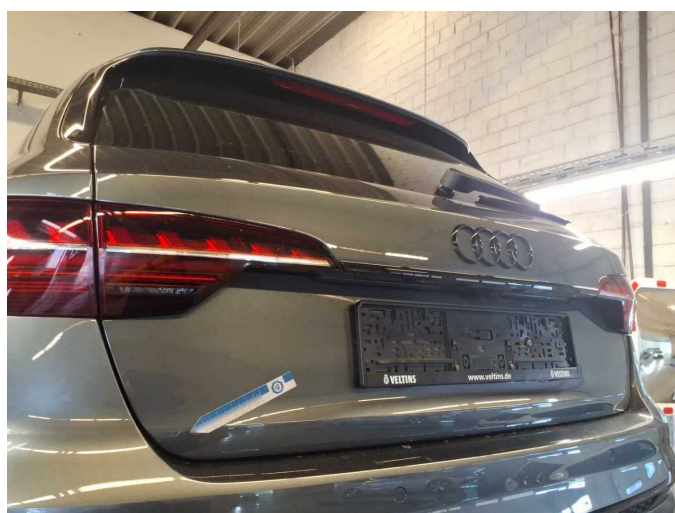
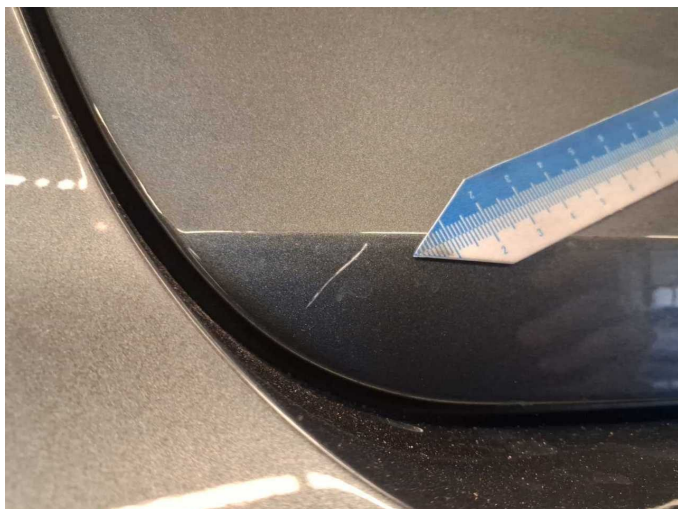
| No. | Component group | Description |
|---|---|---|
| 6 | Boot lid / rear door | Boot lid - Scratch(es) - Smart repair |

**Damage 6:** Boot lid / rear door: Boot lid - Scratch(es) - Smart repair

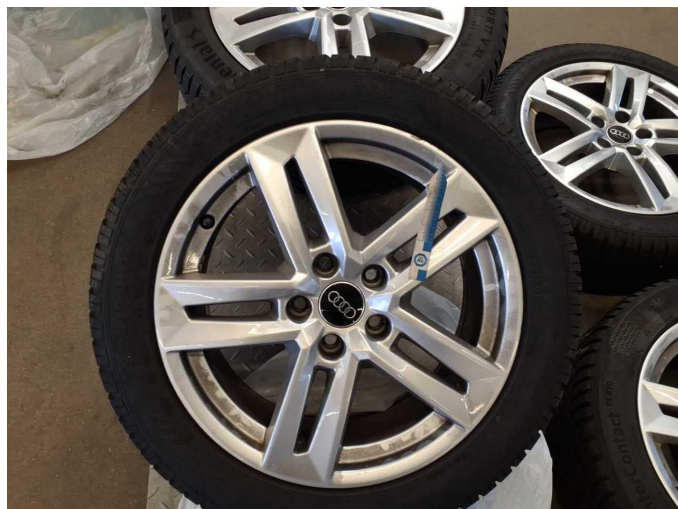
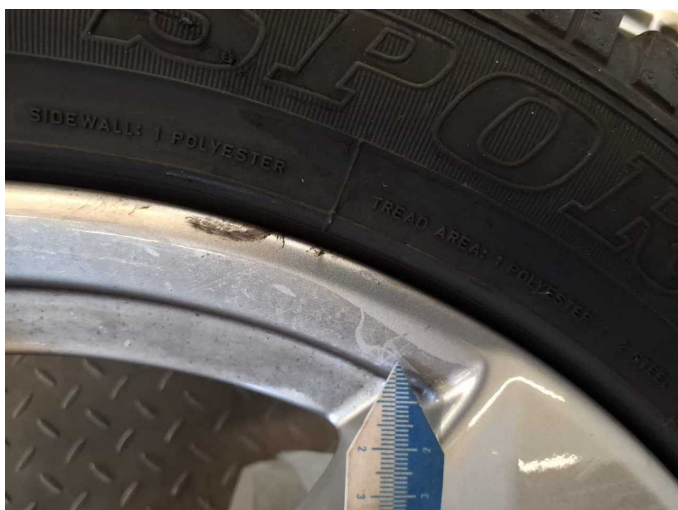
| No. | Component group | Description |
|---|---|---|
| 7 | 2nd wheel set | 1 alloy rim - Scratched - Loss in value |

**Damage 7:** 2nd wheel set: 1 alloy rim - Scratched - Loss in value

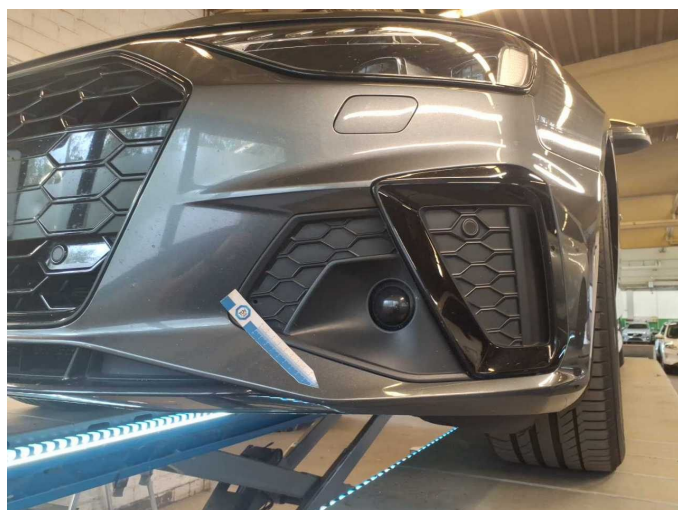
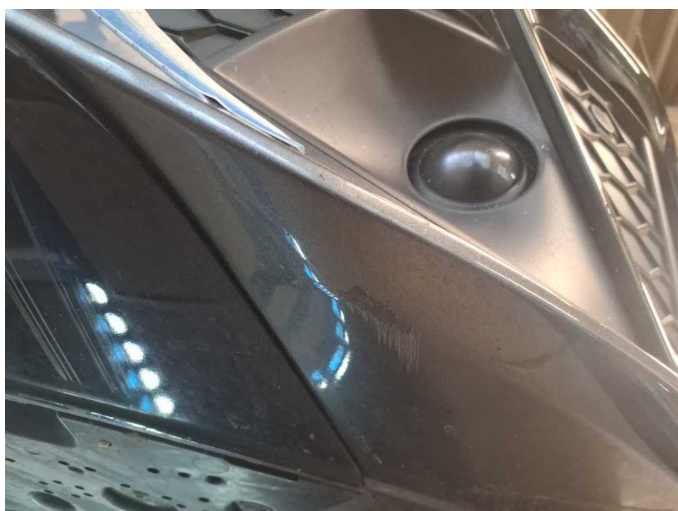
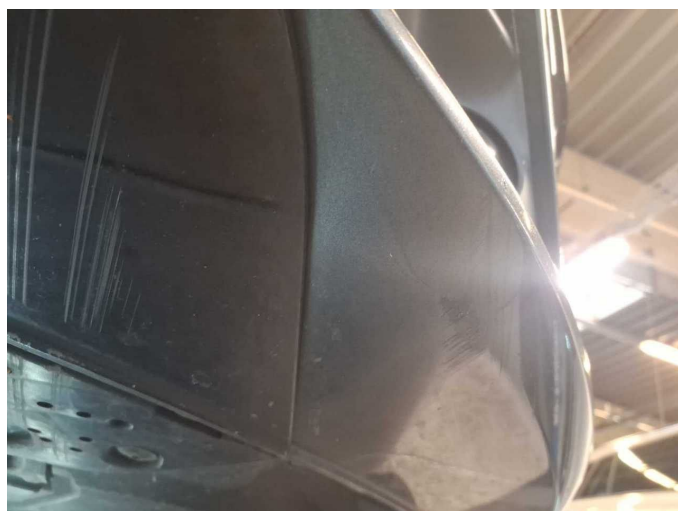
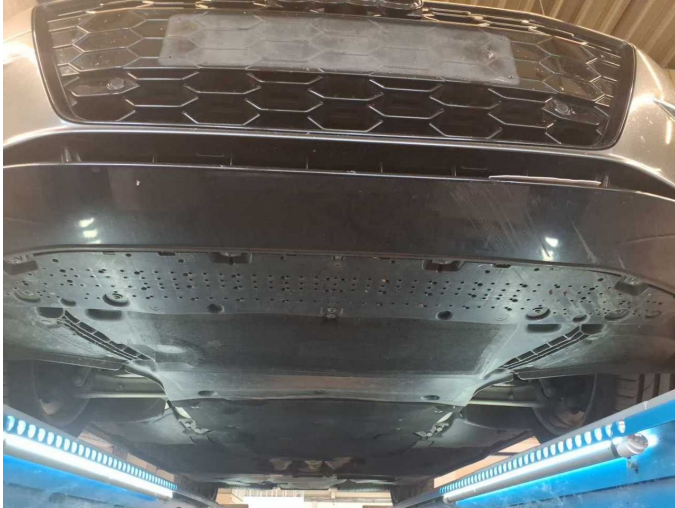
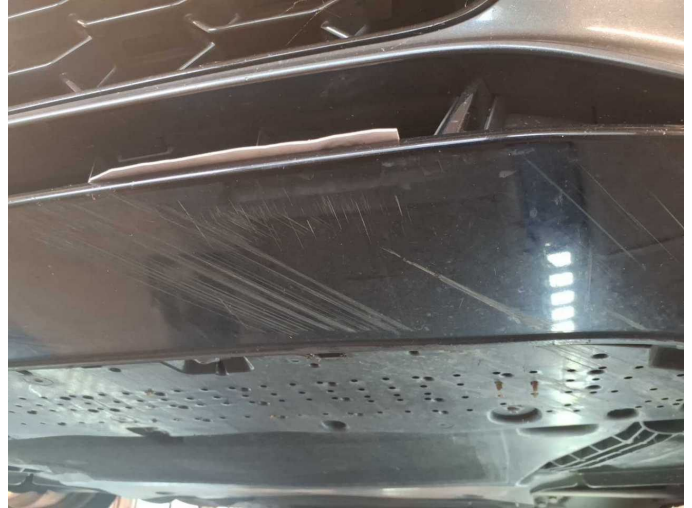
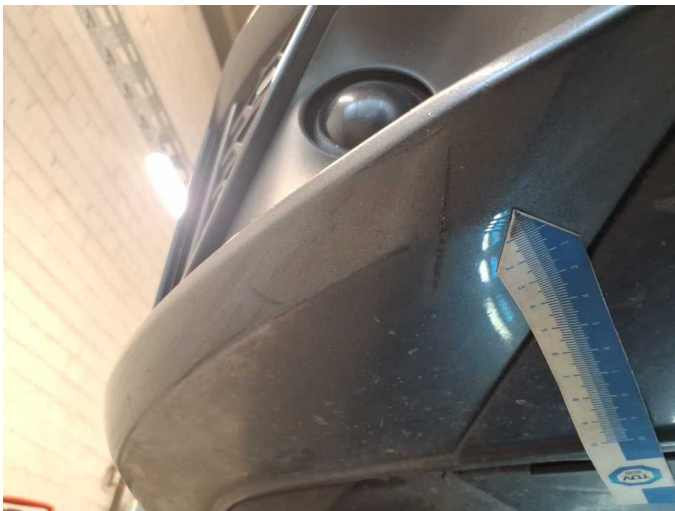
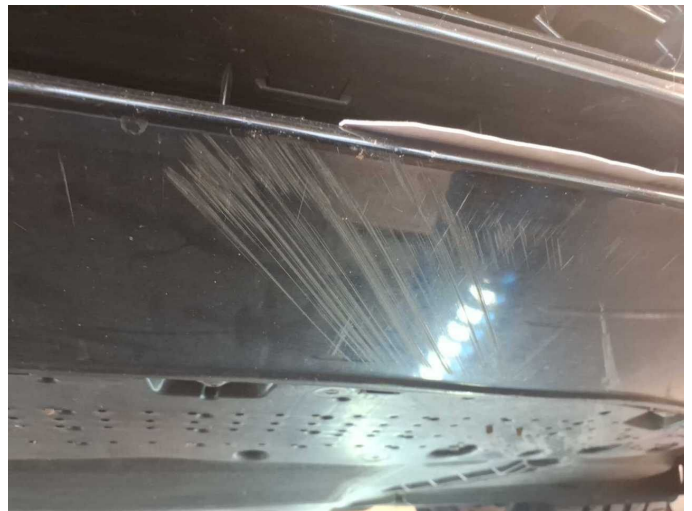
| No. | Component group | Description |
|---|---|---|
| 8 | Front bumper | Front bumper - Scratched - Paint |

**Damage 8:** Front bumper: Front bumper - Scratched - Paint

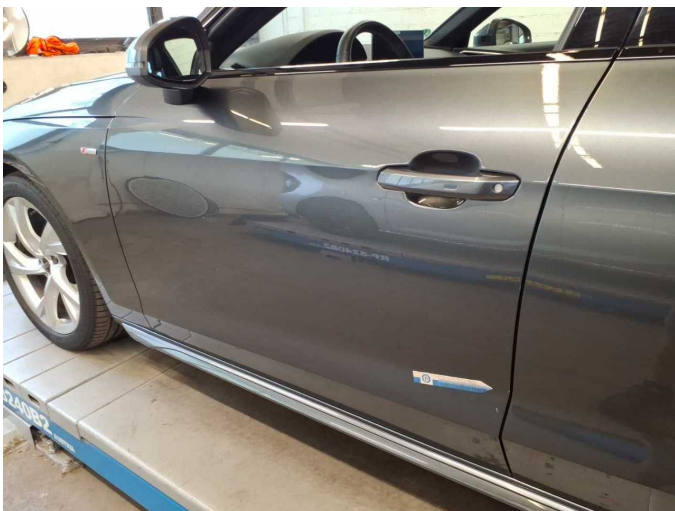
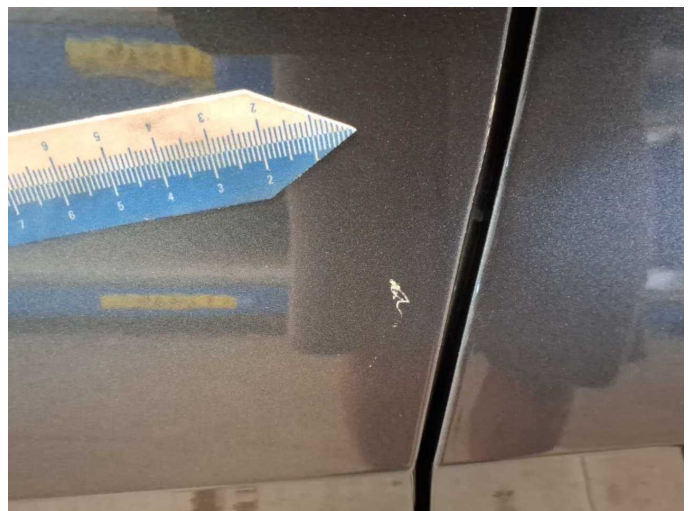
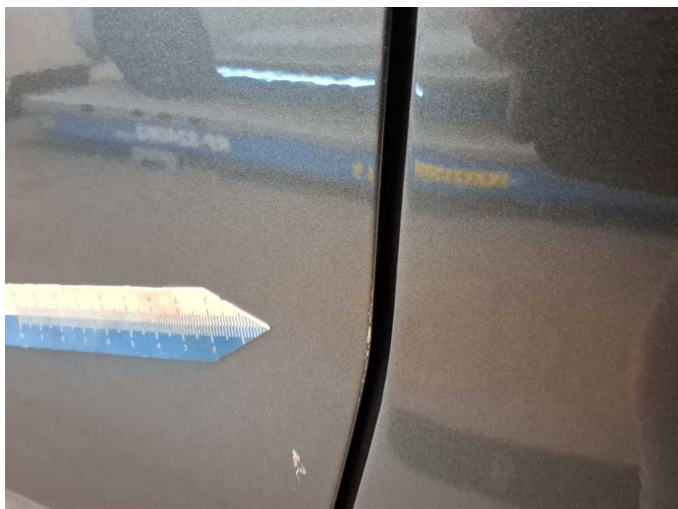
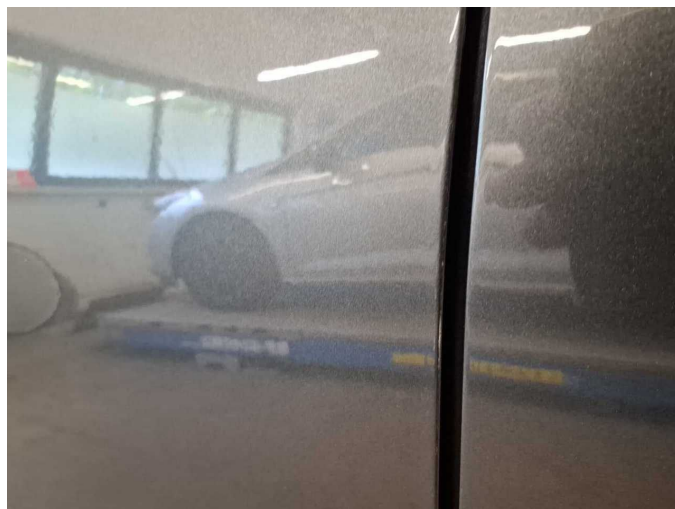
| No. | Component group | Description |
|---|---|---|
| 9 | Door - front left side | Door - Scratched - Paint |

**Damage 9:** Door - front left side: Door - Scratched - Paint

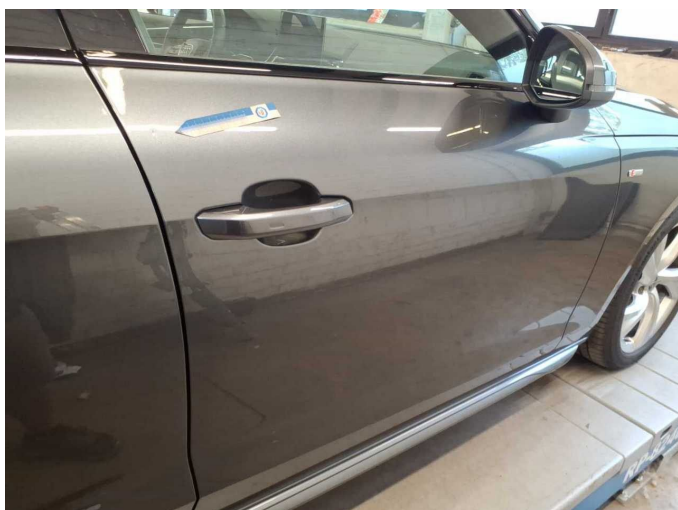
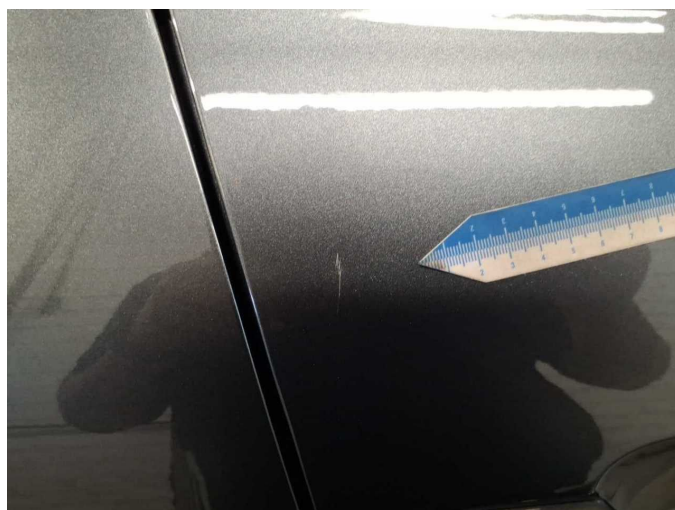
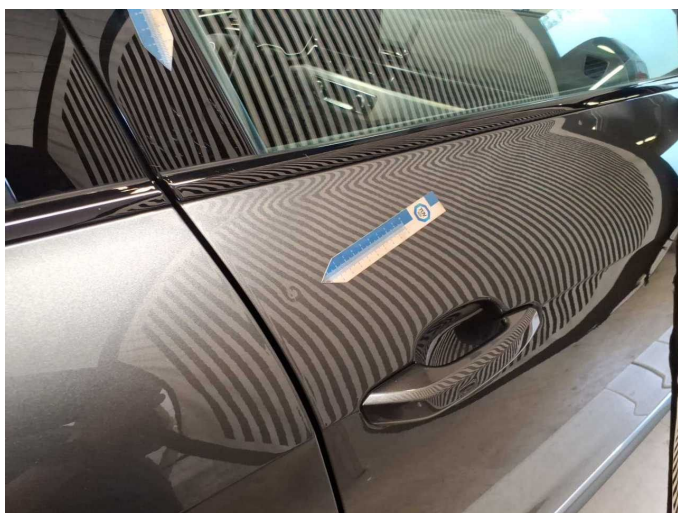
| No. | Component group | Description |
|---|---|---|
| 10 | Door - front right side | Door - Dent / paintcoat damage - Repair and paint |

**Damage 10:** Door - front right side: Door - Dent / paintcoat damage - Repair and paint

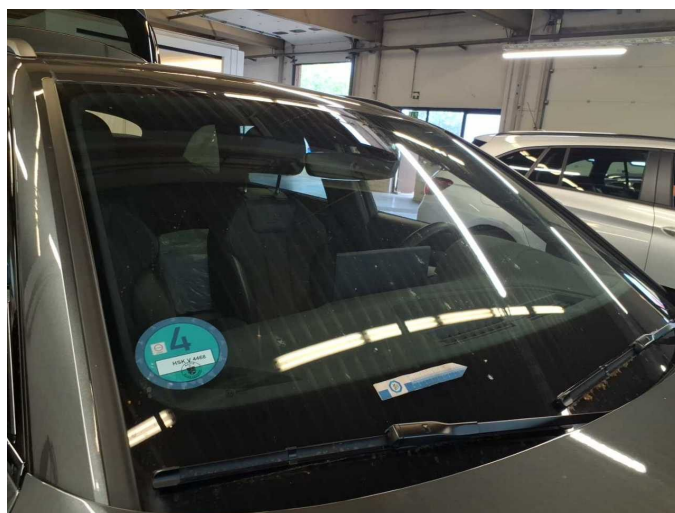
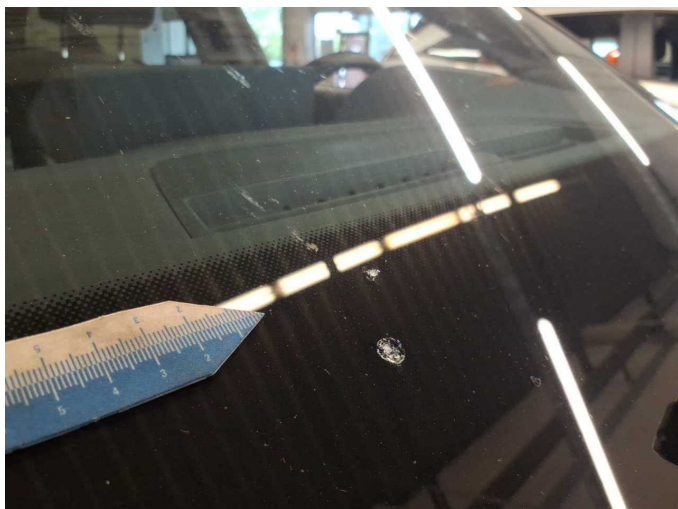
| No. | Component group | Description |
|---|---|---|
| 11 | Vehicle glazing | Windscreen - Broken / torn - Replace |

**Damage 11:** Vehicle glazing: Windscreen - Broken / torn - Replace

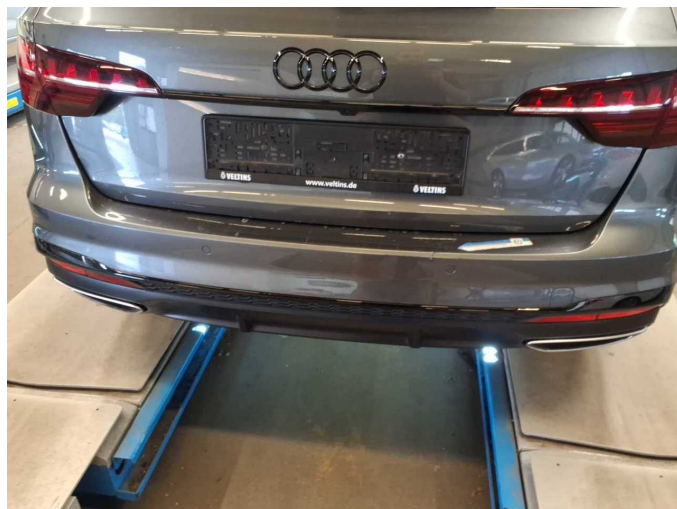
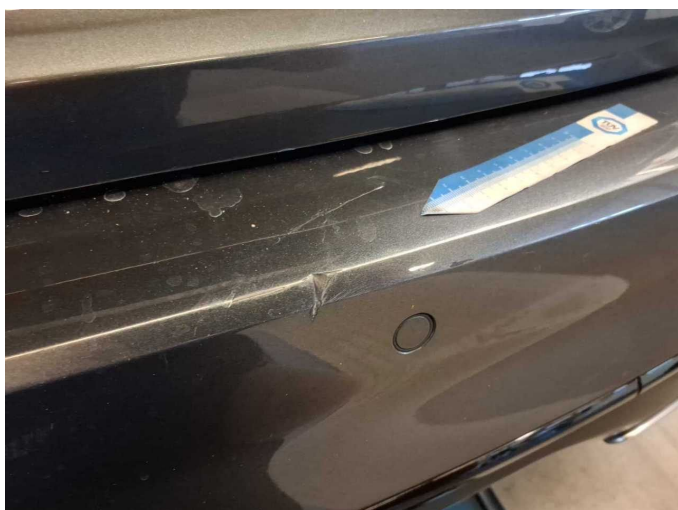
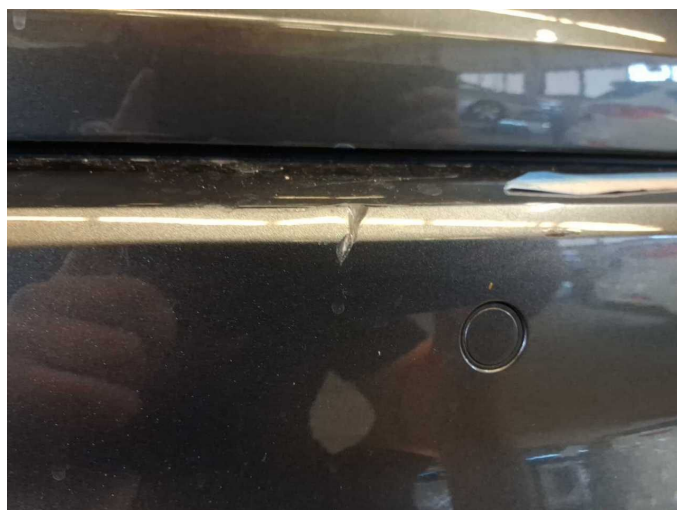
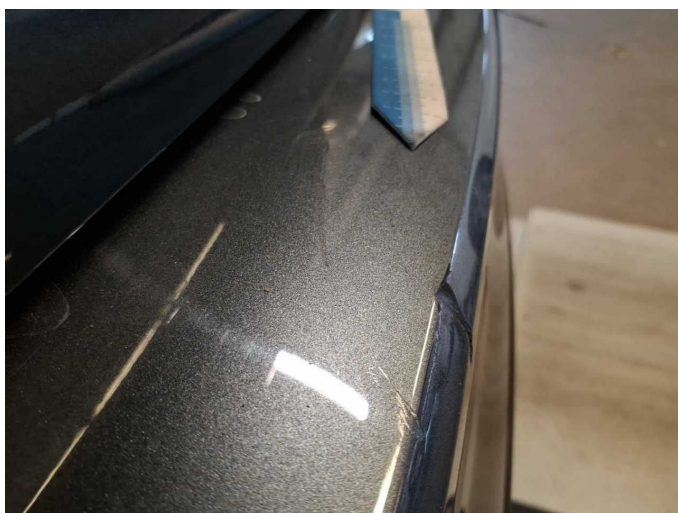
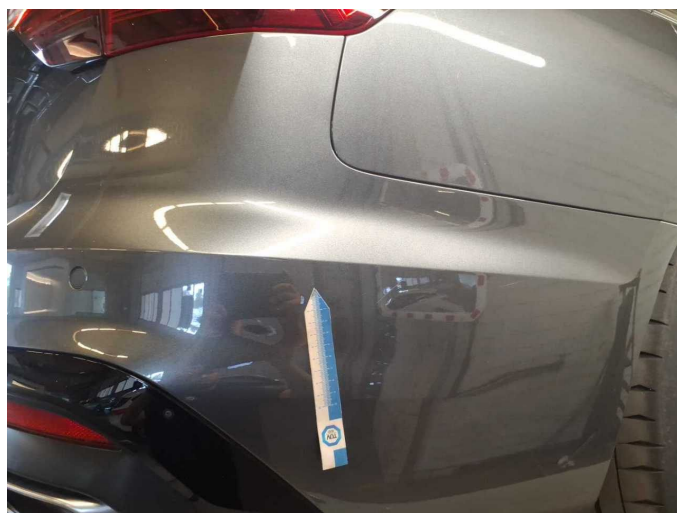
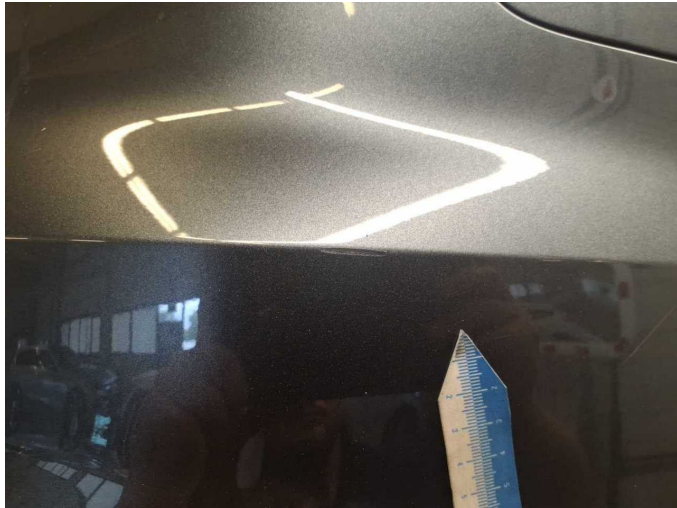
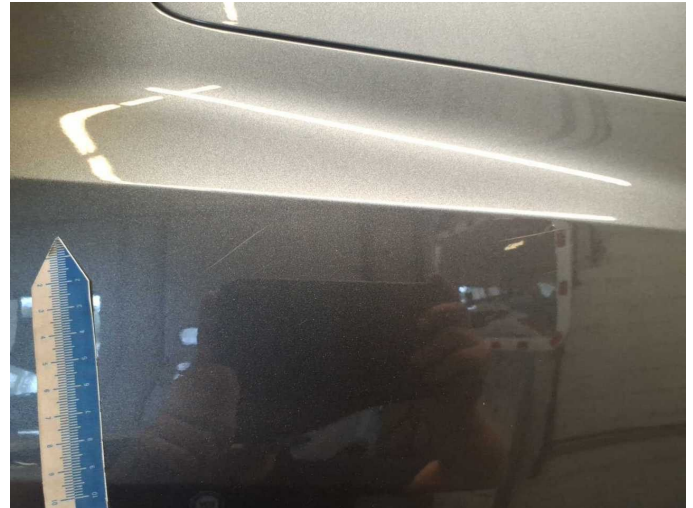
| No. | Component group | Description |
|---|---|---|
| 12 | Rear bumper | Rear bumper (Fhgz. mit Sideassist) - Scratched - Replace |

**Damage 12:** Rear bumper: Rear bumper (Fhgz. mit Sideassist) - Scratched - Replace

**Damage 12:** Rear bumper: Rear bumper (Fhzig. mit Sideassist) - Scratched - Replace
