Expertise

Protocol number: 46086268  
Order No. / Reference: 26543854  
Inspection date: 23 Jun 2026

Manufacturer: Skoda  
VIN: TMBJR9NP4P7053161

Model: Superb Combi 2.0 TDI DSG Sportline

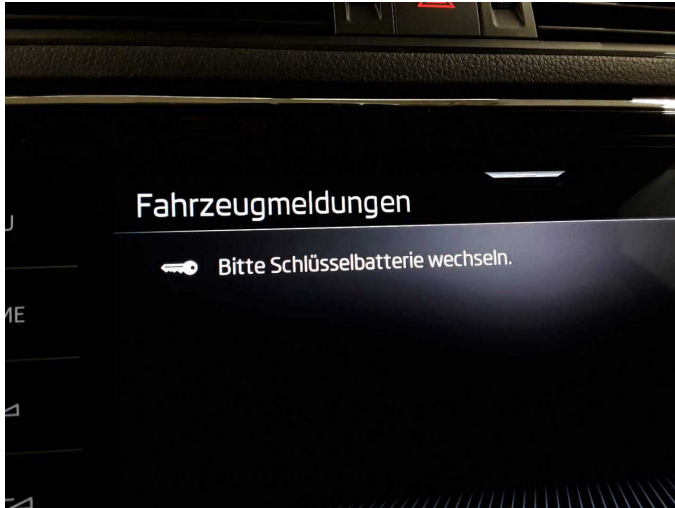
| No. | Component group | Description |
|---|---|---|
| 2 | Equipment | Vehicle key - Empty - Replace |

**Damage 2:** Equipment: Vehicle key - Empty - Replace

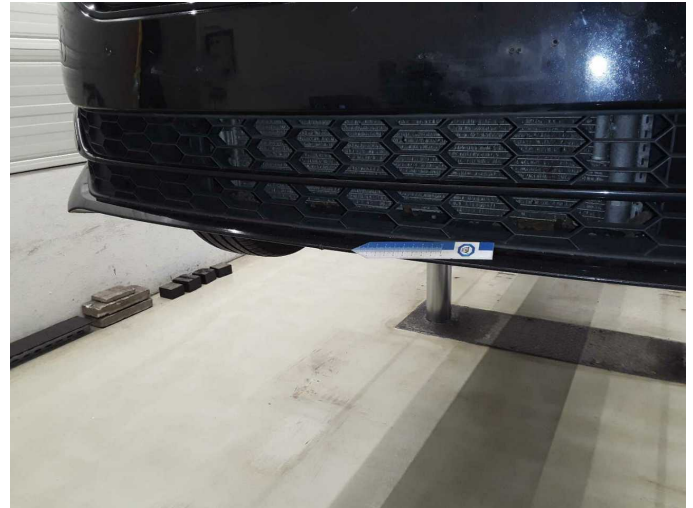
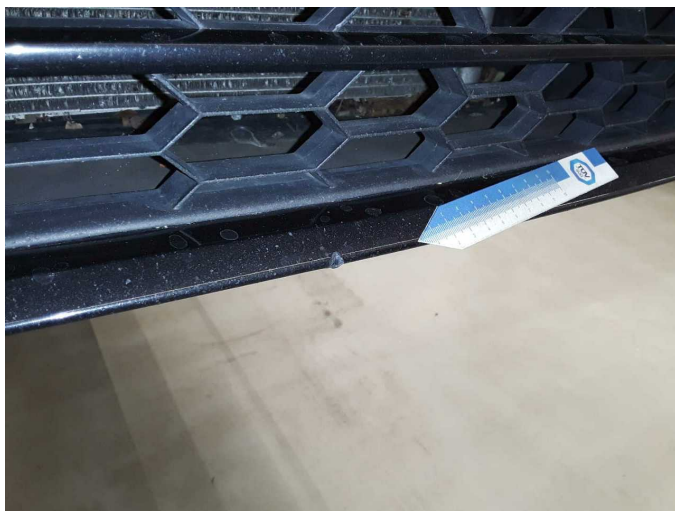
| No. | Component group | Description |
|---|---|---|
| 3 | Front bumper | Front bumper - Scratch(es) - Smart repair |

**Damage 3:** Front bumper: Front bumper - Scratch(es) - Smart repair

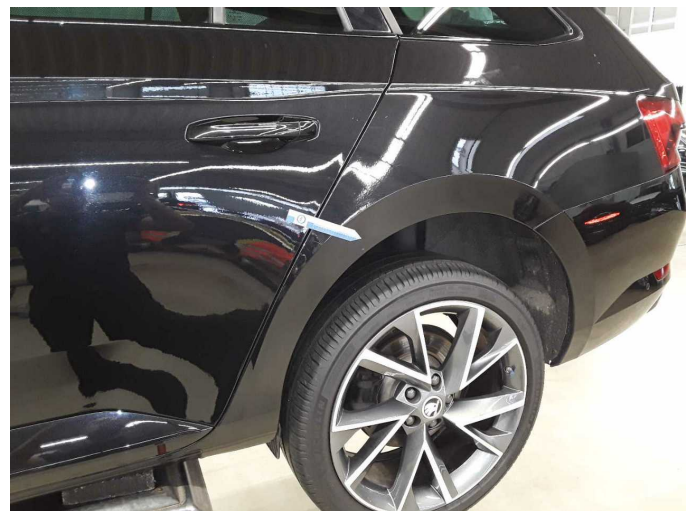
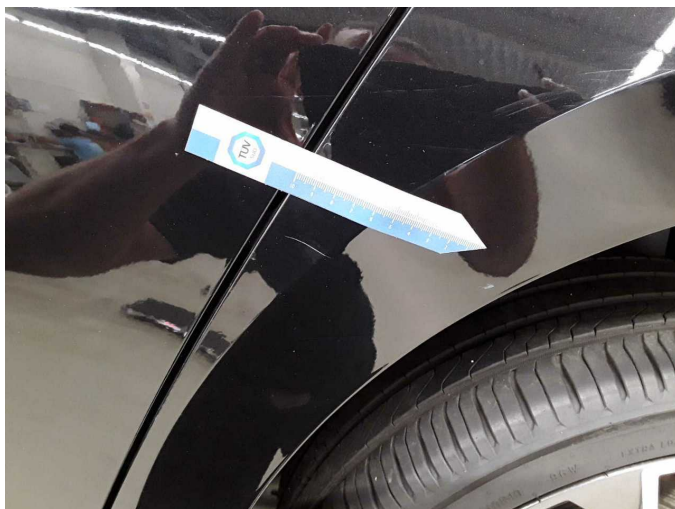
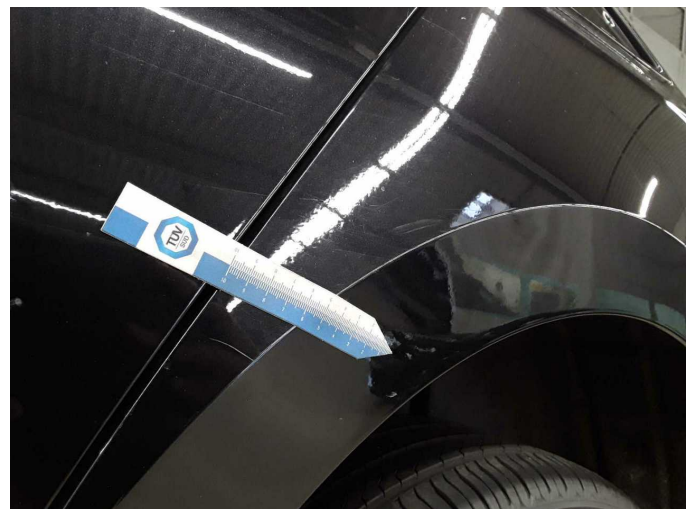
| No. | Component group | Description |
|---|---|---|
| 4 | Side panel - rear left side | Side panel - Scratch(es) - Smart repair |

**Damage 4:** Side panel - rear left side: Side panel - Scratch(es) - Smart repair

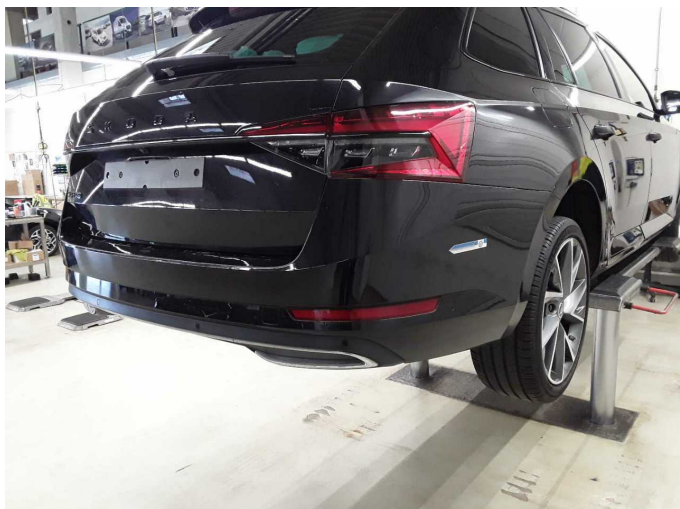
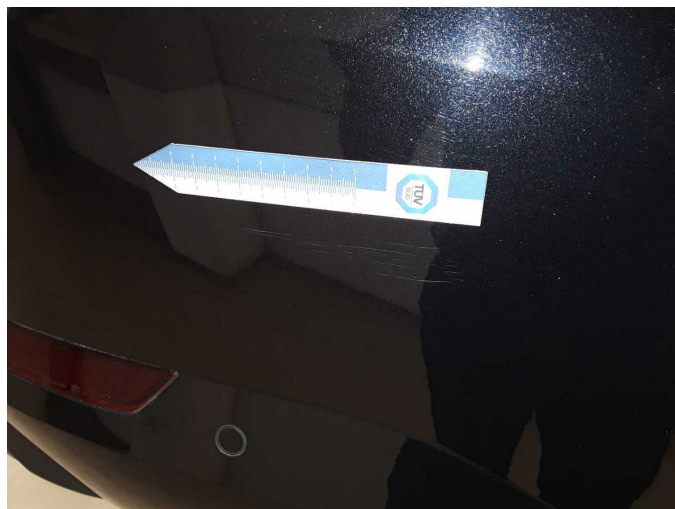
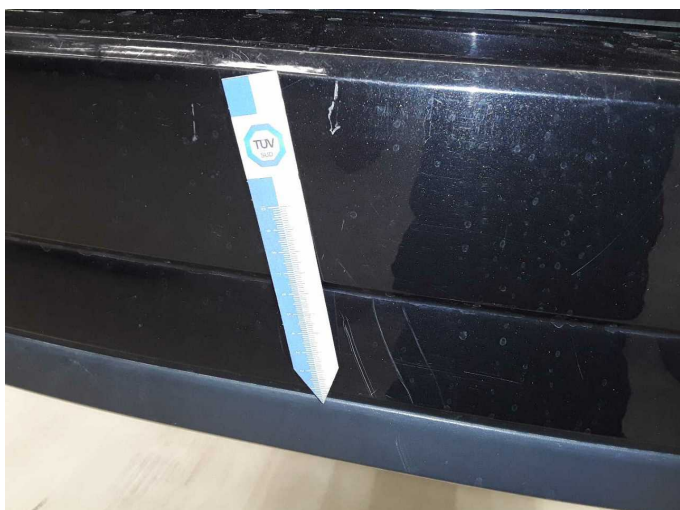
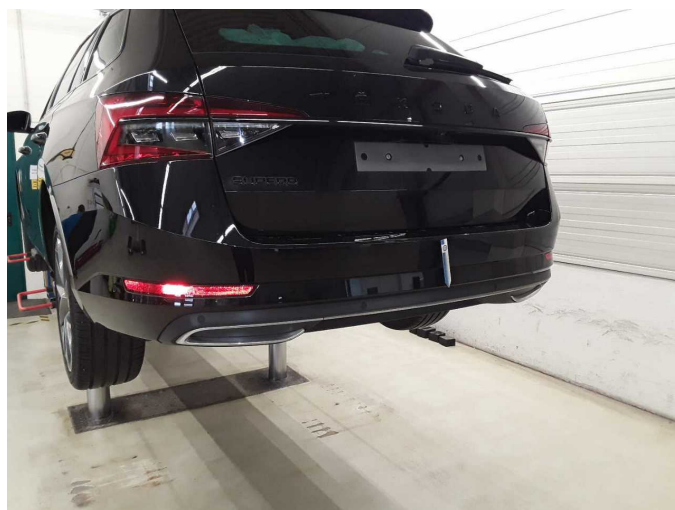
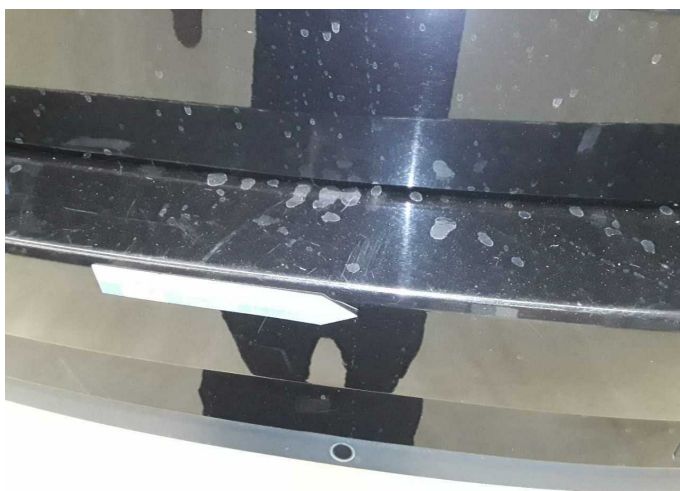
| No. | Component group | Description |
|---|---|---|
| 5 | Rear bumper | Rear bumper - Scratched - Repair and paint |

**Damage 5:** Rear bumper: Rear bumper - Scratched - Repair and paint

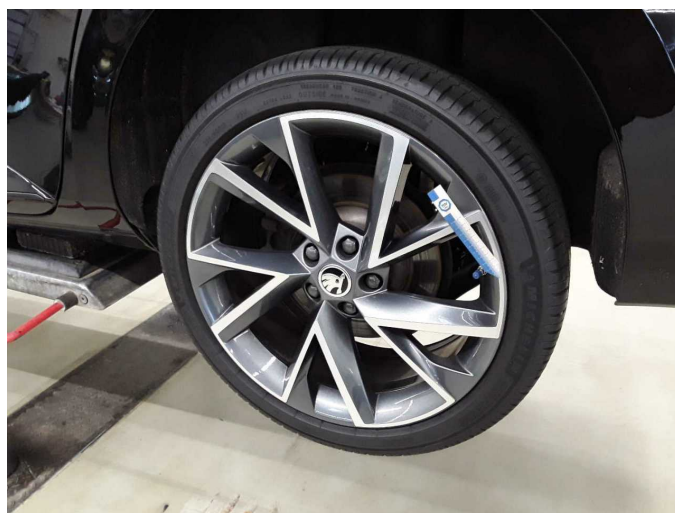
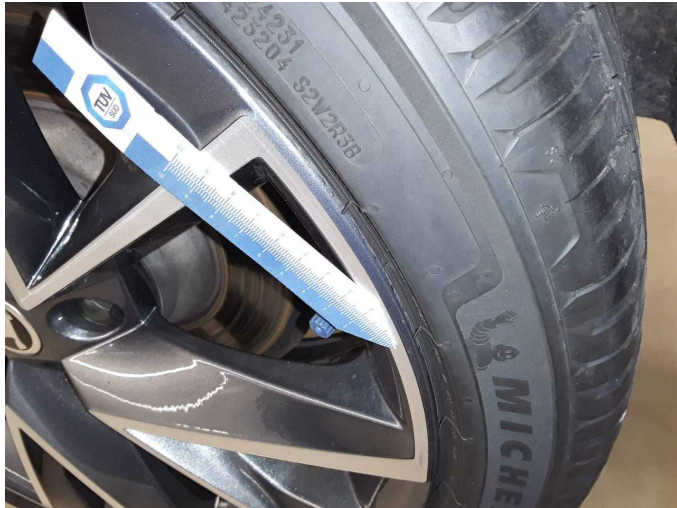
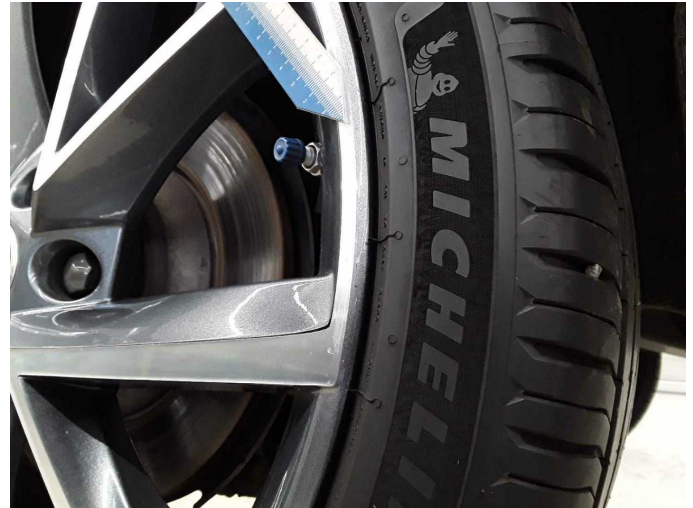
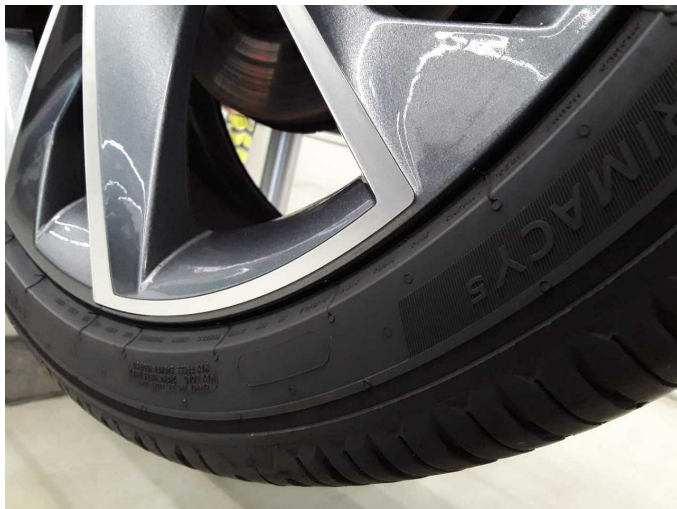
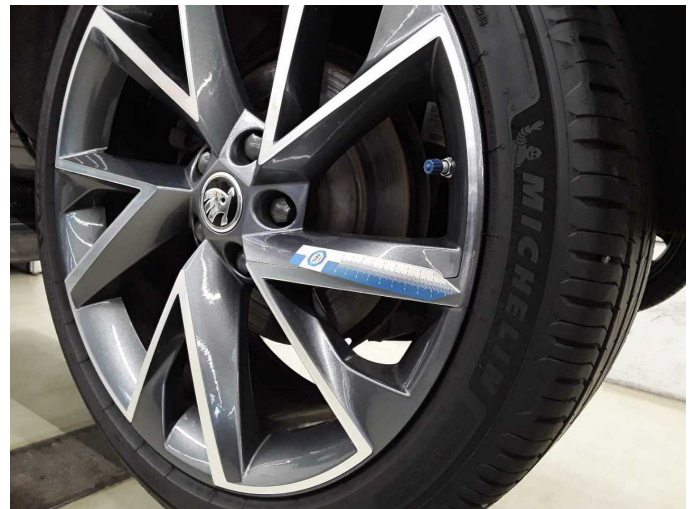
| No. | Component group | Description |
|---|---|---|
| 6 | Wheel / tyres | Alloy rim - rear left side (Wurde bearbeitet) - Unprofessionally repaired - Replace |

**Damage 6:** Wheel / tyres: Alloy rim - rear left side (Wurde bearbeitet) - Unprofessionally repaired - Replace

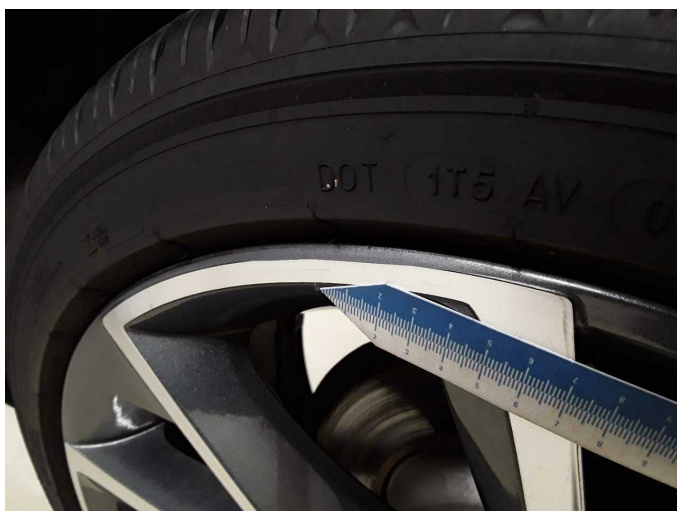
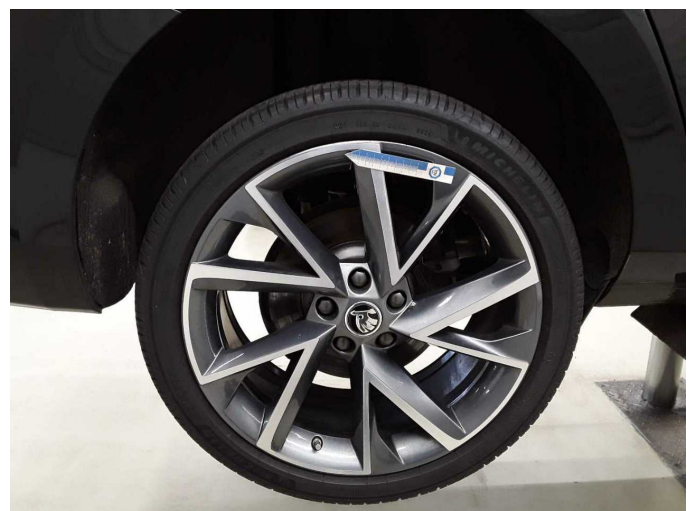
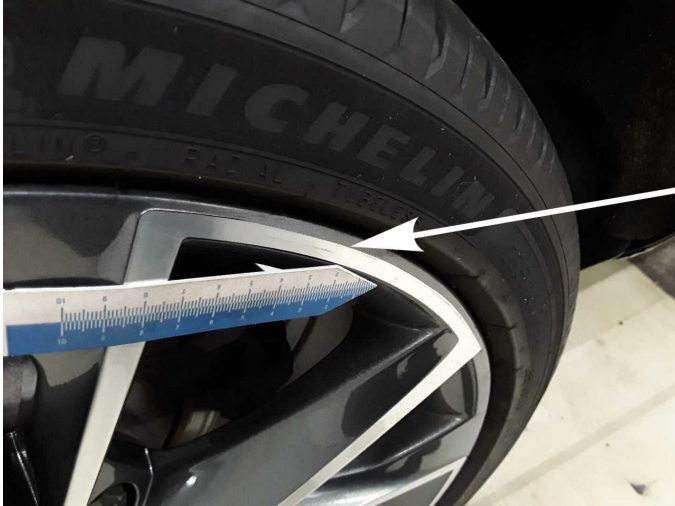
| No. | Component group | Description |
|---|---|---|
| 7 | Wheel / tyres | Alloy rim - rear right side (Wurde bearbeitet) - Unprofessionally repaired - Replace |

**Damage 7:** Wheel / tyres: Alloy rim - rear right side (Wurde bearbeitet) - Unprofessionally repaired - Replace

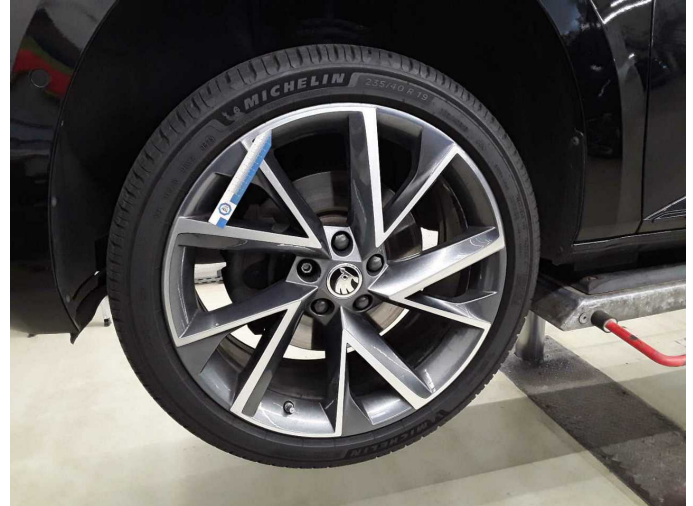
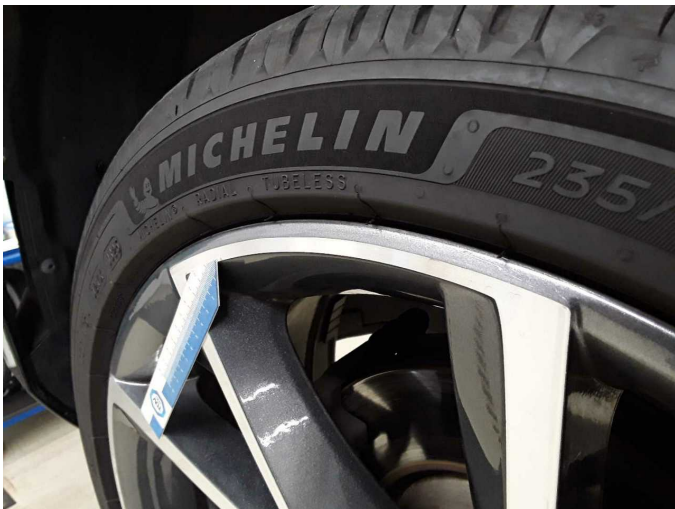
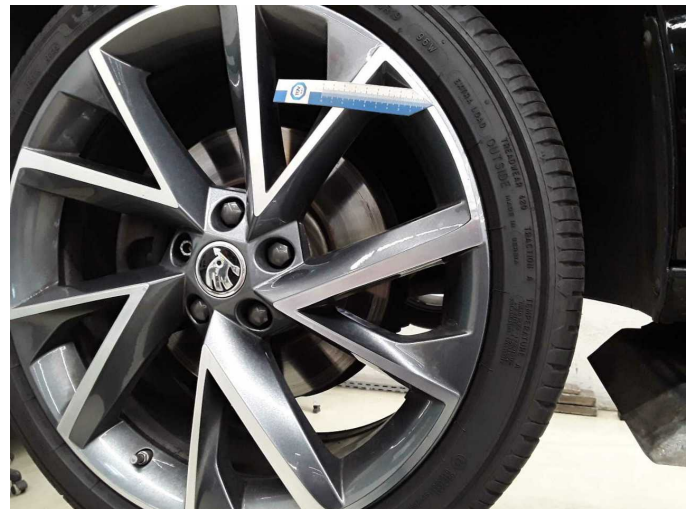
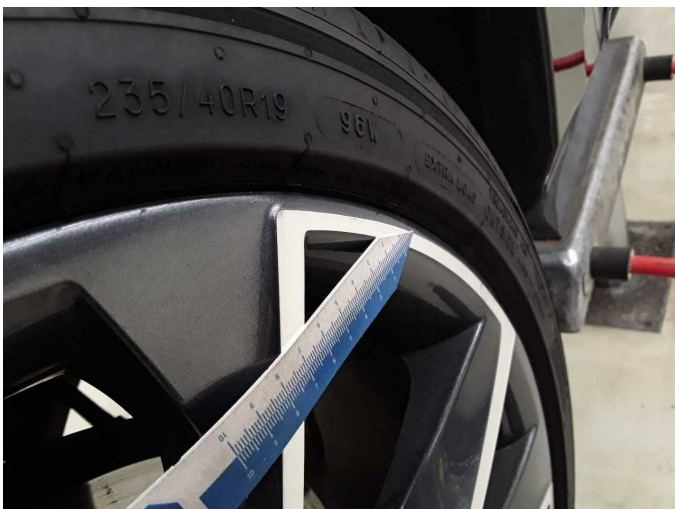
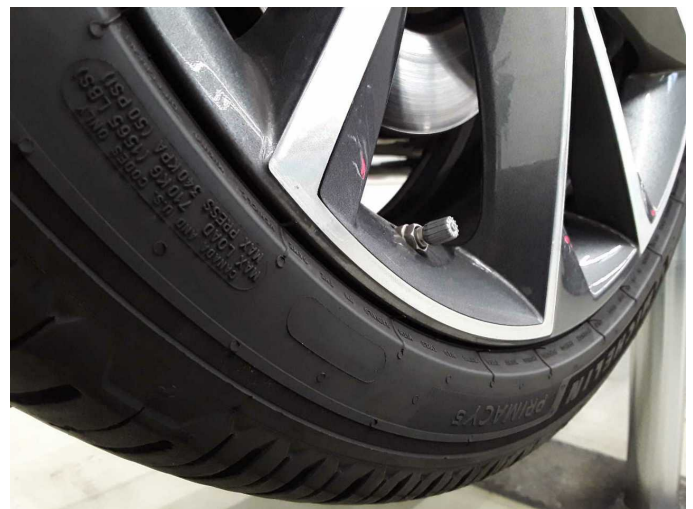
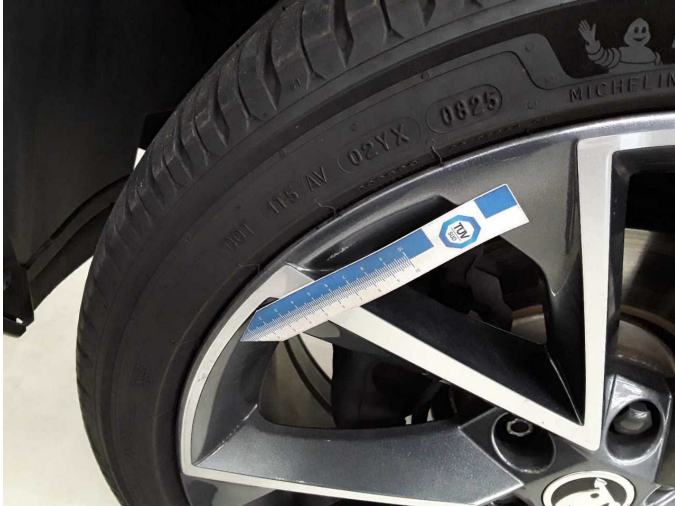
| No. | Component group | Description |
|---|---|---|
| 8 | Wheel / tyres | Alloy rim - front left side (Wurde bearbeitet) - Unprofessionally repaired - Replace |

**Damage 8:** Wheel / tyres: Alloy rim - front left side (Wurde bearbeitet) - Unprofessionally repaired - Replace

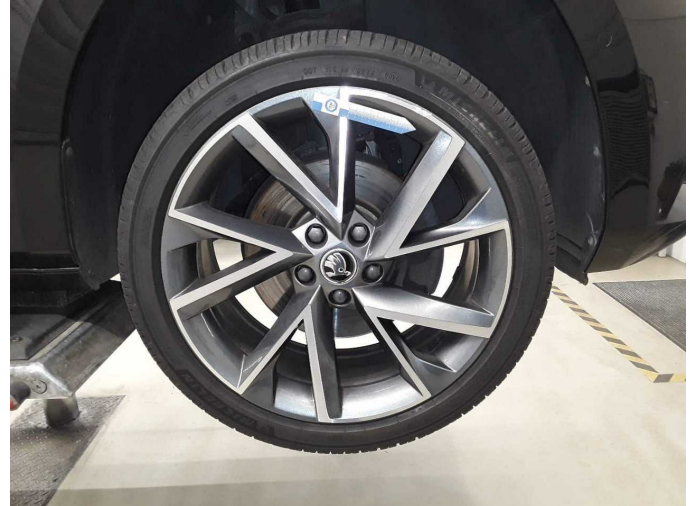
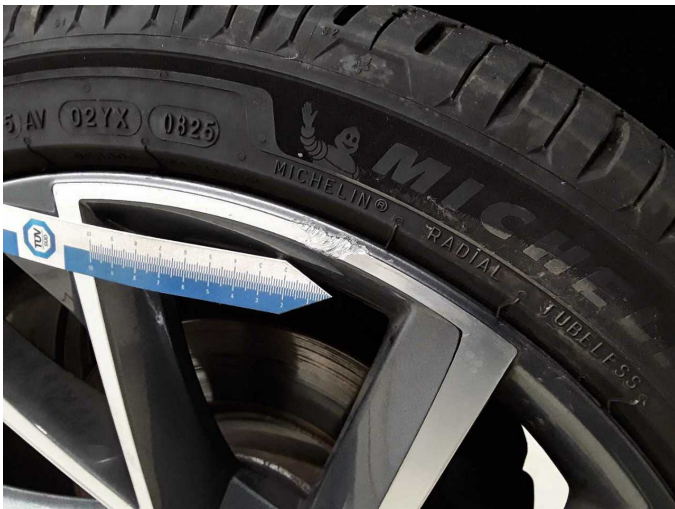
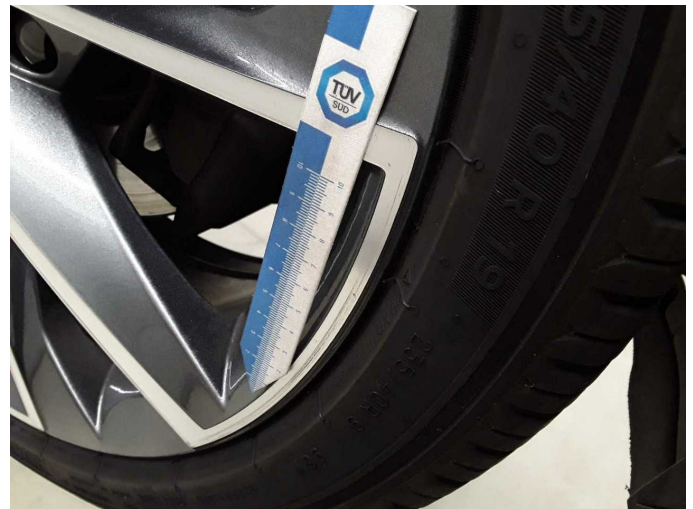
| No. | Component group | Description |
|---|---|---|
| 9 | Wheel / tyres | Alloy rim - front right side (Materialabtrag) - Scratched - Replace |

**Damage 9:** Wheel / tyres: Alloy rim - front right side (Materialabtrag) - Scratched - Replace

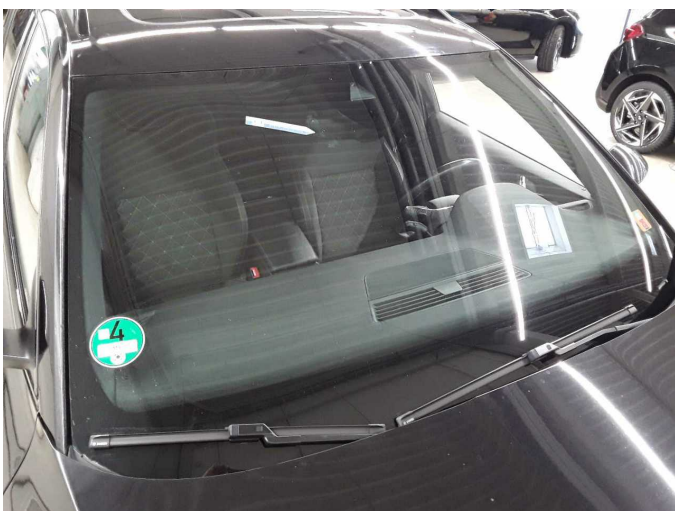
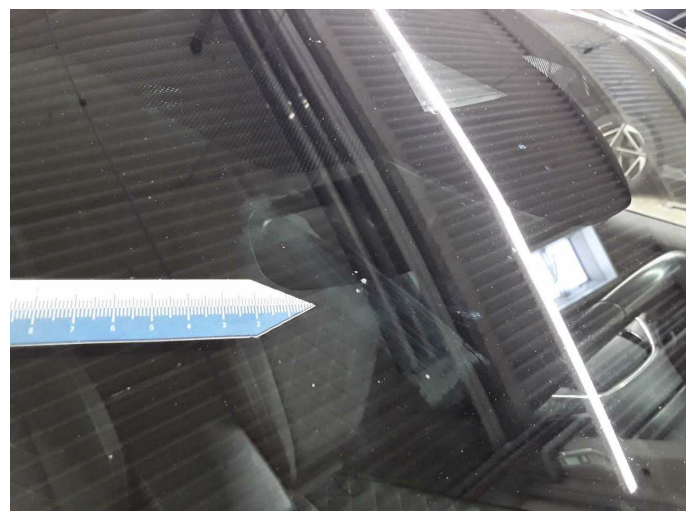
| No. | Component group | Description |
|---|---|---|
| 2 | Vehicle glazing | Windscreen - Stone chips - No deduction |

**Wear and tear 2:** Vehicle glazing: Windscreen - Stone chips - No deduction

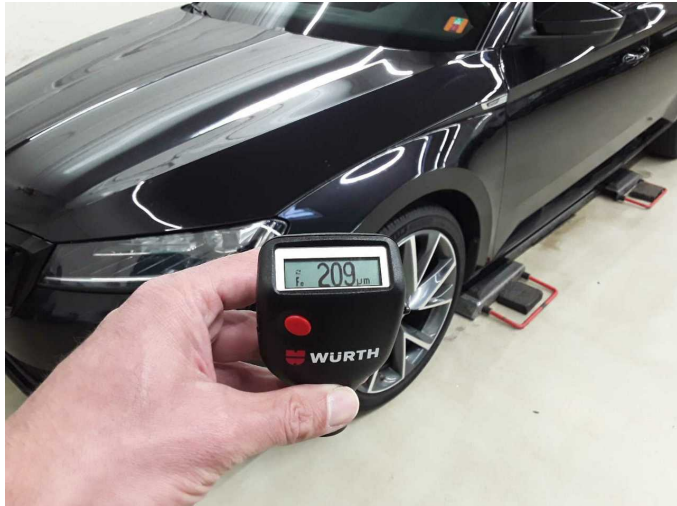
| No. | Repainting |
|---|---|
| 1 | Mudguard - left side, Mudguard - right side, Side panel - rear right side, Door - rear right side, Professionally carried out |

**Mudguard - left side: 209 µm**

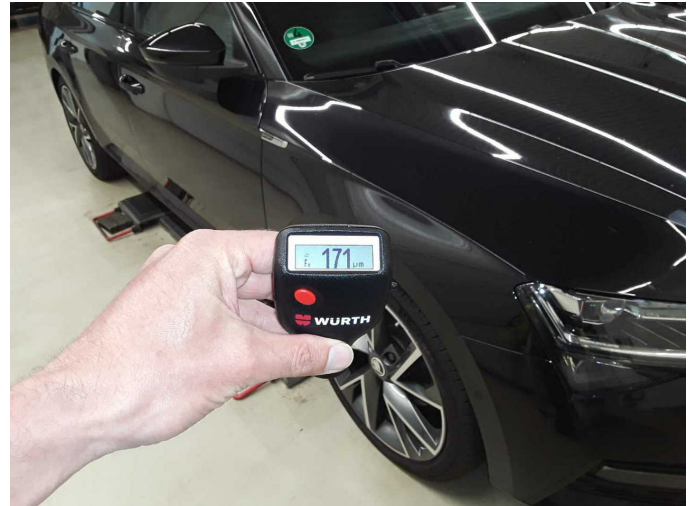
**Mudguard - right side: 171 µm**

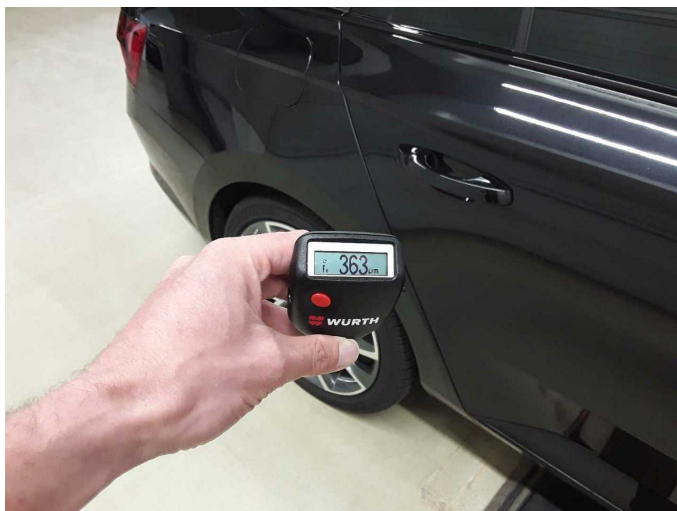
**Side panel - rear right side: 363 µm**

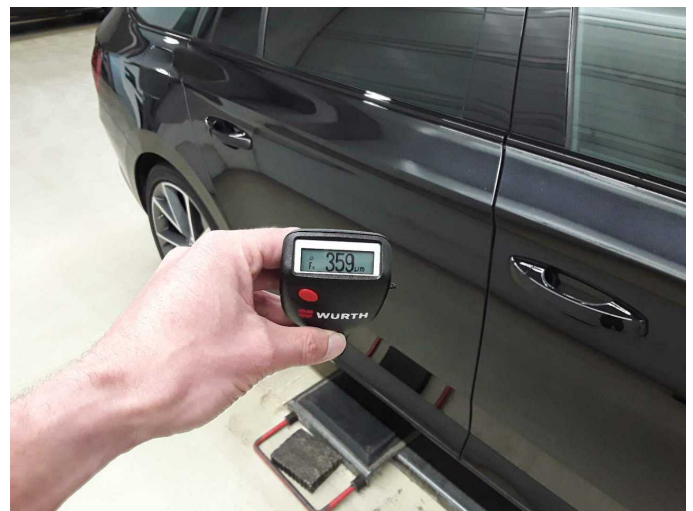
**Door - rear right side: 359 µm**
