Expertise

Protocol number: 45985432
Order No. / Reference: 26580708
Inspection date: 17 Jun 2026

Manufacturer: Volkswagen

Model: Passat Variant 1.4 TSI Plug-In-Hybrid DSG GTE

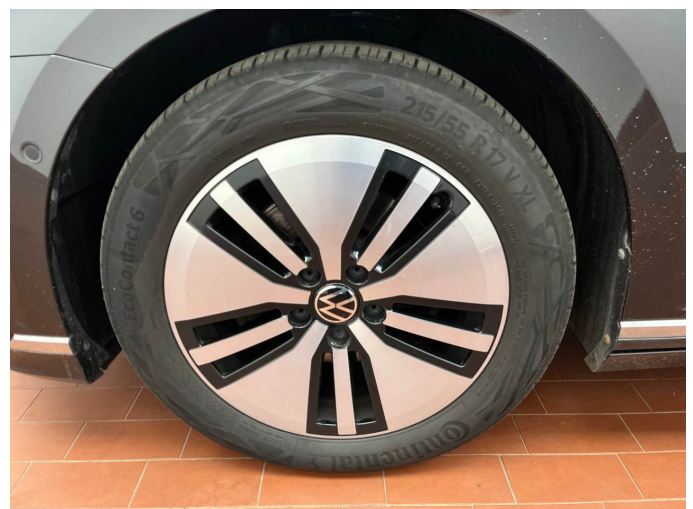
Figure 12: Mounted tyres

| Mounted tyres | | | | |
|---|---|---|---|---|
| 1) | 215/55 R17 98V | Summer tyres on Light alloy | Continental | 4mm / 4mm |
| 2) | 215/55 R17 98V | Summer tyres on Light alloy | Continental | 6mm / 6mm |

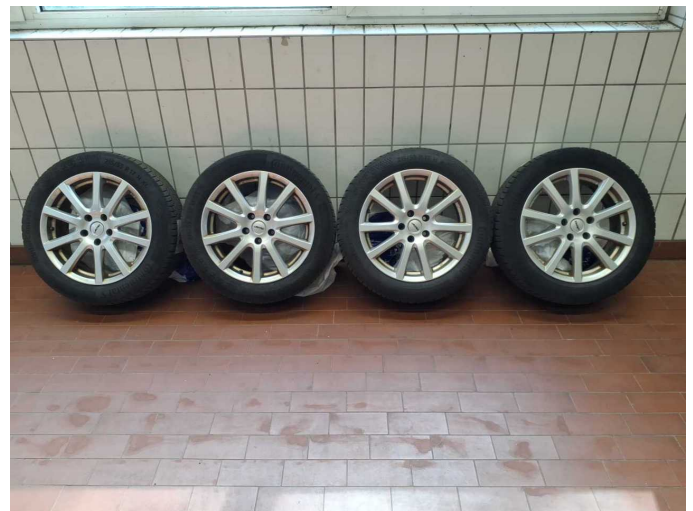
Figure 16: Additional tyres

| Mounted tyres | | | | |
|---|---|---|---|---|
| 1) | 215/55 R17 94H | Winter tyres on Light alloy | Continental | 3mm / 3mm |
| 2) | 215/55 R17 94H | Winter tyres on Light alloy | Continental | 5mm / 5mm |

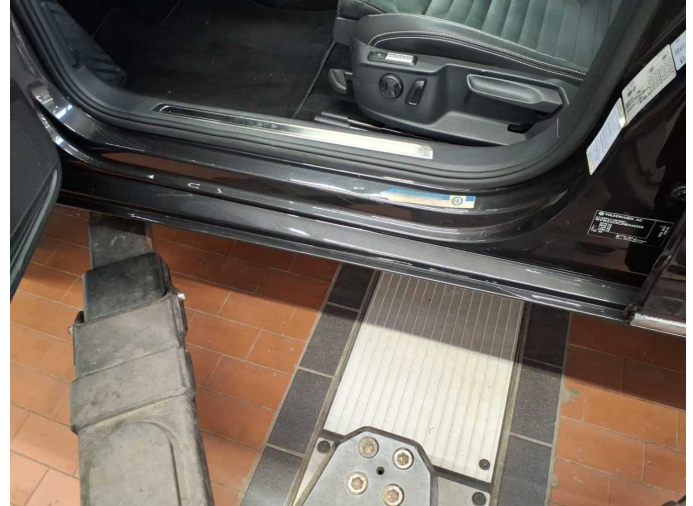
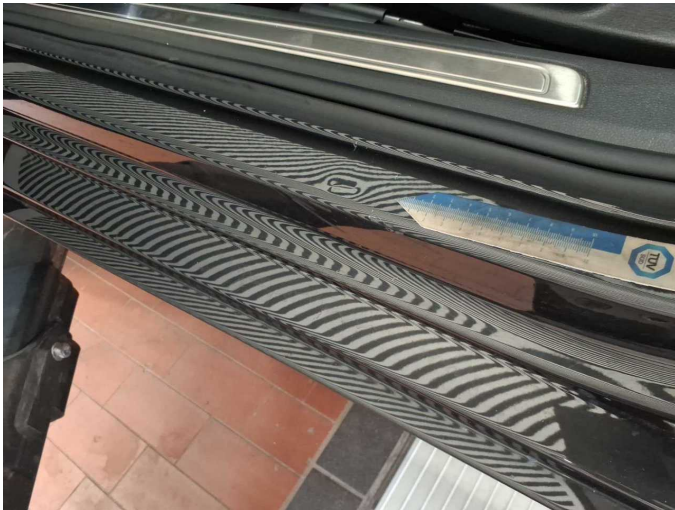
Damage 1: Sill - left side: Sill - dent(s) - Smooth repair work

| No. | Component group | Description |
|---|---|--|
| 1 | Sill - left side | Sill - dent(s) - Smooth repair work |

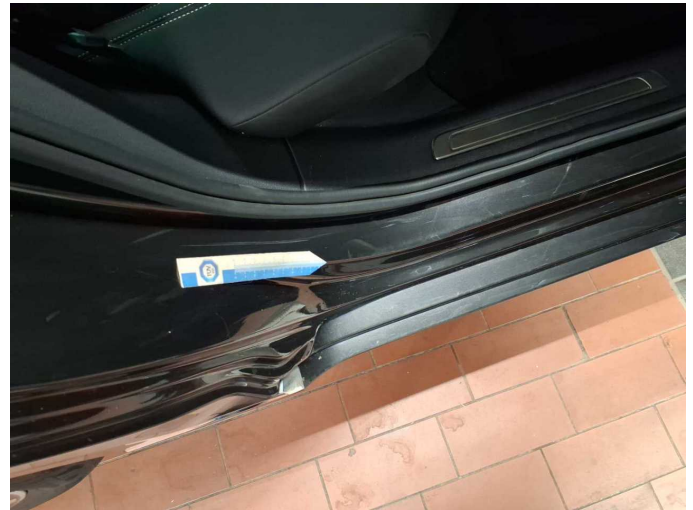
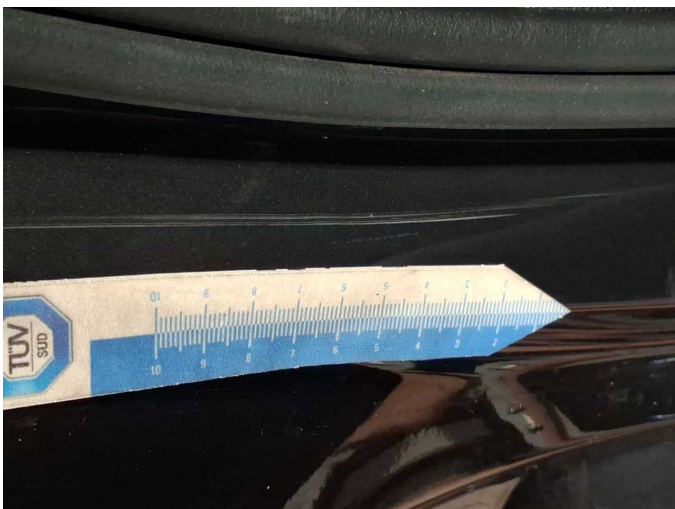
Damage 2: Side panel - rear right side: Sill - Scratch(es) - Smart repair

| No. | Component group | Description |
|---|---|--|
| 2 | Side panel - rear right side | Sill - Scratch(es) - Smart repair |

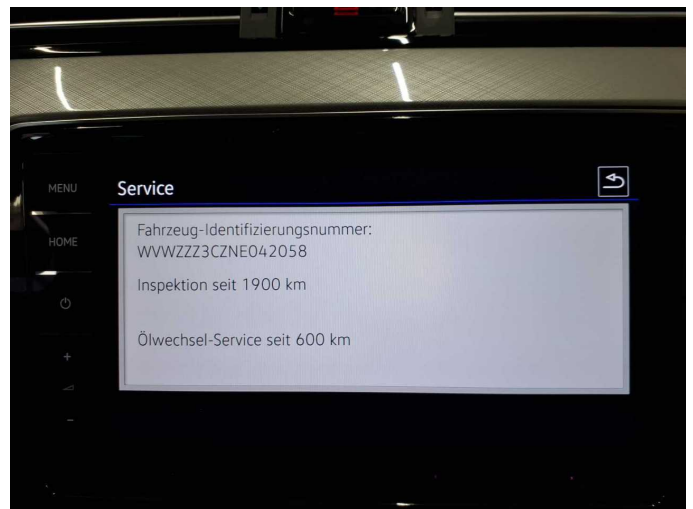
Damage 3: Misc.: Inspection / maintenance - Due - Perform

| No. | Component group | Description |
|---|---|--|
| 3 | Misc. | Inspection / maintenance - Due - Perform |

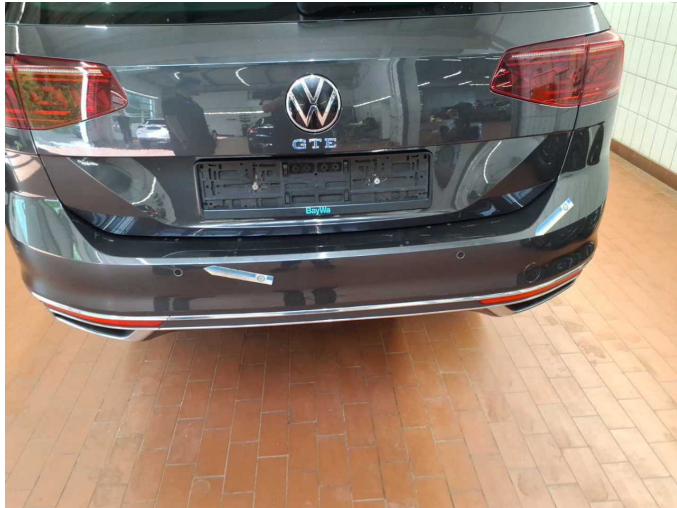
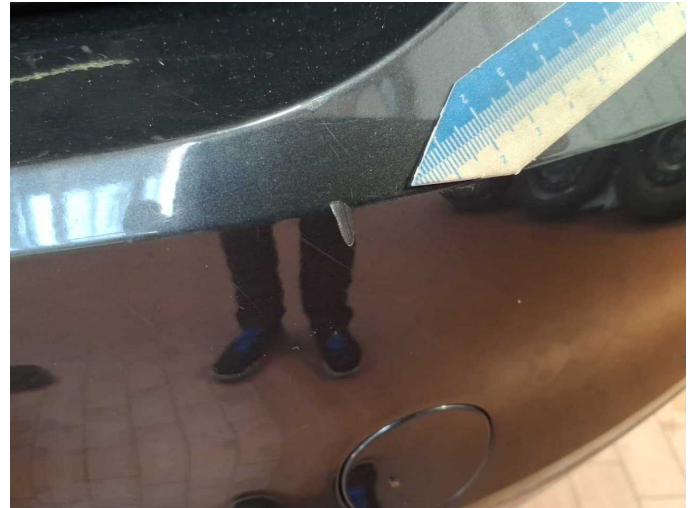
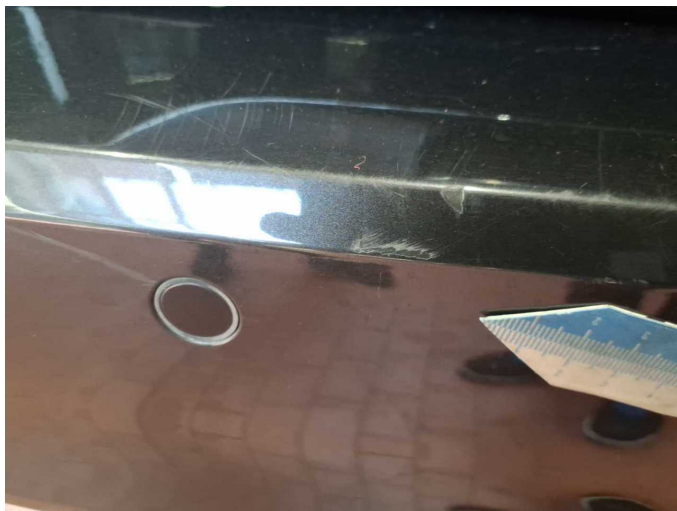
Damage 4: Rear bumper: Rear bumper - Scratched - Paint

| No. | Component group | Description |
|---|---|--|
| 4 | Rear bumper | Rear bumper - Scratched - Paint |

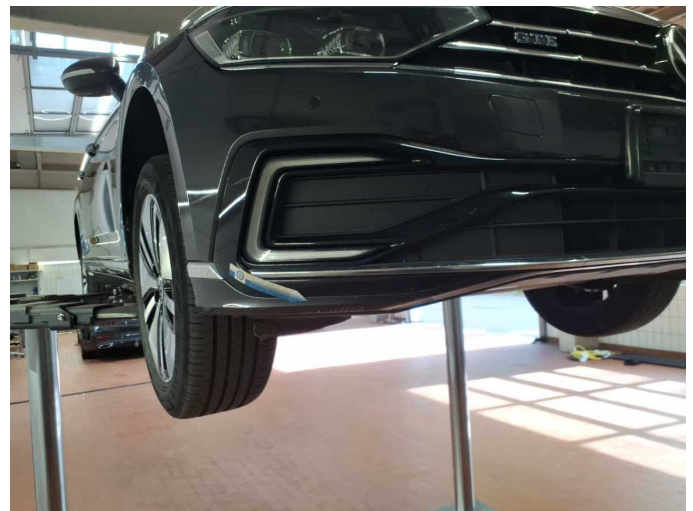
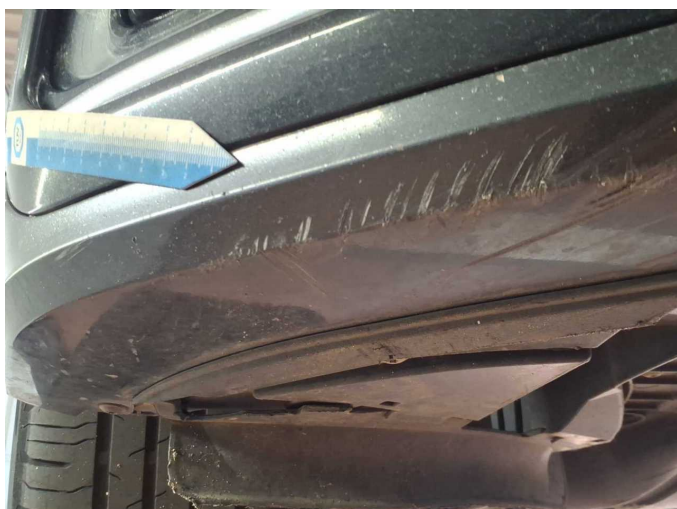
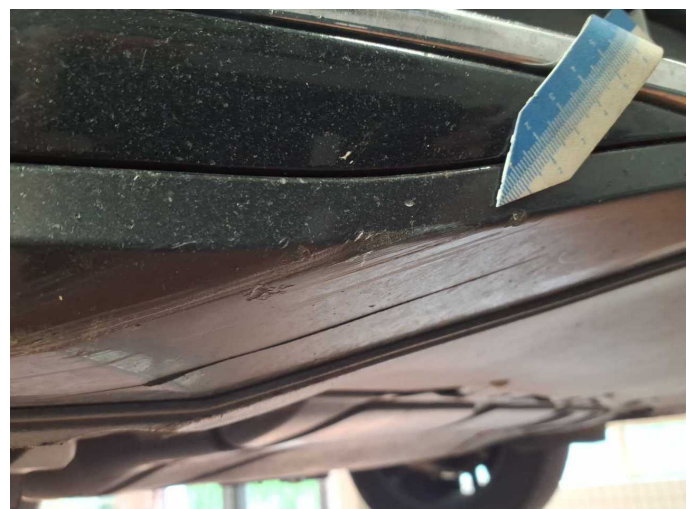
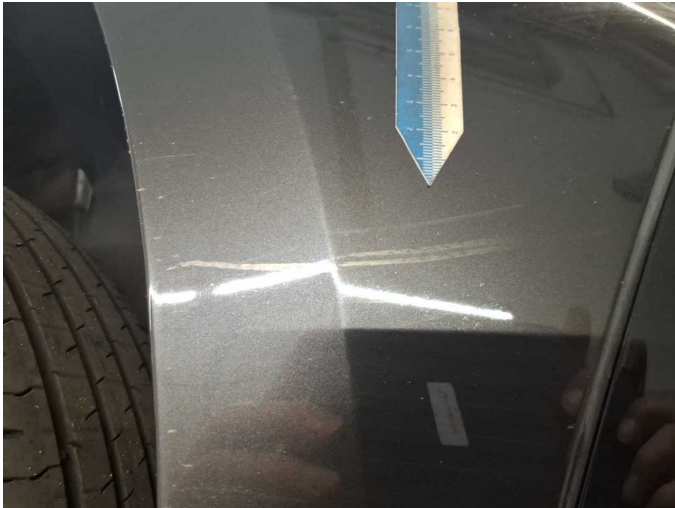
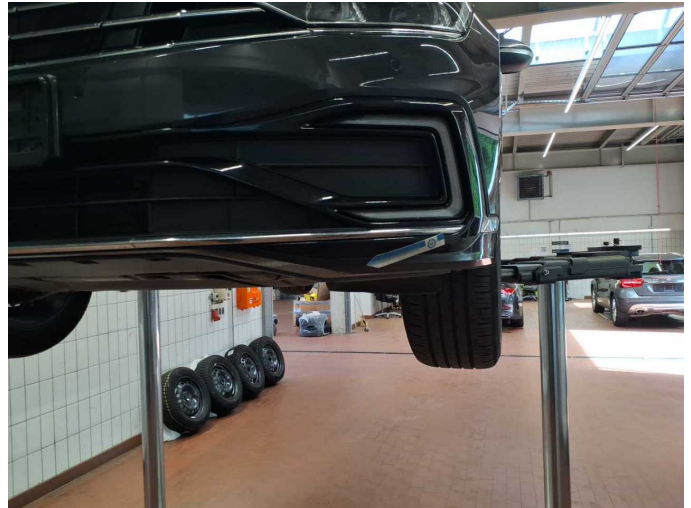
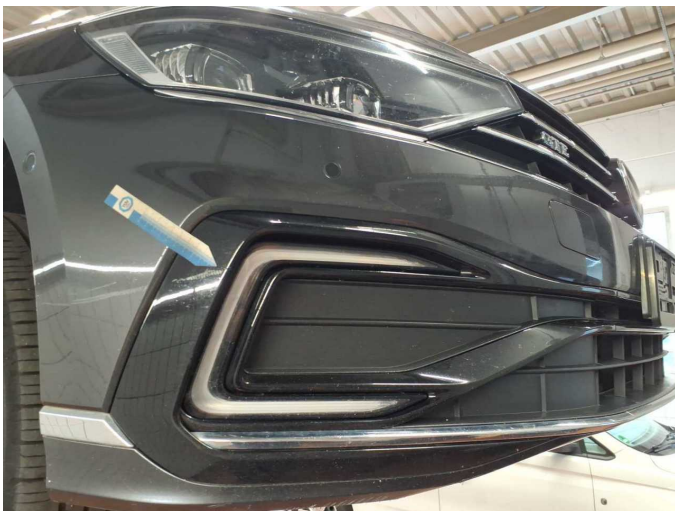
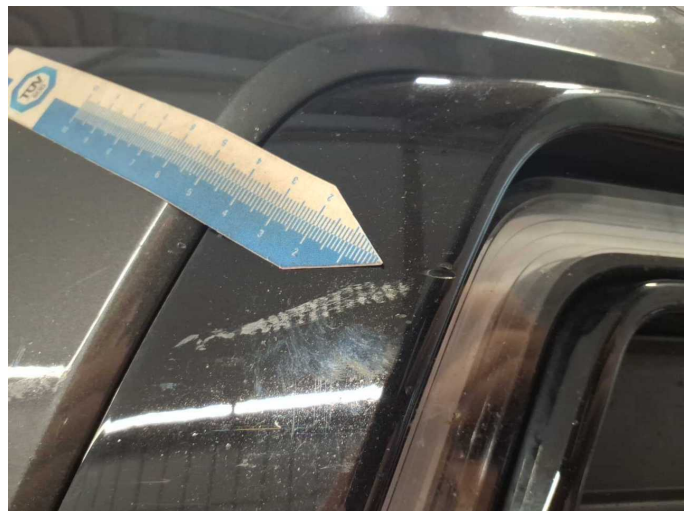
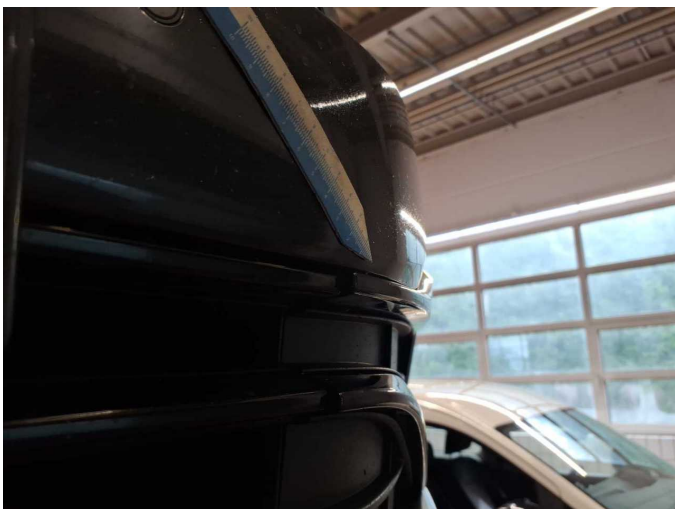
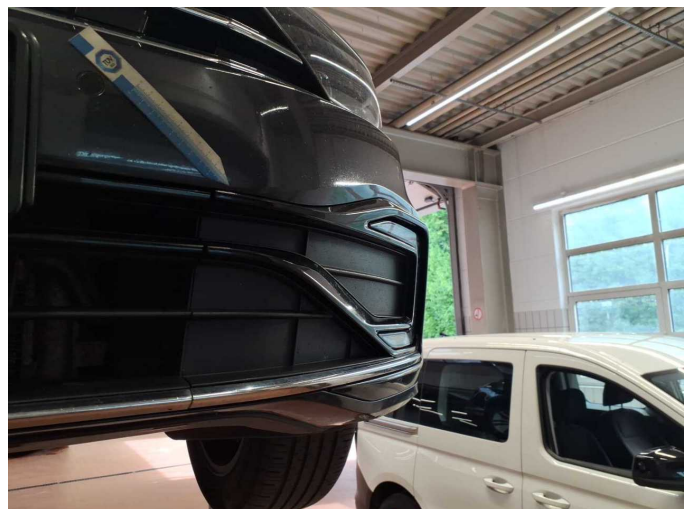
Damage 5: Front bumper: Front bumper (Blende rechts Erneuern / Blende Links A+E) - Scratched - Paint

| No. | Component group | Description |
|---|---|--|
| 5 | Front bumper | Front bumper (Blende rechts Erneuern / Blende Links A+E) - Scratched - Paint |

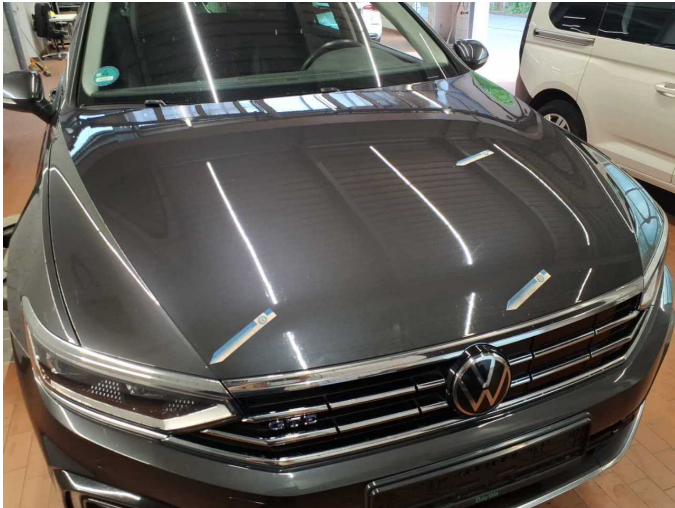
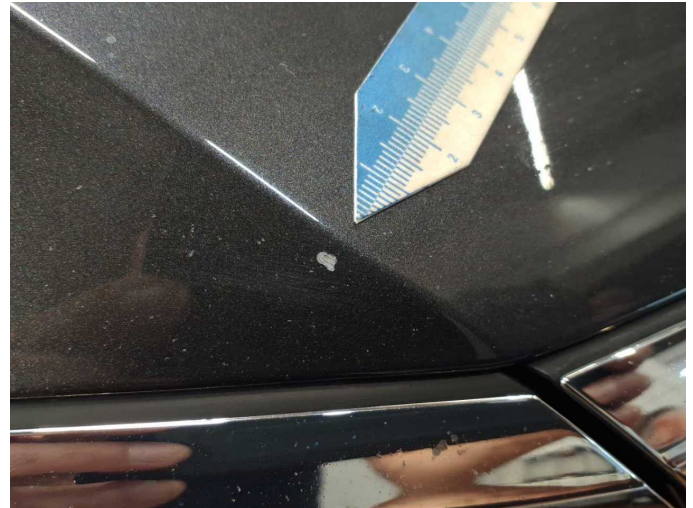
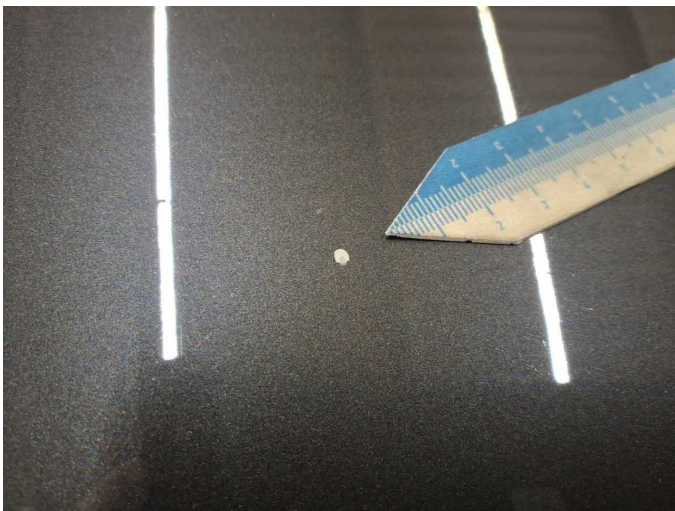
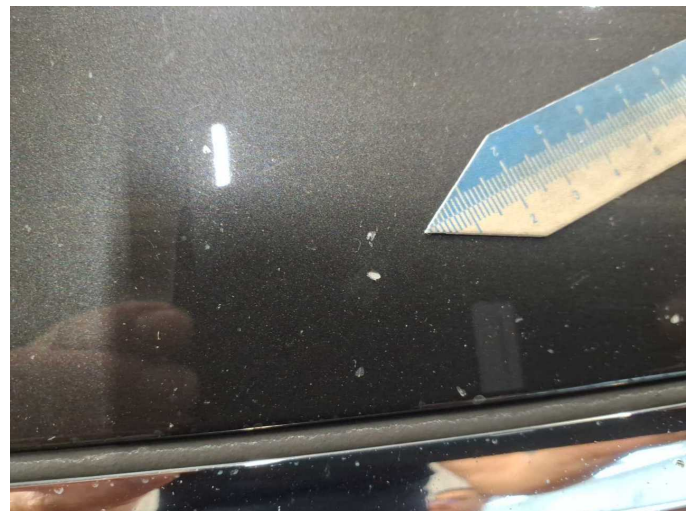
Damage 6: Bonnet: Bonnet - Stone chips - Paint

| No. | Component group | Description |
|---|---|--|
| 6 | Bonnet | Bonnet - Stone chips - Paint |

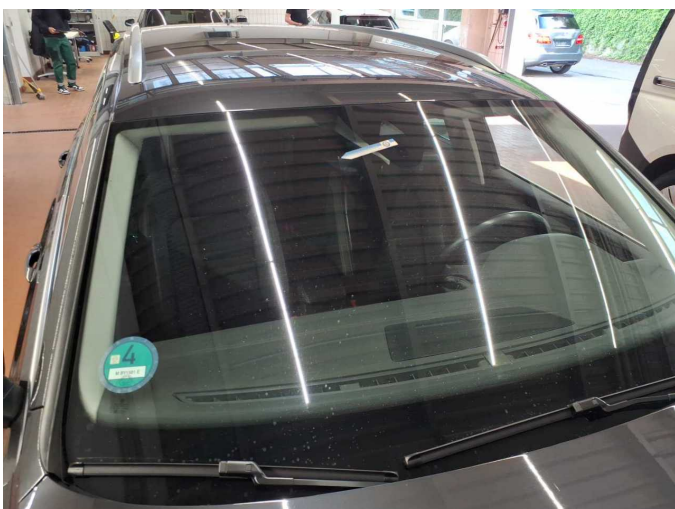
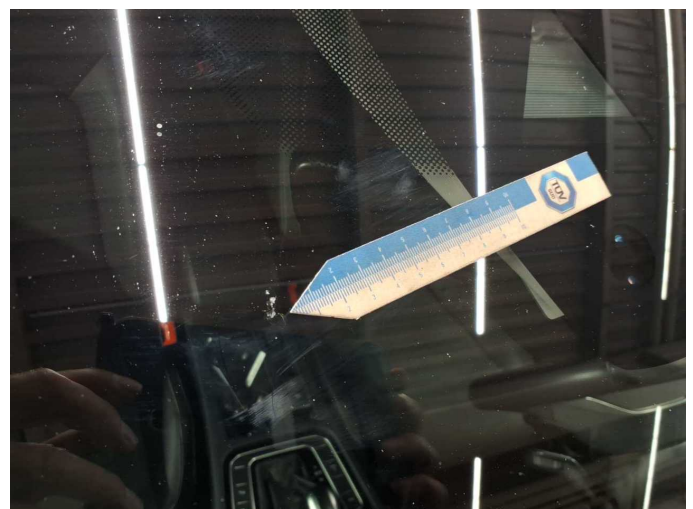
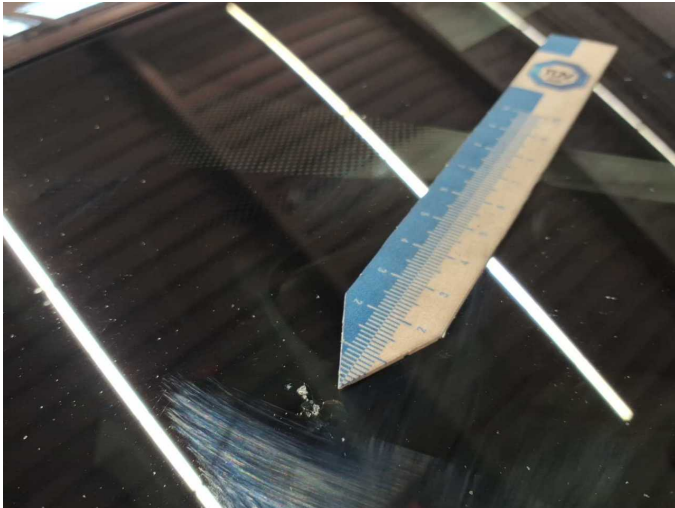
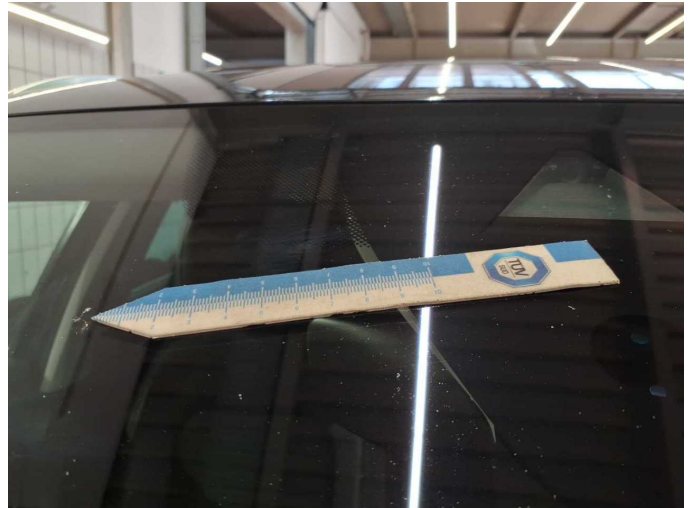
Damage 7: Vehicle glazing: Windscreen with lane departure assistant - Stone chips - Replace

| No. | Component group | Description |
|---|---|--|
| 7 | Vehicle glazing | Windscreen with lane departure assistant - Stone chips - Replace |

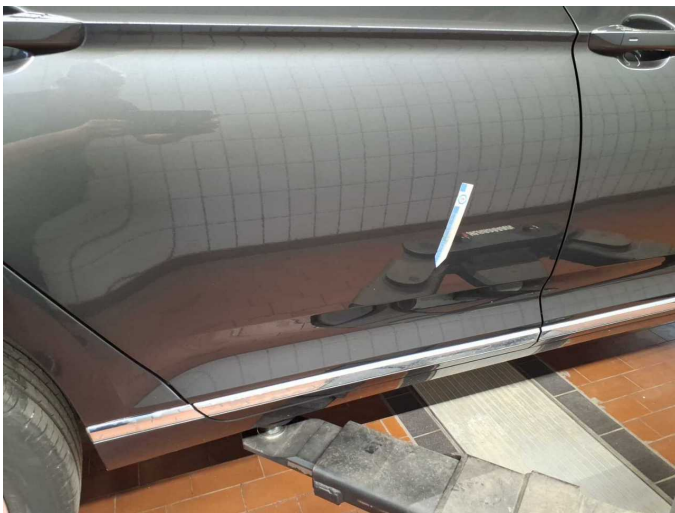
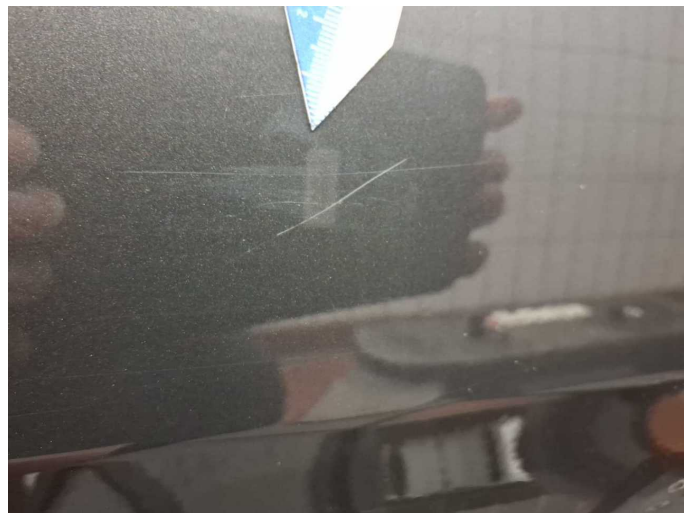
Wear and tear 1: Door - rear right side: Door - Scratch(es) - No deduction

| No. | Component group | Description |
|---|---|---|
| 1 | Door - rear right side | Door - Scratch(es) - No deduction |

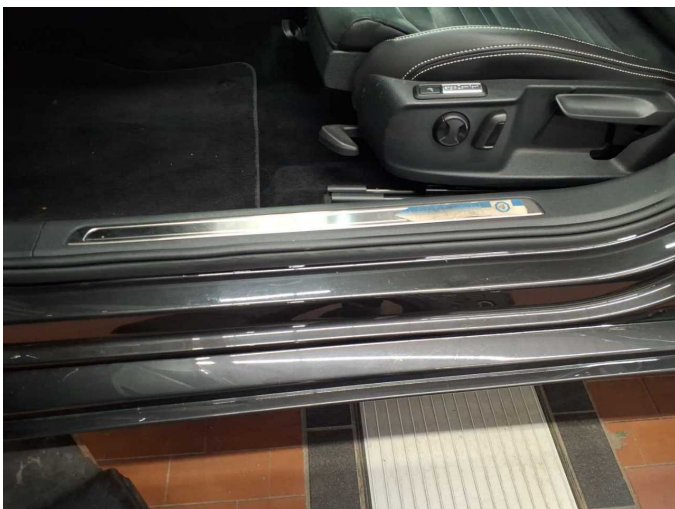
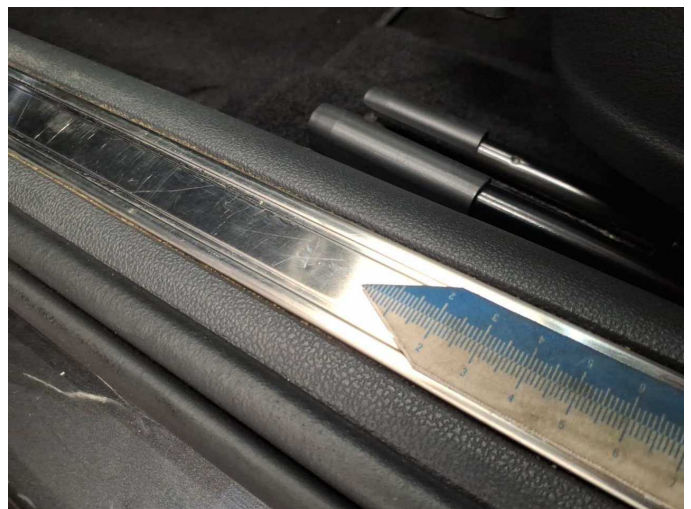
Wear and tear 2: Trim / covers: Sill - front left side - dent(s) - No deduction

| No. | Component group | Description |
|---|---|---|
| 2 | Trim / covers | Sill - front left side - dent(s) - No deduction |

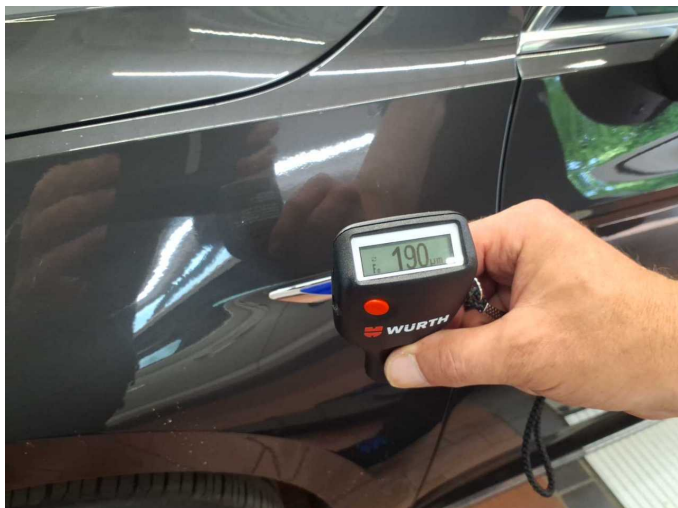
| No. | Repainting |
|---|---|
| 1 | Mudguard - left side, Professionally carried out, Invoice of repair done Non-existent |

| Mudguard - left side | 190 µm | Door - rear left side | 264 µm |

Repainting 1: Mudguard - left side

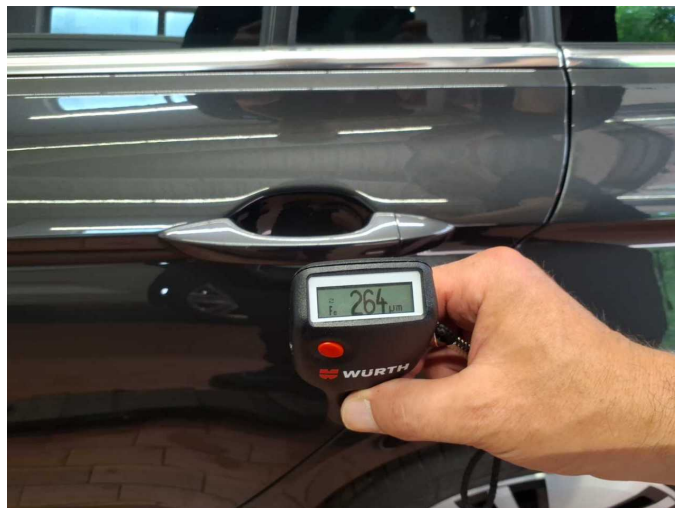
| No. | Repainting |
|---|---|
| 2 | Door - rear left side, Professionally carried out, Invoice of repair done Non-existent |

Repainting 2: Door - rear left side

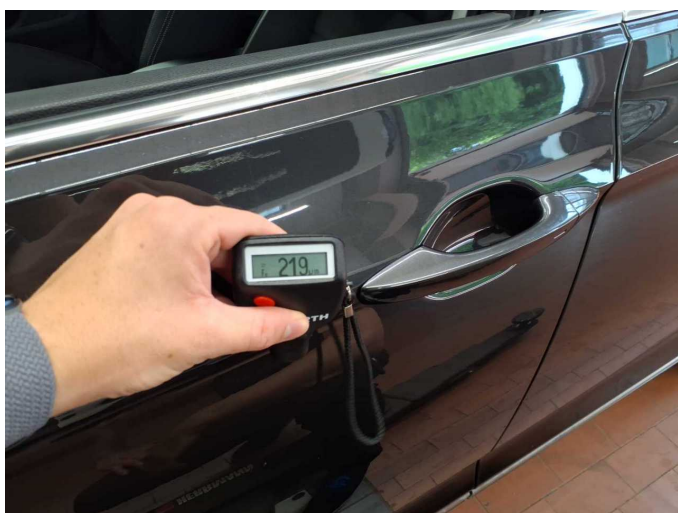
| No. | Repainting |
|---|---|
| 3 | Door - front left side, Professionally carried out, Invoice of repair done Non-existent |

| Door - front left side | 219 µm | | |

Repainting 3: Door - front left side
