Expertise

Protocol number: 46403927  
Order No. / Reference: 26639255  
Inspection date: 8 Jul 2026

Manufacturer: Mercedes-Benz

Model: GLB 200 d 8G-DCT Style

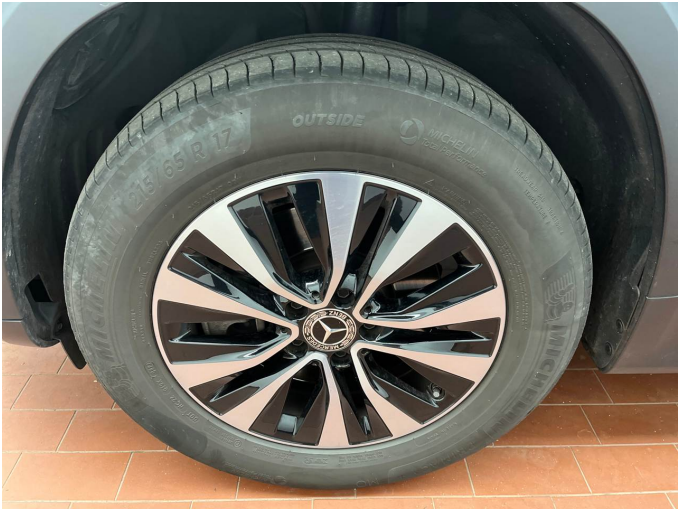
Figure 12: Mounted tyres

| # | Tyre size | Type of tyre | Manufacturer | Tread depth |
|---|---|---|---|---|
| 1) | 215/65 R17 99V | Summer tyres on Light alloy | Michelin | 4mm / 4mm |
| 2) | 215/65 R17 99V | Summer tyres on Light alloy | Michelin | 5mm / 5mm |

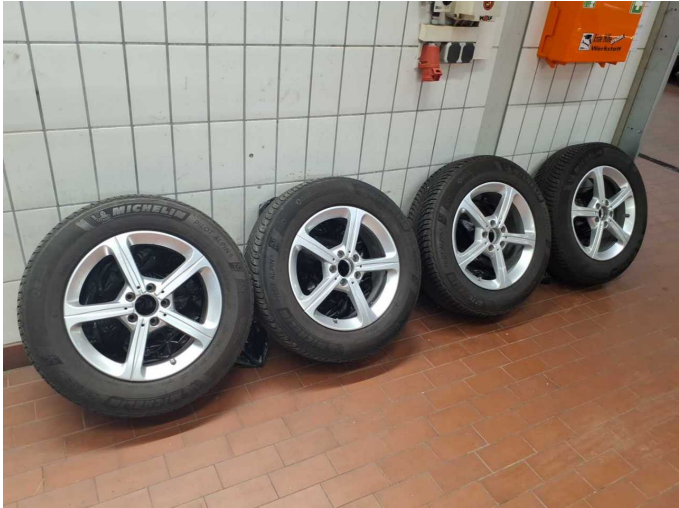
Figure 16: Additional tyres

| # | Tyre size | Type of tyre | Manufacturer | Tread depth |
|---|---|---|---|---|
| 1) | 215/65 R17 99H | Winter tyres on Light alloy | Michelin | 4mm / 4mm |
| 2) | 215/65 R17 99H | Winter tyres on Light alloy | Michelin | 6mm / 6mm |

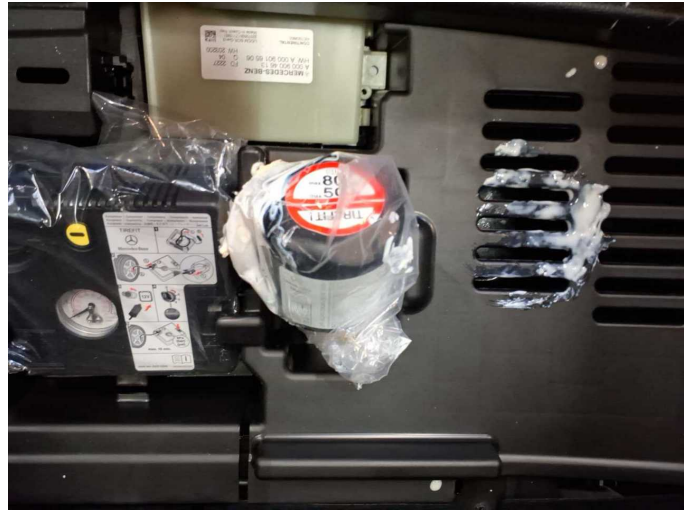
**Damage 1:** Equipment: Tirefit filler - Leaking - Replace

| No. | Component group | Description |
|---|---|---|
| 1 | Equipment | Tirefit filler - Leaking - Replace |

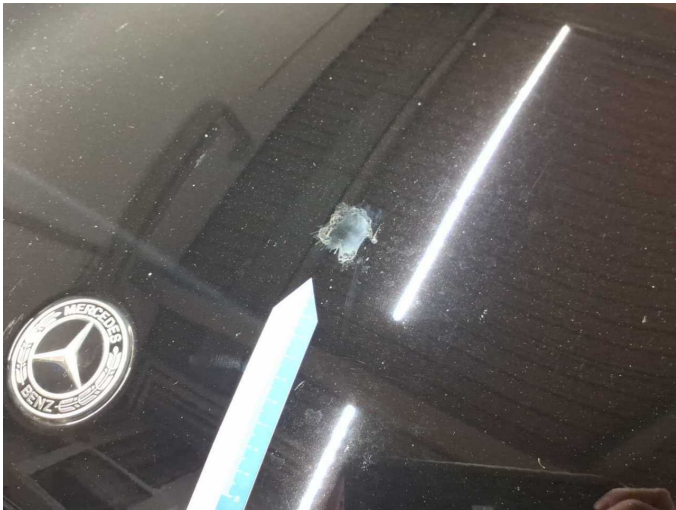
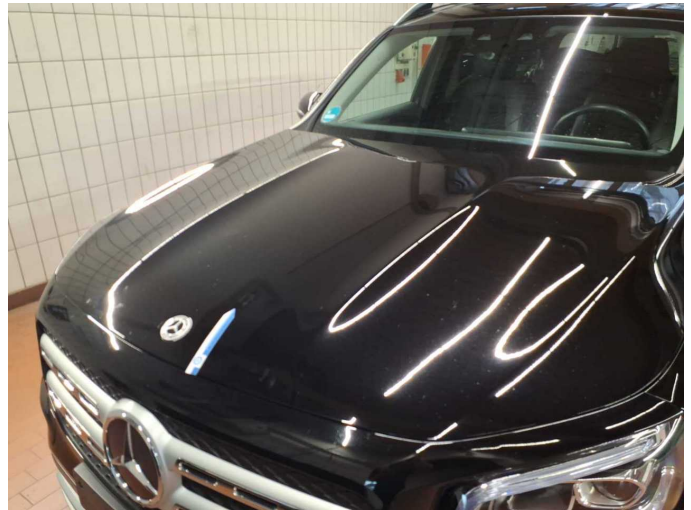
**Damage 2:** Bonnet: Bonnet (Folgekosten möglich) - Soiled - Conditioning

| No. | Component group | Description |
|---|---|---|
| 2 | Bonnet | Bonnet (Folgekosten möglich) - Soiled - Conditioning |

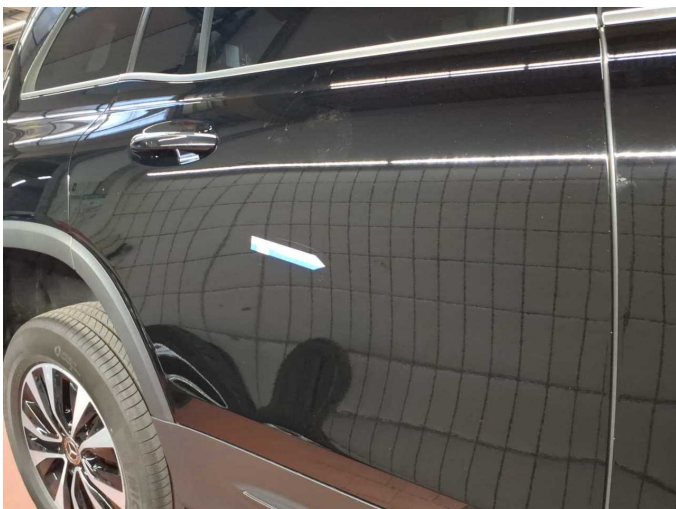
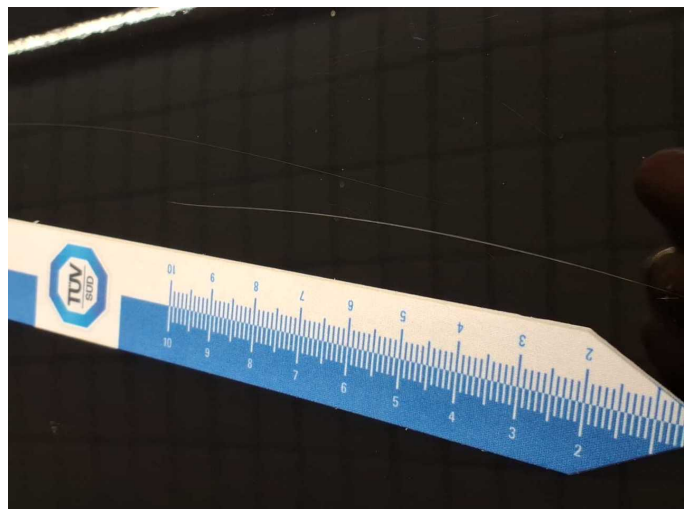
**Damage 3:** Door - rear right side: Door - Scratch(es) - Paint

| No. | Component group | Description |
|---|---|---|
| 3 | Door - rear right side | Door - Scratch(es) - Paint |

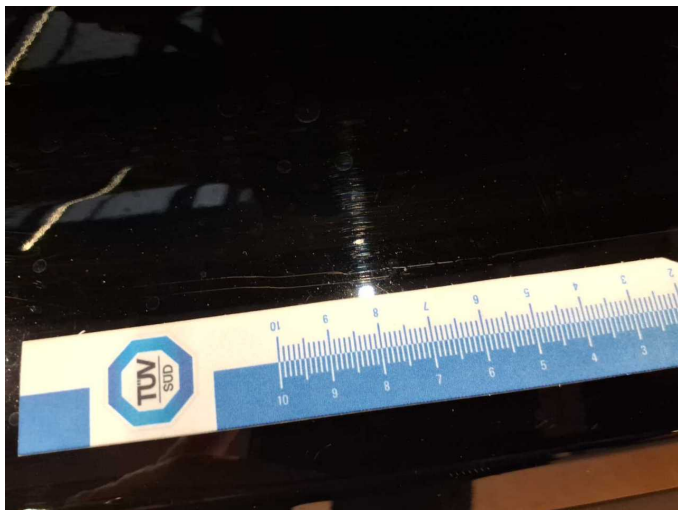
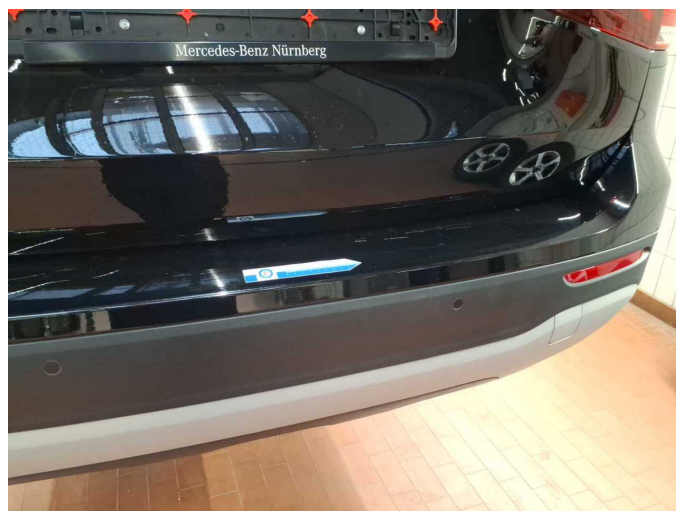
**Wear and tear 2:** Rear bumper: Rear bumper (Ladekante) - Scratch(es) -  
No deduction

| No. | Component group | Description |
|---|---|---|
| 2 | Rear bumper | Rear bumper (Ladekante) - Scratch(es) - No deduction |
