Expertise

Protocol number: 45918261  
Order No. / Reference: 26397475  
Inspection date: 12 Jun 2026

Manufacturer: Mercedes-Benz  
VIN: W1N2539231V341735

Model: GLC 400 d 4Matic 9G-TRONIC AMG Line

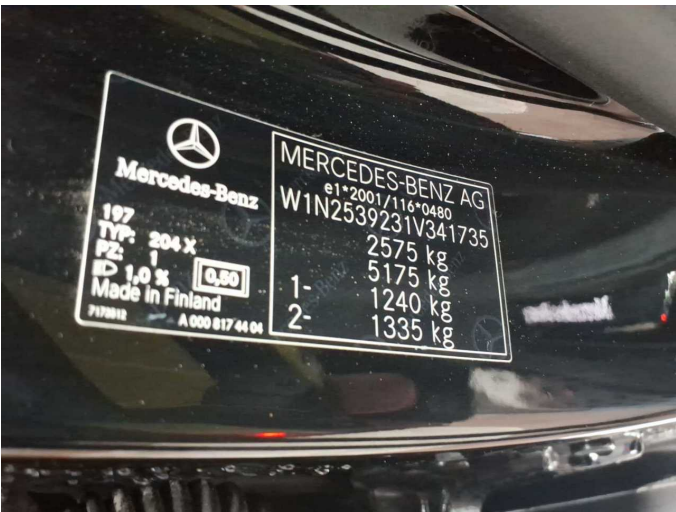
Figure 11: VIN

| VIN comparison | The vehicle identification number (VIN) was read from the vehicle and its conformity with the submitted documents was confirmed by the undersigned during the inspection. |

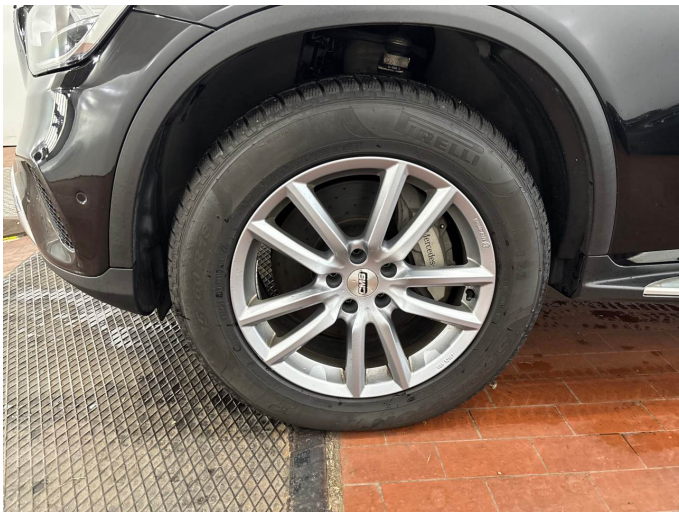
Figure 12: Mounted tyres

| Tyres | | | | |
|---|---|---|---|---|
| 1) | 235/60 R18 103H | Winter tyres on Light alloy | Pirelli | 6mm / 6mm |
| 2) | 235/60 R18 103H | Winter tyres on Light alloy | Pirelli | 5mm / 5mm |

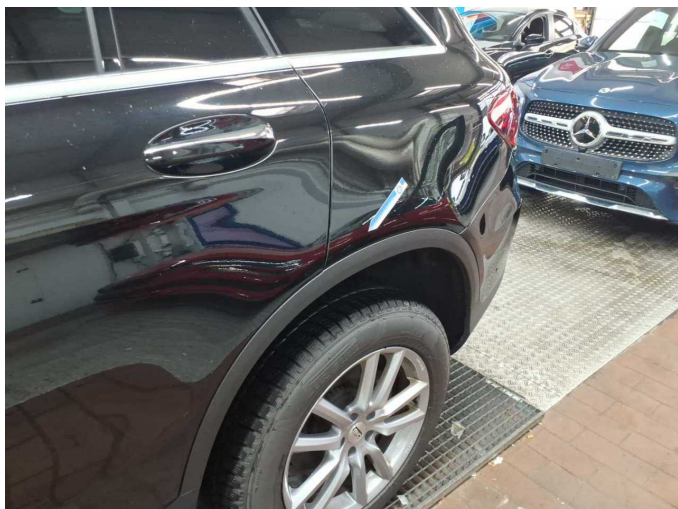
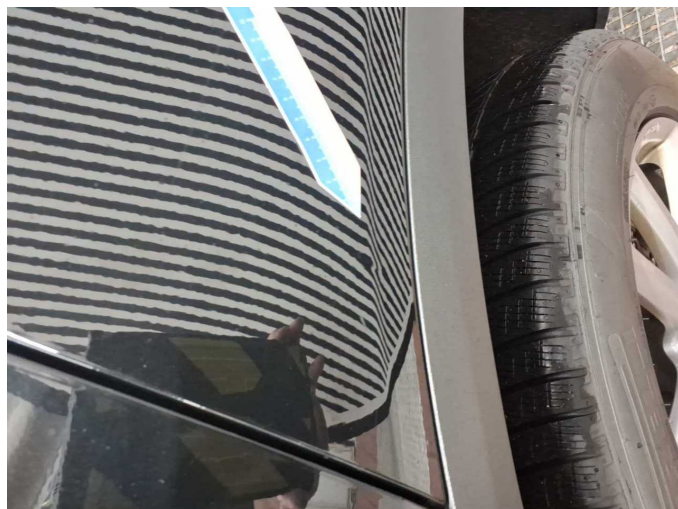
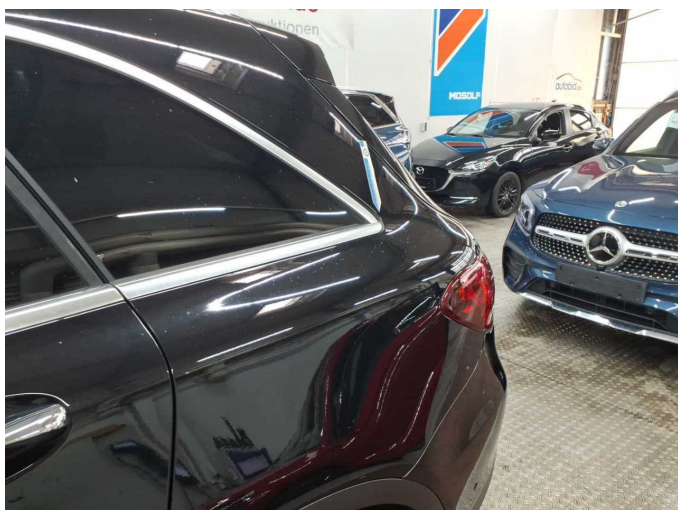
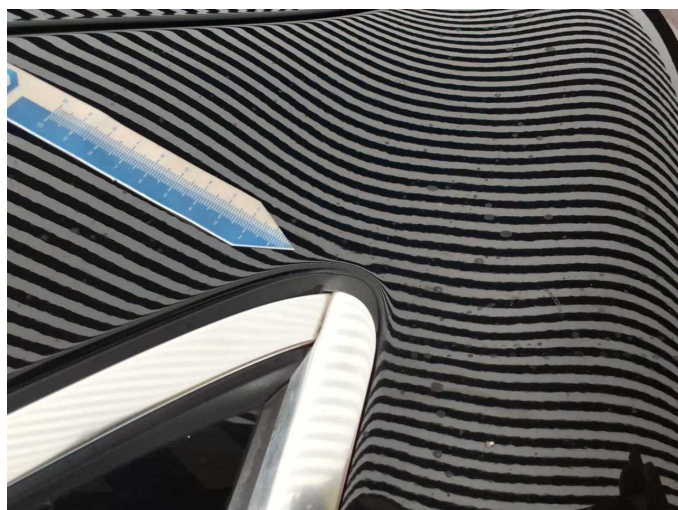
| No. | Component group | Description |
|---|---|---|
| 1 | Side panel - rear left side | Side panel (Kante) - dent(s) - Paint |

**Damage 1:** Side panel - rear left side: Side panel (Kante) - dent(s) - Paint

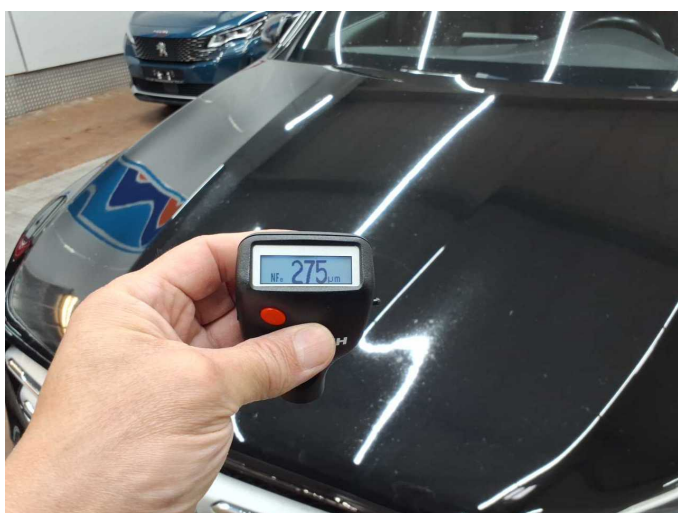
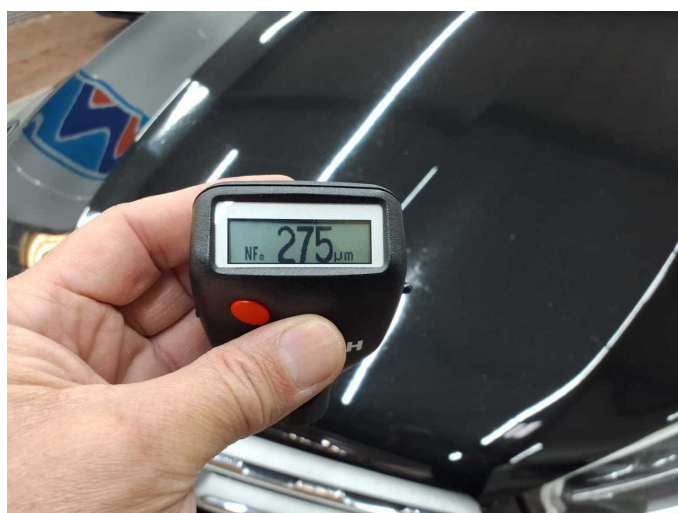
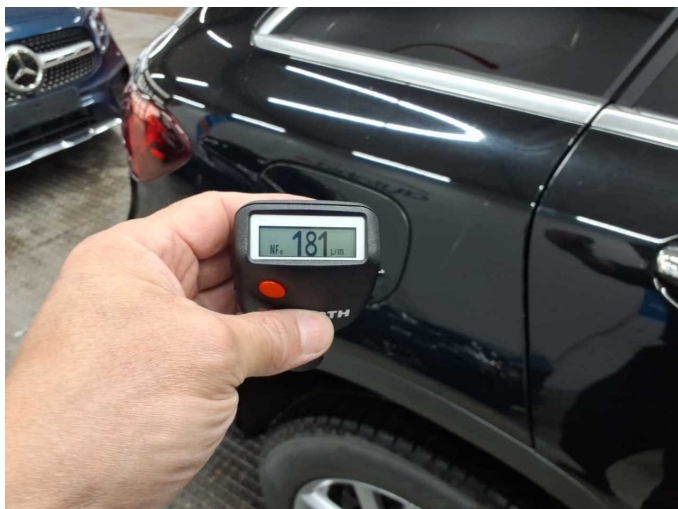
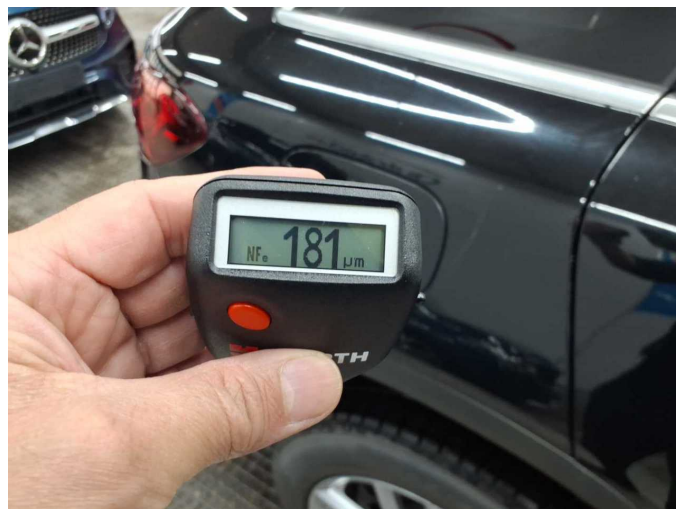
| No. | Repainting |
|---|---|
| 1 | Bonnet, Side panel - rear right side, Professionally carried out |

| Bonnet | 275 µm | Side panel - rear right side | 181 µm |

**Repainting 1:** Bonnet, Side panel - rear right side
