Expertise

Protocol number: 46635743  
Order No. / Reference: 26724018  
Inspection date: 21 Jul 2026

Model: A5 Sportback 35 TDI S tronic S line

VIN: WAUZZZF52NA036386

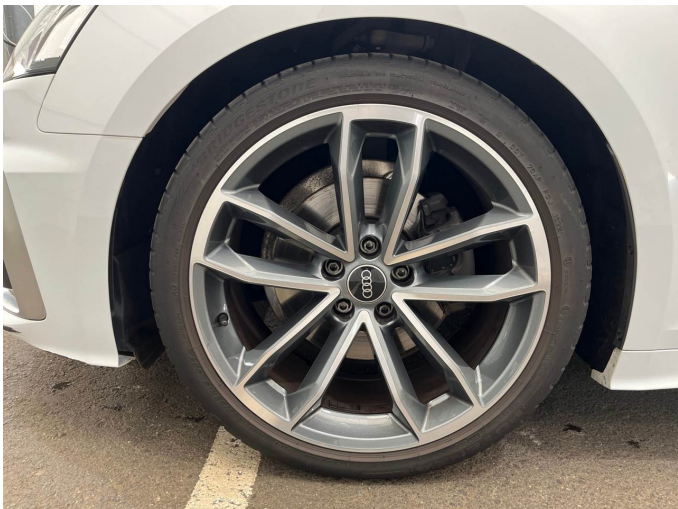
| # | Tyre size | Type of tyre | Manufacturer | Tread depth |
|---|---|---|---|---|
| 1) | 225/35 R19 96Y | Summer tyres on Light alloy | Bridgestone | 6mm / 6mm |
| 2) | 255/35 R19 96Y | Summer tyres on Light alloy | Bridgestone | 7mm / 7mm |

Figure 12: Mounted tyres

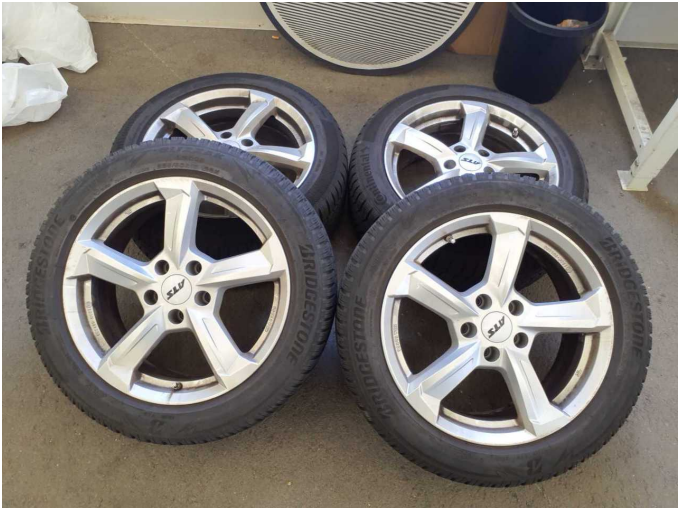
| # | Tyre size | Type of tyre | Manufacturer | Tread depth |
|---|---|---|---|---|
| 1) | 225/50 R17 98H | Winter tyres on Light alloy | Bridgestone | 5mm / 5mm |
| 2) | 225/50 R17 98H | Winter tyres on Light alloy | Continental | 6mm / 6mm |

Figure 16: Additional tyres

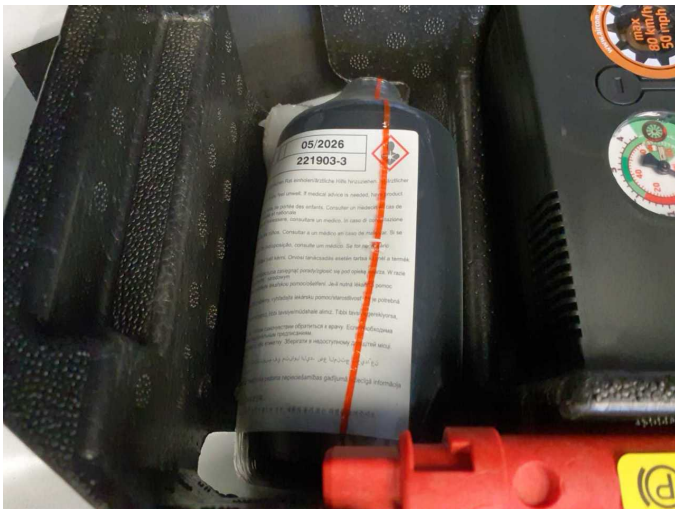
| No. | Component group | Description |
|---|---|---|
| 1 | Equipment | Tirefit filler - Expired - Replace |

Damage 1: Equipment: Tirefit filler - Expired - Replace

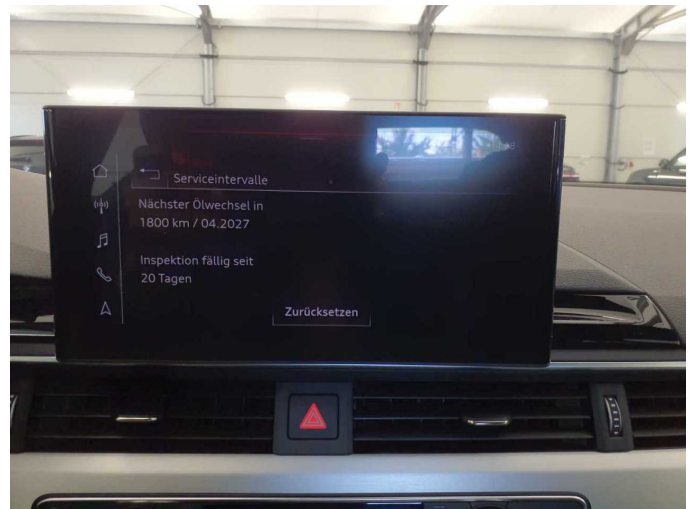
| <b>Maintenance booklet / proof</b> | digital proof / complete | <b>Next maintenance in</b> | -20 Tag(e) |

| No. | Component group | Description |
|---|---|---|
| 3 | Misc. | Inspection / maintenance - Due - Perform |

Damage 3: Misc.: Inspection / maintenance - Due - Perform

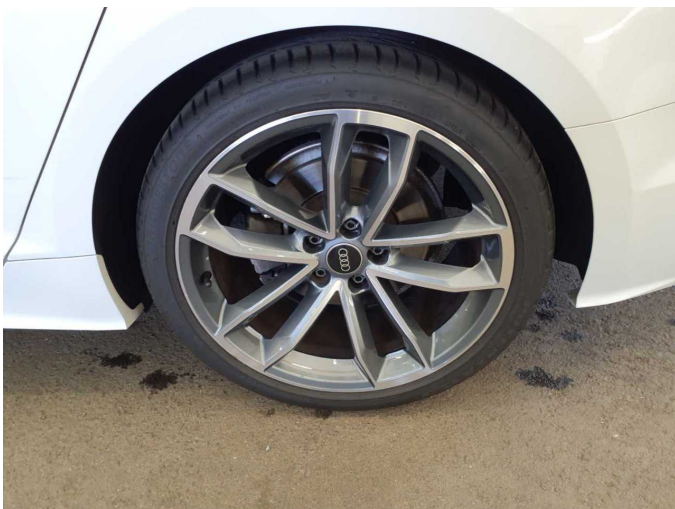
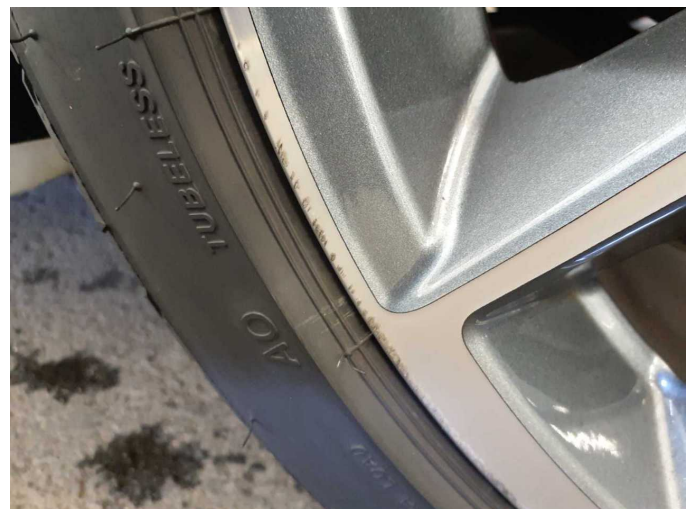
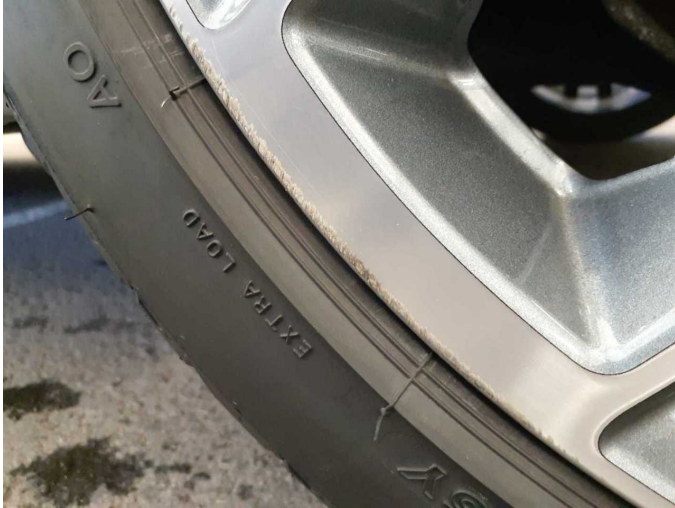
| No. | Component group | Description |
|---|---|---|
| 4 | Wheel / tyres | Alloy rim - rear left side - Scratched - Replace |

Damage 4: Wheel / tyres: Alloy rim - rear left side - Scratched - Replace

**Damage 4:** Wheel / tyres: Alloy rim - rear left side - Scratched - Replace

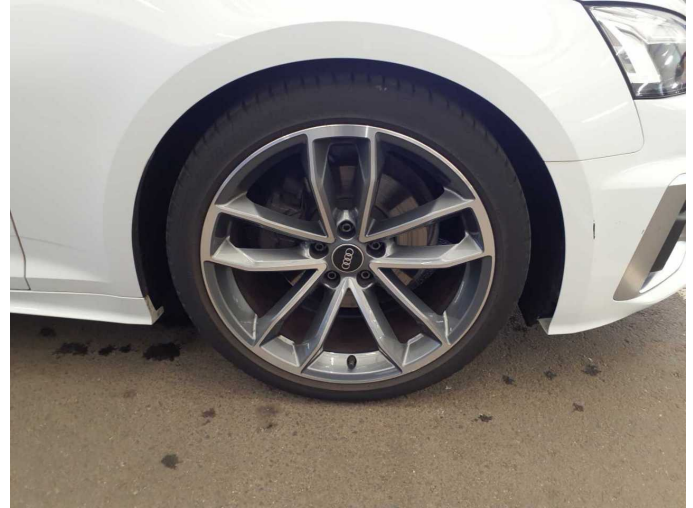
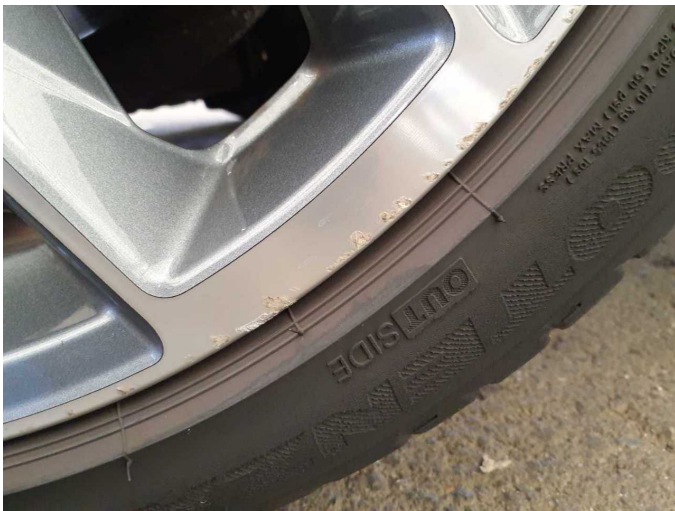
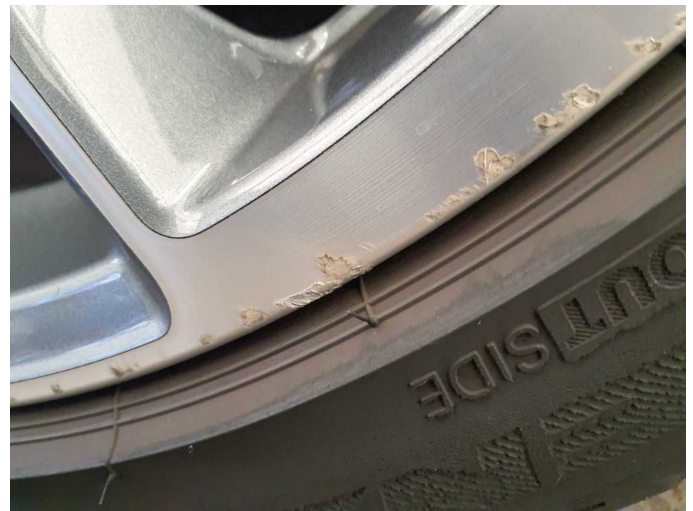
| No. | Component group | Description |
|---|---|---|
| 5 | Wheel / tyres | Alloy rim - front right side - Scratched - Replace |

**Damage 5:** Wheel / tyres: Alloy rim - front right side - Scratched - Replace

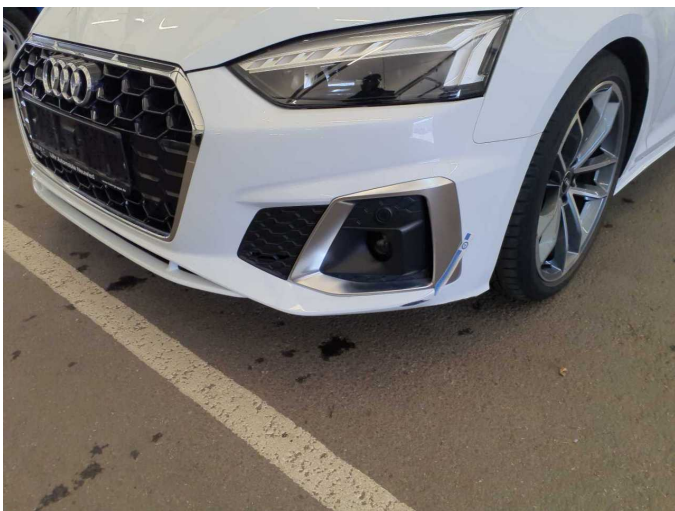
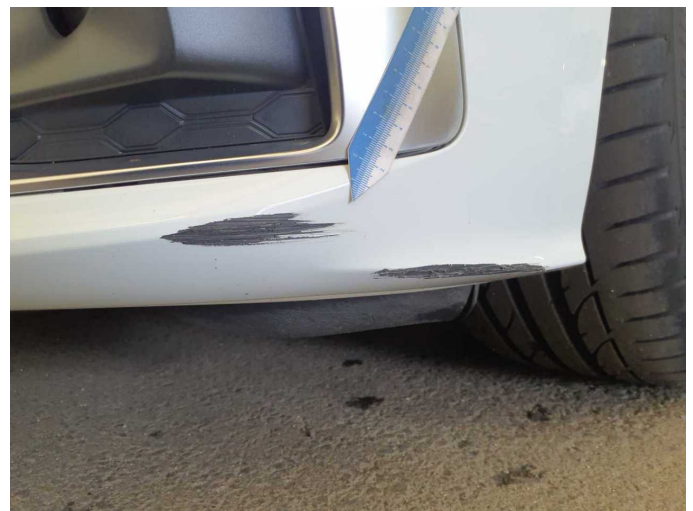
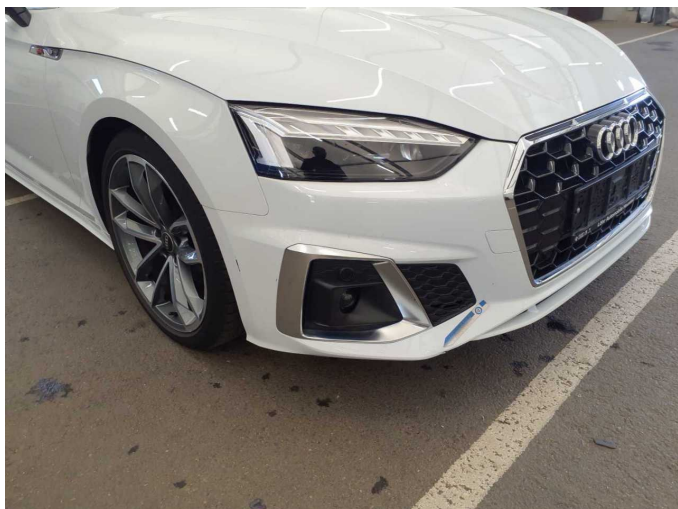
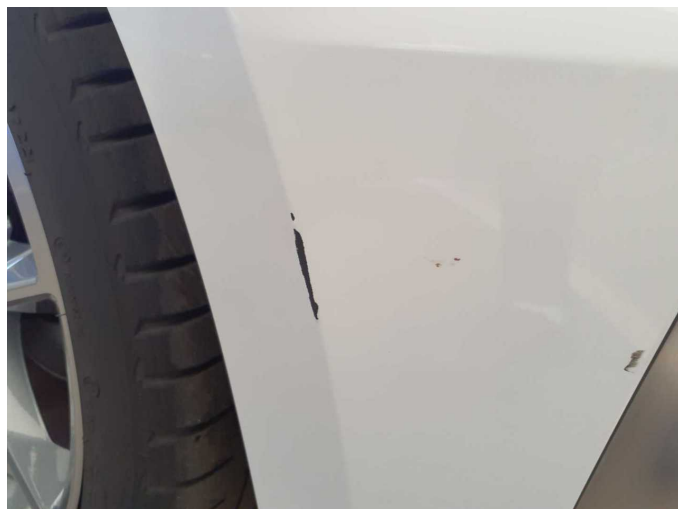
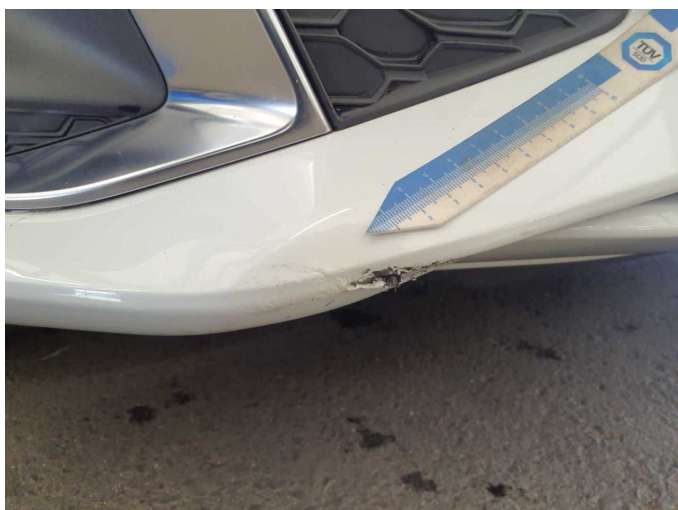
| No. | Component group | Description |
|---|---|---|
| 6 | Front bumper | Front bumper - Scratch(es) - Repair and paint |

**Damage 6:** Front bumper: Front bumper - Scratch(es) - Repair and paint

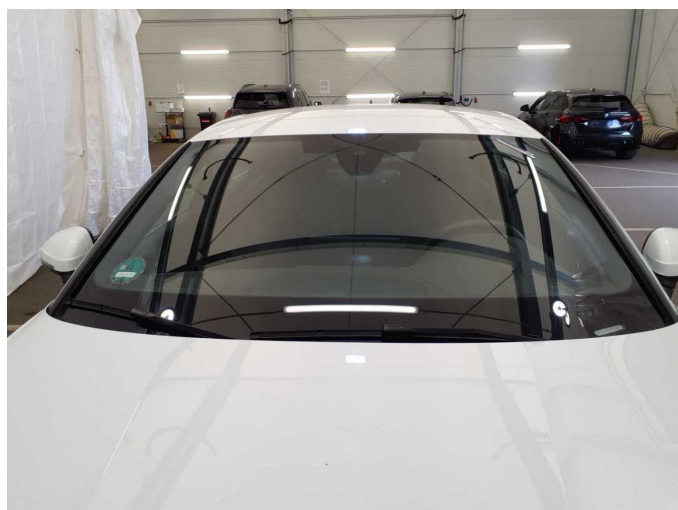
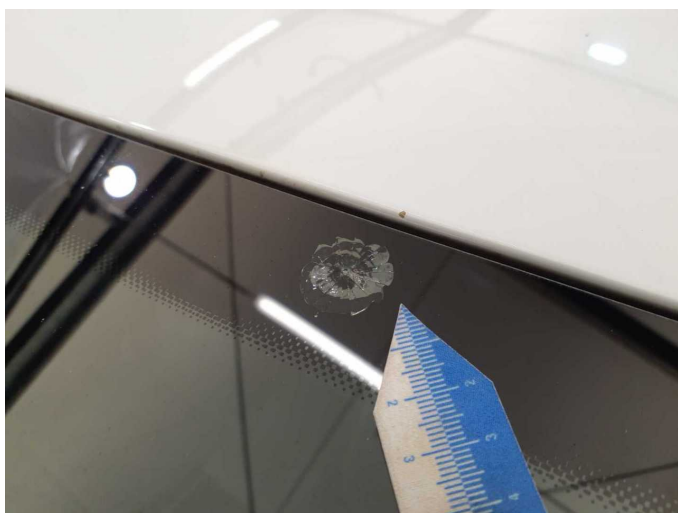
| No. | Component group | Description |
|---|---|---|
| 7 | Vehicle glazing | Windscreen with lane departure assistant - Stone chips - Replace |

**Damage 7:** Vehicle glazing: Windscreen with lane departure assistant - Stone chips - Replace
